# Arboricultural Consultancy for Aviva - Commercial

| Insured | Reading Spiritualist Church | Address | 81 Baker Street, Reading, RG1 7XY | | |
| ES Ref | SA-245627 | Consultant | Giles Mercer | Contact No. | 0330 380 1036 |
| Report Date | 14/01/2020 | | | | |

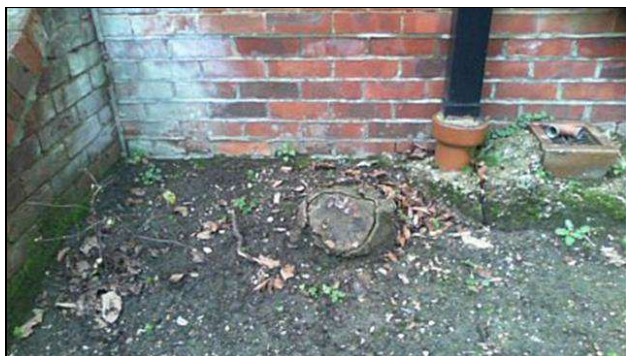
ST1 - Other

| Tree No. | Species | Age Cat | Approx. Height (m) | Distance to Building (m) * | Ownership | Action | Requirement |
|---|---|---|---|---|---|---|---|
| ST1 | Stump | 1 | 0.2 | 0.2 | C - Insured | No action | No works. |

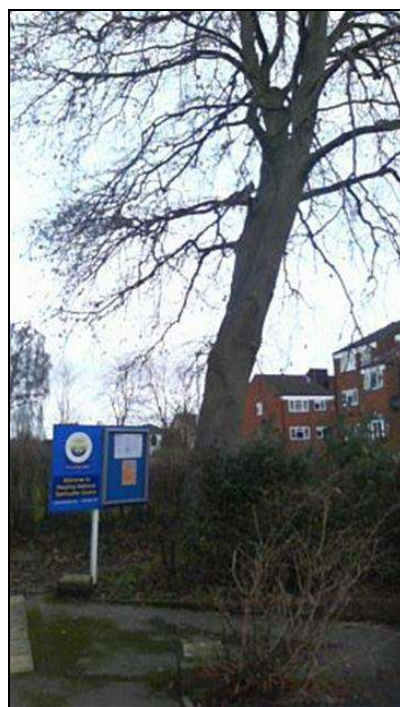
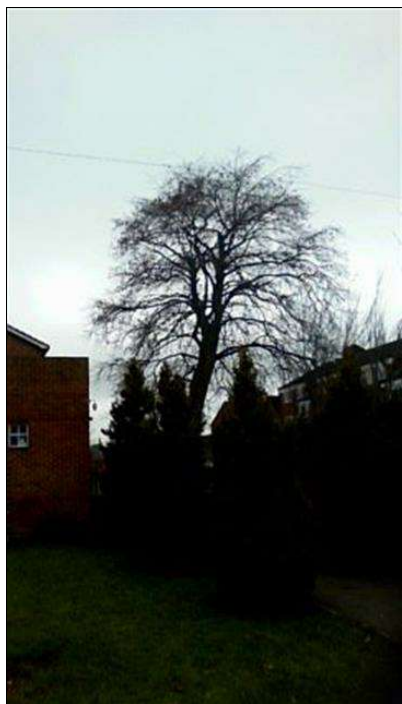
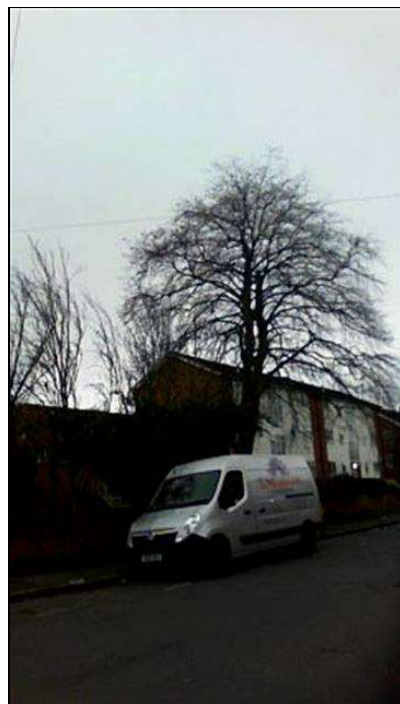
T1 - Beech

Removal of the Beech (T1) will offer the most certain and reliable arboricultural solution likely to restore long-term stability.

| Tree No. | Species | Age Cat | Approx. Height (m) | Distance to Building (m) * | Ownership | Action | Requirement |
|---|---|---|---|---|---|---|---|
| T1 | Beech | 3 | 15.6 | 4.6 | C - Insured | Remove | Remove close to ground level and treat stumps to inhibit regrowth. |

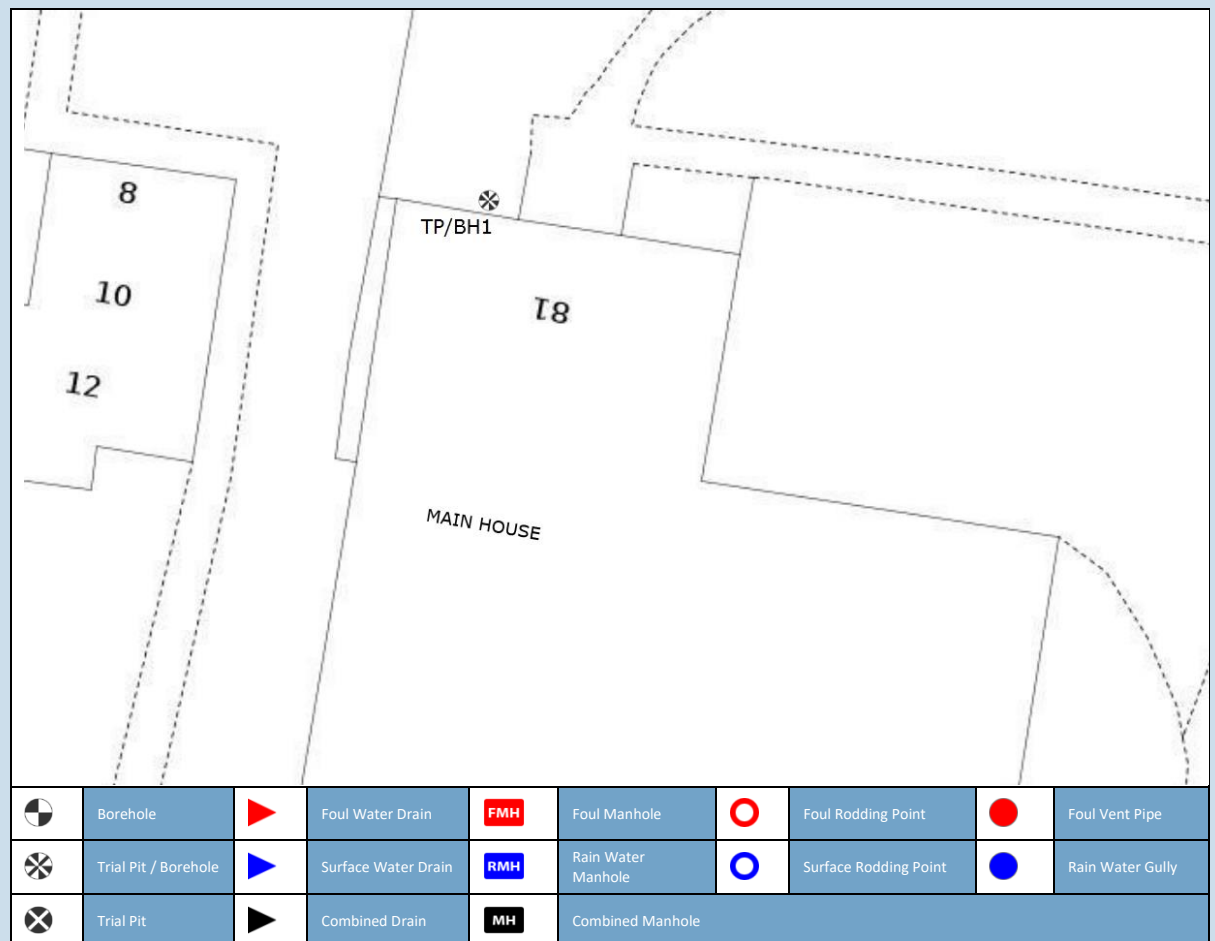
### Site Plan

House foundation was exposed and the underside of foundation (USF) recorded to be 0.65m bgl (TP/BH 1).

Roots encountered to 1.7m bgl (TP/BH 1).
