**Page & John Kendrick/ Addington Road & Haines Faculty (South Side of School)**

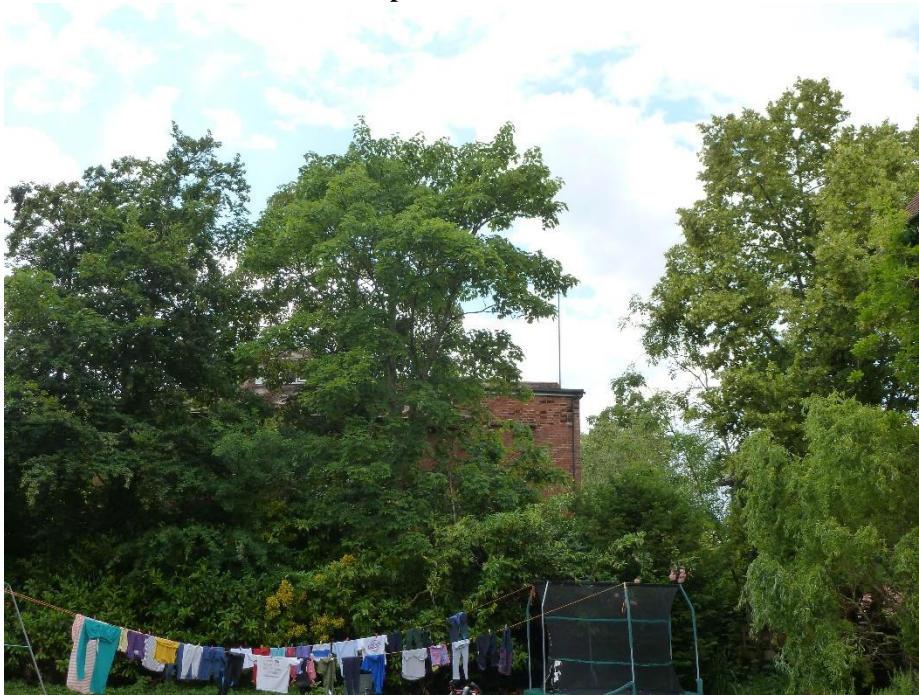
Grp 14

| No | Species | Tree Works Recommended |
|---|---|---|
| Grp 14<br><br>C grade | Sycamore<br>Ash<br>Beech<br>Lime<br>Plum<br>Elm<br>+ evergreen shrubs | <u>Basal Areas:</u> <ul style="list-style-type: none"> <li>• Unable to access due to dense vegetation and Ivy smothering bases.</li> </ul> <u>Trunks:</u> <ul style="list-style-type: none"> <li>• Unable to access due to dense vegetation and Ivy smothering bases.</li> </ul> <u>Crowns:</u> <ul style="list-style-type: none"> <li>• Crown shapes dictated by group pressures.</li> <li>• There is a Tree House in the Sycamore at the northern end of the group.</li> </ul> <b>Conclusions:</b> <ul style="list-style-type: none"> <li>• Will need to deal with the Ivy and access issues.</li> </ul> <b>Recommendations:</b> <ul style="list-style-type: none"> <li>• <i>Clear a route to tree bases and sever the Ivy.</i></li> </ul> |

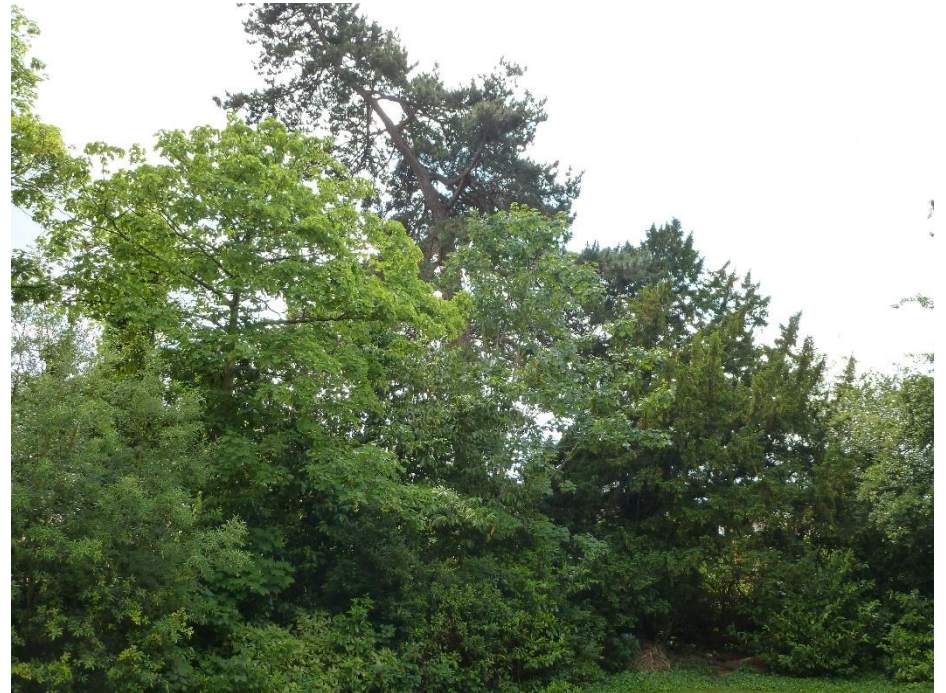
T45

| No | Species | Tree Works Recommended |
|---|---|---|
| T45<br><br>B grade | English Yew<br><i>Taxus baccata</i> | <u>Basal Area:</u> <ul style="list-style-type: none"> <li>• The basal area was sounded and no evidence of internal decay and hollowing was recorded.</li> </ul> <u>Trunk:</u> <ul style="list-style-type: none"> <li>• Found to be sound and healthy.</li> </ul> <u>Crown:</u> <ul style="list-style-type: none"> <li>• Some Chlorosis and yellowing of foliage and sparseness to crown overall.</li> <li>• Has improved slightly since my last visit three years ago.</li> </ul> <b>Conclusions:</b> <ul style="list-style-type: none"> <li>• No works required at this time.</li> </ul> <b>Recommendations:</b> <ul style="list-style-type: none"> <li>• No works required at this time.</li> </ul> |

| No | Species | Tree Works Recommended |
|---|---|---|
| T46<br><br>B<br>grade | <b>Corsican Pine</b><br><i>Pinus nigra var. Maritima</i> | <u>Basal Area:</u> <ul style="list-style-type: none"> <li>Unable to verify health and safety due to dense Ivy smothering.</li> </ul> <u>Trunk:</u> <ul style="list-style-type: none"> <li>Unable to verify health and safety due to dense Ivy smothering.</li> </ul> <u>Crown:</u> <ul style="list-style-type: none"> <li>Flat topped and sparse and typical of this type of conifer – some large dead branches above road.</li> </ul> <b>Conclusions:</b> <ul style="list-style-type: none"> <li>Will need to deal with the Ivy.</li> </ul> <b>Recommendations:</b> <ul style="list-style-type: none"> <li><i>Sever Ivy and then re-inspect.</i></li> </ul> |

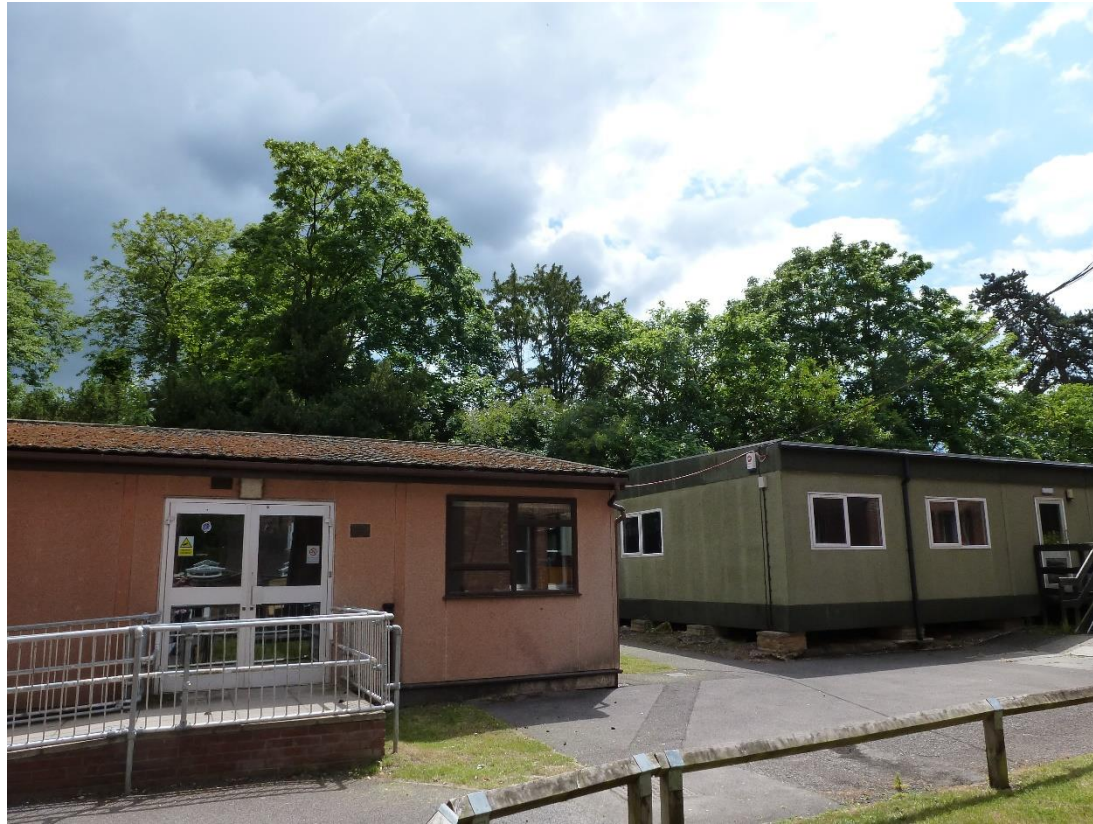
## Grp 16

| No | Species | Tree Works Recommended |
|---|---|---|
| Grp<br>16<br><br>C<br>grade | <b>Sycamore</b><br><b>Holly</b><br><b>Norway Maple</b><br><b>Laurel and other evergreen shrubs</b> | <u>Basal Areas:</u> <ul style="list-style-type: none"> <li>Sound and healthy overall but there is significant decay in the base of the Norway Maple.</li> </ul> <u>Trunks:</u> <ul style="list-style-type: none"> <li>Found to be sound and healthy overall.</li> </ul> <u>Crowns:</u> <ul style="list-style-type: none"> <li>Crown shapes dictated by group pressures.</li> <li>Low branching habit to Laurels and Sycamores affecting building roof.</li> <li>Dead top to Yew tree at eastern end of the grouping.</li> </ul> <b>Conclusions:</b> <ul style="list-style-type: none"> <li>Need to deal with branches touching the roof and also remove dead tops.</li> </ul> <b>Recommendations:</b> <ul style="list-style-type: none"> <li><i>Crown lift to clear roof of classroom</i></li> <li><i>Remove the dead top of the Yew tree</i></li> </ul> |

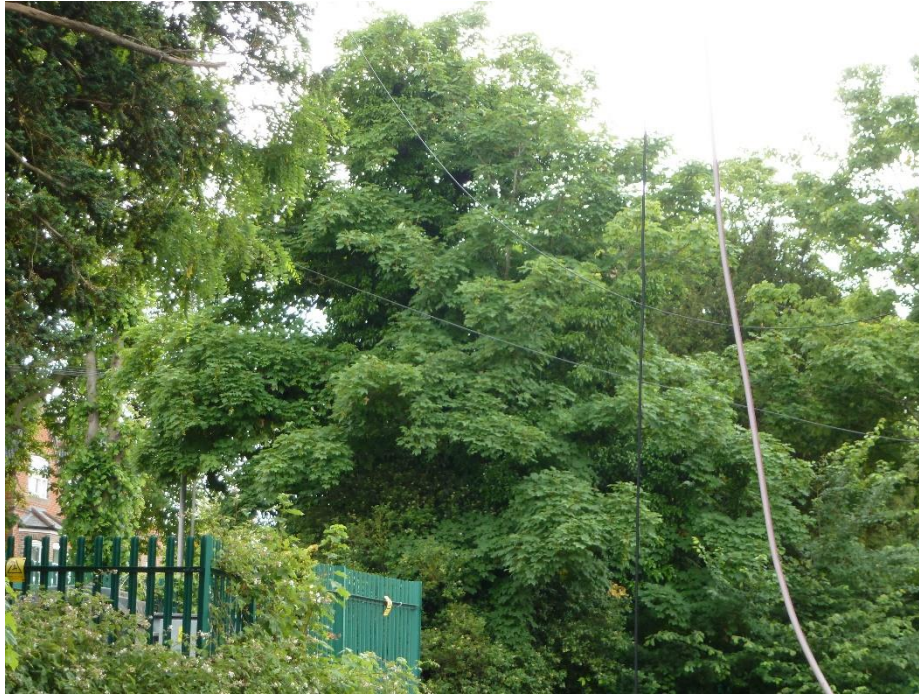
T49

| No | Species | Tree Works Recommended |
|---|---|---|
| T49<br><br>- | False Acacia<br><i>Robinia pseudoacacia</i> | <ul style="list-style-type: none"> <li>This tree has been removed.</li> </ul> |

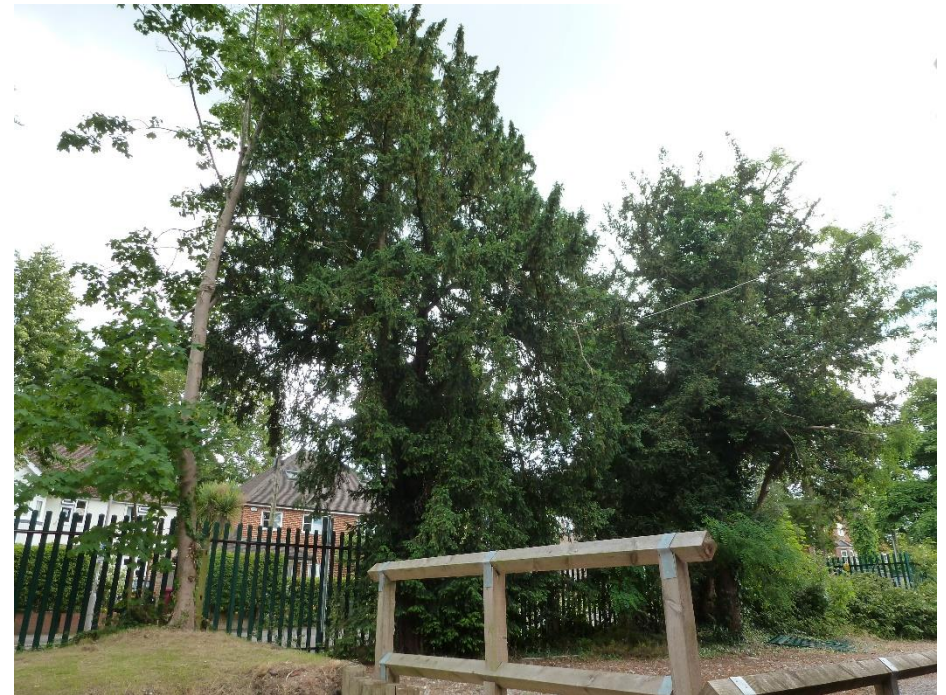
| No | Species | Tree Works Recommended |
|---|---|---|
| T47<br><br>C<br>grade | <b>Sycamore</b><br><i>Acer pseudoplatanus</i> | <p><u>Basal Area:</u></p> <ul style="list-style-type: none"> <li>The basal area was sounded and no evidence of internal decay and hollowing was recorded.</li> </ul> <p><u>Trunk:</u></p> <ul style="list-style-type: none"> <li>Dead Ivy clinging to the trunk.</li> </ul> <p><u>Crown:</u></p> <ul style="list-style-type: none"> <li>Dead Ivy overhangs the highway.</li> </ul> <p><b>Conclusions:</b></p> <ul style="list-style-type: none"> <li>Will need to deal with the dead Ivy for safety reasons.</li> </ul> <p><b>Recommendations:</b></p> <ul style="list-style-type: none"> <li><i>Remove dead Ivy from trunk for safety reasons.</i></li> </ul> |

| No | Species | Tree Works Recommended |
|---|---|---|
| T50<br><br>C<br>grade | English Yews<br><i>Taxus baccata</i><br>x 2 of | <p><u>Basal Area:</u></p> <ul style="list-style-type: none"> <li>The basal areas were sounded and no evidence of internal decay and hollowing was recorded.</li> </ul> <p><u>Trunk:</u></p> <ul style="list-style-type: none"> <li>Found to be sound and healthy.</li> </ul> <p><u>Crown:</u></p> <ul style="list-style-type: none"> <li>Saplings have mostly been removed so these Yews should now improve over the coming years.</li> <li>Major deadwood in the crown above the road and parking bays.</li> </ul> <p><b>Conclusions:</b></p> <ul style="list-style-type: none"> <li>Will need to deal with the deadwood for safety reasons.</li> </ul> <p><b>Recommendations:</b></p> <ul style="list-style-type: none"> <li><b>Remove ALL dead branches and dieback.</b></li> </ul> |

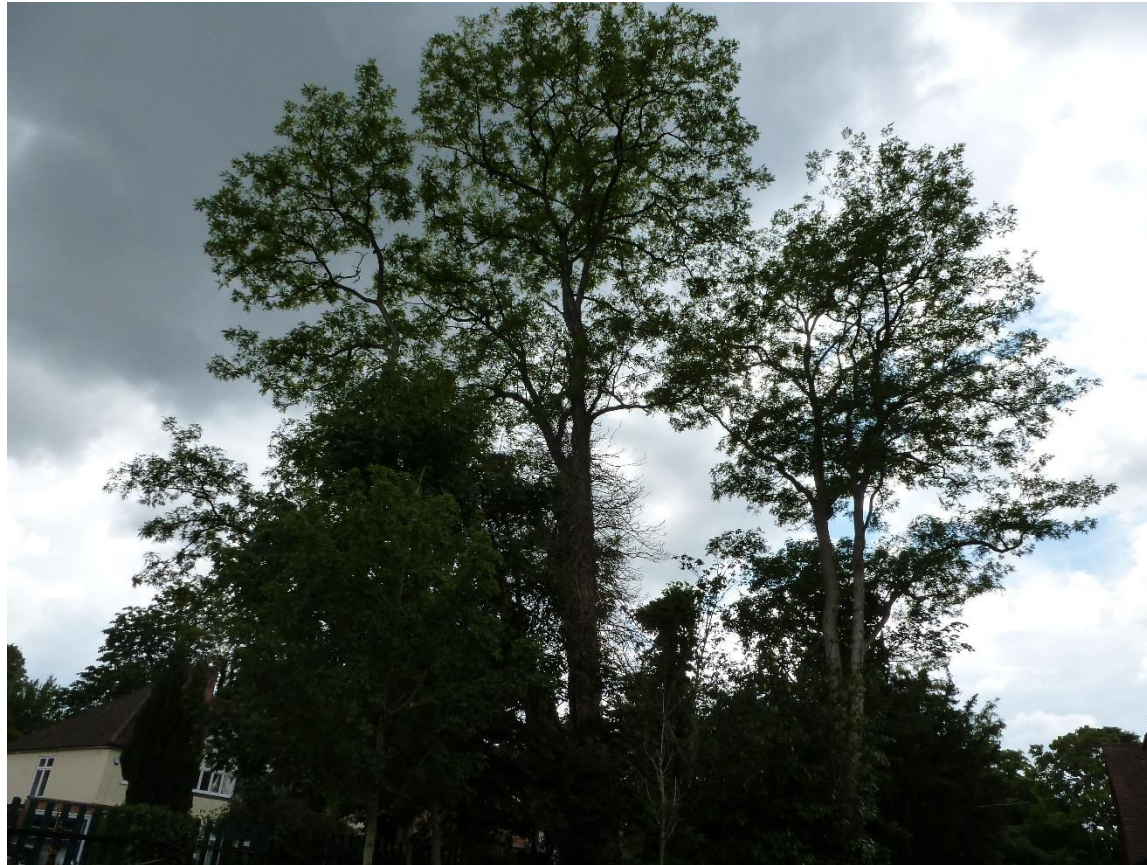
| No | Species | Tree Works Recommended |
|---|---|---|
| T51<br><br>- | <b>False Acacia</b><br><i>Robinia pseudoacacia</i> | <ul style="list-style-type: none"> <li>Has very recently been removed for safety reasons.</li> </ul> |

| No | Species | Tree Works Recommended |
|---|---|---|
| T51a<br><br>- | <b>False Acacia</b><br><i>Robinia pseudoacacia</i> | <ul style="list-style-type: none"> <li>This tree has been removed.</li> </ul> |

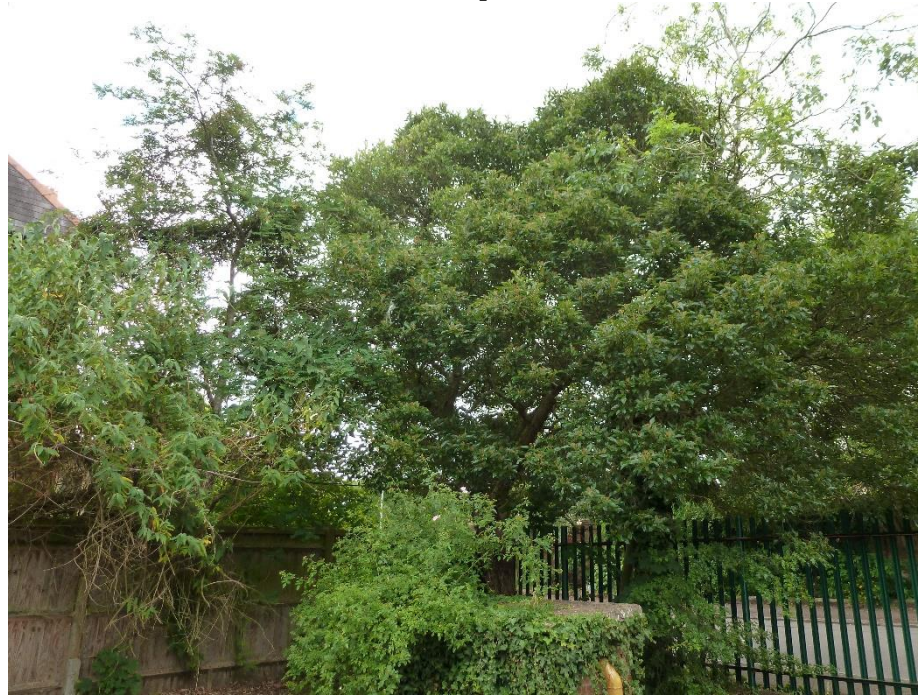
Grp 19

| No | Species | Tree Works Recommended |
|---|---|---|
| Grp 19<br><br>B grade | Midland Thorns<br>x 2 of | <p><u>Basal Areas:</u></p> <ul style="list-style-type: none"><li>• Sound and healthy.</li></ul> <p><u>Trunks:</u></p> <ul style="list-style-type: none"><li>• Found to be sound and healthy overall.</li></ul> <p><u>Crowns:</u></p> <ul style="list-style-type: none"><li>• Low branching habit over footpath and parking bays.</li></ul> <p><b>Conclusions:</b></p> <ul style="list-style-type: none"><li>• Low branching habit will need to be addressed for safety reasons.</li></ul> <p><b>Recommendations:</b></p> <ul style="list-style-type: none"><li>• <i>Crown lift to clear from the path and parking bays.</i></li></ul> |
