# Arboricultural Consultancy for Aviva - Commercial

| Insured | Reading Spiritualist Church | Address | 81 Baker Street, Reading, RG1 7XY | | |
| ES Ref | SA-245627 | Consultant | Giles Mercer | Contact No. | 0330 380 1036 |
| Report Date | 14/01/2020 | | | | |

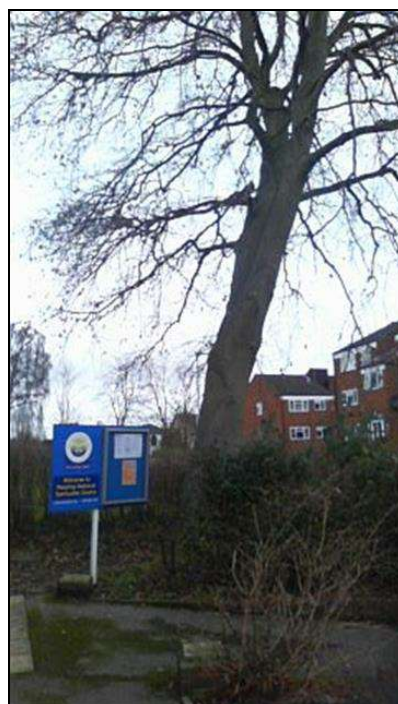
T1 - Beech

In assessing the extent of damage, the potential drying influence of the vegetation on site and based on our site investigations, taking account of vegetation location, relative to the focal area of movement/ damage, it is our opinion that, the Beech (T1) is considered the dominant feature and accordingly we have identified it as the principal cause of the subsidence damage.

Removal of the Beech (T1) will offer the most certain and reliable arboricultural solution likely to restore long-term stability.

| Tree No. | Species | Age Cat | Approx. Height (m) | Distance to Building (m) * | Ownership | Action | Requirement |
|---|---|---|---|---|---|---|---|
| T1 | Beech | 3 | 15.6 | 4.6 | C - Insured | Remove | Remove close to ground level and treat stumps to inhibit regrowth. |
