**20 Clevedon Road  
Tilehurst  
Berkshire  
RG31 6RL**

# **Preliminary Bat Roost Assessment**

*Report prepared by Verity West QCIEEM; reviewed by Vicky Potts MCIEEM*  
**Ref: R3506/a**

**August 2023**

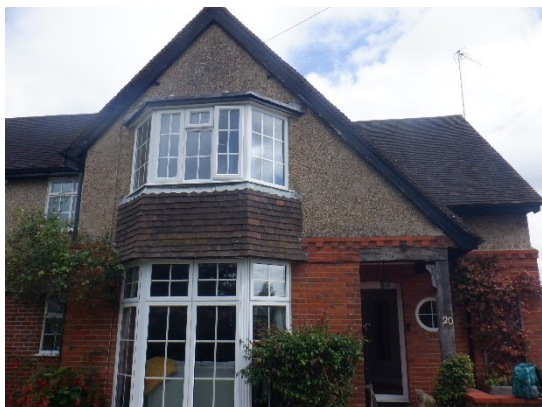
1. Front of property viewed from the southwest.

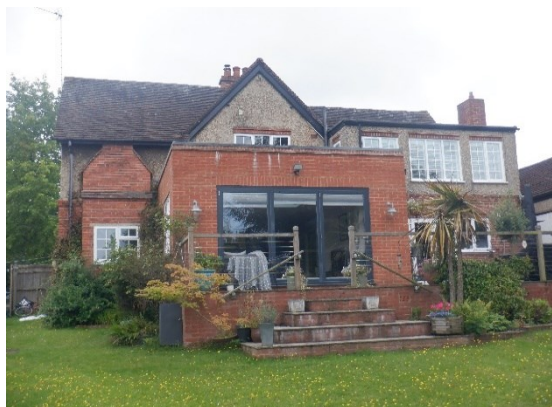
2. Rear of property viewed from the northeast.

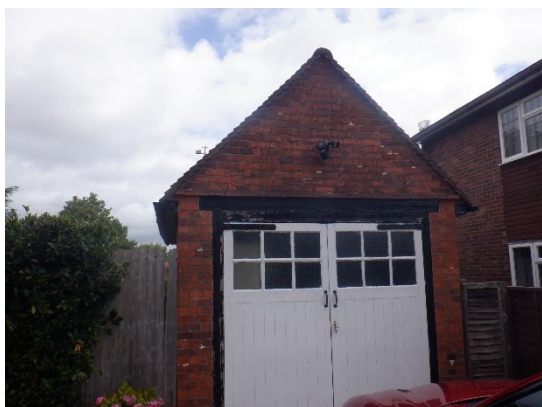
3. Front of the garage viewed from the southwest.

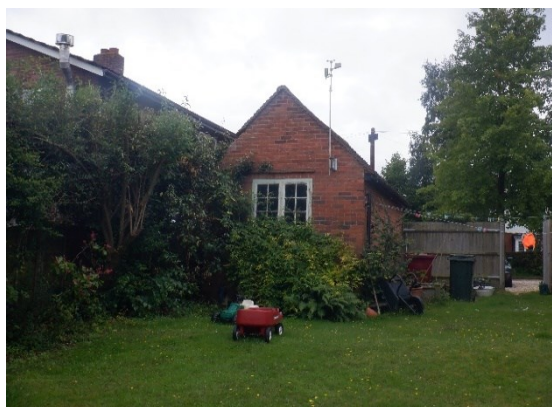
4. Rear of the garage viewed from the northeast.

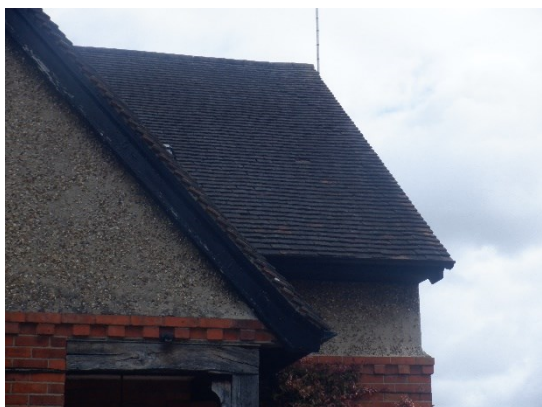
5. Roof tiles with occasionally lifted tiles.

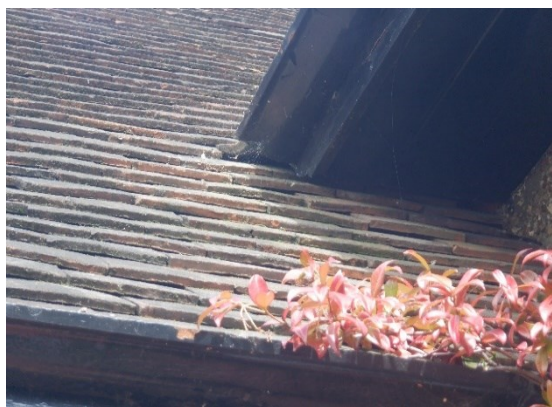
6. Roof tiles with occasionally lifted tiles.

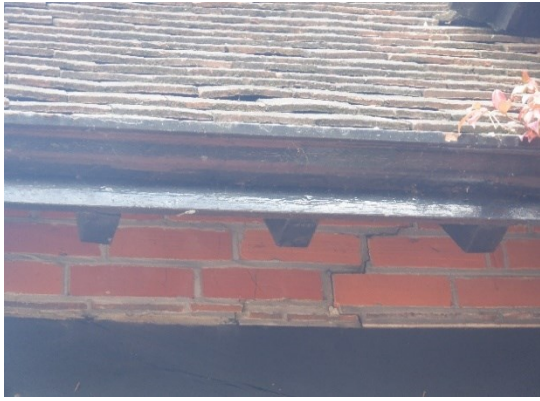
**7. Roof tiles with occasionally lifted tiles.**

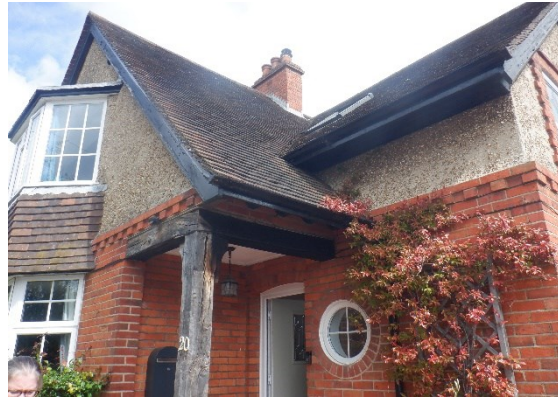
**8. Verge mortar of front gable intact.**

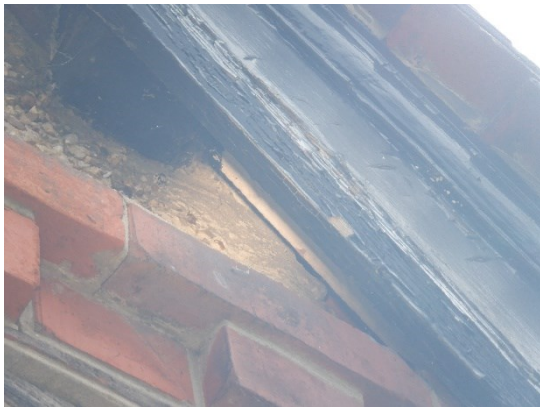
**9. Gap behind front gable barge board.**

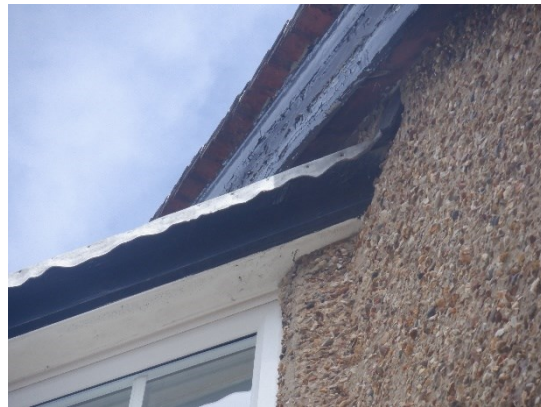
**10. Gaps behind the lead flashings**

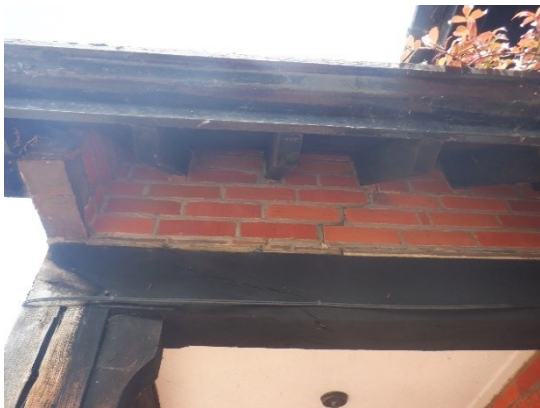
**11. Soffit mostly tight to brickwork throughout.**

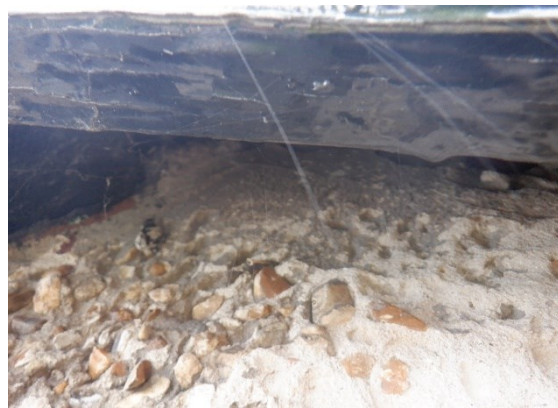
**12. Gap behind soffit on porch investigated thoroughly.**

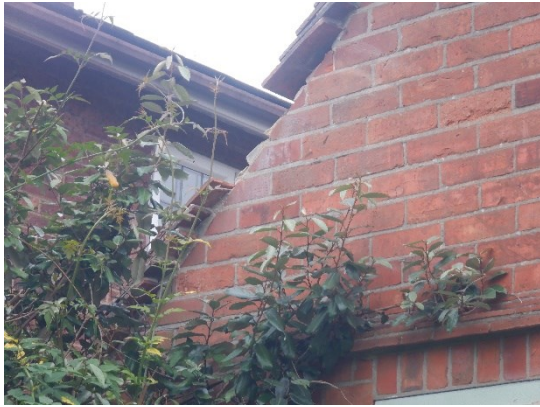
- 4.2.3** The detached garage was of single skin brick construction with a concrete tiled gable roof. There were multiple missing tiles (**Photograph 13; Target note 9**). There was also missing mortar on the verges and brickwork walls (**Photographs 14-15; Target note 10**) and gaps around the timber frame doors at the front (**Photograph 16; Target note 11**). There were gaps behind the soffits which were heavily cobwebbed (**Target note 12**).

**13. Missing tiles on garage roof.**

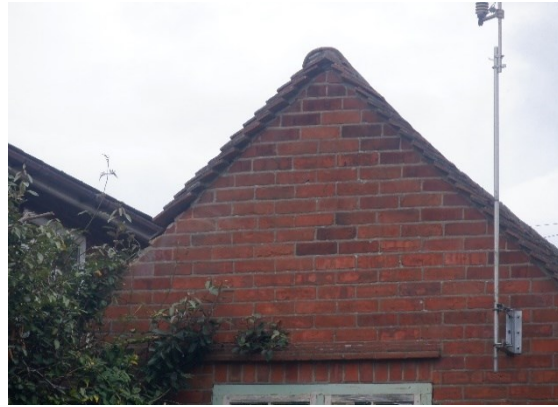
**14. Missing mortar on verges.**

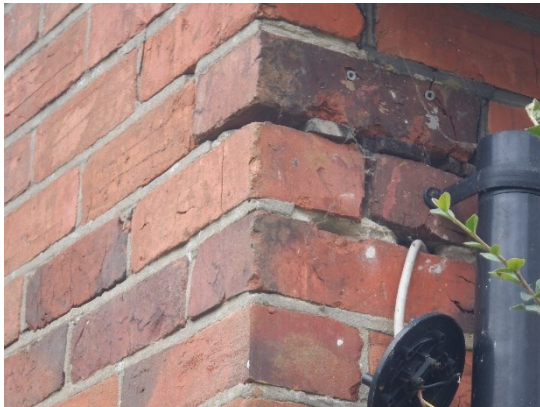
**15. Gaps in the brickwork from missing mortar.**

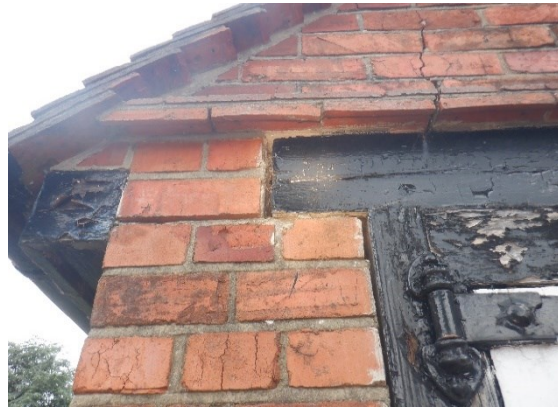
**16. Gaps around timber door frame.**

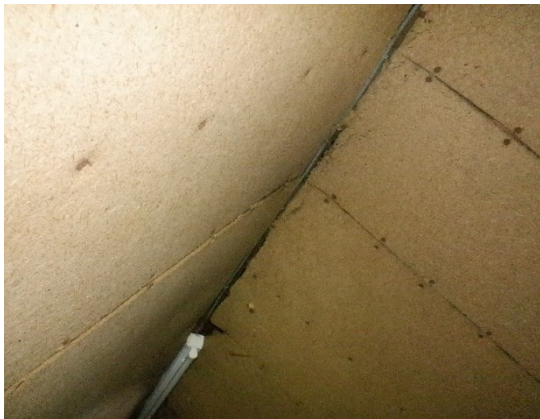
- 4.3.1** The main roof void was boarded over unlined roof tiles, with occasional gaps and gaps in the boards (**Photographs 17-19; Target note 13**). The floor was part-boarded on top of fibreglass insulation (**Photograph 20; Target notes 14-15**). The blockwork gable end had a visible gap at the apex and was heavily cobwebbed (**Photograph 21; Target note 16-17**). The eaves were open and part

**17. Boarded unlined roof tiles in main void.**

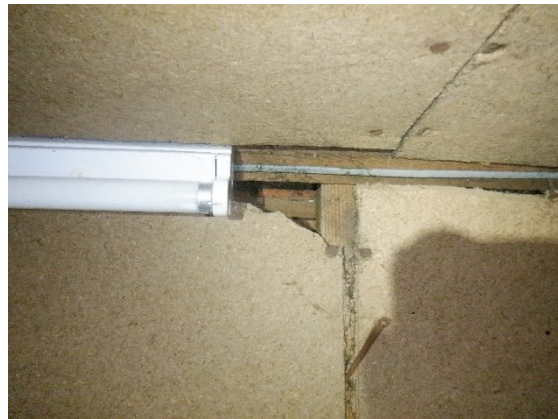
**18. Occasional gaps in boarding.**

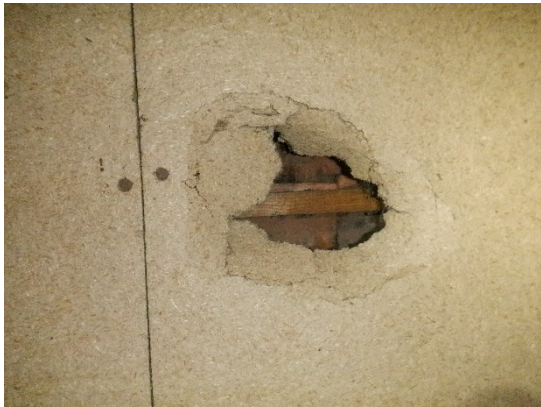
**19. Occasional gaps in boarding.**

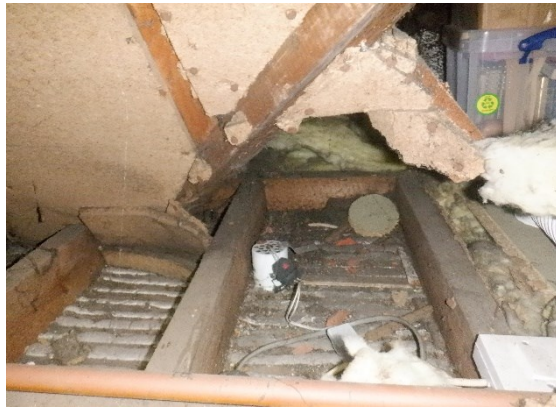
**20. Part boarded floor over fibreglass insulation.**

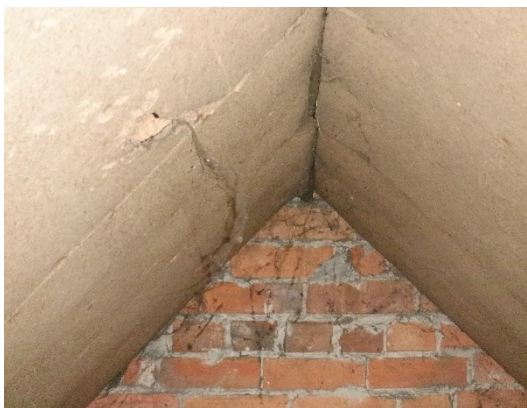
**21. Gap at apex of blockwork gable, heavily cobwebbed.**

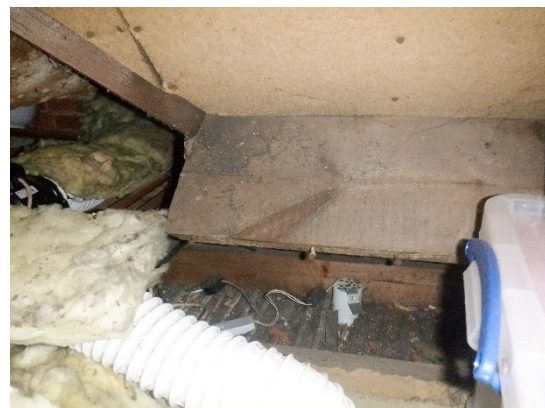
covered with wooden planks (**Photograph 22; Target note 18**). An old wasp nest was visible (**Target note 19**).

**22. Eaves open and part covered with wooden planks.**

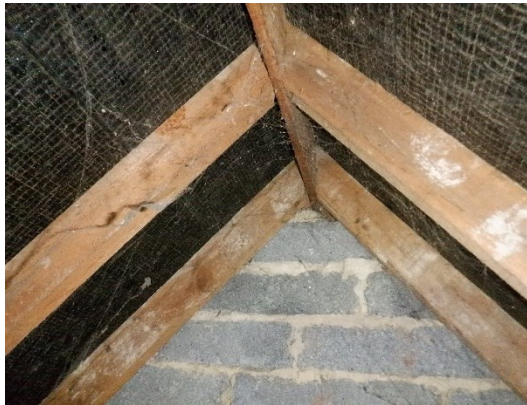
**4.3.2** The smaller second roof void was lined with bitumen reinforced felt liner, which had occasional tears (**Photographs 23-34; Target notes 19-20**). The floor was part boarded over fibreglass insulation, up to and covering the eaves (**Photograph 25; Target notes 21-22**).

**23. Bitumen reinforced felt liner.**

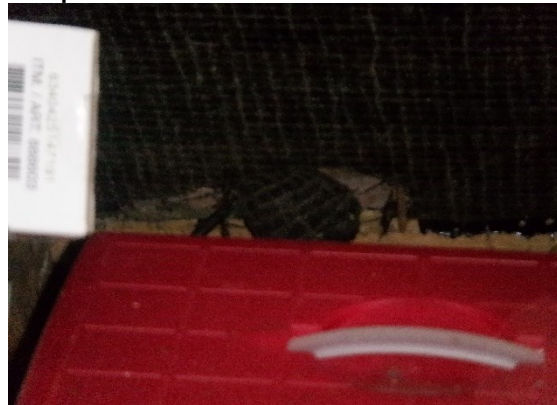
**24. Bitumen reinforced felt liner.**

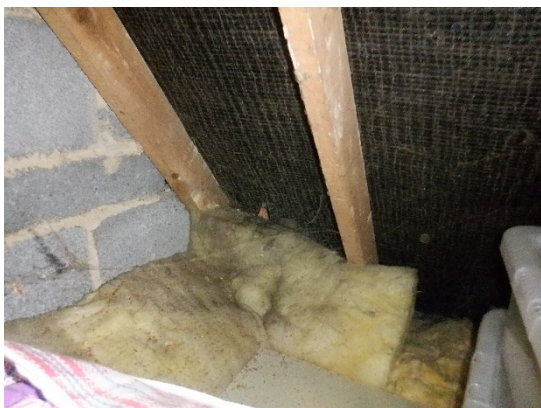
**25. Part boarded over fibreglass insulation.**

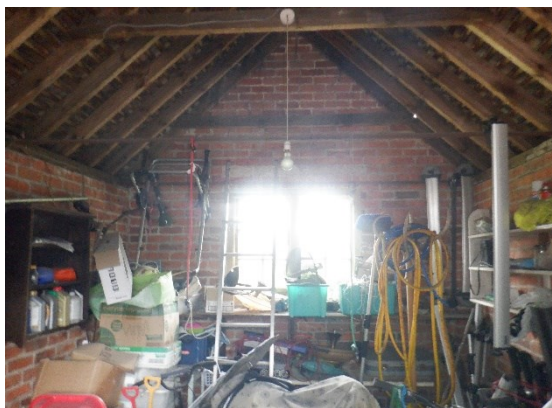
**4.3.3** The garage was open to the roof with unlined tiles where daylight was visible (**Photograph 26; Target notes 23-24**). There were gaps visible at the eaves and vegetation had encroached (**Target notes 25-26**). The space was heavily cobwebbed.

- 5.1.3** The detached garage was considered to have negligible potential for roosting bats, due to the unlined, draughty and heavily cobwebbed features.

**26. Garage internally open and unlined, daylight visible.**

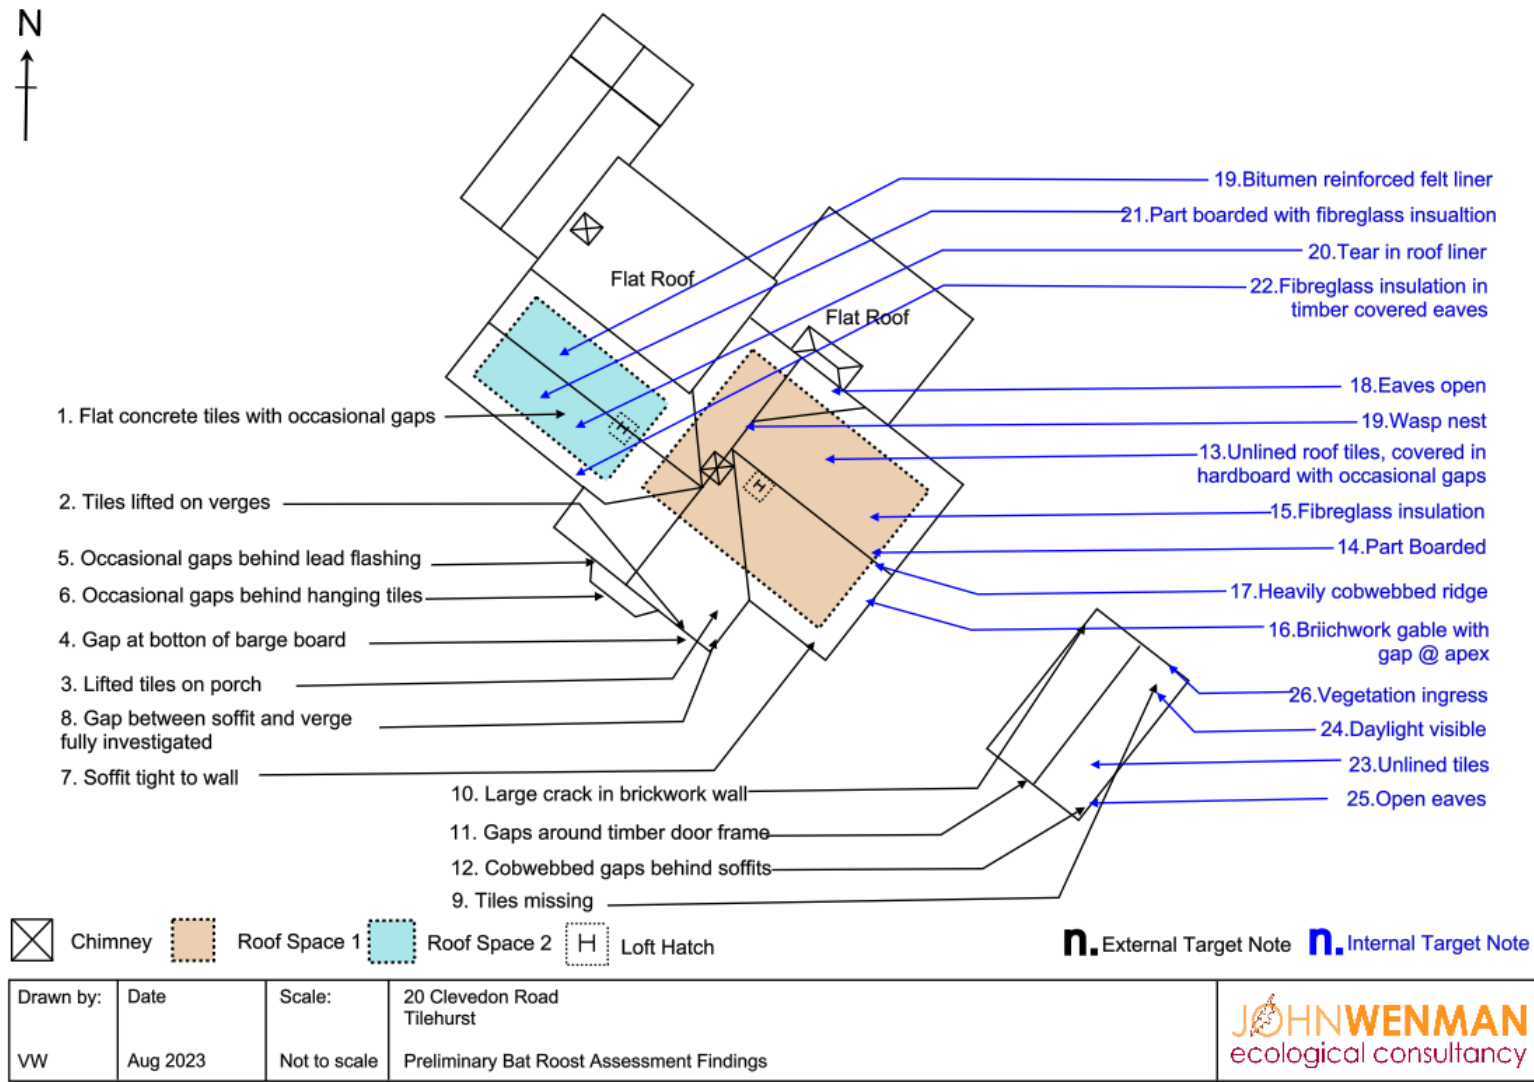
APPENDIX 2 – PRELIMINARY ROOST ASSESSMENT PLAN

- 4.1.1** Photographs of the property are presented in **Appendix 1** and a plan of the external and internal survey findings with associated target notes is shown in **Appendix 2**. The survey findings from the exterior and interior of the property are described as follows:
