# Phase 1 Geo-Environmental Investigation (Desk Study) Draft Report

Land Adjacent to,  
28 Venetia Close,  
Emmer Green,  
Reading,  
Berkshire,  
RG4 8UG

Project Reference J166

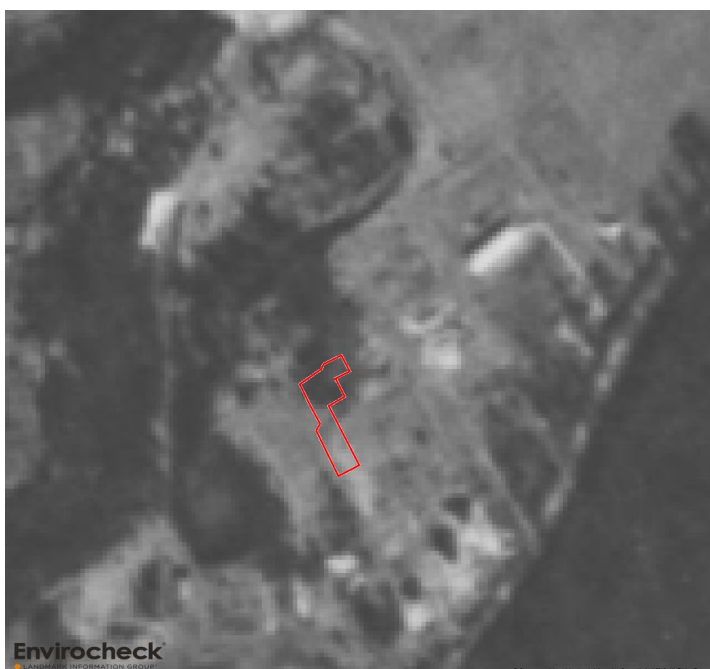
*Above, the 1947 aerial picture*

The 1947 aerial picture (left) is very blurry but shows the length of the garden to No.49 Kiln Road.

The kiln building with its three long drying sheds is just about visible (bottom left hand corner) as well as the line of the tramway between the clay pit and the kiln.

The 1947 aerial picture also shows that the northern end of the conveyor appears to terminate at a rectangular building which is not visible on the pre war maps. This may have been a mill where clay was mixed with sand or pulverised flint and probably lime before being sent to the brickworks for forming, drying and then firing.

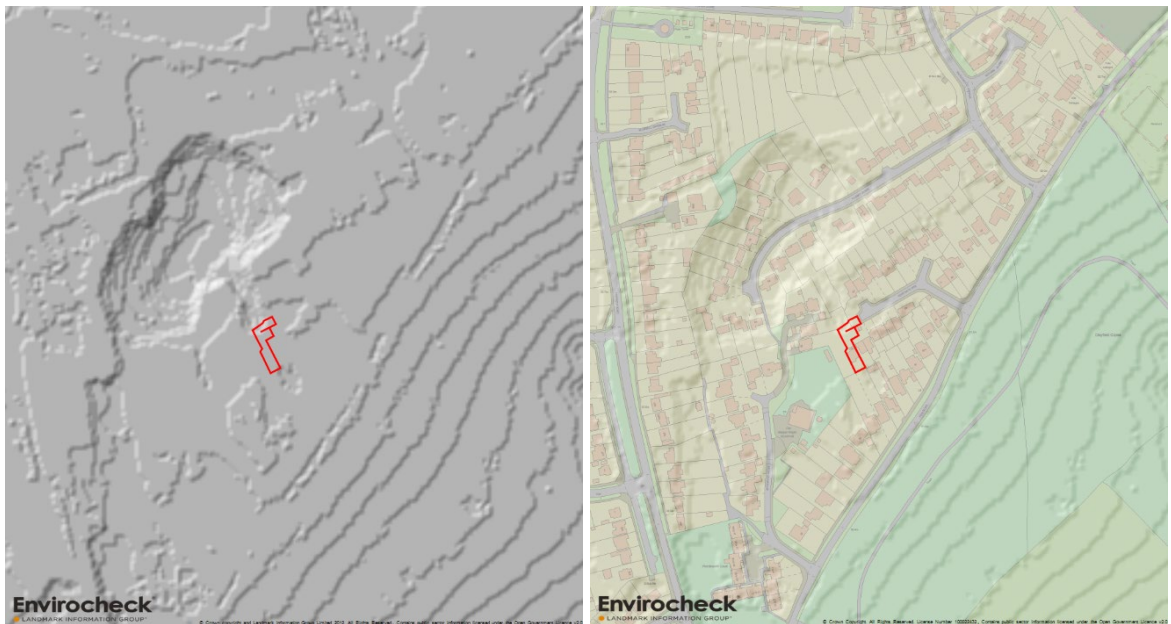
*Above left LIDAR topography, Above right, LIDAR data overlain on a modern map*

The LIDAR data above shows the most recent topographic survey of the area using airplane mounted lasers. Various overlays with Ordnance Survey mapping are presented. As discussed above with regard to the historic maps, the site area appears to have been excavated for brick making clay in stages. The resulting topography can be seen above.

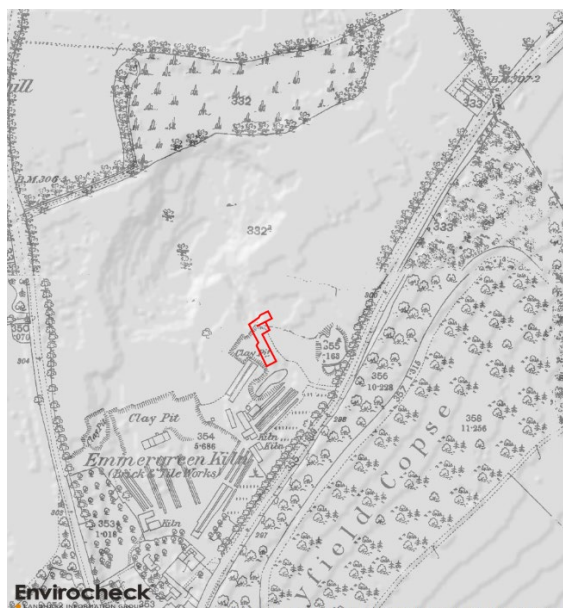
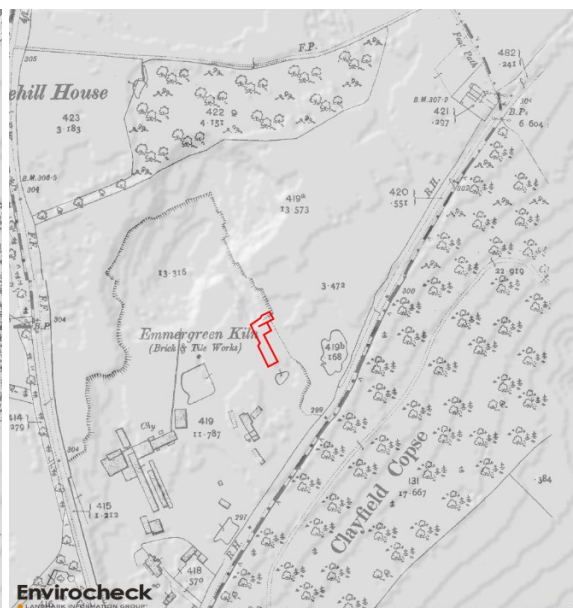
The first stage of works shown on the 1878 map has left behind only a very small remnant topographical feature visible today which is marked clay pit on the map and lies just 40m to the west of the kilns (150m south east of the site). These excavations appear to have been widened and deepened on the next map dated 1913. LIDAR shows that small section of the edge of this larger clay pit, just 50m to the north of the kilns, appears to still be present on the LIDAR image.

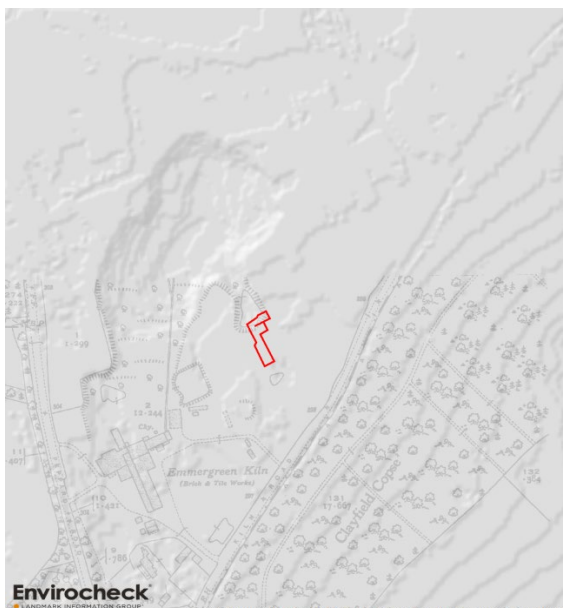
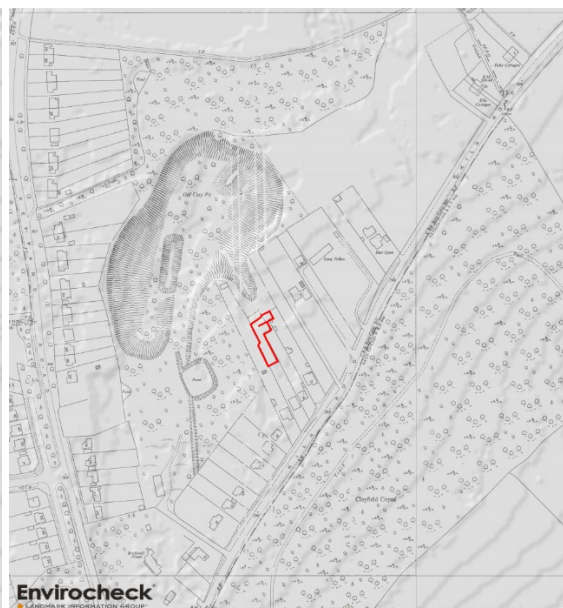
The 1936 map has partial coverage of a much larger clay pit to the north of the site whose boundary extends below the very northern section of the site (driveway) the rest of the pit is not shown on the map.

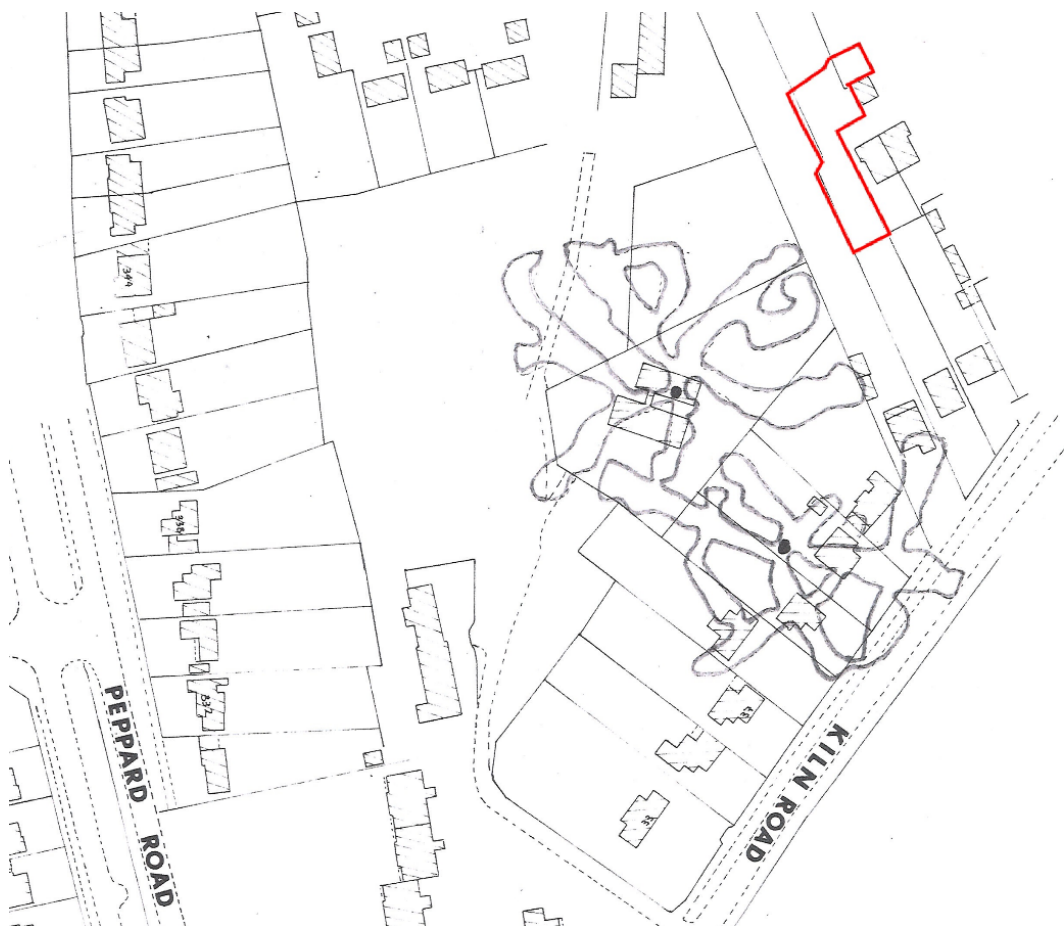
As discussed, chalk was often needed for brickmaking and the Emmer Green Kilns included deep adit chalk mines.

The map above was obtained from Reading Borough Council and shows the extents of the adits below ground from where chalk was extracted. These old chalk workings at depth are of concern regarding the channelling of ground gases toward the site area that are being generated by waste or old timbering left in the adits.

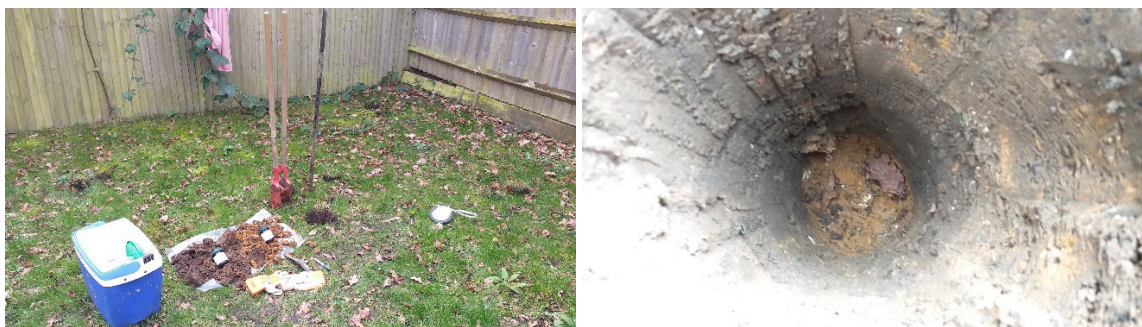
*Above left, a trial hole being excavated and sampled. Above right, inside the trial hole*

This topsoil material was damp and easily excavated in both pits however, at depths of 0.6m and 0.4m the pits found the base of the topsoil layer. There was no gradual gradation from topsoil into the underlying subsoil in terms of colour, just a clean interface with a marked increase in density when encountering the subsoil.
