# GEOSHIELD Verification Report

GEO101478

Westside CFA Piling - Balfour Beatty/Galldris

Gas membrane to specification BS8485 2015

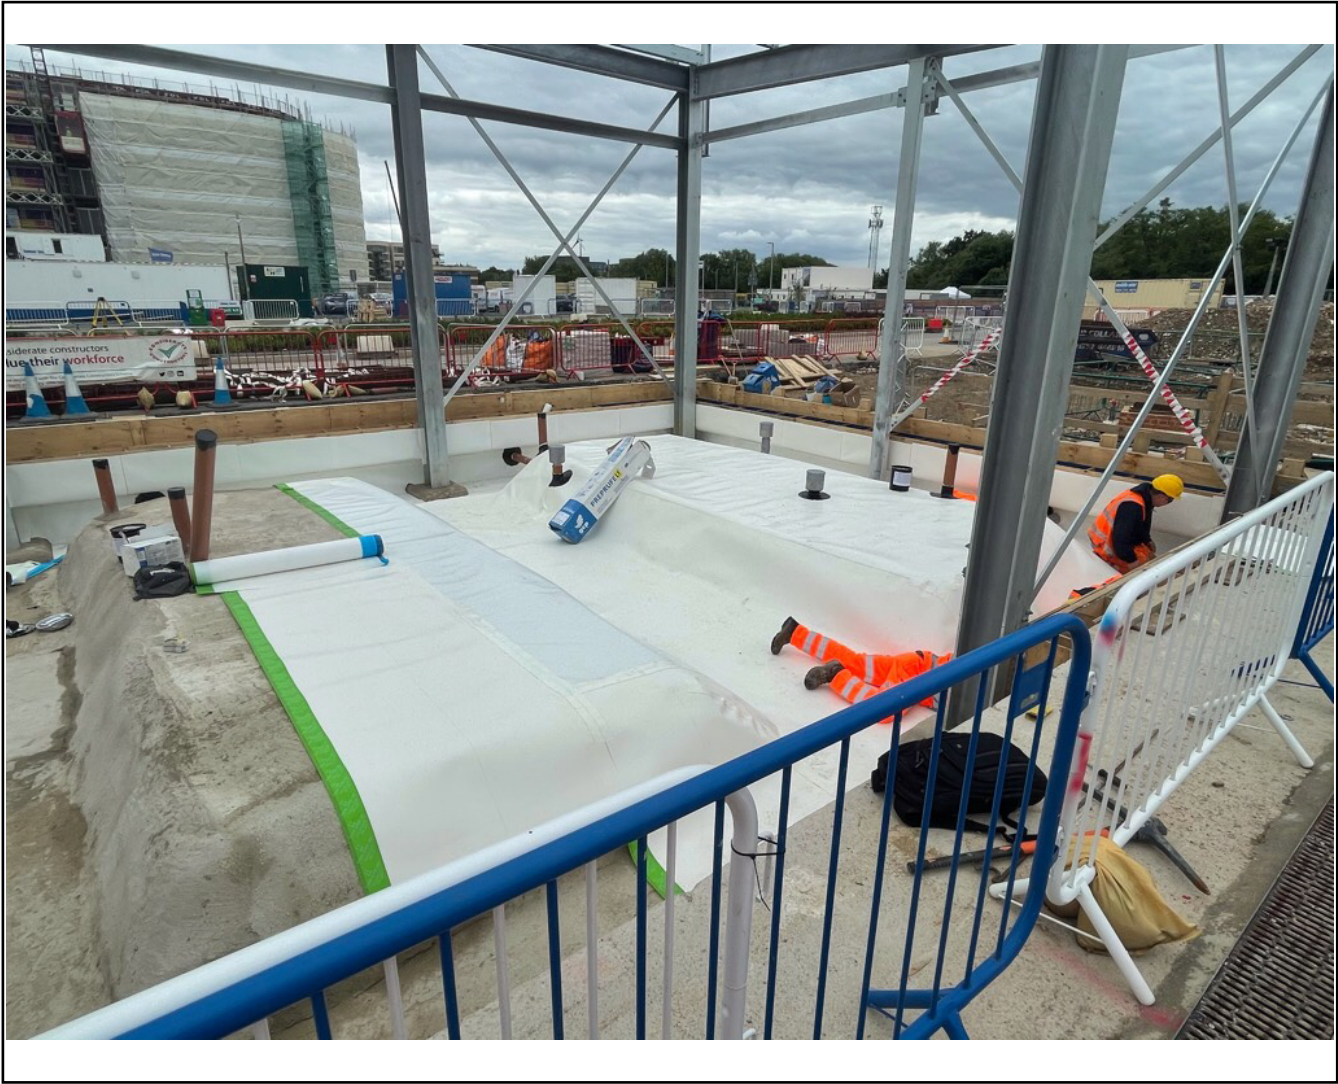
The photograph above shows the overview of a section of the station which

was verified during this visit.

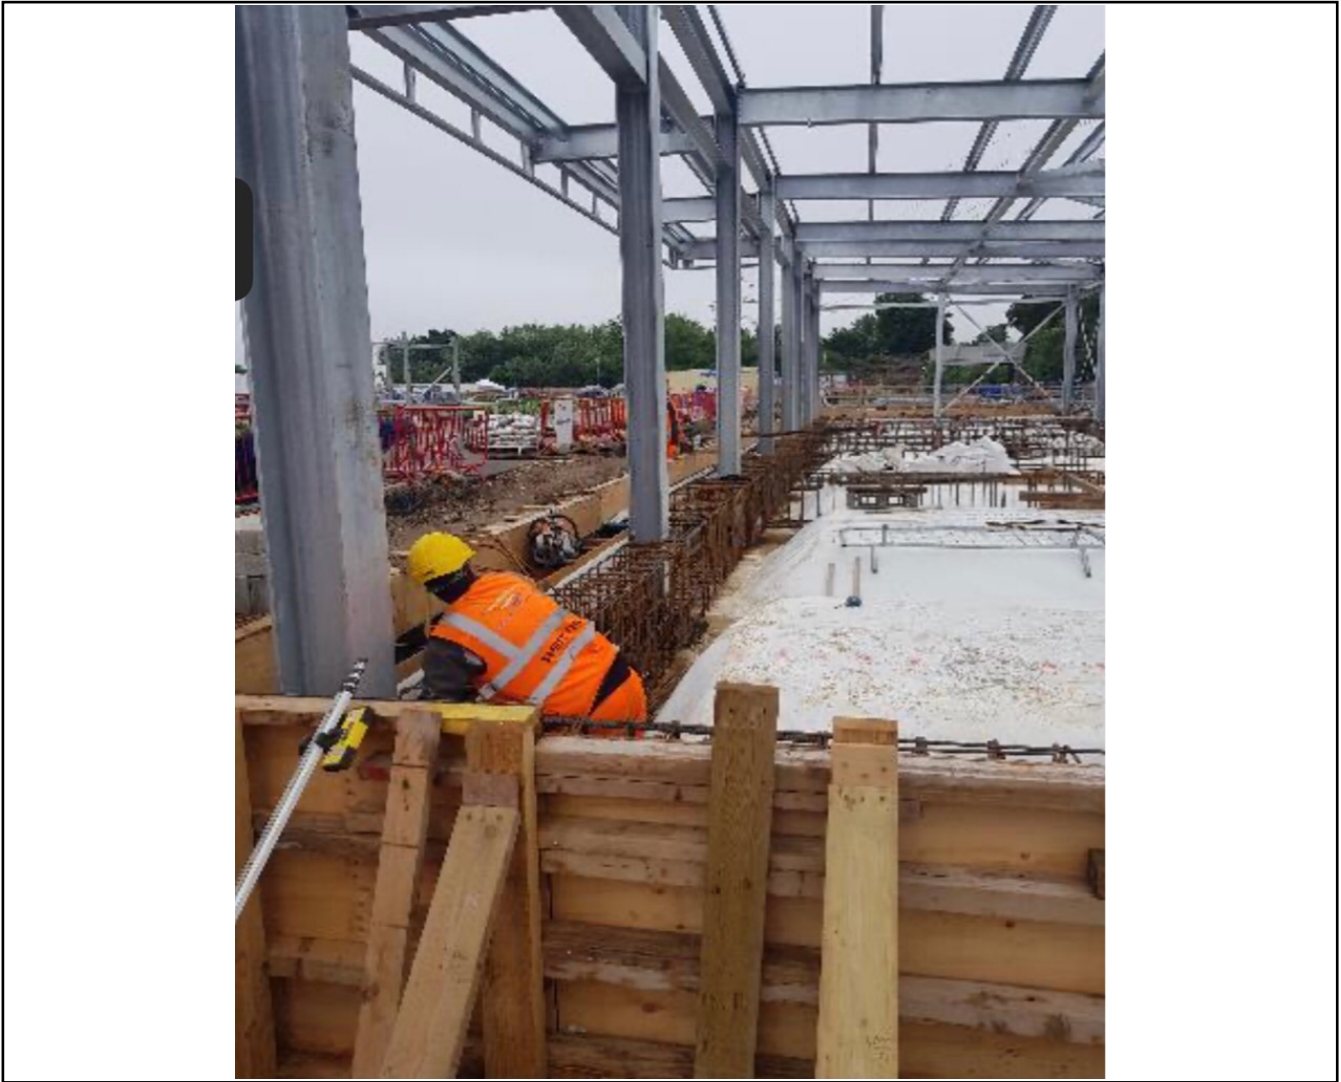
The photograph above shows an overview of the station where the

PrePrufe 300R Plus LT has been installed to the entire footprint of the

building.

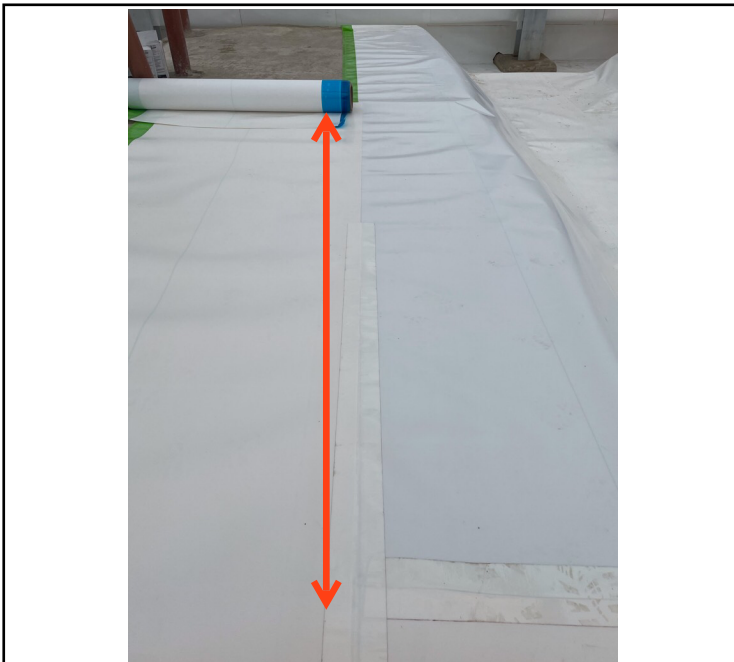
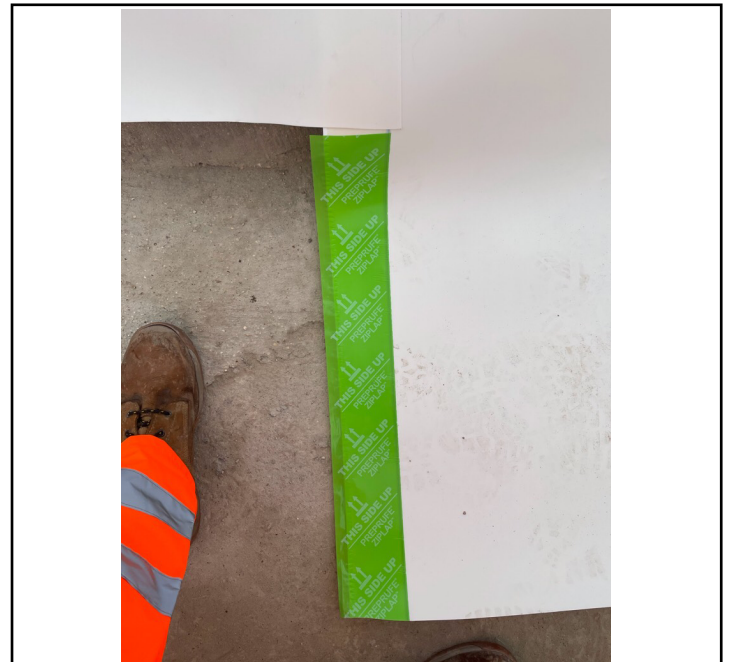
The first photograph below shows an overview of a sealed lap of the PrePrufe 300R

Plus LT, the installers have first ensured the membrane is the correct way up as shown

in the second photograph below.

The installers have then used lap tape to reinforce the laps to ensure a strong seal

has been achieved and there are no gaps.

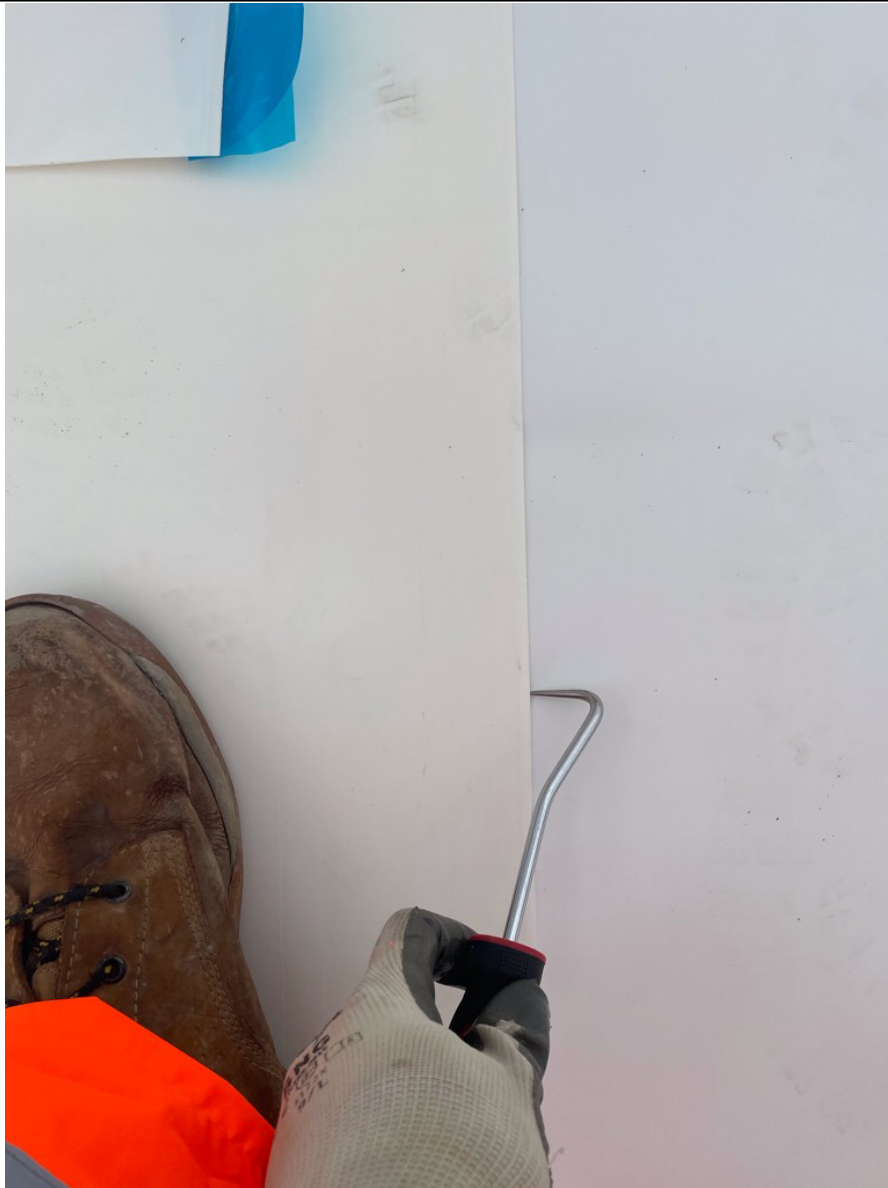
The photograph above shows a pick and probe test carried out to the membrane verified during this visit. The installers have achieved a strong seal and no faults or defects were identified.

Verified in accordance with CIRIA 735.

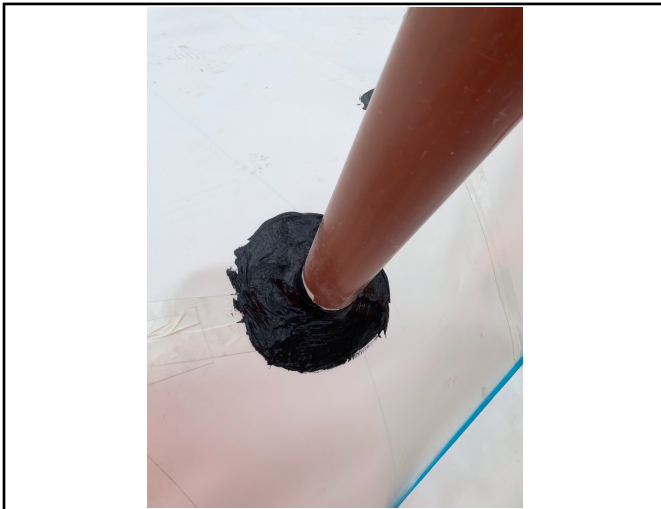
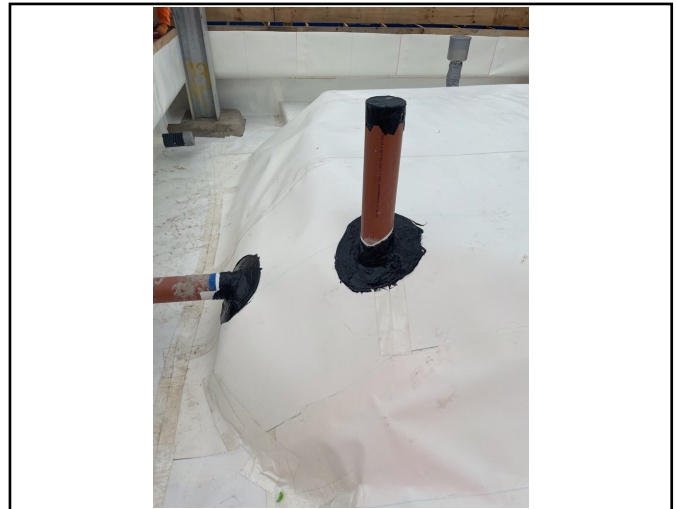
The two photographs below show examples of sealed pipe penetrations which were inspected during this visit. The installers have first cut the membrane tightly around each pipe to minimise any gaps.

Next the installers have used bituthene liquid membrane to apply a sufficient fillet around each pipe penetration.

All pipes in the area verified during this visit have been fully sealed and no repairs were needed.

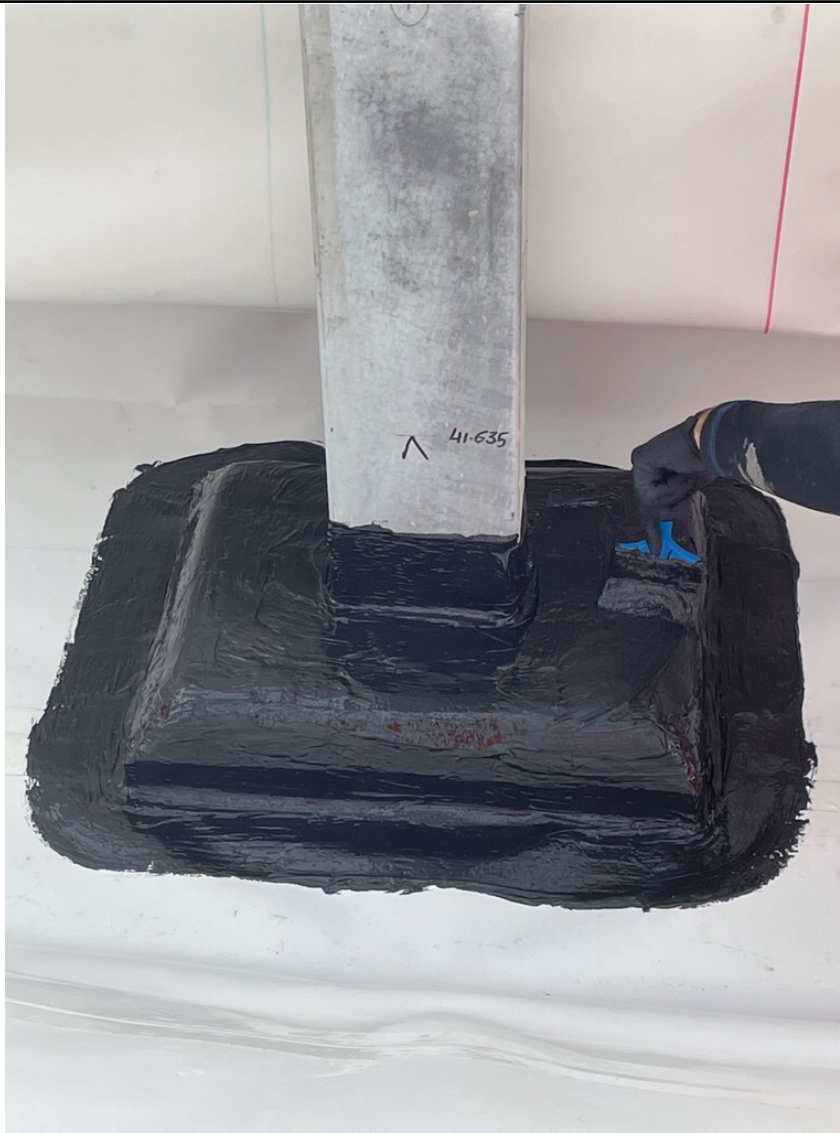
The photograph above shows a sealed column base. The installers have installed the membrane tightly around each column base before applying a thick and even coat of the liquid membrane.

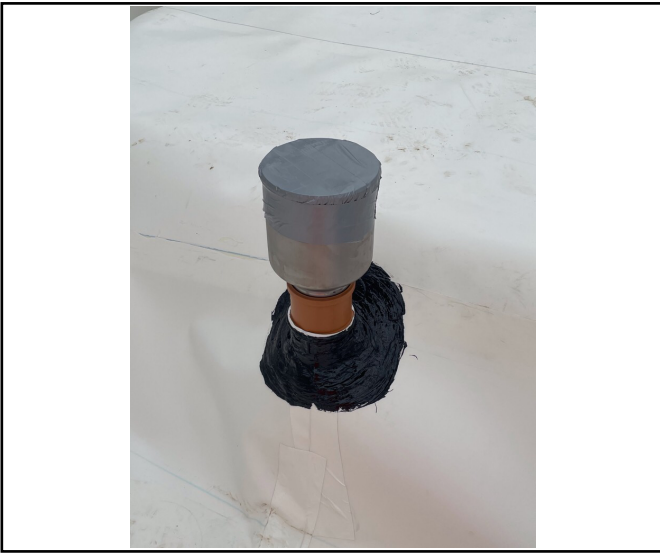
Additional sealed pipe penetration.

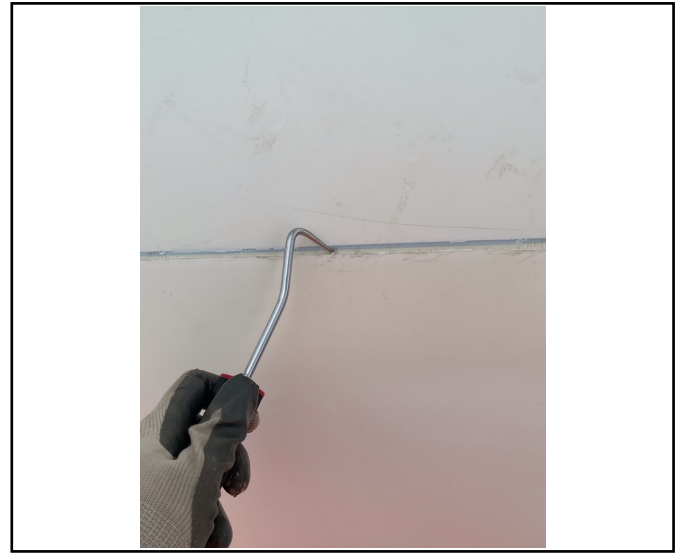
Additional pick and probe test carried out to sealed lap.

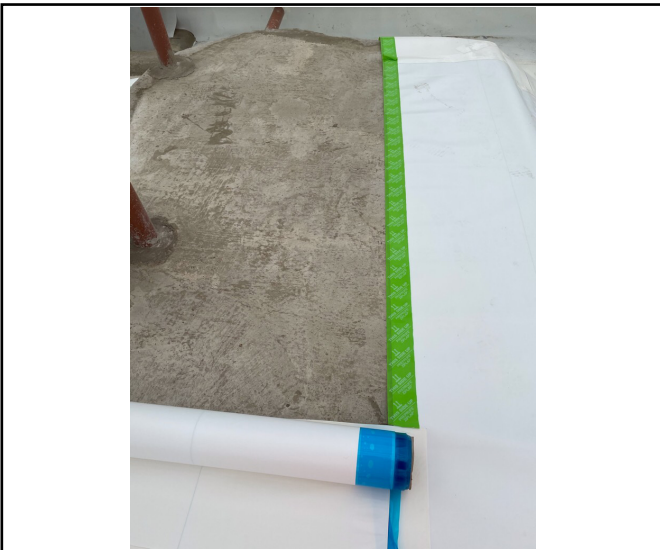
PrePrufe 300R Plus LT membrane  
preformed taped lap correct way up.

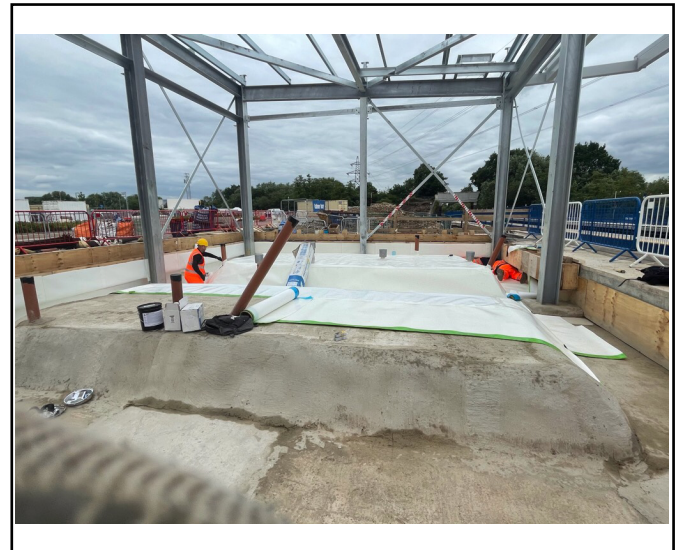
Additional overview photograph.
