## **TECHNICAL REPORT ON A SUBSIDENCE CLAIM**

**Crawford Reference: SU2003018**

**38 Holyrood Close  
Reading,  
RG4 6PZ**

### **SUBSIDENCE CLAIM**

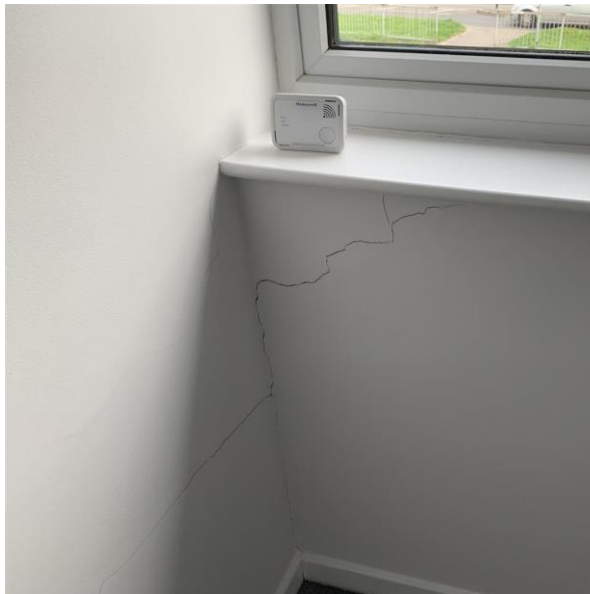
Front Right Bedroom

Diagonal crack below right side of window and extending as horizontal crack on internal wall

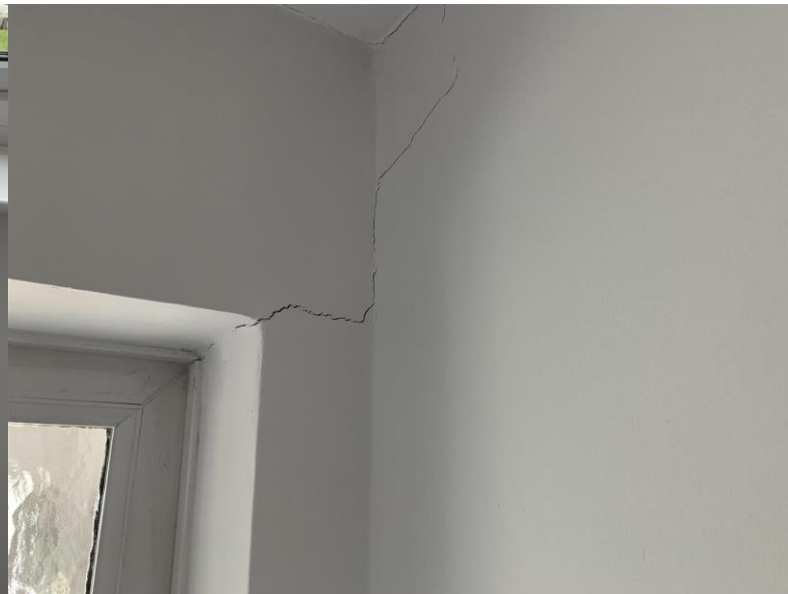
Hall

Diagonal crack above left side of internal door opening  
Vertical crack to wall adjacent to right side of door opening  
Diagonal crack on rear lounge wall at high level

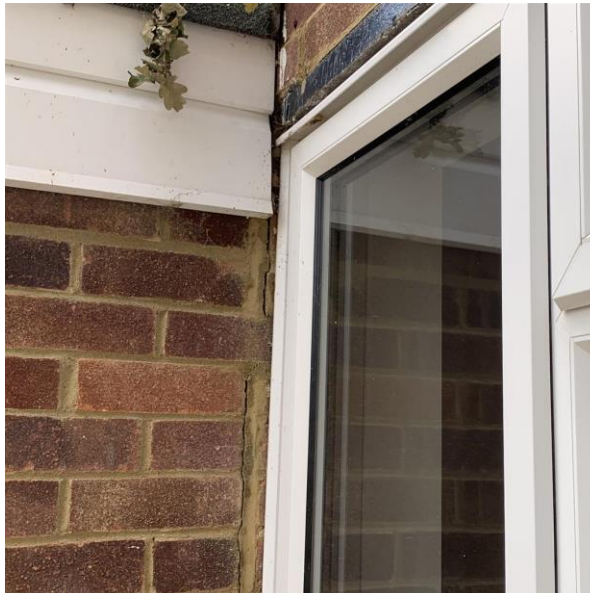
Tapering vertical crack at right towards junction with front house wall, open 8 mm. Previously repointed.

Porch junction crack - note previous repointing

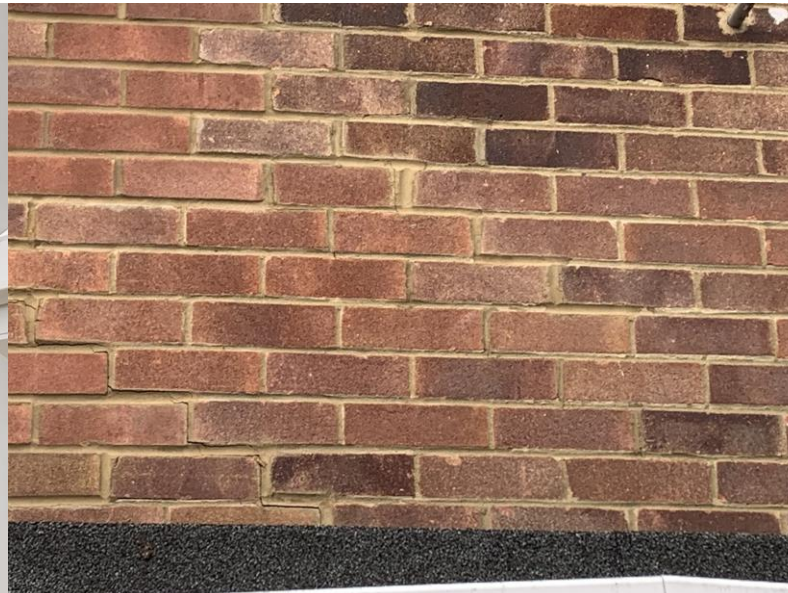
Stepped cracking on front elevation and previous repointing

Stepped cracks x3 from left bedroom window to top of porch. Repointed but now slight re-opening.  
 Tapering vertical crack to right side of porch. Repointed but has reopened by 3 to 4 mm  
 Stepped diagonal crack at low-level on the right side of porch  
 Cracks above and below bathroom window

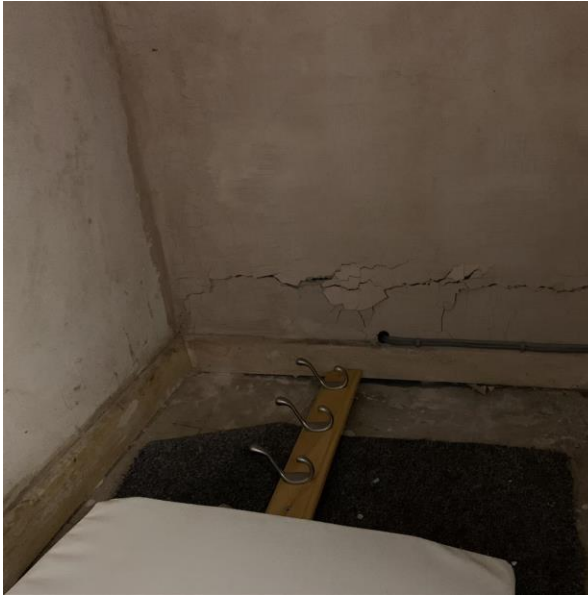
Lounge Cupboard

Horizontal crack on stairs wall

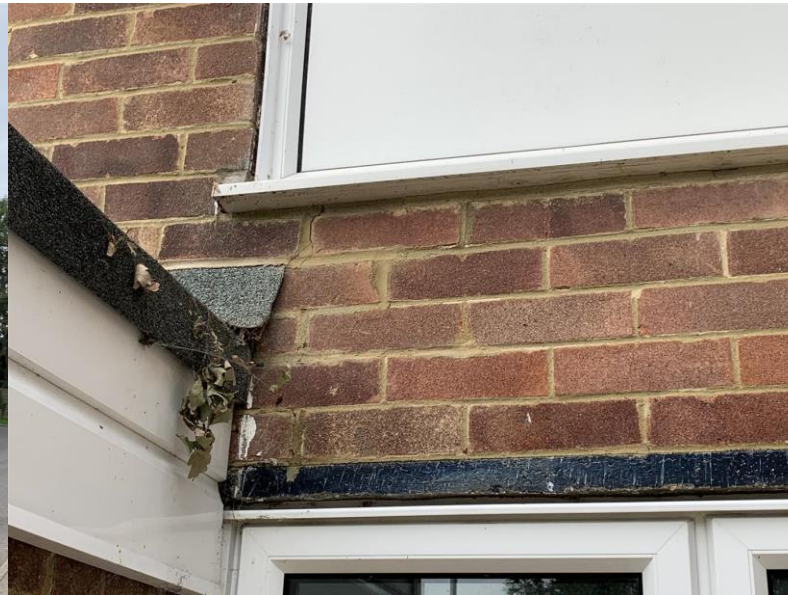
Crack below right bedroom window

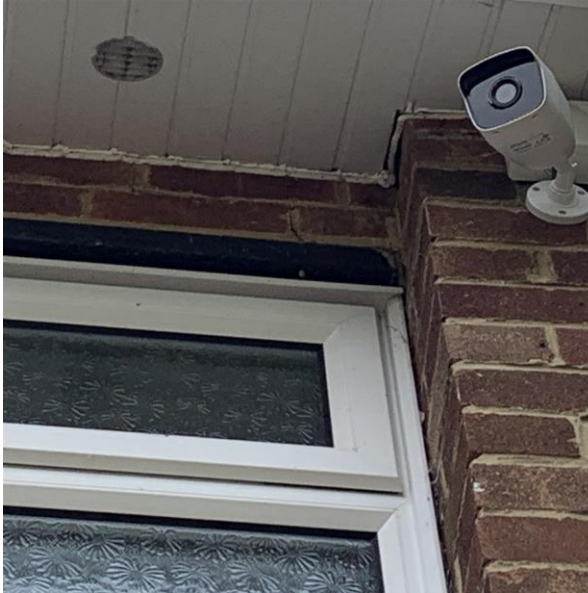
Crack above right bedroom window

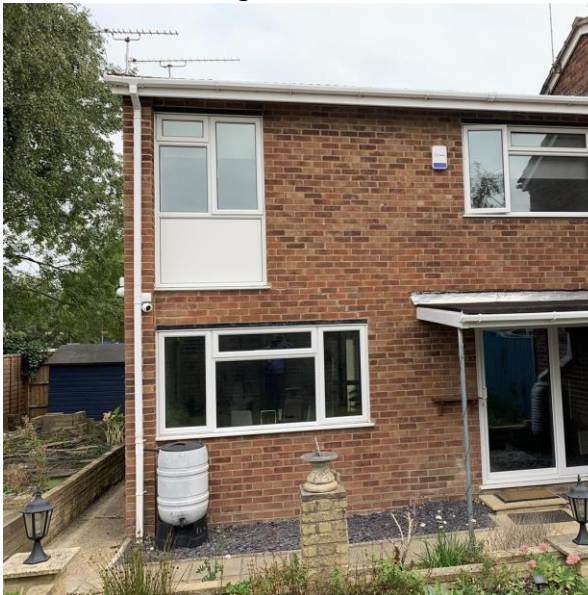
Rear elevation

Historic stepped crack above the lounge window (not subsidence)
