## **HIGH LEVEL GABLE REPAIRS TO QUEEN VICTORIA STREET, READING**

### **Overview**

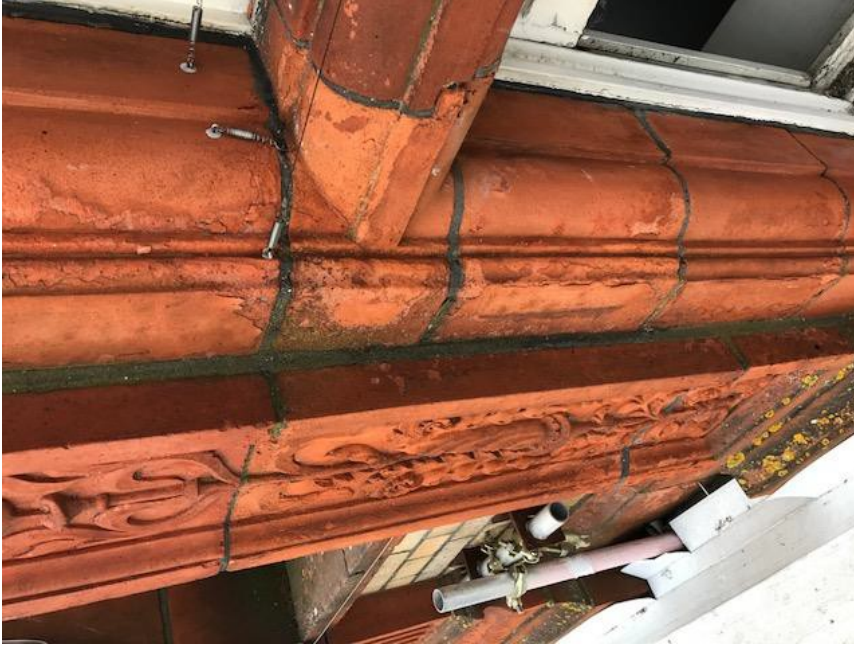
The terracotta generally is heavily weathered but is not in bad condition for its age and exposure to the elements. Overall there are units that need replacing, or lifting and re-bedding and pointing. The brickwork to the rear of the gables is generally in poor condition and needs careful repointing and re-bedding in places. The terracotta has been severely compromised by being previously pointed in neat cement pointing which has damaged and split the adjacent arrisses and caused numerous other areas to fail. This same problem occurs with the majority of the brickwork that forms the supporting substrate to the gables. We would recommend removing all the cement pointing from the terracotta and brickwork and replacing in a lime mortar. If this is not an option for financial reasons, then the minimum we would recommend is to replace the cement with lime where it has currently failed.

Cement pointing causing failure of the terracotta.

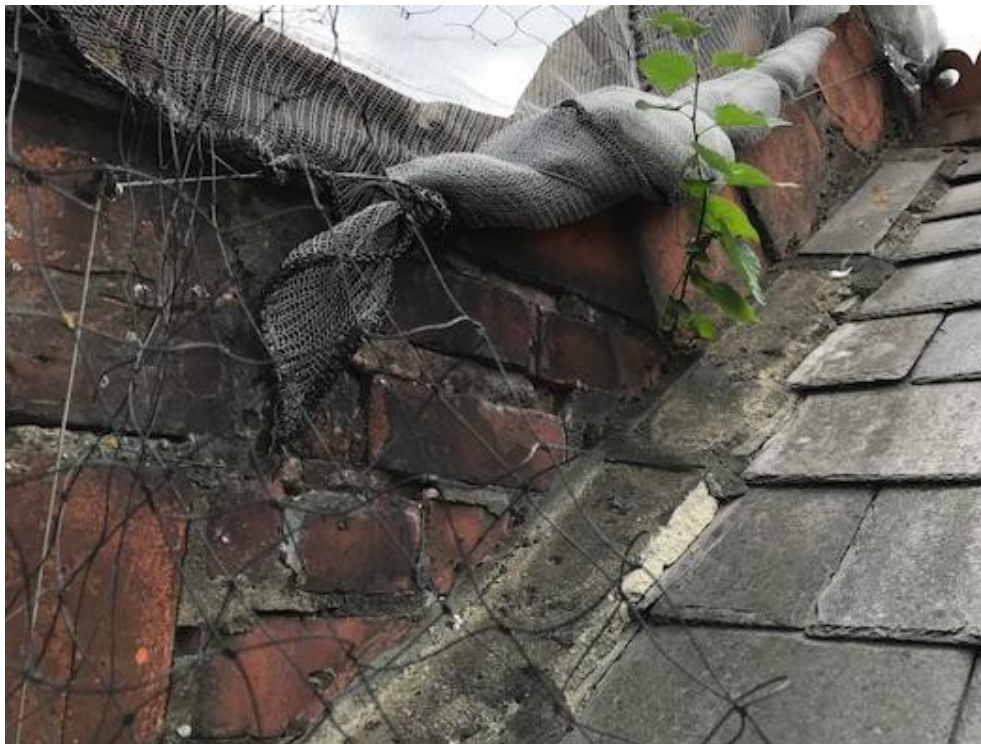
Cement pointing to failed brickwork supporting small gable.

There is presently a large cement fillet (see photograph above) to the joint between the gable brickwork and the slate roof. This is a bad feature that has failed and been poorly patched in numerous areas. There is evidence of damp ingress internally where this joint has failed and it has the potential to compromise (rot) the timber roof structure. We would recommend that this fillet removed and replaced with a properly chased in lead flashing.

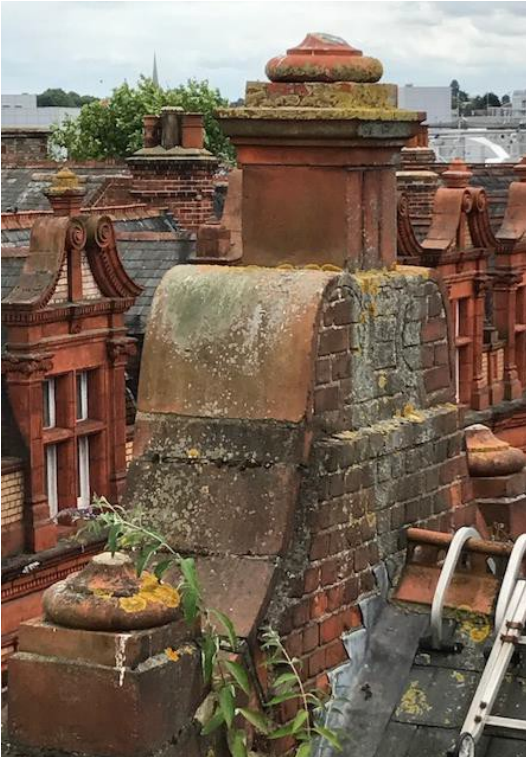
Large Gable

**Large Gables** : The majority of these have been compromised by the failure of the joints/pointing and in some the actual units have spalled and split. We may be able to salvage these with resin and stainless steel pins, if the terracotta has not become too friable and weak, but if this is not possible we can either cast new ones in our yard or construct new ones on site from coloured mortars. If there are numerous failed units that are the same it is more economic to cast new ones in the yard, so this is something we cannot determine until the gables are properly accessible.
