**Garages at 9 Eldon Square  
Reading  
Berkshire  
RG1 4DP**

# **Preliminary Bat Roost Assessment**

Ref: R3075/b

**April 2022**

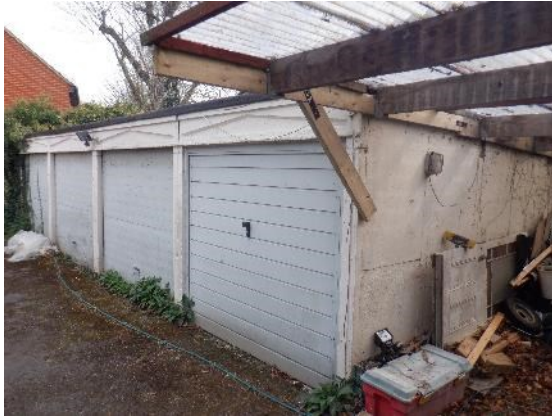
- 4.2.1** The row of garages was of prefabricated concrete panel construction, with a timber framed lean-to attached on the eastern elevation and a timber storage shed on the rear elevation (**Photographs 1 & 2**). The garages featured a flat roof covered with bitumen roofing felt, which was tight to the barge board on the front elevation and had superficial cobwebbed gaps on the rear elevation, which were of limited potential for use by bats (**Photographs 3 & 4; Target notes 1, 2 & 3**). There were large open gaps between concrete panels and the soffit above the blocked garage doors on the front elevation, which were closely inspected and limited suitability for bats and showed no signs of use by them (**Photograph 5; Target note 4**). The frame was tight around the metal garage door serving the interior at the eastern end of the building (**Photograph 6; Target note 5**). The timber framed lean-to at the eastern end of the garages had a corrugated plastic sheet roof covering and had slight gaps present between the timber and the concrete wall of the garage building of limited extent, which showed no evidence of the presence of bats (**Photographs 7 & 8; Target notes 6 & 7**). There was a simply constructed timber shed to the rear of the garages, at the south-eastern end, which was open to the exterior on the western side (**Photograph 9; Target note 8**).

**1. Front of garages viewed from north.**

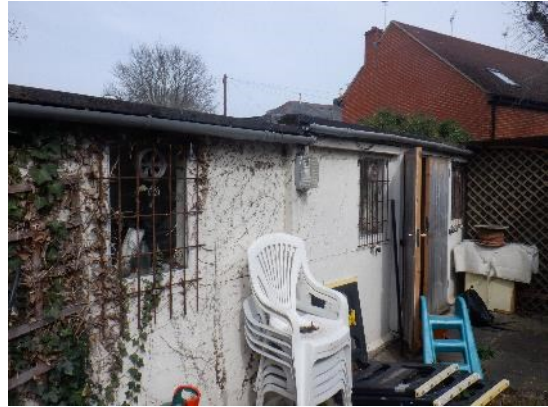
**2. Rear of garages viewed from south.**

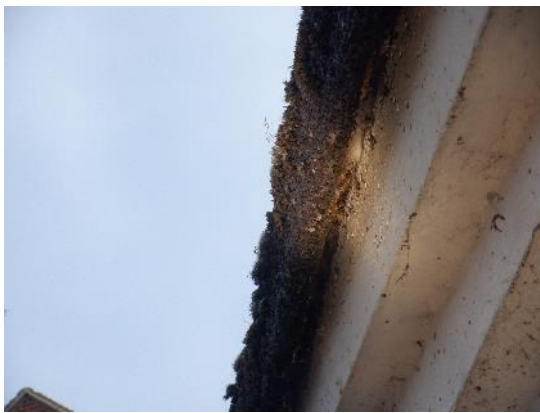
**3. Bitumen roofing felt covering roof (front elevation).**

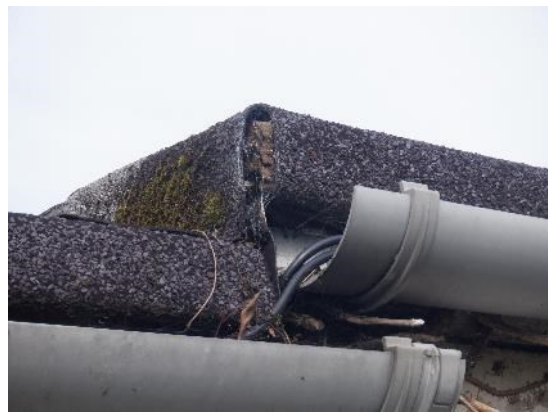
**4. Superficial gap between the bitumen roofing felt and the barge board (rear elevation).**

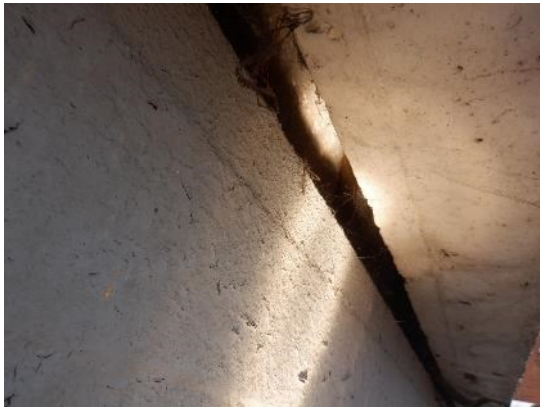
**5. Large open gaps between soffit and concrete panels (front elevation).**

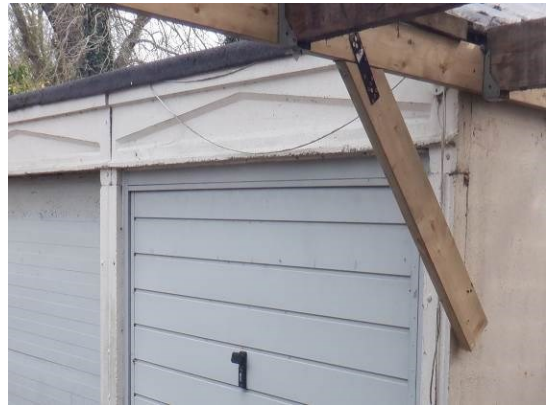
**6. Frame tight to metal garage door (front elevation).**

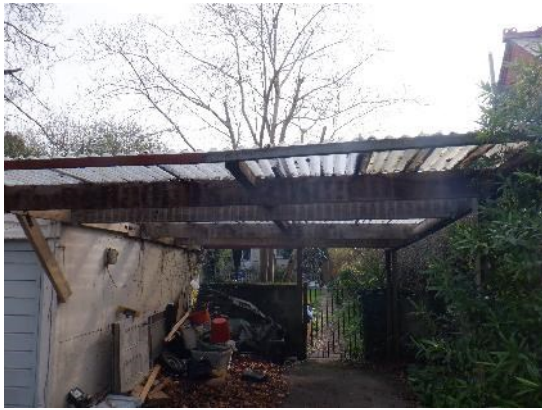
**7. Corrugated plastic sheeting above timber framed lean-to at the western end of the site.**

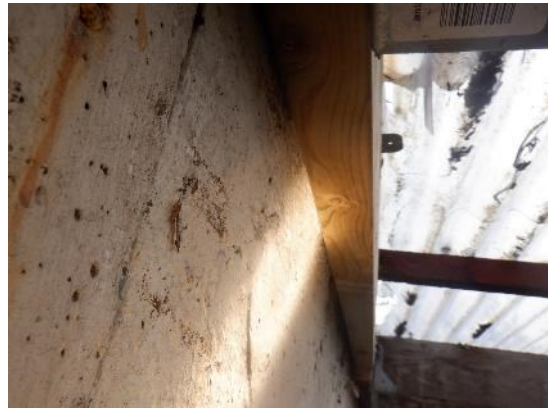
**8. Open gap between timber frame and concrete wall (western elevation).**

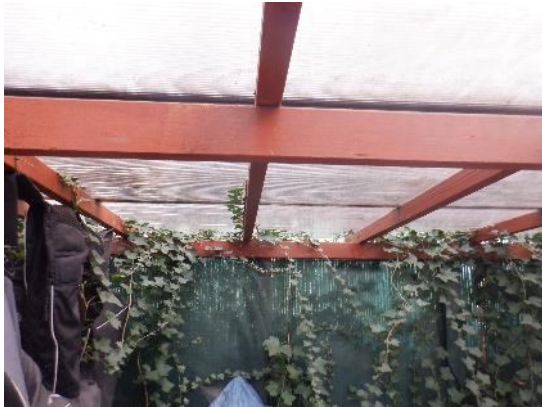
**9. Corrugated sheeting above timber framed storage shed.**

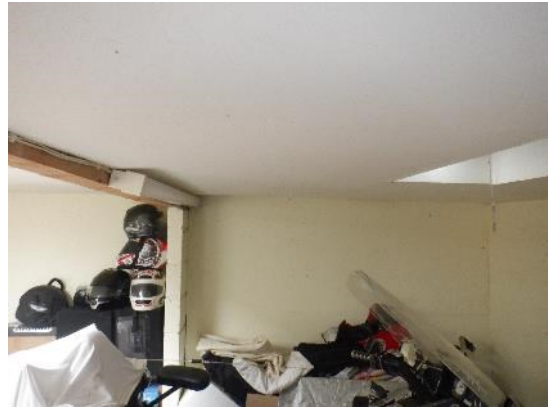
- 4.3.1** The garages had no enclosed roof void internally and were used for storage. Three of the four metal garage doors had been sealed with plasterboard internally (**Photograph 10; Target note 9**). The ceiling and walls were fully plastered, blocking the eaves and sealing the interior from the exterior, and there was a concrete floor that was partially carpeted (**Photograph 11; Target note 10**). A section of the plasterboard ceiling was damaged in the north-east side of the garage, with fibreglass insulation present and the underside of the boarded roof visible (**Photograph 12; Target note 11**).

**10. Stored items in front of plastered over garage doors.**

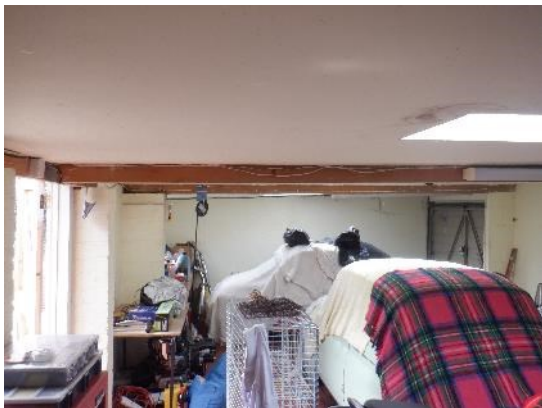
**11. The ceiling and walls were fully plastered internally.**

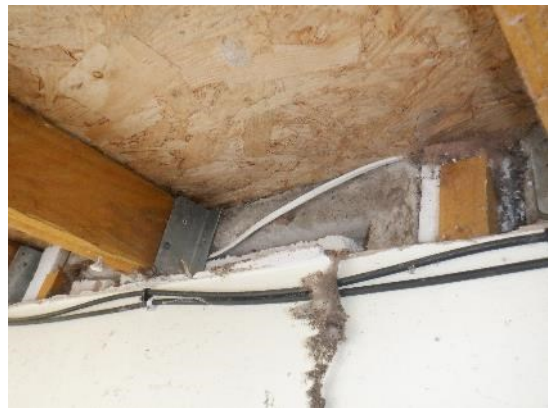
**12. Gap in plasterboard ceiling with the underside of the boarded roof with fibreglass insulation visible.**

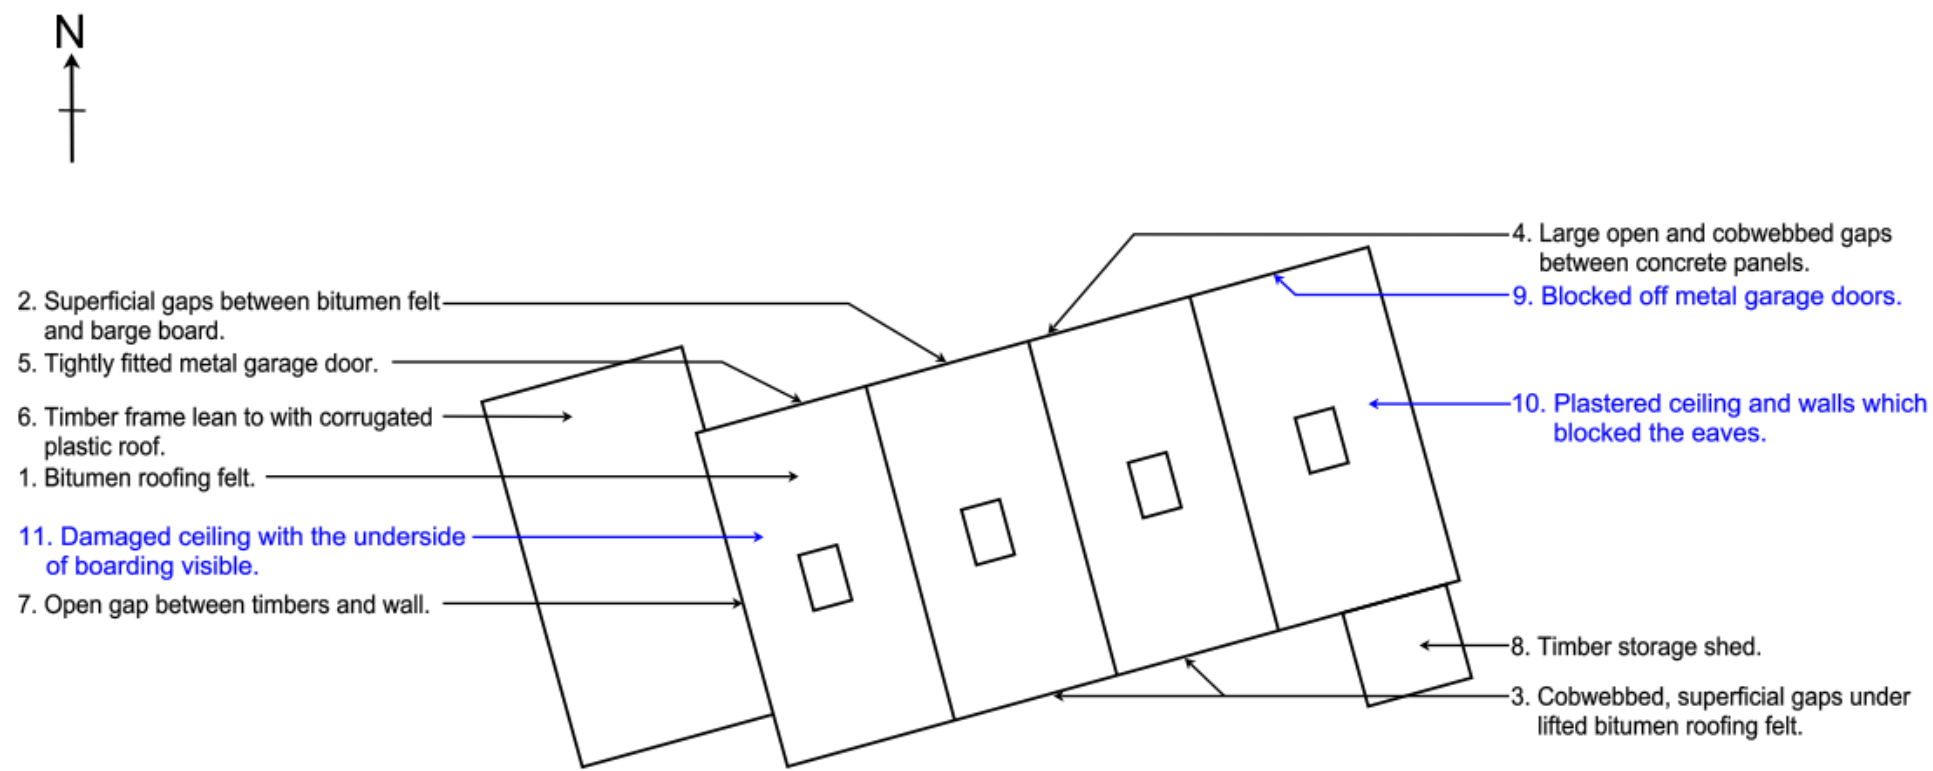
APPENDIX 2 – PRELIMINARY BAT ROOST ASSESSMENT PLAN

- 4.1.1** Photographs of the buildings are presented in **Appendix 1** and a plan of the external and internal survey findings with associated target notes is shown in **Appendix 2**. The survey findings from the exterior and interior of the garages are described as follows:
