Eaton Court, Reading (5710)

# Technical Note TN01: Update Bat Survey and Assessment

15<sup>th</sup> December 2022

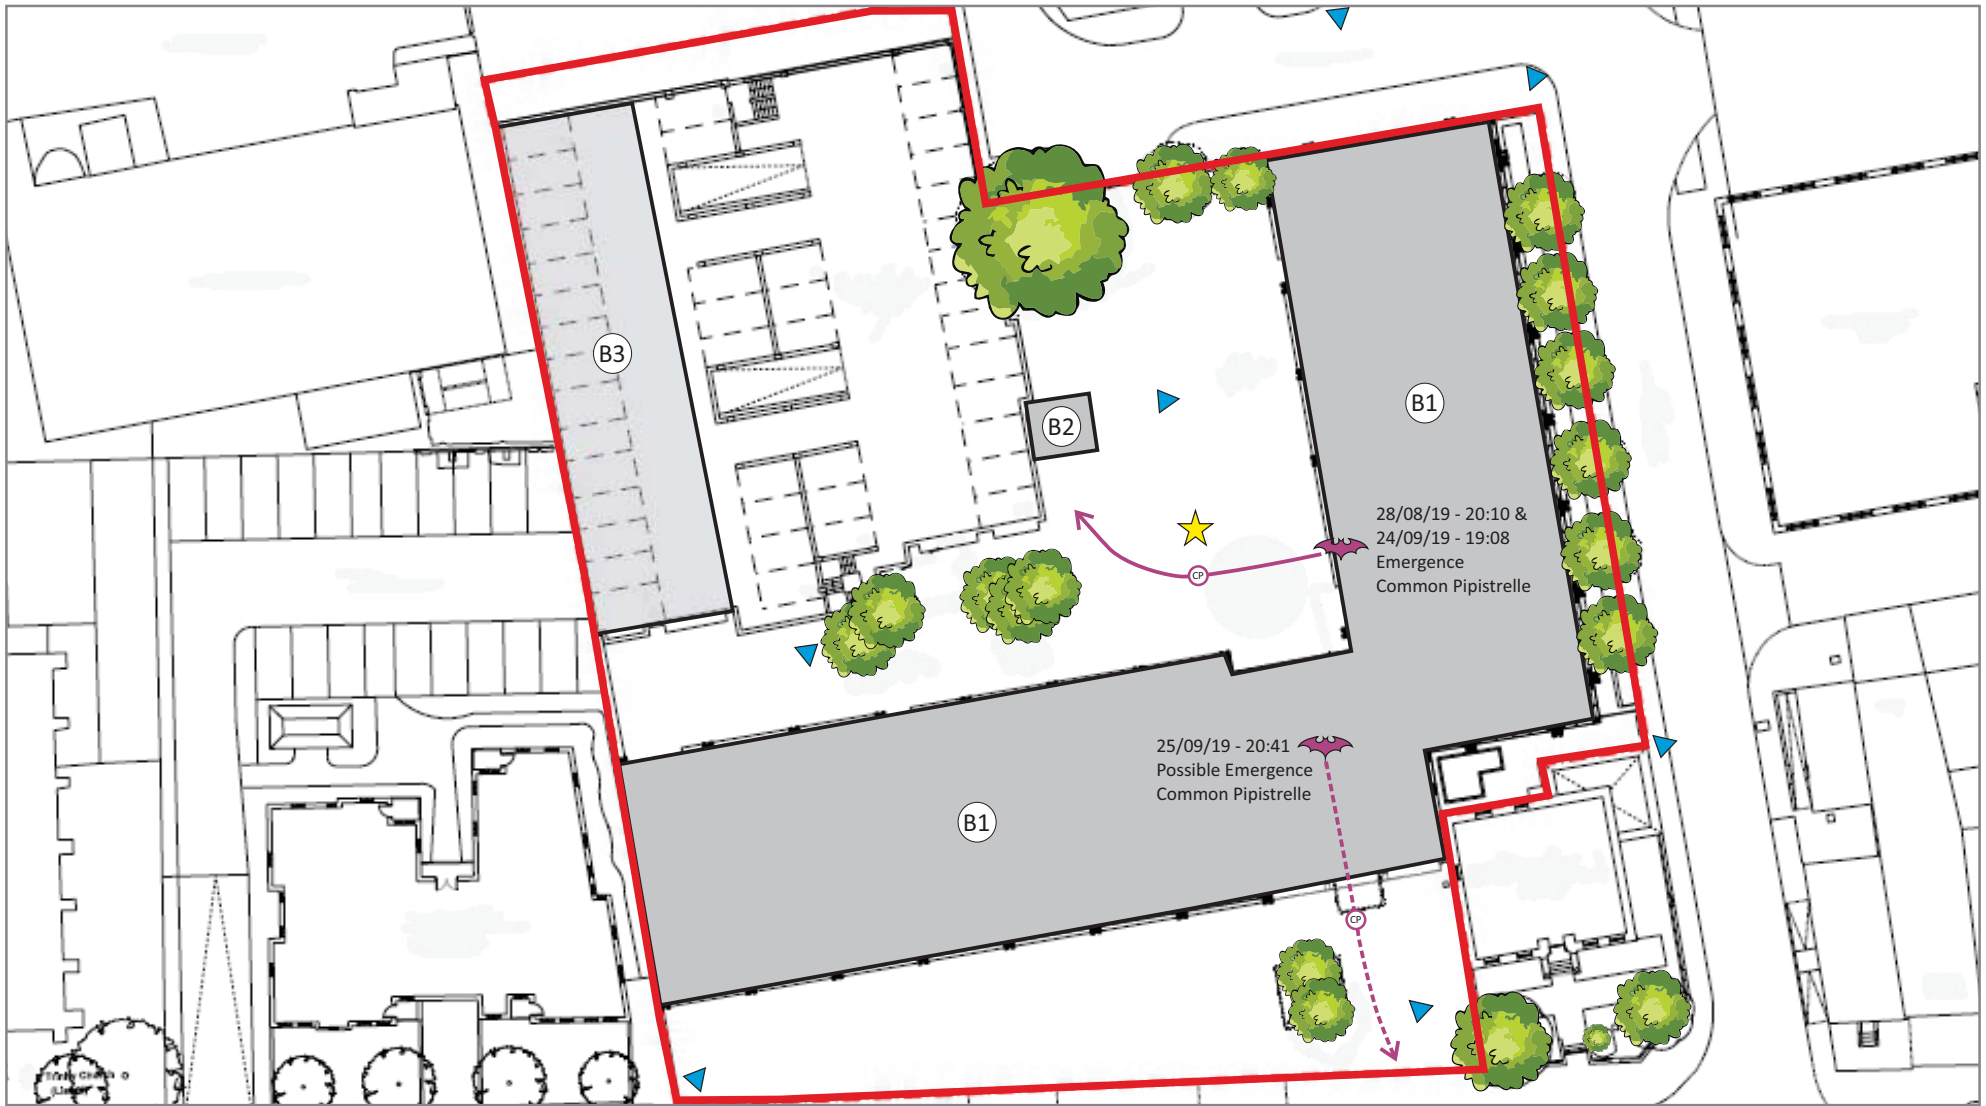
## Plan 5710/BSA2:

- 3.4. In common with the 2019 inspection survey findings, no evidence of roosting bats was recorded in association with building B1 during the 2022 update inspection survey. However, based on the 2019 dusk emergence / dawn re-entry surveys, B1 is known to support a non-breeding day roost for a low number of Common Pipistrelle *Pipistrellus pipistrellus* and, as described above, external crevice opportunities for this species remain. Despite the lack of fresh evidence, given the relatively recent nature of the previous survey work, and current condition of the building, it is reasonable to assume the bat roost remains present.

- 4.3. A suitable mitigation strategy will need to be implemented under the proposals to ensure bats are safeguarded during the construction and operational phases of the development. Mitigation measures will include a pre-works inspection survey immediately prior to any demolition works, a soft strip demolition of potential roosting features under ecological supervision and the provision of replacement and new roosting opportunities for bats (see Section 4 of Bat Survey and Assessment report, dated March 2021, for full mitigation details).
