READING CENTRAL CLUB MURAL

CONSERVATION ASSESSMENT  
NOVEMBER 2017

# Reading Central Club Mural

## Condition Survey and Conservation Assessment

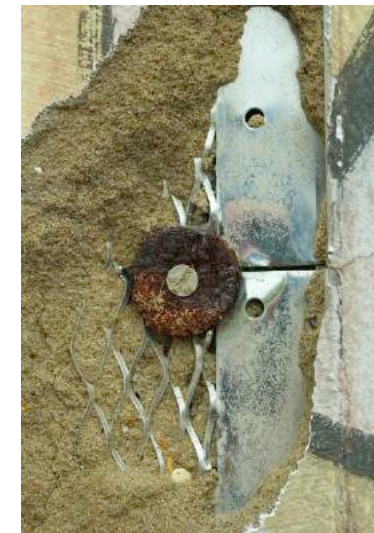
The two areas of loss associated with the corrosion of the washers have occurred along the vertical juncture between two adjacent EML panels, each of which is in line with the sides of the window opening. Close examination indicates that the EML has been placed against the edges of the window reveal, forming a straight vertical edge against which the render has been applied, thus also creating a corner to the reveal. Above the window opening the edge of the EML continues vertically to the parapet of the roof – i.e. the area over the window is a separate rectangular panel of EML. The effect of this is that there is an exposed, vertical metal edge within the mural above both corners of the window, each side corresponding with the areas where the washers have become corroded. It is possible that localised structural movement along this edge has allowed water to penetrate to a greater degree and this location and resulted in corrosion here but not yet elsewhere.

*Edge of EML and corroded washers*

| 7.1.11 Rust treatment | If required apply Hammerite Kurust <sup>13</sup> rust treatment, which contains tannin and converts iron oxide to stable iron tannate. Treated areas to be given protective surface coating consisting of Paraloid B72 varnish (15% in acetone). Rusted washers and other ferrous fixings should be replaced with stainless steel versions. |

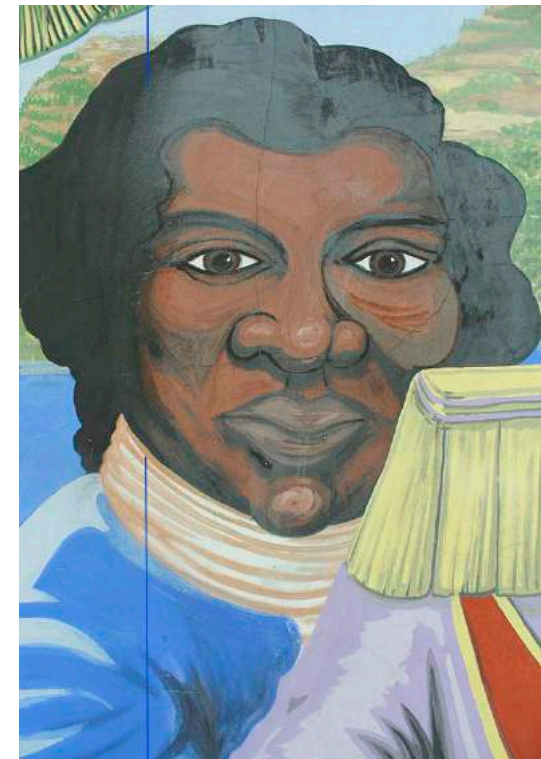
There is a semi-opaque surface coating on approximately three fifths of the mural, on the right (west) side. The layer appears to have been deliberately applied, but it is unclear why it only appears to exist on half of the painting. The layer is probably a varnish or protective surface coating which has itself now deteriorated, probably through a combination of UV oxidation and the effects of humidity. Paint analysis shows that the layer is thin and discontinuous and examination of the boundary between the coated and un-coated sides of the mural show that it was probably applied as a spray rather than a brush. There are numerous spots and spatters of the material fading out to none as one moves from the varnished west side of the mural to the other unvarnished east side. The juncture between the two areas is distinctly visible on one figure in particular. Here the sprayed finish, a degraded semi-opaque surface coating, fades out on the black area of hair, the coated right and uncoated left sides clearly evident (see photo right – the spray varnish finishing at the vertical blue line).

The surface coating provides an element of water resistance to the surface of the painting as is clearly evident when it rains and water falling on the uncoated side is absorbed whilst that landing on the coated side is easily visible as water droplets. This does not, however, mean that the potentially adverse effects of the rainwater are totally mitigated as the surface coating is degraded and fine cracking in the surface mean that the water will still penetrate the paint layers.

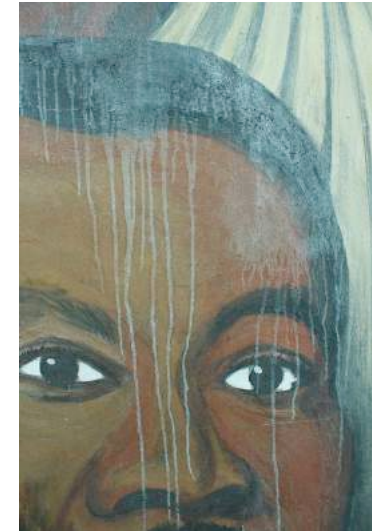
In addition to the effects of UV, migration of water through a varnish may contribute to the physical disruption of the varnish with the presence of water causing the layer to 'blanch' or become whitish and increasingly opaque as is seen here in all areas where the paint layer has been coated. Another adverse effect, clearly seen on the figure of Martin Luther King (*image right*), is the numerous disfiguring drip marks, which have been left as a result of the uneven application of the coating. In areas that received an excessive amount of spray the varnish has run down the surface and whilst this may not have been evident when first applied, the deterioration of the coating and heavy blanching has resulted in clearly visible whitish deposits.

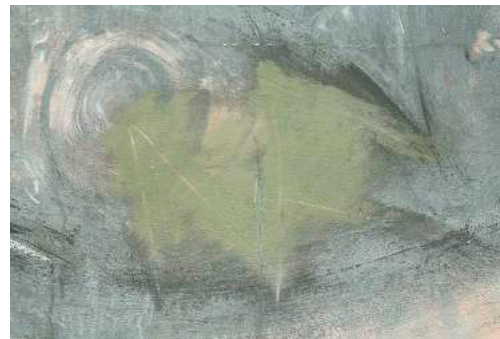
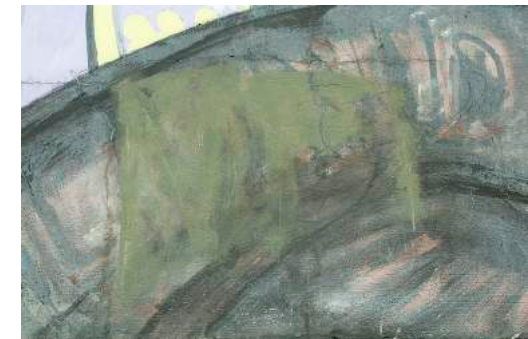
The mural is remarkably unaffected by later graffiti and other surface accretions, and although a few crudely scratched right-wing insignia have been scrawled into the mural at lower level, these have been over-painted with brown paint and are not immediately evident. However, the incisions appear to be made relatively deeply into the paint layers and are therefore only partially obscured by the later re-paint. A more successful repair would require filling of the incisions with a more accurate retouching of the colours and design.

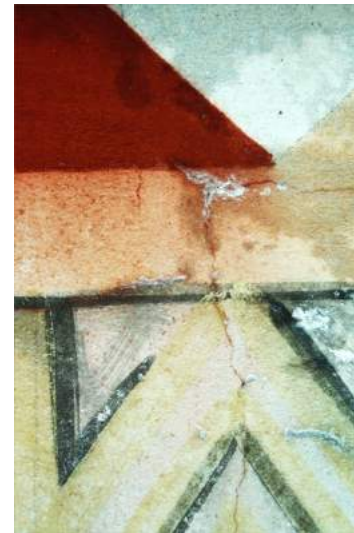
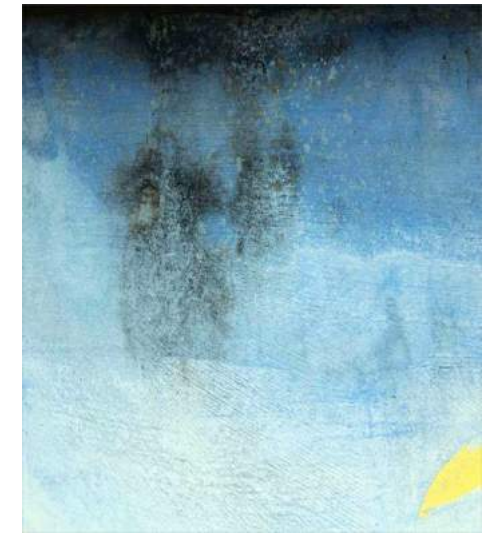
In addition to airborne contaminants there are also localised areas of calcareous material in places. This is mostly found at the top of the wall on the left side where rainwater has apparently found its way down between the joints of the parapet capping, seeped into vertical cracks in the render and leached out part of the calcium content of the cement (*photo left: white deposits along cracks*). The most obvious areas are above the windows where whitish calcium deposits are evident around the cracks. The effect of this has also been to cause some patchy staining and darkening of the colours in these areas.

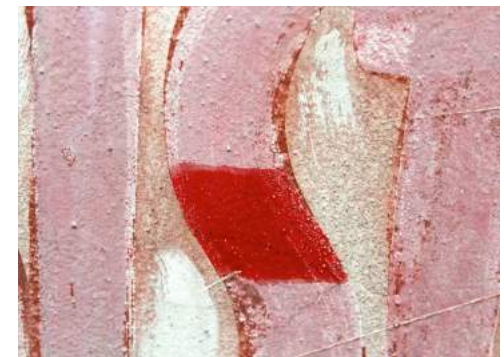
A limited number of conservation trials were undertaken during the survey. These focused on the two main issues affecting the paint layers – the presence of the degraded surface coating and the powdery condition of the underbound paint. Localised cleaning tests were undertaken using aqueous solutions to remove superficial surface dust and dirt. An initial cleaning trial was carried out using deionised water applied and cleared using small cotton wool swabs but it was felt that the result was uneven and required prolonged contact with the surface which risked damage to the underbound pigment. An increase in strength was considered, as it was felt that adding different reagents might obtain a better result, speeding up the cleaning process and reducing contact time with the paint layer. Slightly stronger mixes were trialed with the addition of ammonium bicarbonate and tri-ammonium citrate to create solutions in deionised water. A 5% solution of tri-ammonium citrate proved to be the most effective in lifting superficial dirt from the surface. The cleaning was carried out through acid-free L2 tissue since this minimises initial contact with the cotton wool swab and allows greater control. Cleaning also removed the white surface 'bloom' found on some areas (*photo right*).

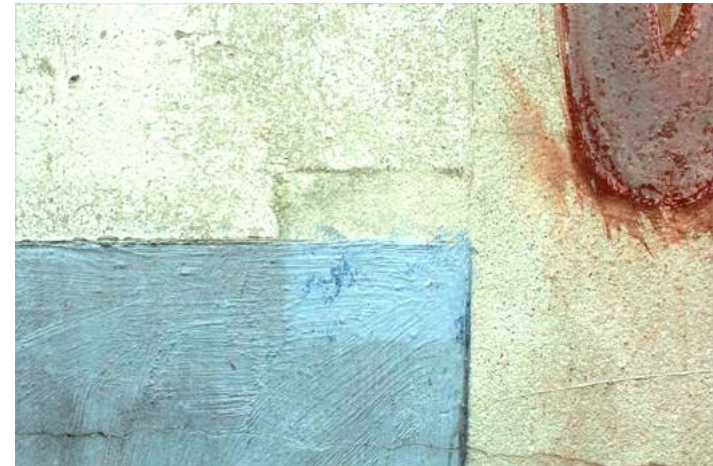
Preliminary cleaning tests proved effective in removing superficial dust and dirt from the surface of the paint. However, the underbound nature of the paint means that the work must be done carefully to avoid unacceptable loss of the original. Removal of the grey dirt layer exposes strong, bright colour beneath. Localised losses within the surface are also revealed (see *photo right*).

The areas that are coated with degraded varnish were also tested and here trials focussed on determining possible methods for the removal of the coating without risking damage to the underlying original polychromy. Close examination of the area around Bob Marley's head revealed the surface coating to be thickly but unevenly applied, resulting in the formation of numerous drip marks (*photo below left*). The increased opacity of the layer where it is thickest is most evident where there are drips and in areas where it has pooled within the troughs of the brushwork. The degraded layer is flaking away in places (*photo centre below*) revealing the original colour and demonstrating the degree to which the colour has become transformed and hidden by the increasingly opaque layer that now covers it.

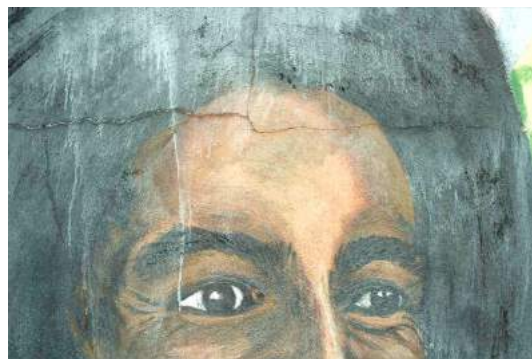
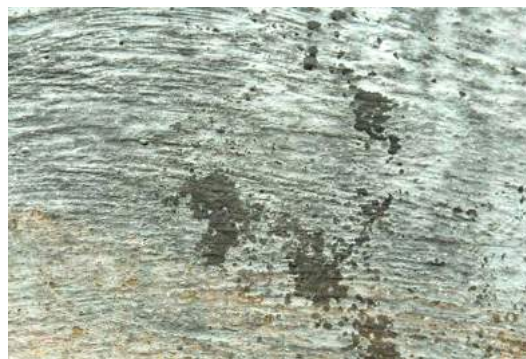
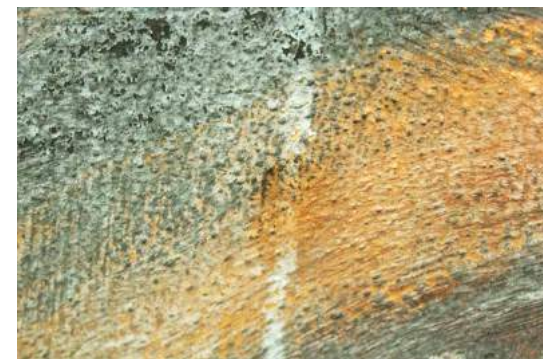
Cleaning trials were carried out using a range of solvents applied and cleared using cotton wool swabs. Preliminary tests indicated that the surface coating could be successfully cleared from the underlying paint using a range of organic solvents including isopropanol and acetone. Minimal contact was maintained through the application of a tissue layer and care required to ensure that risk to the underlying paint was minimised. For a larger area to be cleaned one would need to determine an optimum method of application and removal and it will be necessary to look at options for stabilising areas of weak and powdery paint in conjunction with cleaning.

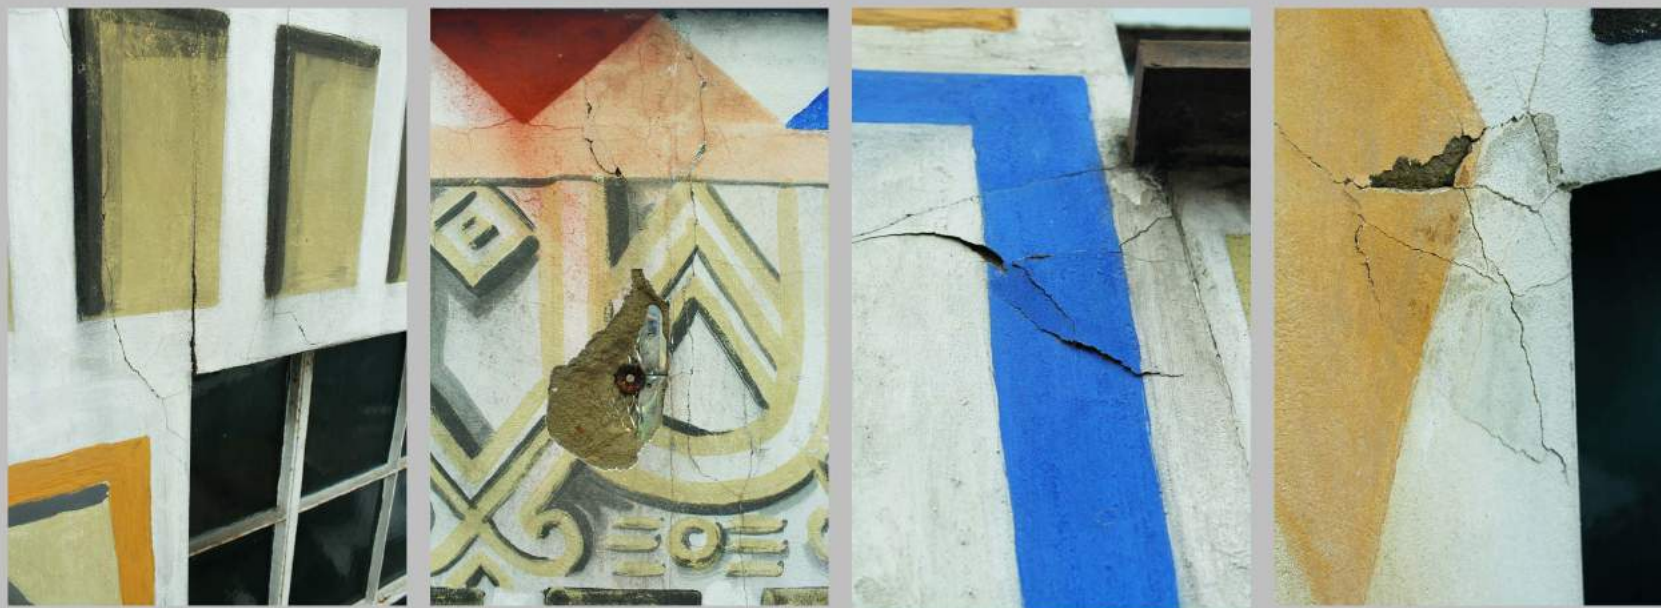
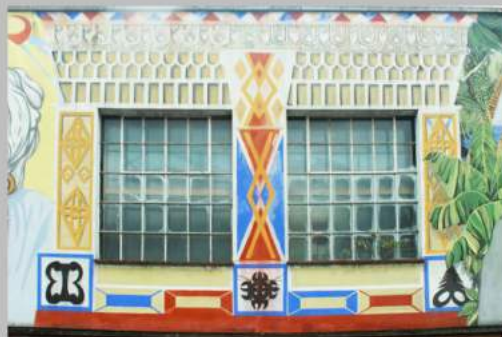
Plates 1-5 - Condition of Support & Render (clockwise from lower left)

The window area presents the only break in what is an otherwise continuous expanse of brickwork and has been subject to localised structural movement, which is evident at the corners of the reveals. There are three areas where the render has blown due to relatively small structural movements that have resulted in compression at these corners. This is evident on the upper left, lower left and lower right corners of the double window where compression have resulted in cracking and lifting of the render away from the wall plane. (See Page *i* - Plates 1-5)

Overall view of the windows showing generally good condition of the render with the exception of the details show above

Loss of render caused by corrosion of ferrous washers and cracking along juncture of expanded metal lath panels above upper left corner

Delamination and bulging of the upper surface of the render in lower left corner of left window caused by compression below the sill

Area of cracking and bulging in upper left corner of right window associated with movement the juncture of the lintel and the central pier

Repairs to the areas of damaged render should be carried out using a cementitious render of similar mix to that used originally. This will require some testing to determine the ratio of cement to aggregate and the type of sand used. Filling of numerous cracks within the render would probably be best done using a material such as Flügger™<sup>4</sup>, a compatible lime-based filler that is fine enough to be able to fill hairline cracks to sufficient depth to ensure a good bond. On drying the filler becomes water resistant and provides a good base for subsequent retouching.

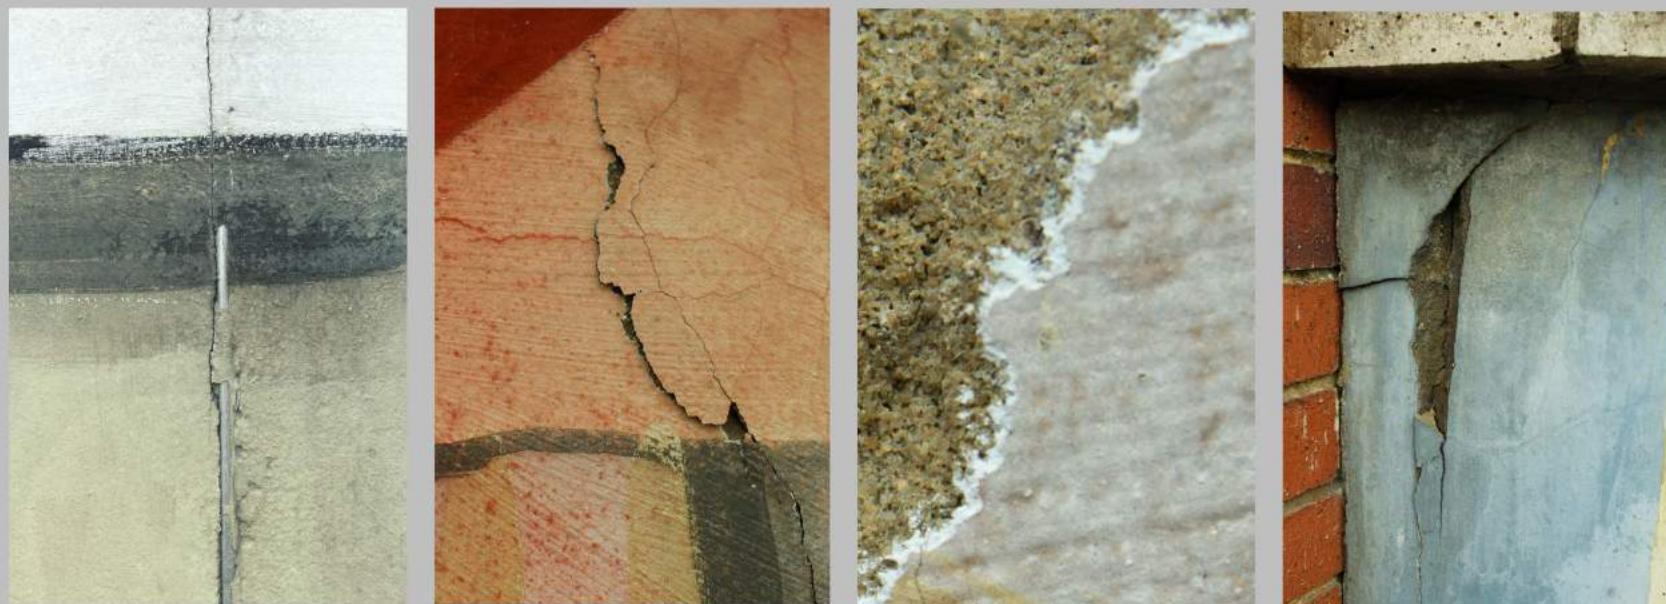
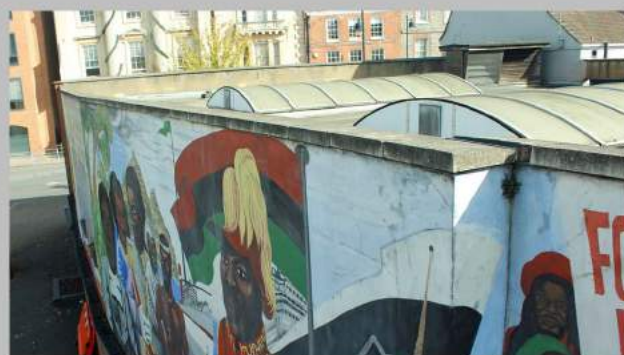
Plates 6-10 - Condition of Support & Render (clockwise from lower left)

Overall view of left half of the mural showing the parapet roof construction. There appears to be no difference in condition between the upper area exposed to the elements on both sides and the lower parts backed by the interior of the building.

Cracking and delamination in the upper corner

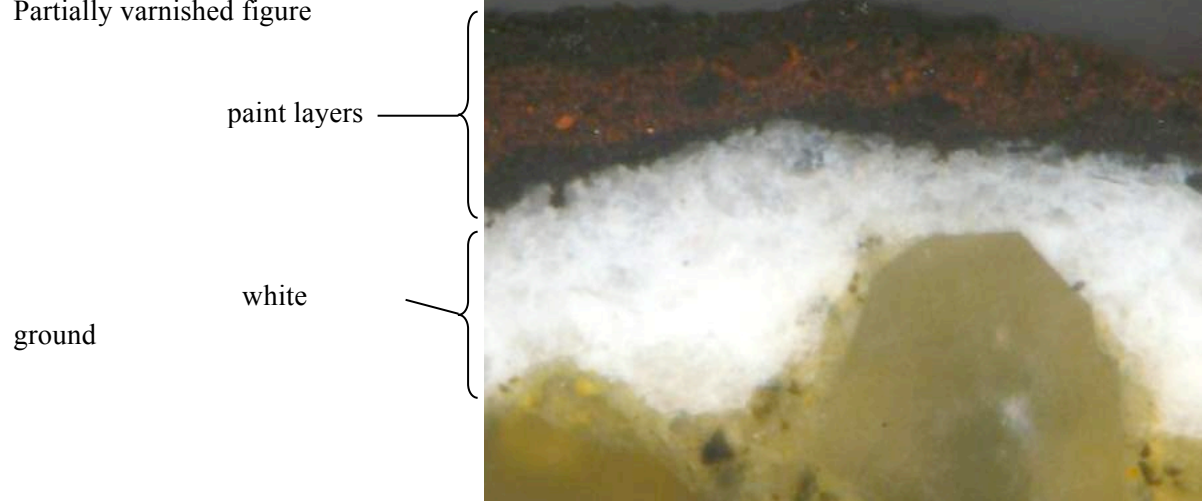
Black from area 4

Partially varnished figure

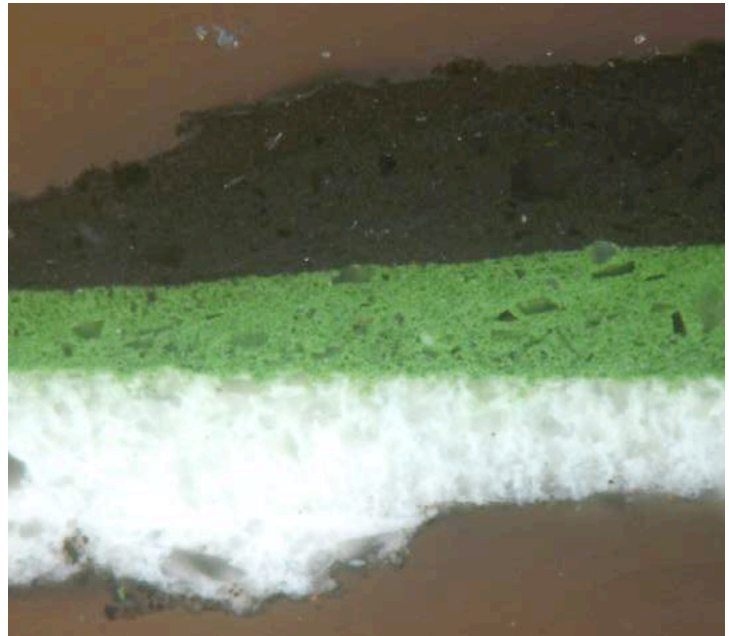
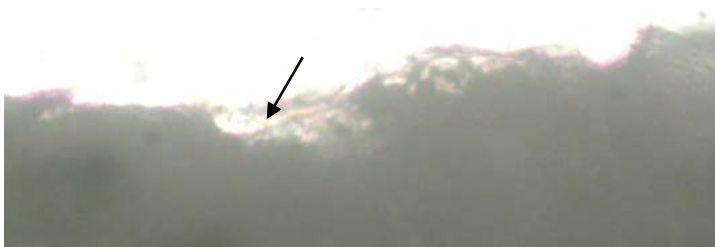
**SAMPLE 2**Black from flag to right of figure  
in hat by ship

Detail of the surface of the black

Lit from behind to show the thin  
layer of varnish

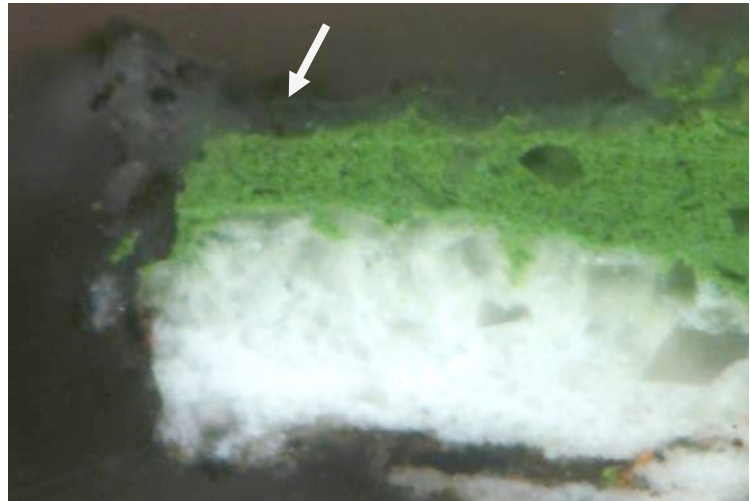
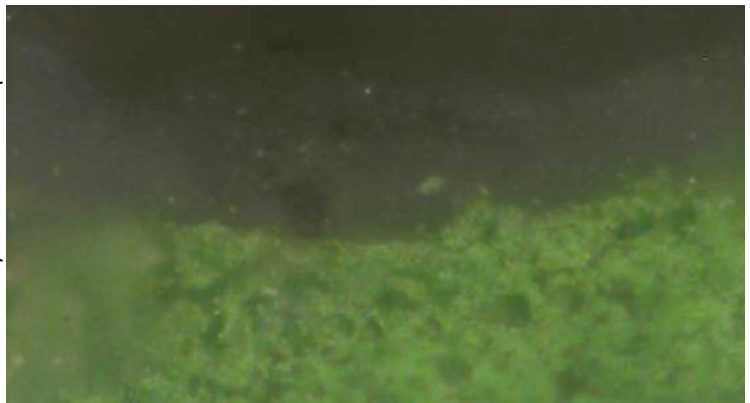
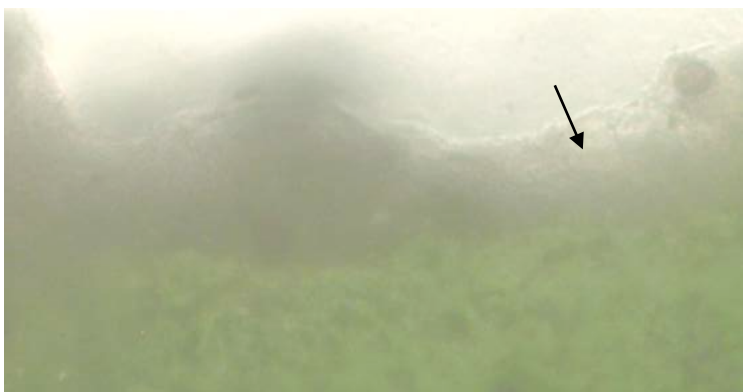
**SAMPLE 3**

In this sample there is a  
thick  
area of the 'varnish'  
coating

Detail of the coating  
which  
cloudy appears

Lit from behind to show that  
the coating is semi-  
translucent

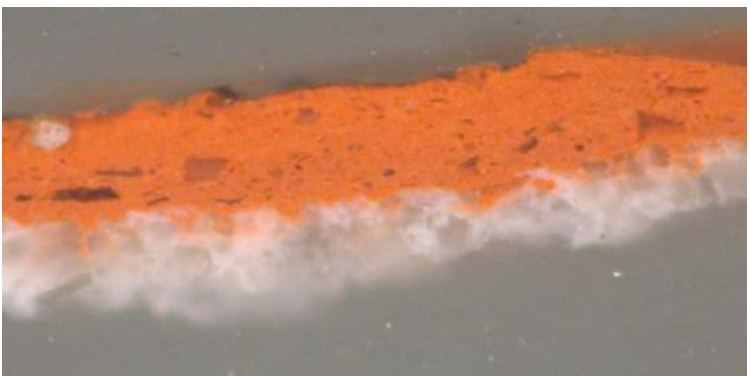
**SAMPLE 4**

In this sample the varnish is  
so thin that it is almost invisible

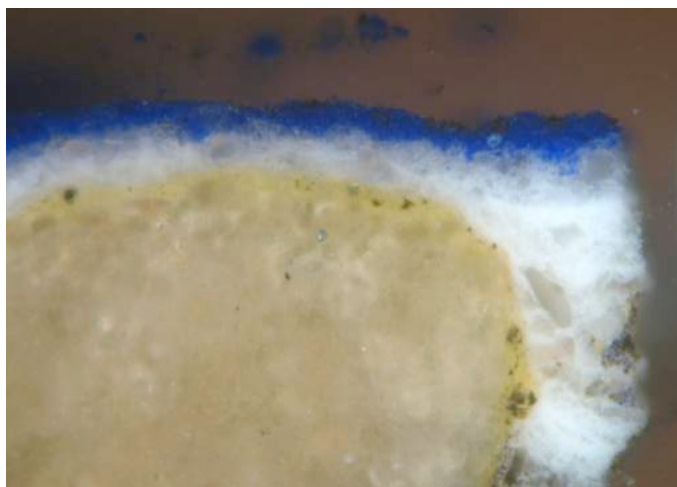
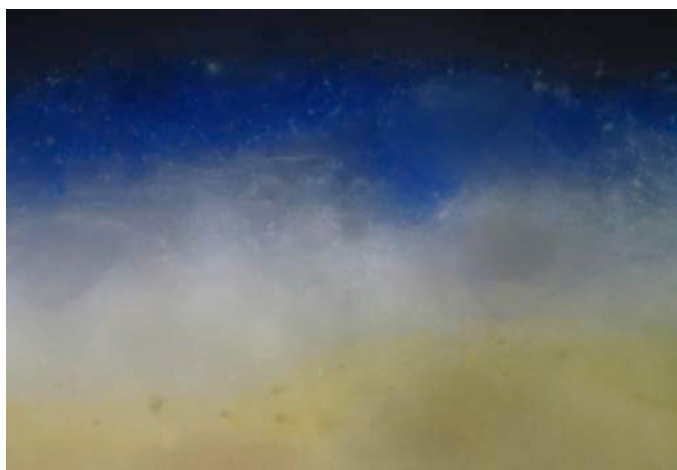
**SAMPLE 5**

Area 3 - Blue under window  
with no varnish

French ultramarine mixed with  
a small amount of organic  
blue

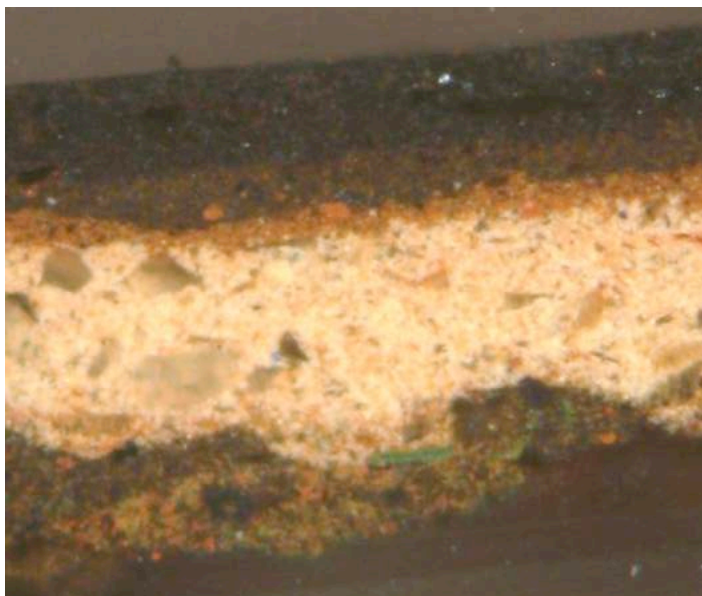
**SAMPLE 8**

Black hair from figure of Bob Marley – taken after cleaning test to remove degraded surface coating

There is no ground layer and it must have been lost when the fragment was taken.

The section is confusing because of the many layers of brown. This particular figure must have been gone over several times, when the mural was being created
