## Addendum Arboricultural Report

### Subsidence Damage Investigation at:

38 Holyrood Close  
Reading  
RG4 6PZ

| MWA REF: | SUB210106-8164REV01 |

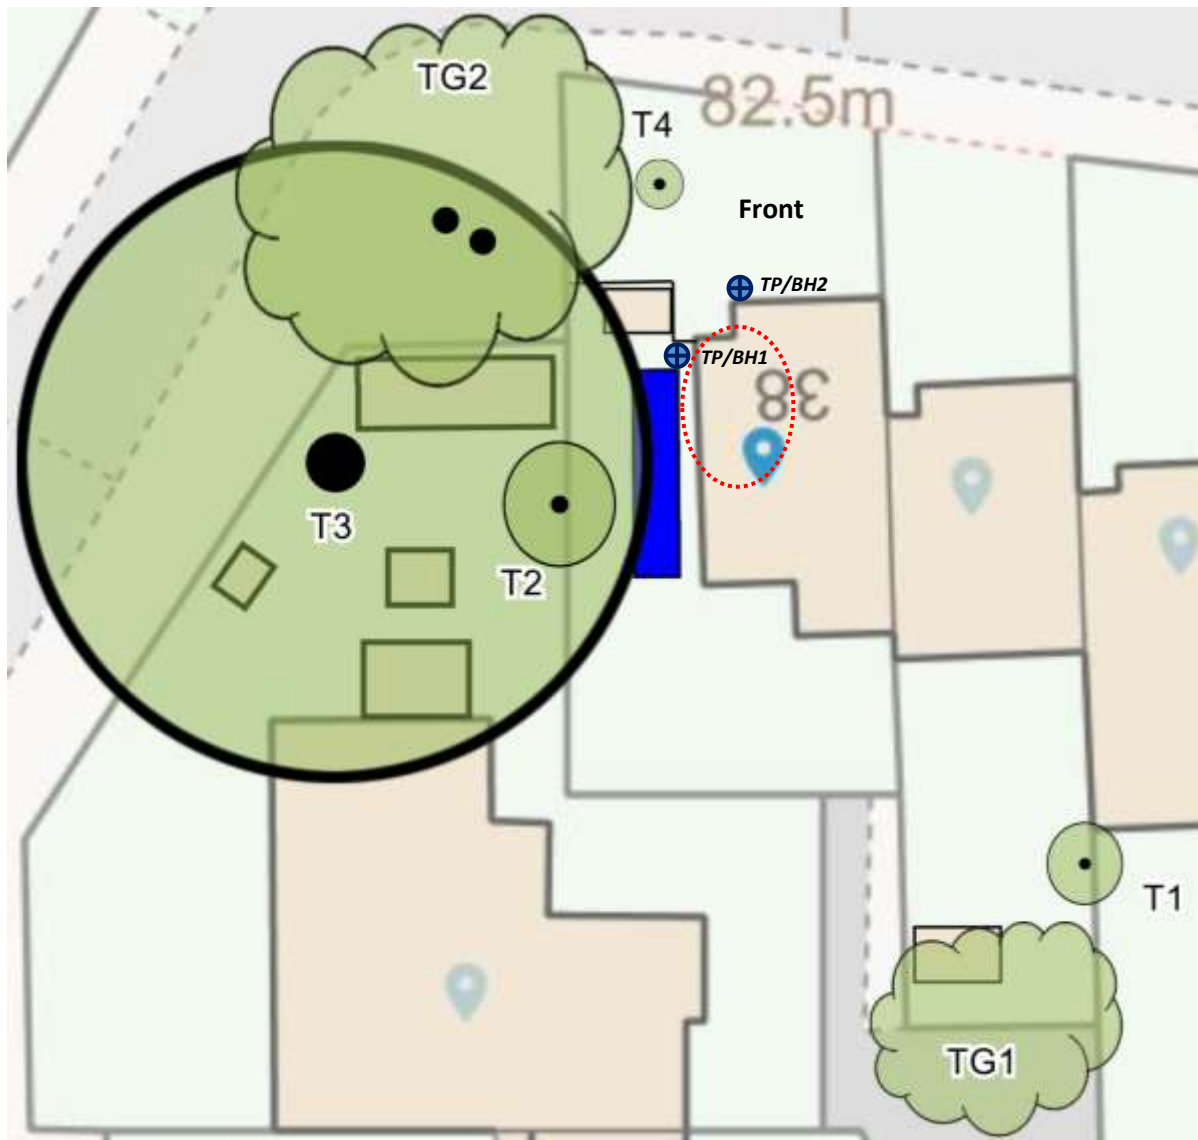
Approximate areas of damage

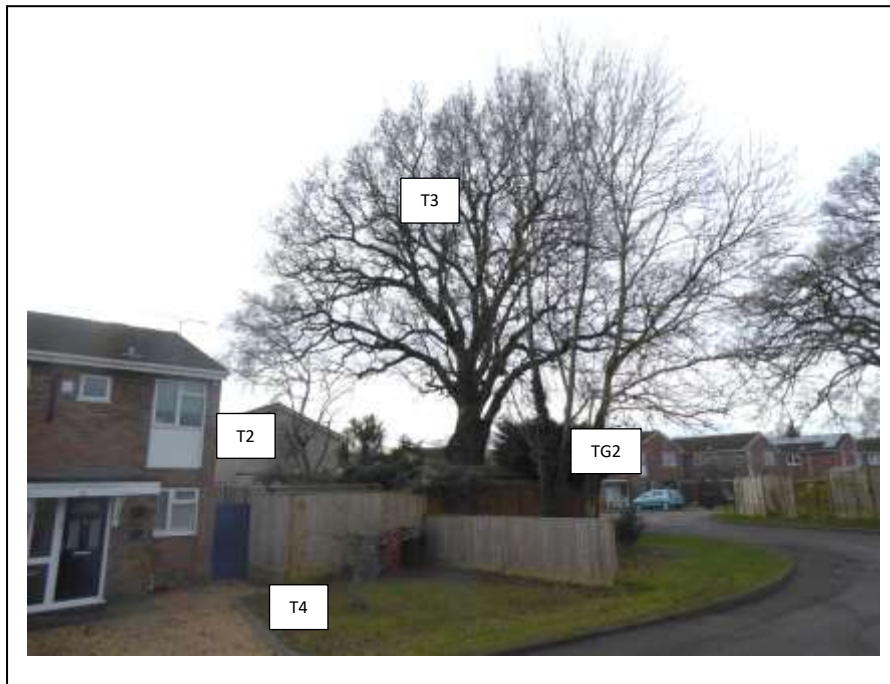
View of trees to right from front

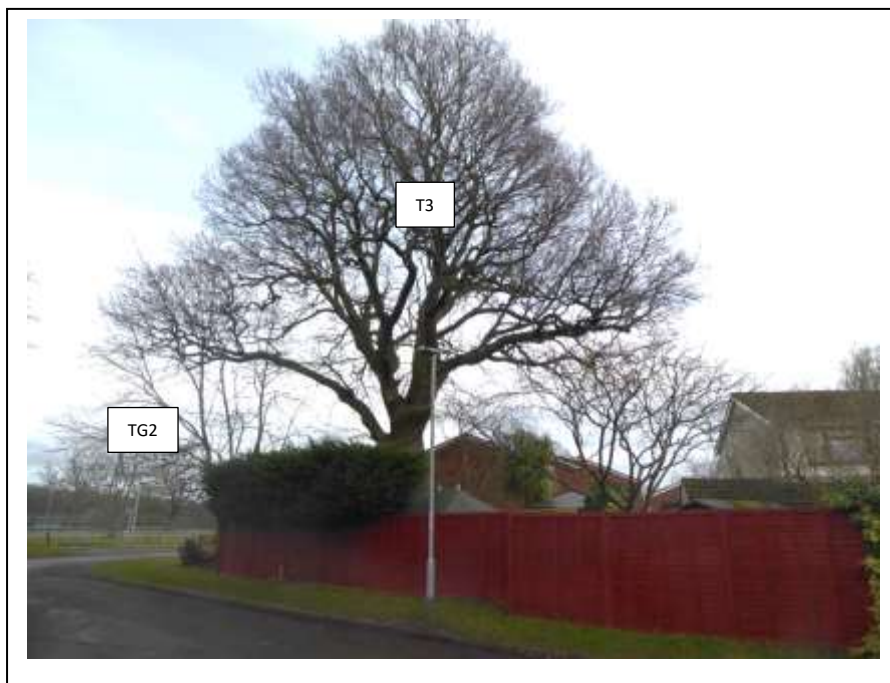
View of trees to right from right

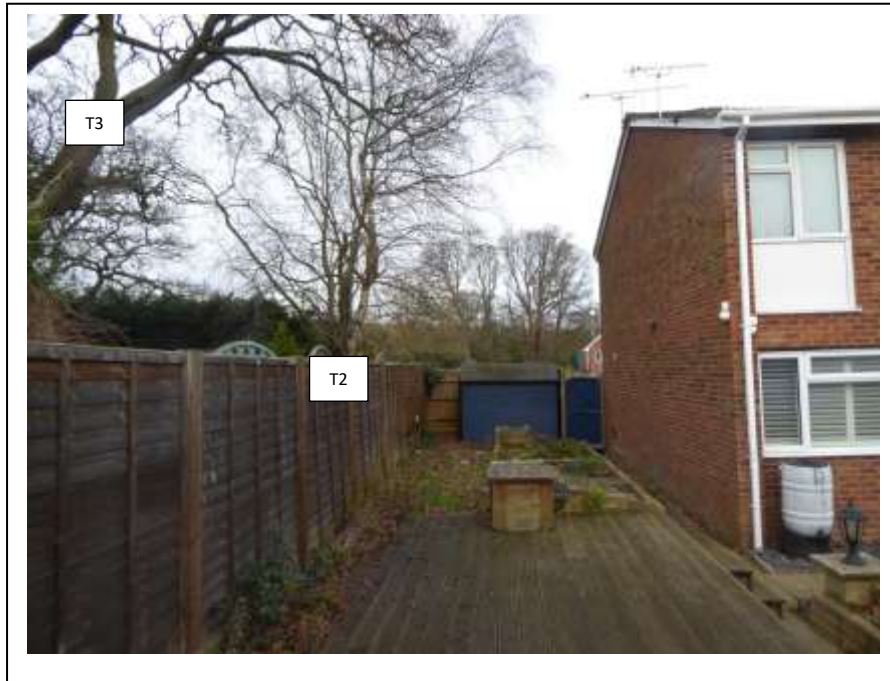
View of right flank from rear

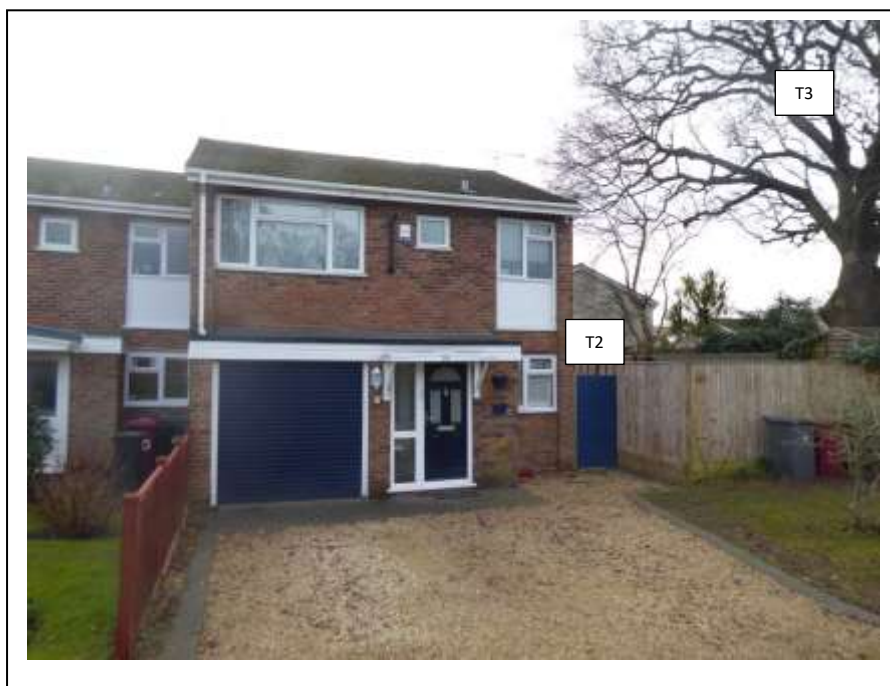
View of front elevation
