# Your survey report

32 Wantage Road, Reading, Berkshire, United Kingdom, RG30 2SE

11/06/2022

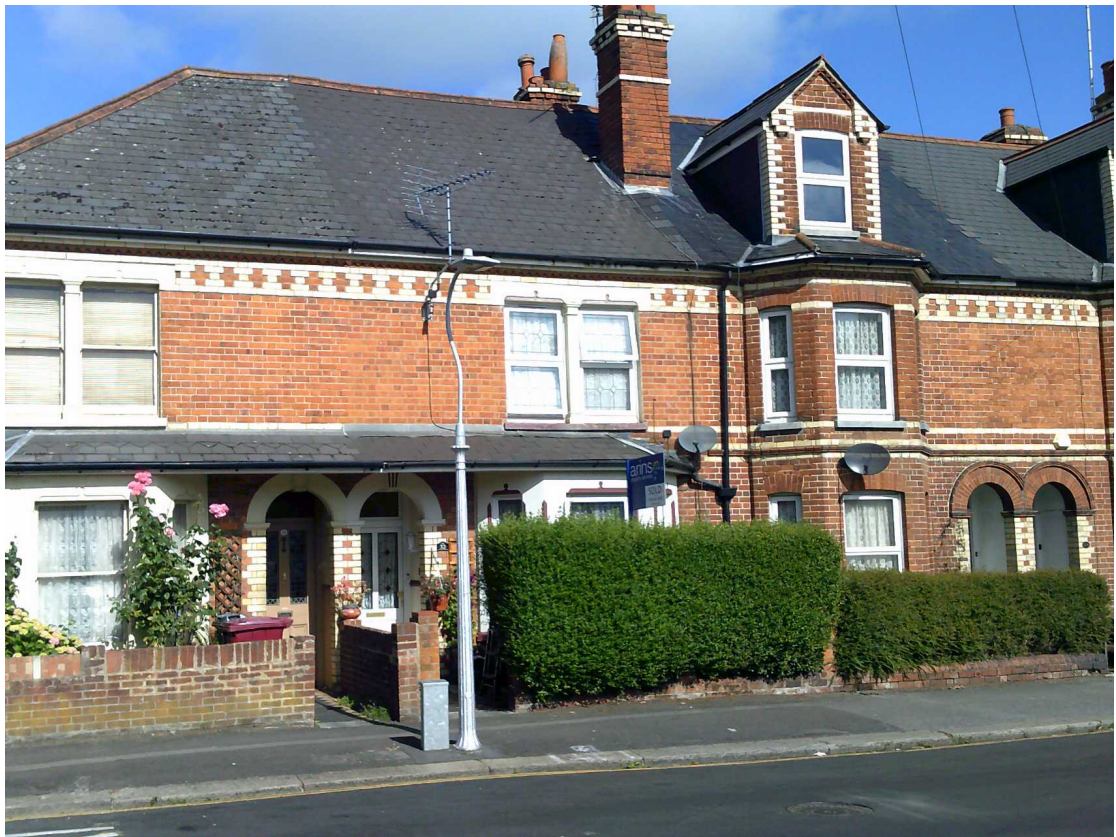
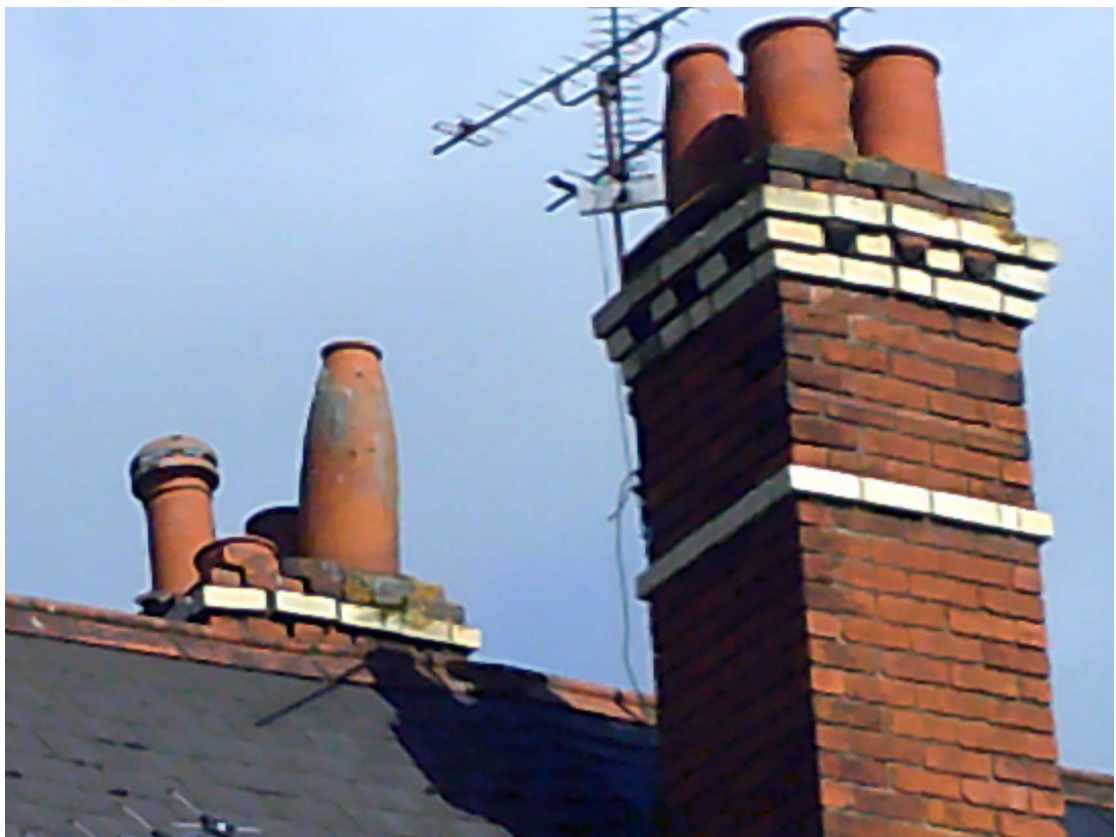
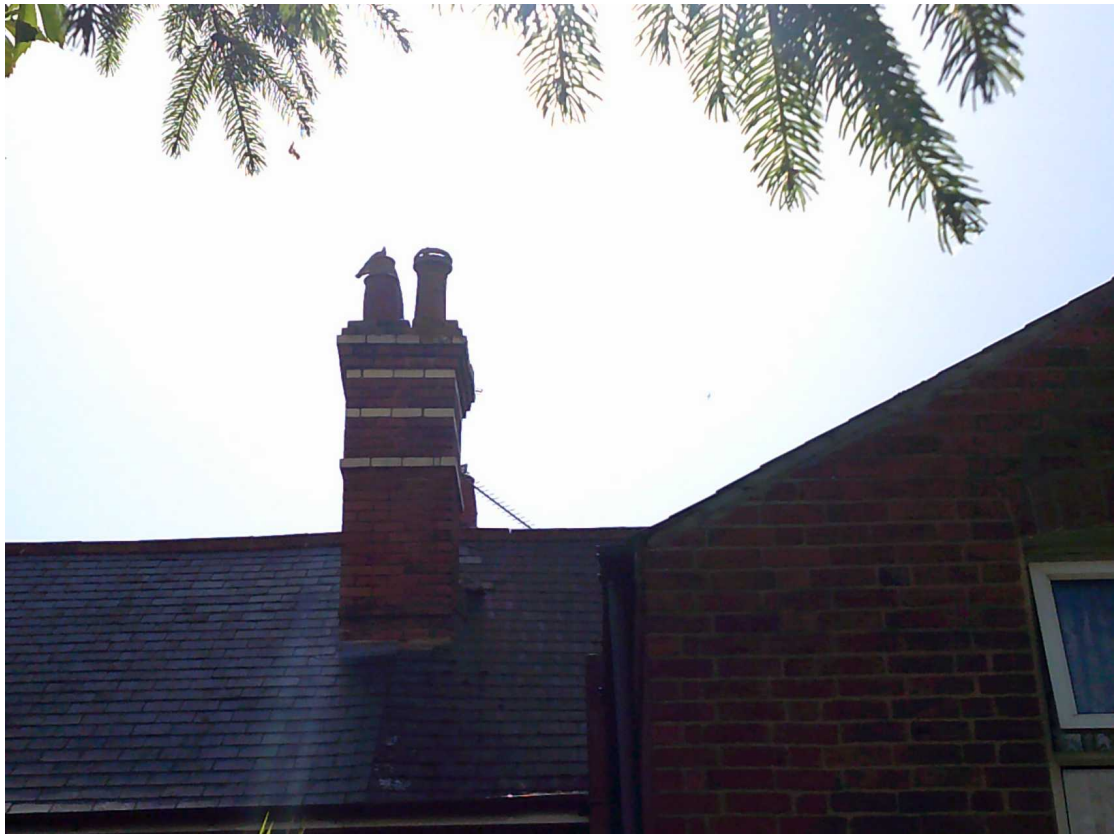
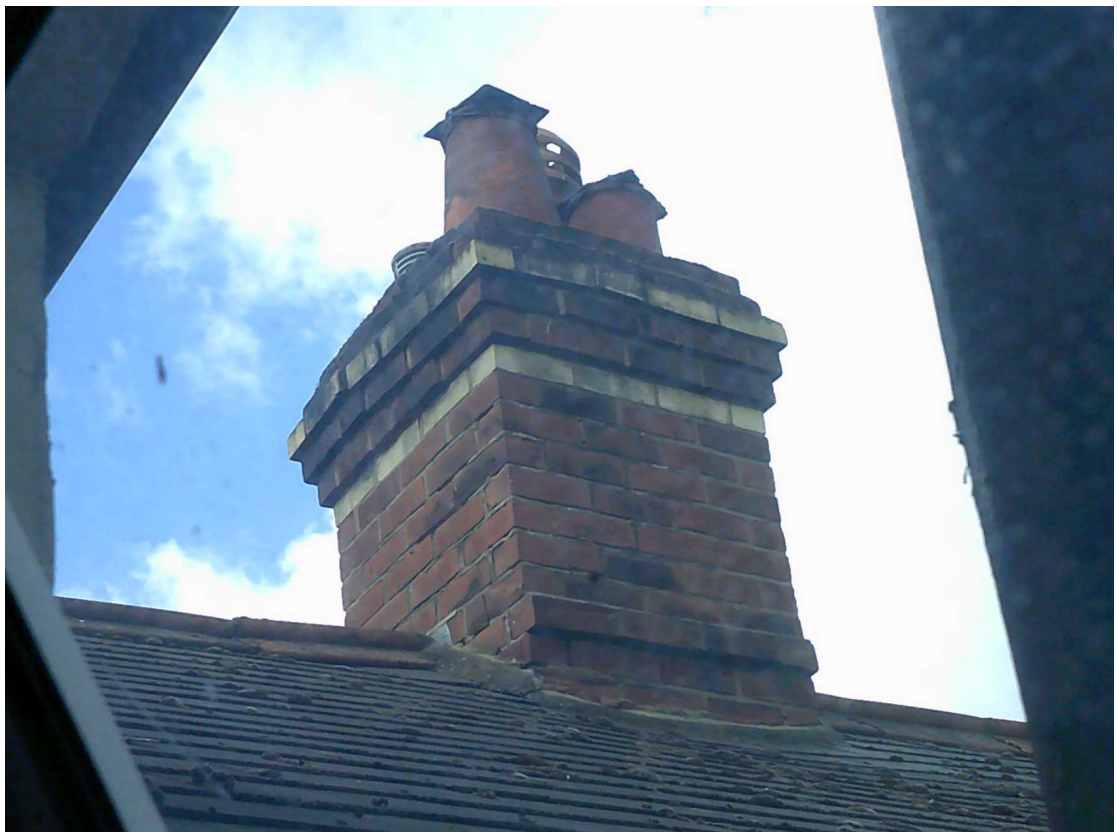
The top sections of all the chimney are in poor condition with loose brickwork, loose chimney pots and cement capping. The top section of all the chimney now needs to be rebuilt. Because this work will affect the neighbouring properties, you should discuss this with the owners prior to purchase to establish if the party wall agreement will be necessary to upgrade the entire chimney including the neighbours.

The junction between the chimney and pitched roof to the two rear chimney stacks has been protected with cement fillets. The cement fillets are cracked and broken and will need to be replaced with lead flashing. The chimney on the front elevation has already been upgraded and the junction is protected with lead flashing.

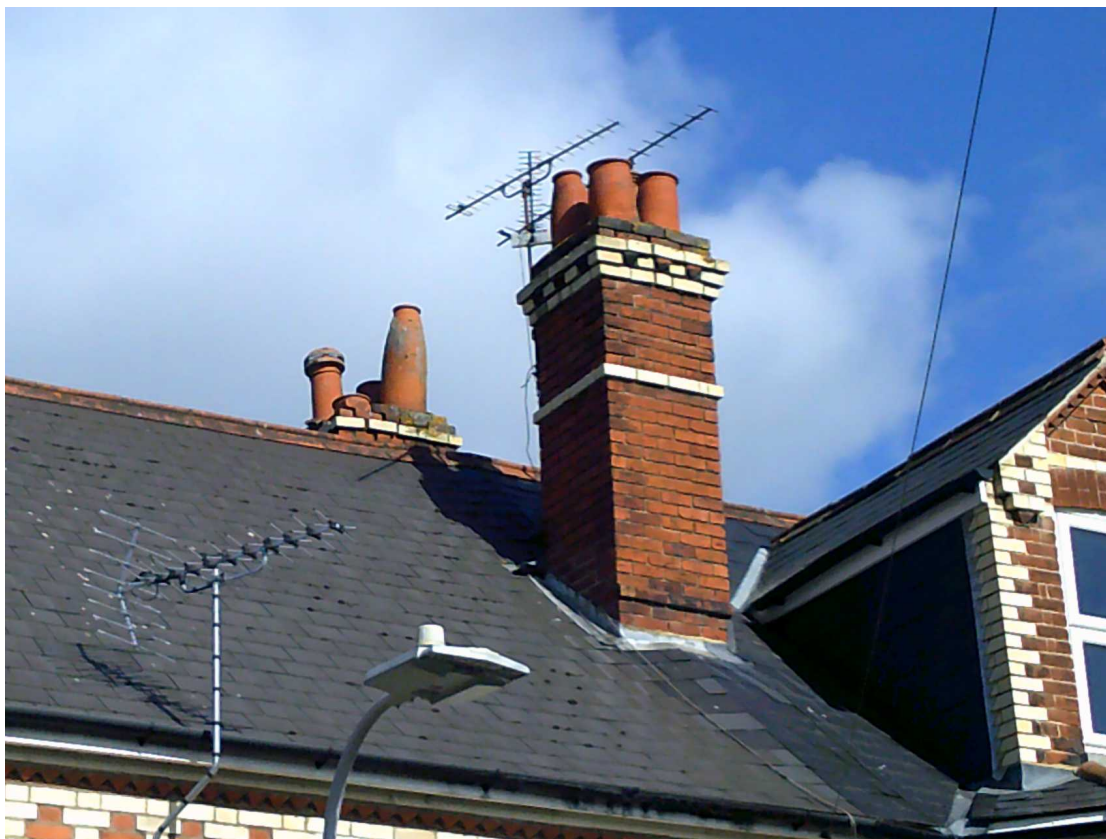
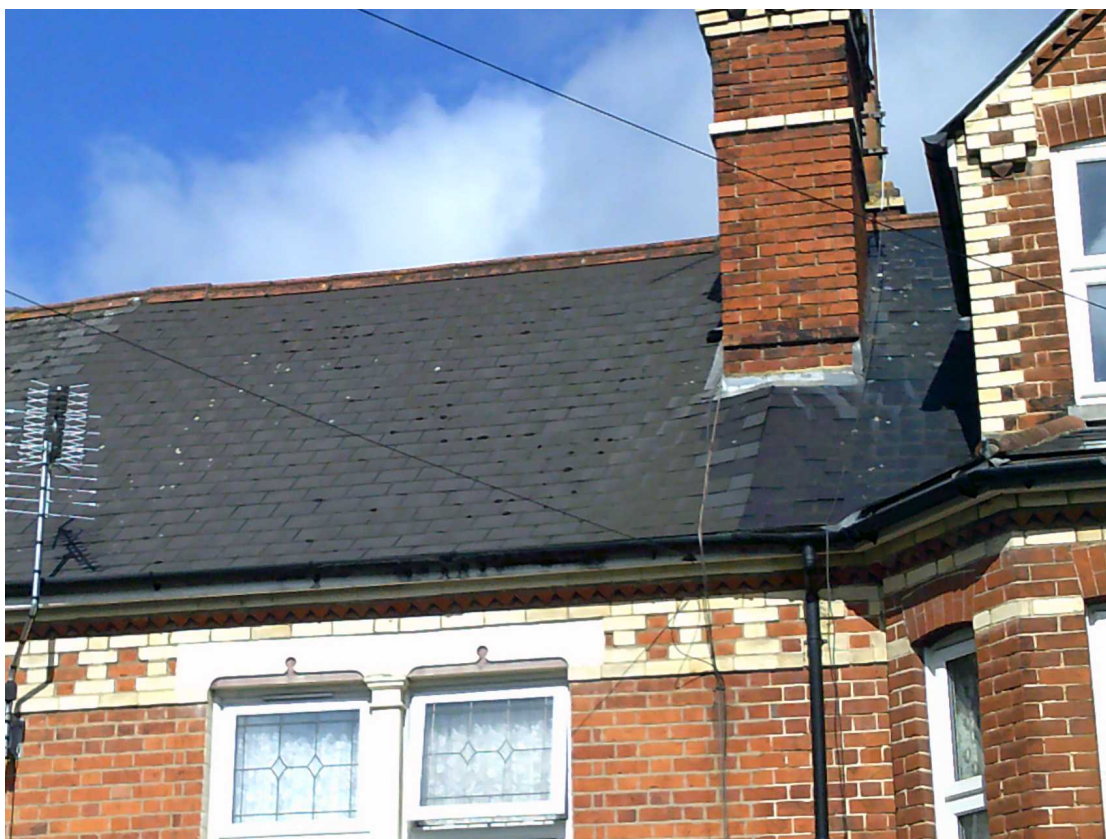
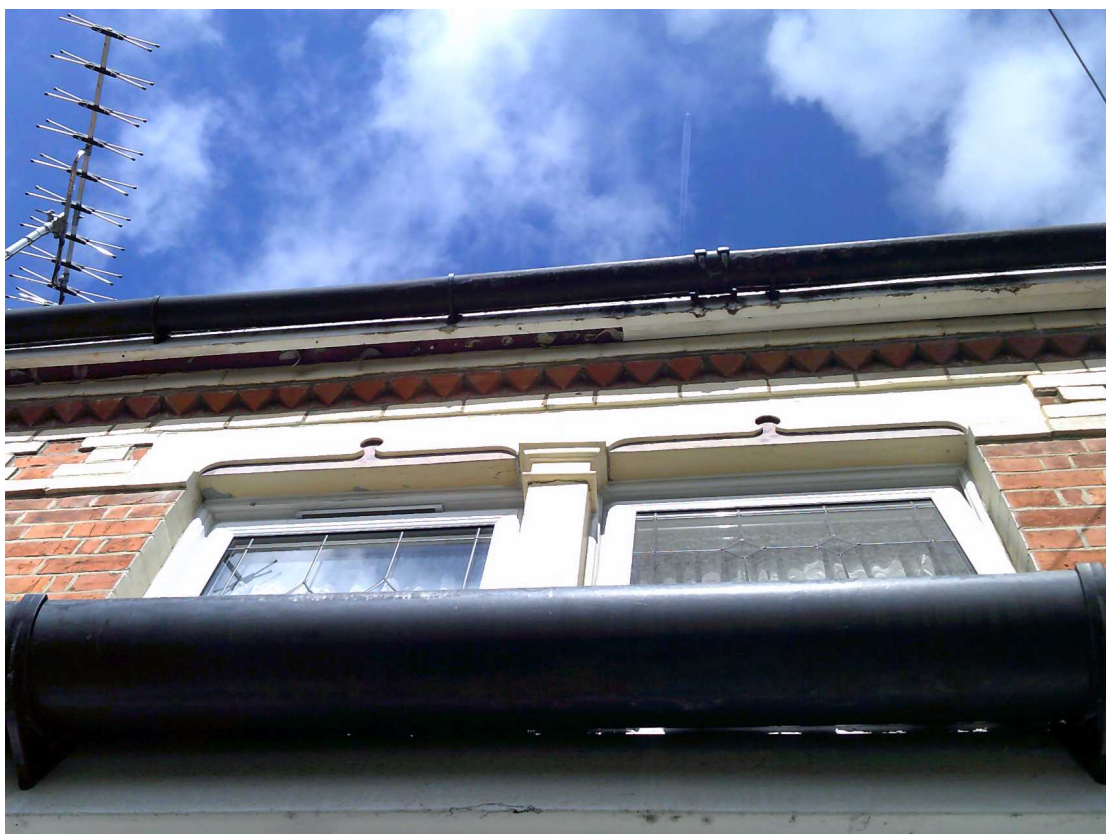
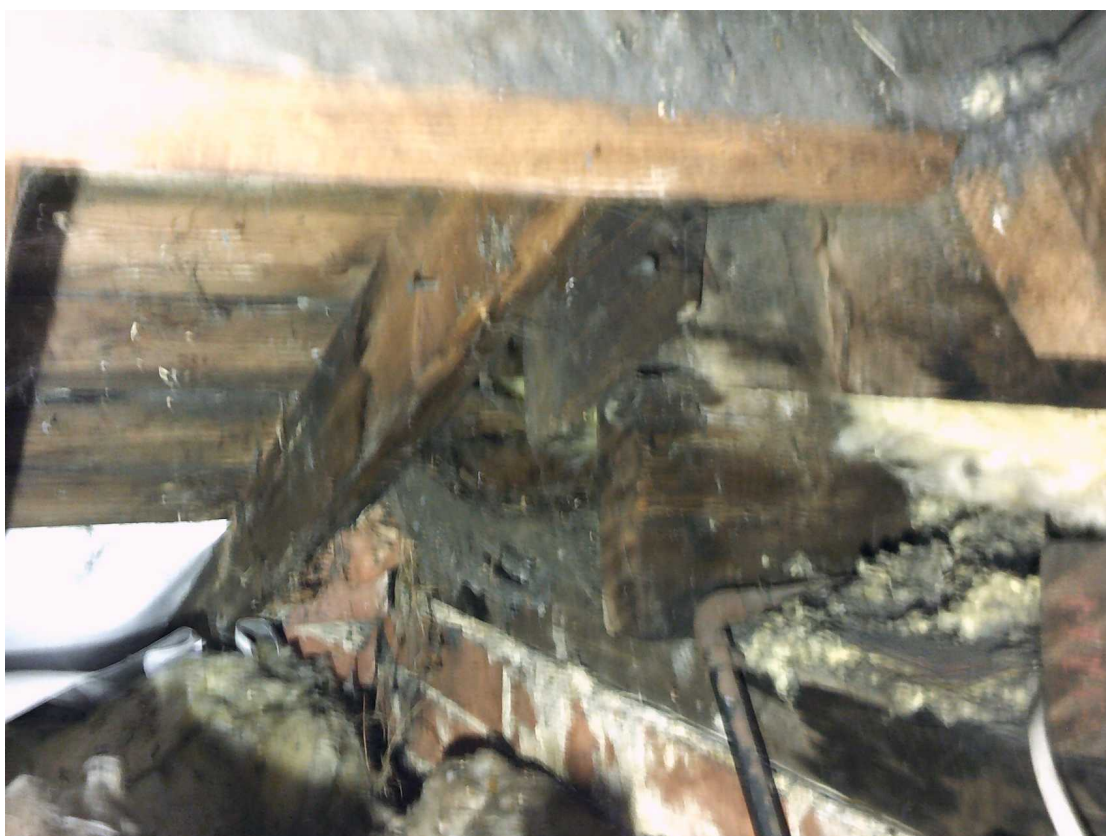
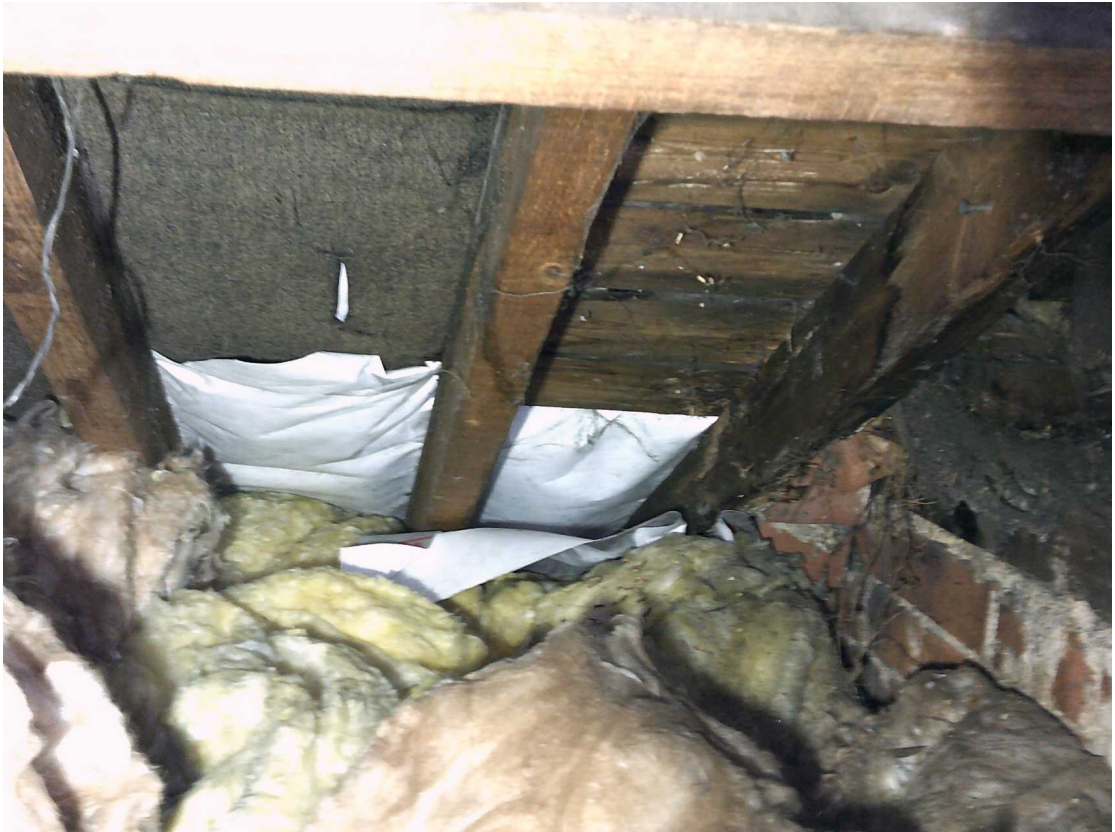
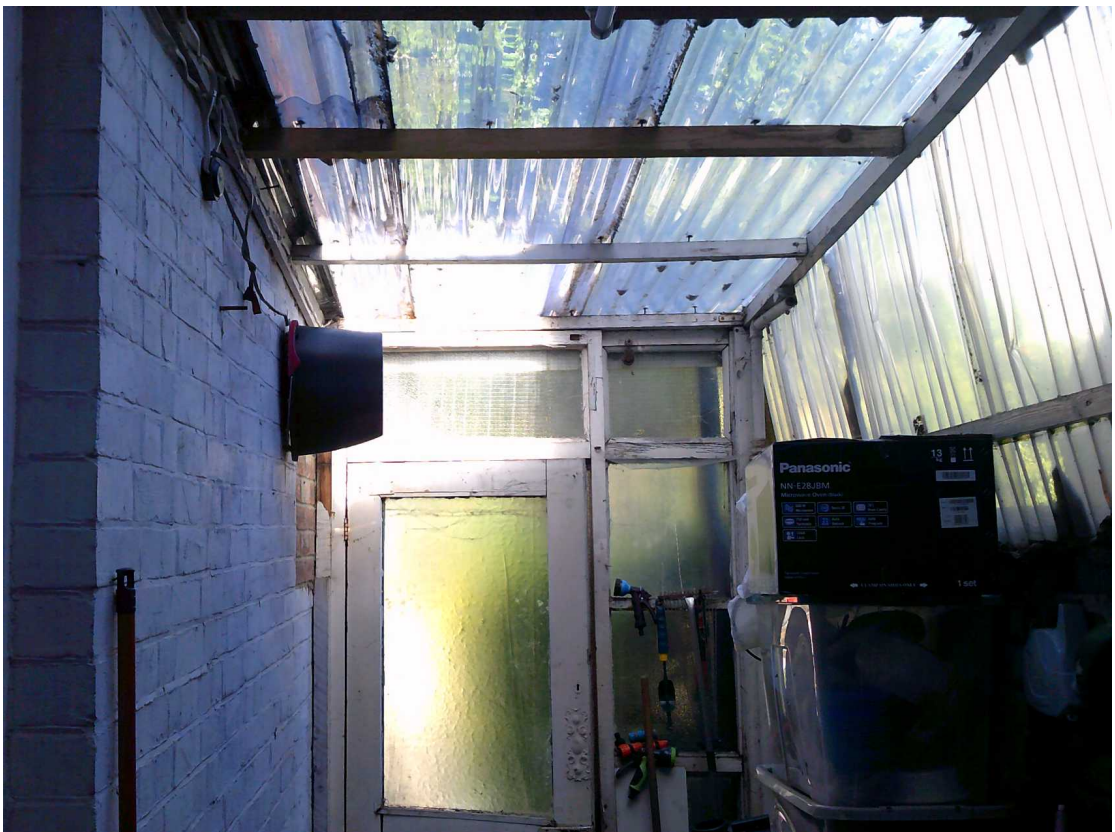
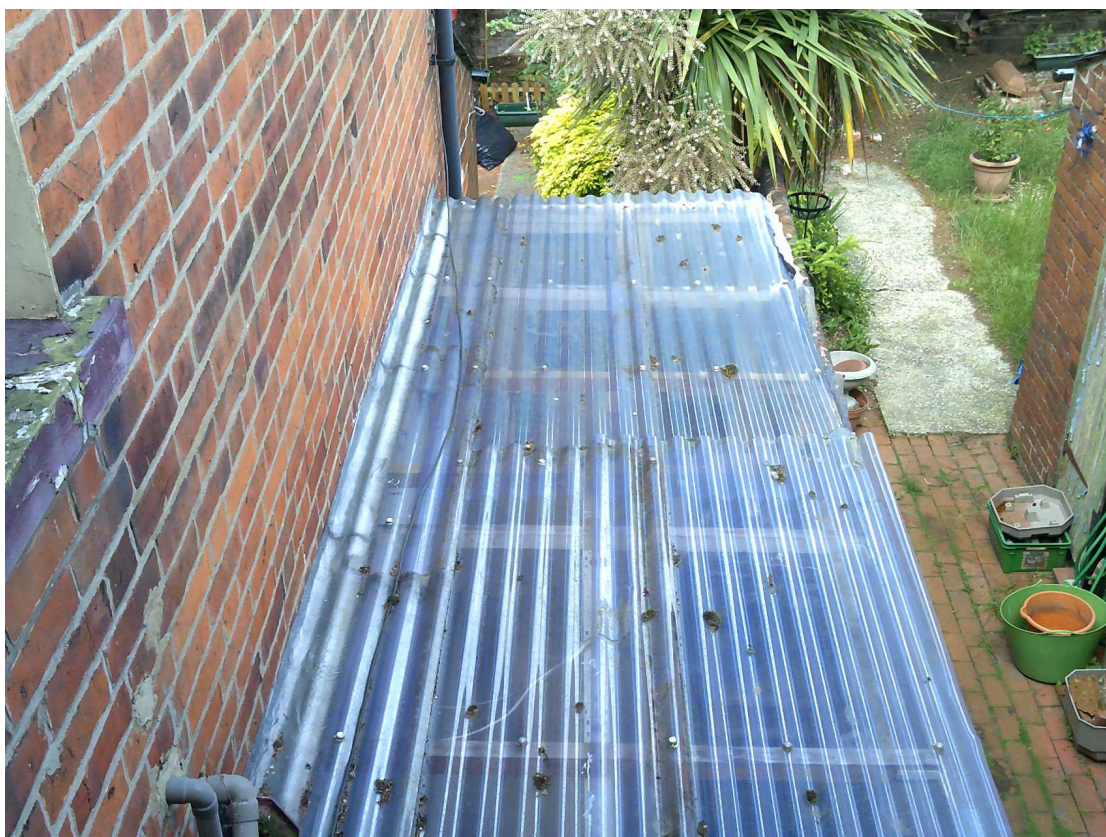
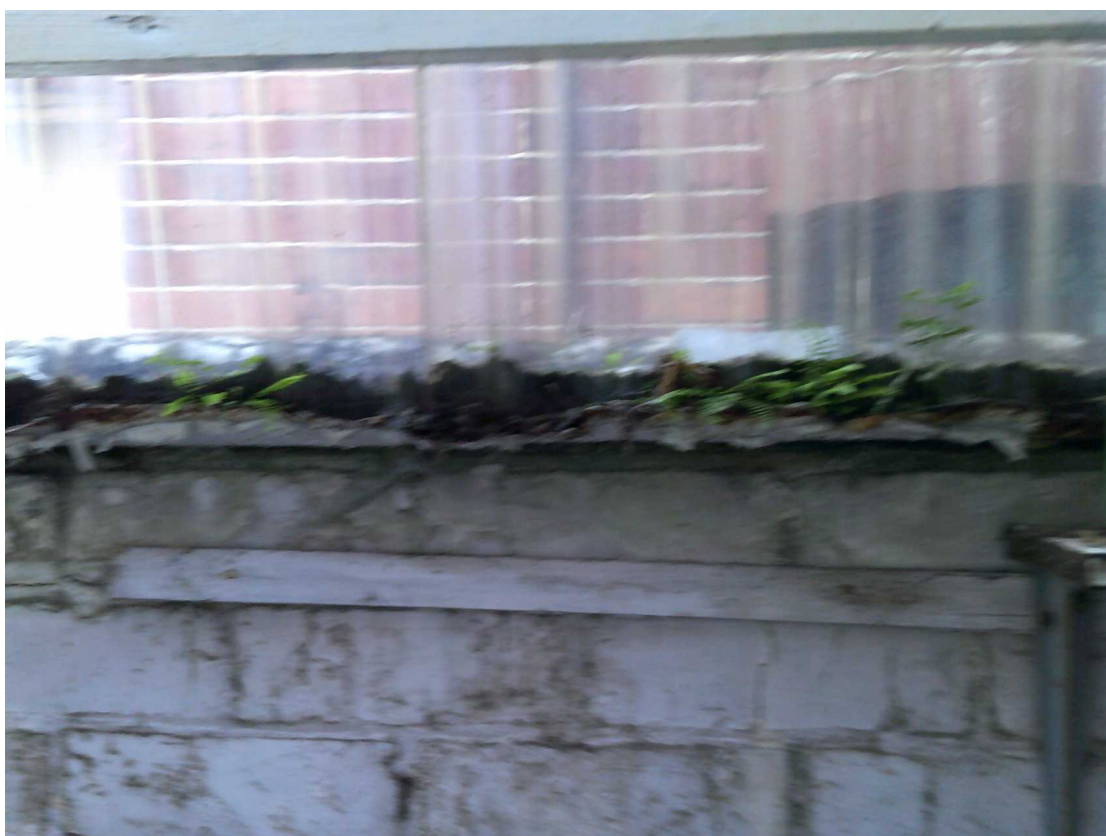
The pitched roof has been recovered in simulated cement composite slates laid over the top of a bitumen under felt. The junction between the two roof surfaces on the rear elevation has been protected with a lead valley gutter and there are protective ridge capping.

When viewed from the front elevation, there is a dip in the roof surface and this is due to deflection of the roof timbers. (Please see the roof structure section).

Viewed from inside the loft space, there is evidence that additional patch repair and under cloaking in the form of polythene sheeting has been installed under the rear valley gutter. There is also evidence of rotten timber at this location. I could not tell if there was still water ingress at this location and you should ask a roofing contractor to check the condition of the rear valley gutter to ensure that it is waterproof. (Please see roof structure section)

On the back elevation a translucent corrugated PVC cover has been formed above the back door and side path leading to the garden. The roof is poorly constructed and the protection between the external brick walls and the roof has been made with a temporary flash band. Storm water is running off the corrugated sheets causing damp in the boundary wall between the two adjoining properties. The PVC sheets and framing should be removed and replaced with a permanent cover, if required, so long as there is no encroachment onto the boundary wall. You should check with your legal adviser if there has been a dispute regarding this temporary structure and the encroachment saturating the boundary wall.

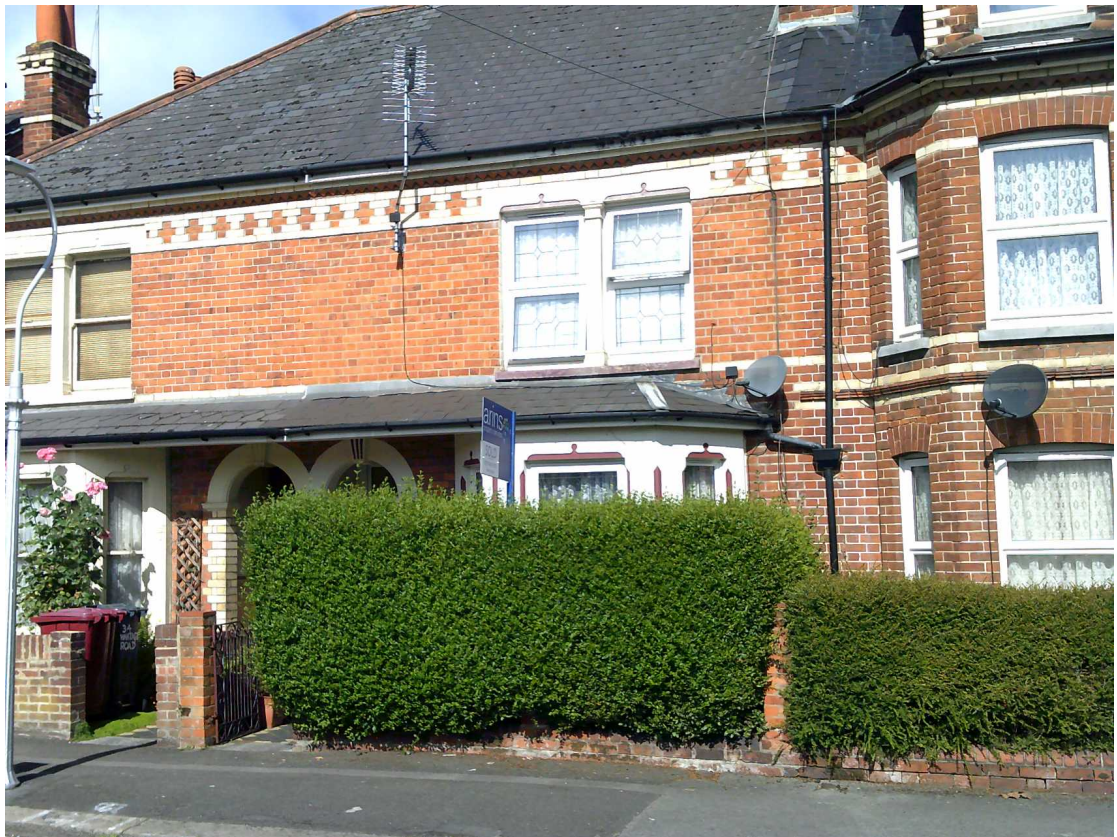
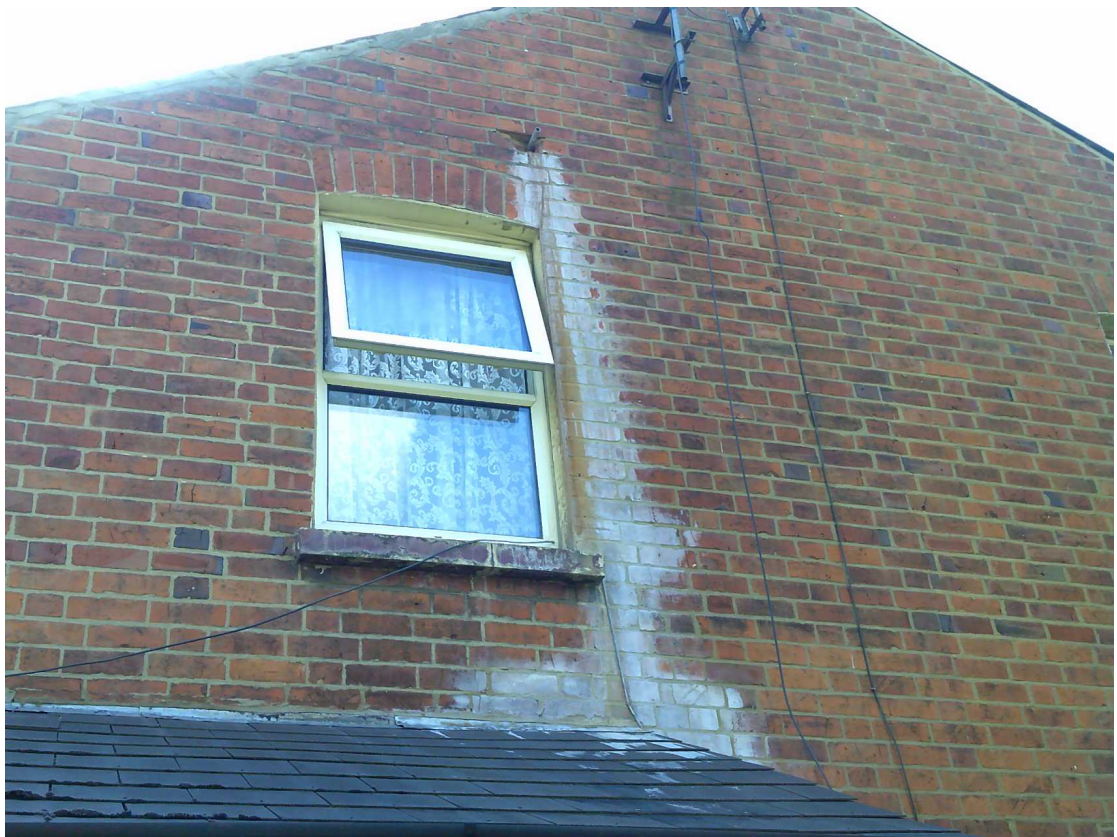
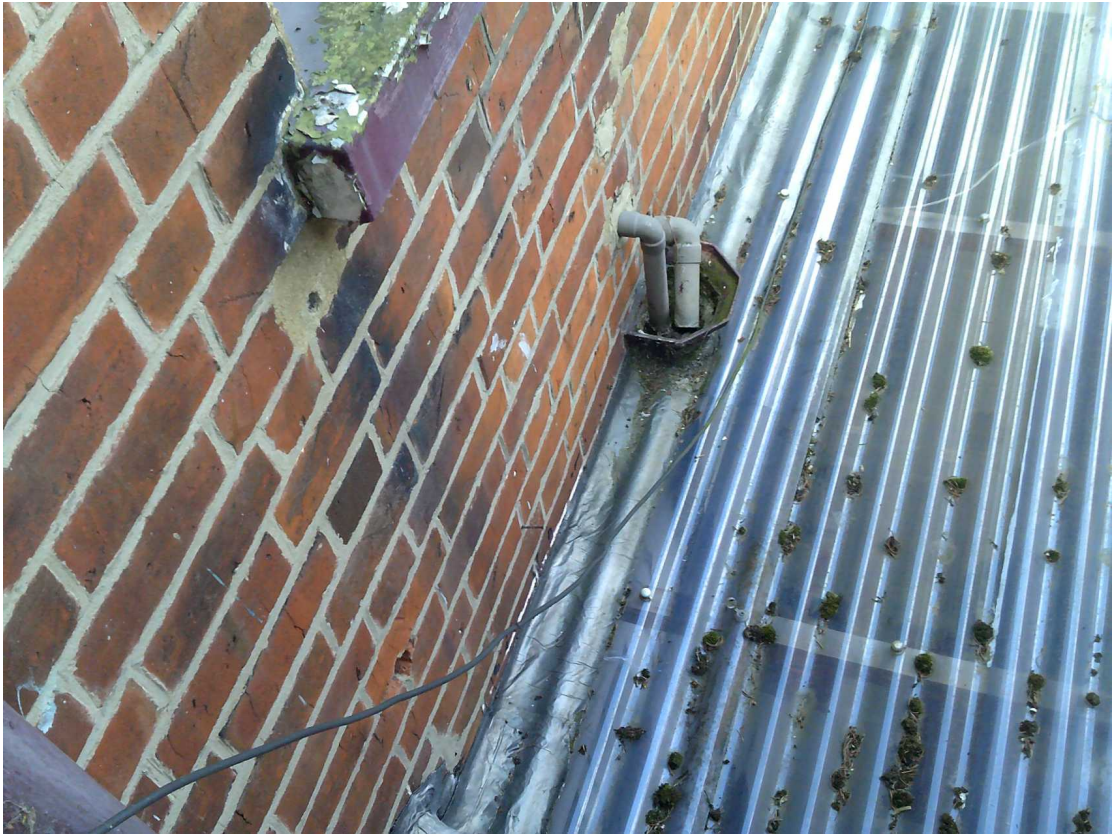
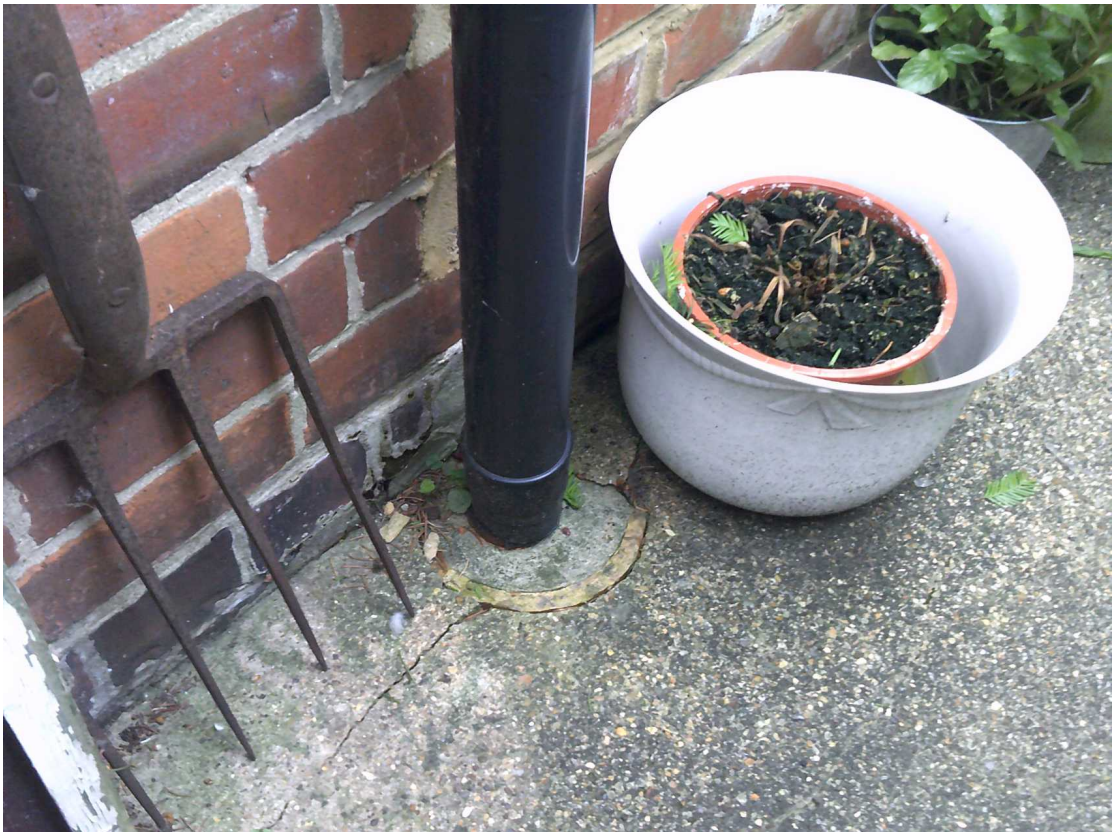
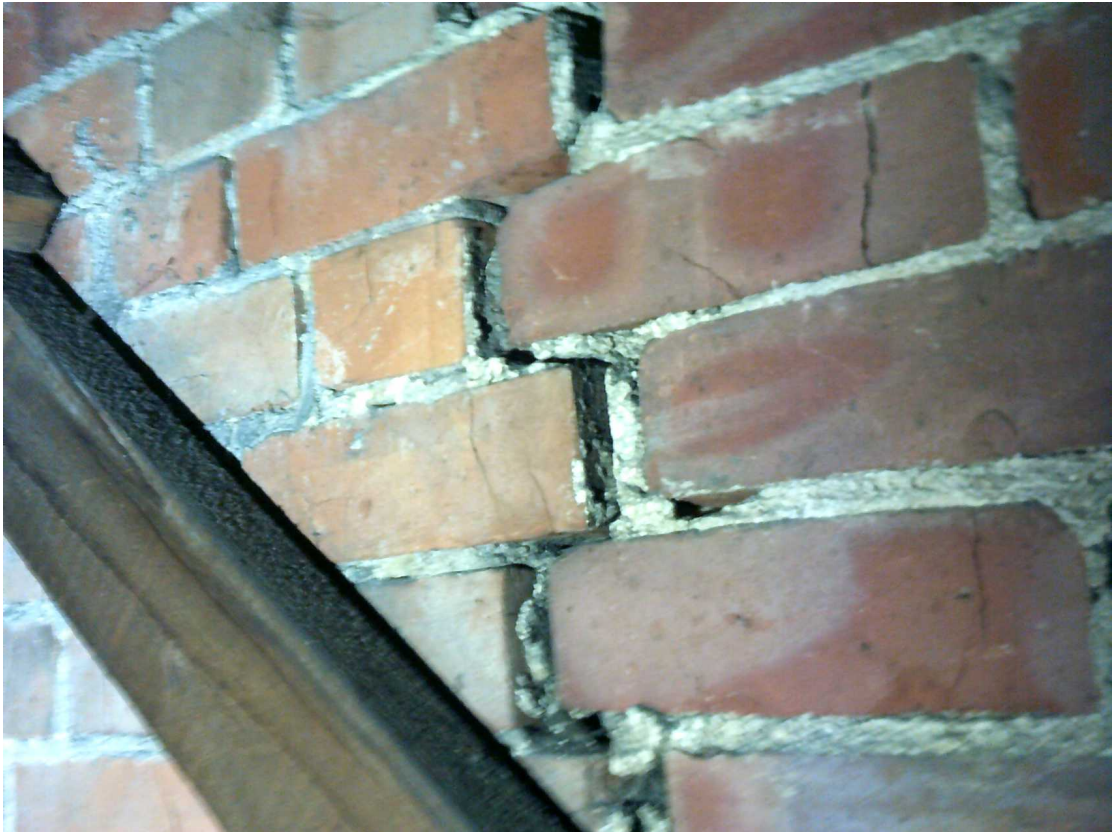
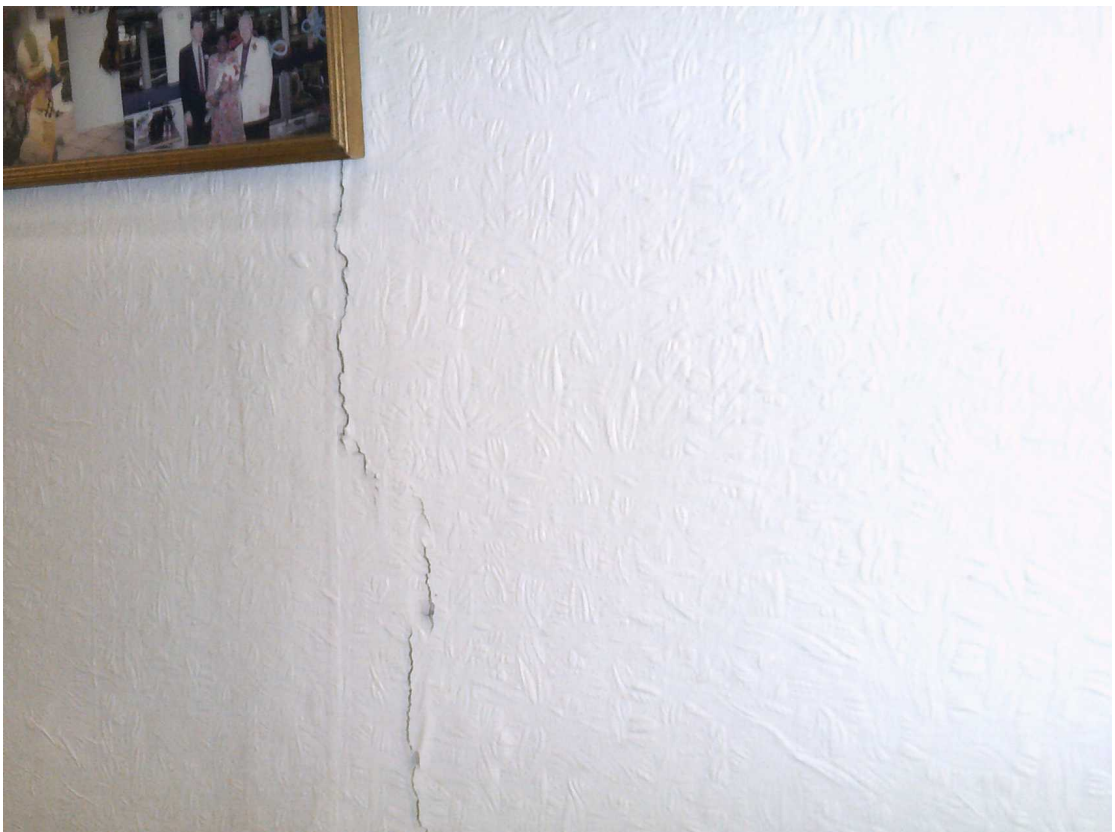
The external walls are constructed in solid brickwork on average 250 mm thick. The walls have not been built off a damp proof course but have been plastered internally. The walls on the front elevation are built with a decorative red frost proof brick laid in Flemish bond in a 1/1 ratio laid in lime mortar. There is a decorative buff coloured brick banding in the fenestration finished in Portland stone, some of which has now been painted.

The rear elevation has been laid in matching red bricks laid in Flemish bond in a 1/3 ratio also in lime mortar. The brickwork has been stained beneath the cold water storage tank overflow pipe due to a historic leak which appears to have been resolved. The staining needs to be cleaned off.

All of the walls have been repointed in cement mortar. Cement mortar is impervious and traps damp under the surface and the lime mortar can no longer allow water vapour to travel through the brickwork and evaporate from the outside surface. I recommend that all of the external walls are repointed with matching lime mortar.

There is evidence of settlement within the structure and this can be seen within the loft space close to the loft hatch where the party wall has cracked and the movement has been in the order of 12 mm wide. The crack in the party wall has been filled below in the corridor and is only evident with a 1/2mm crack. The cracking is considered to be historic and there is no other significant cracking within the structure.

Damp readings were taken and they ranged from nine through 27% but the target is 7%. There is no evidence that any retrospective damp proofing work has been undertaken to the house and I recommend that you ask a specialist damp proofing contractor to complete a survey and advise on how best to rid the house of rising and penetrating damp. In addition to a new silicon damp proof course, I recommend that the paving surrounding the house is cut back and French drains are installed to increase drainage and reduce splashing around the house which in turn will reduce the damp.

None of the solid brick walls are insulated and I recommend that you get a specialist insulation contractor to advise on how best to improve the thermal performance of the external walls.

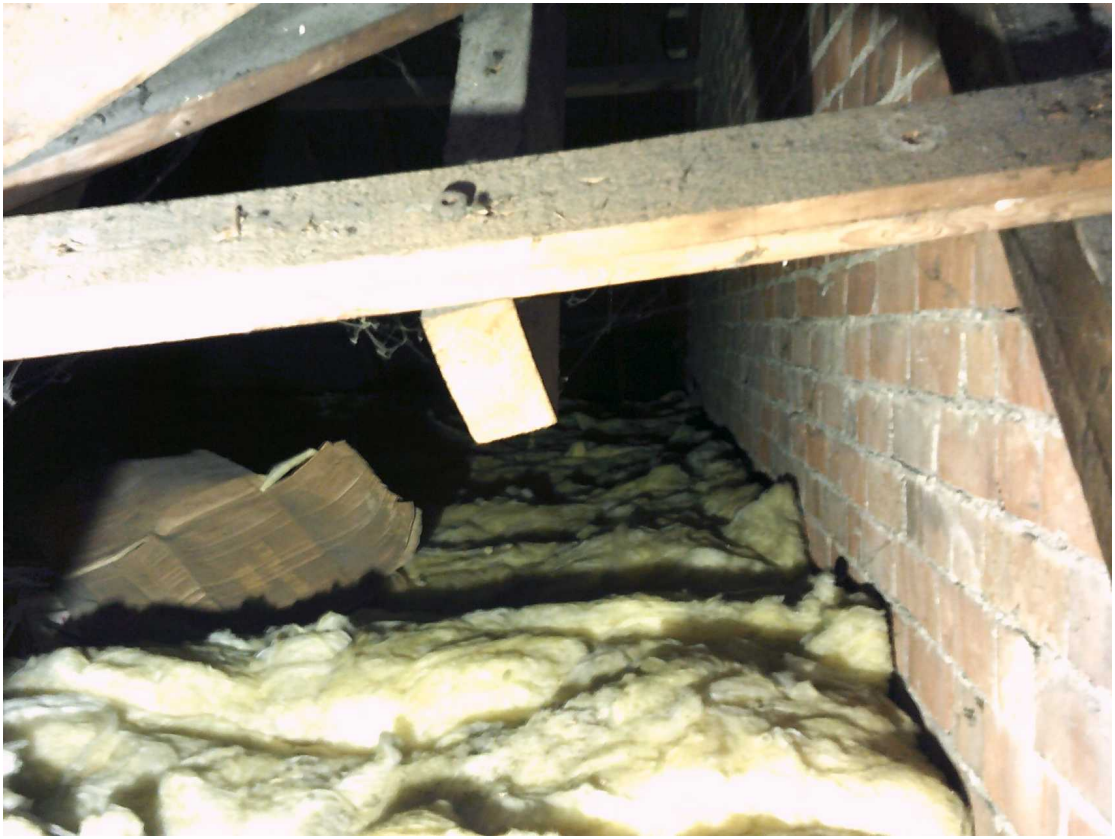
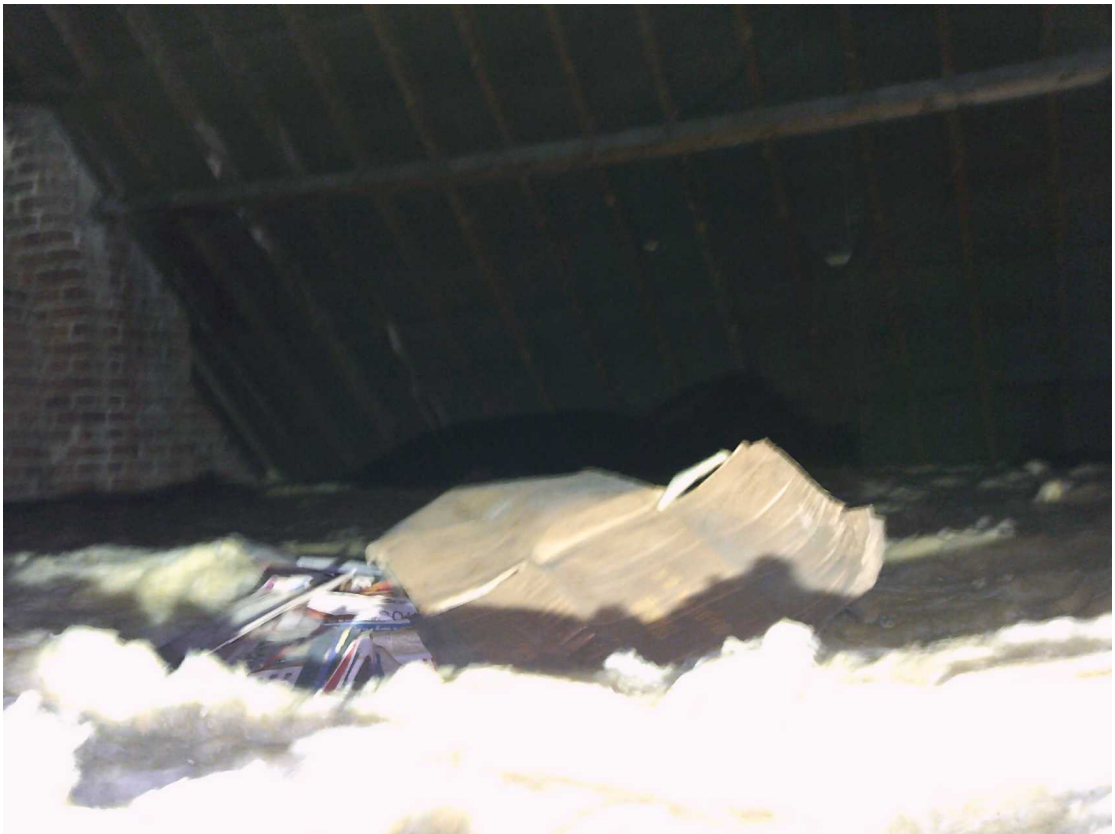
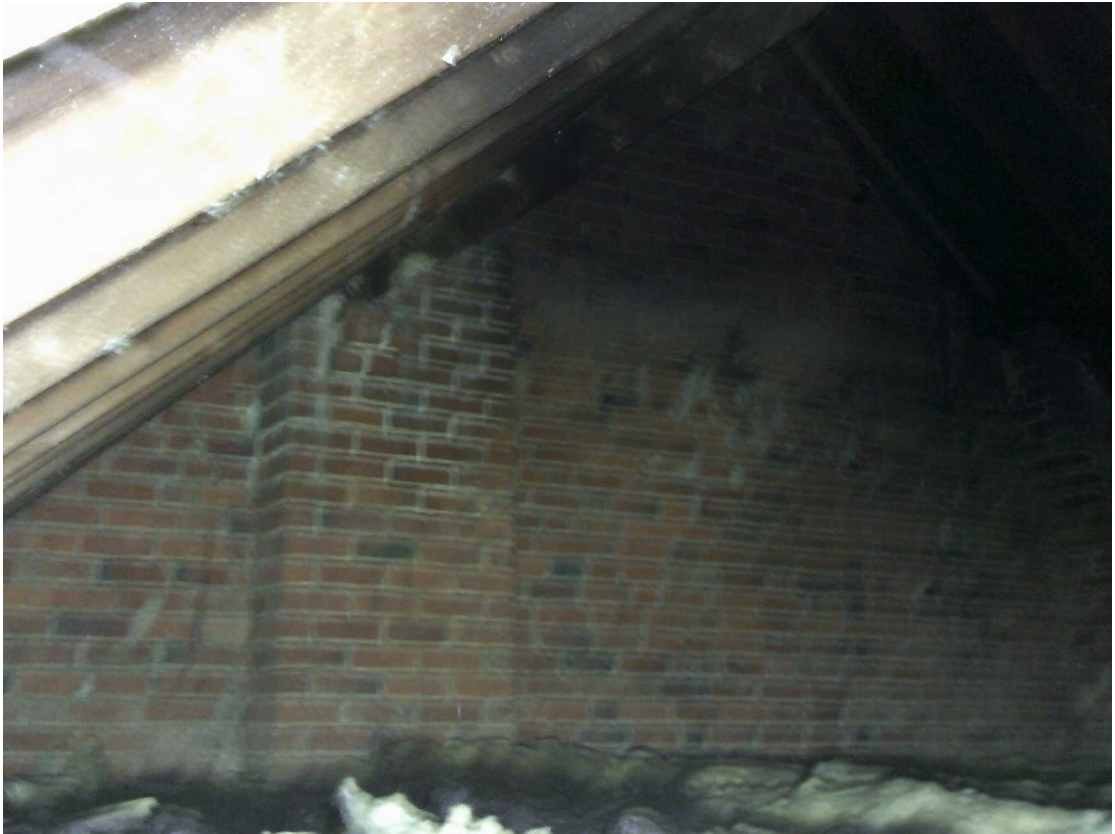
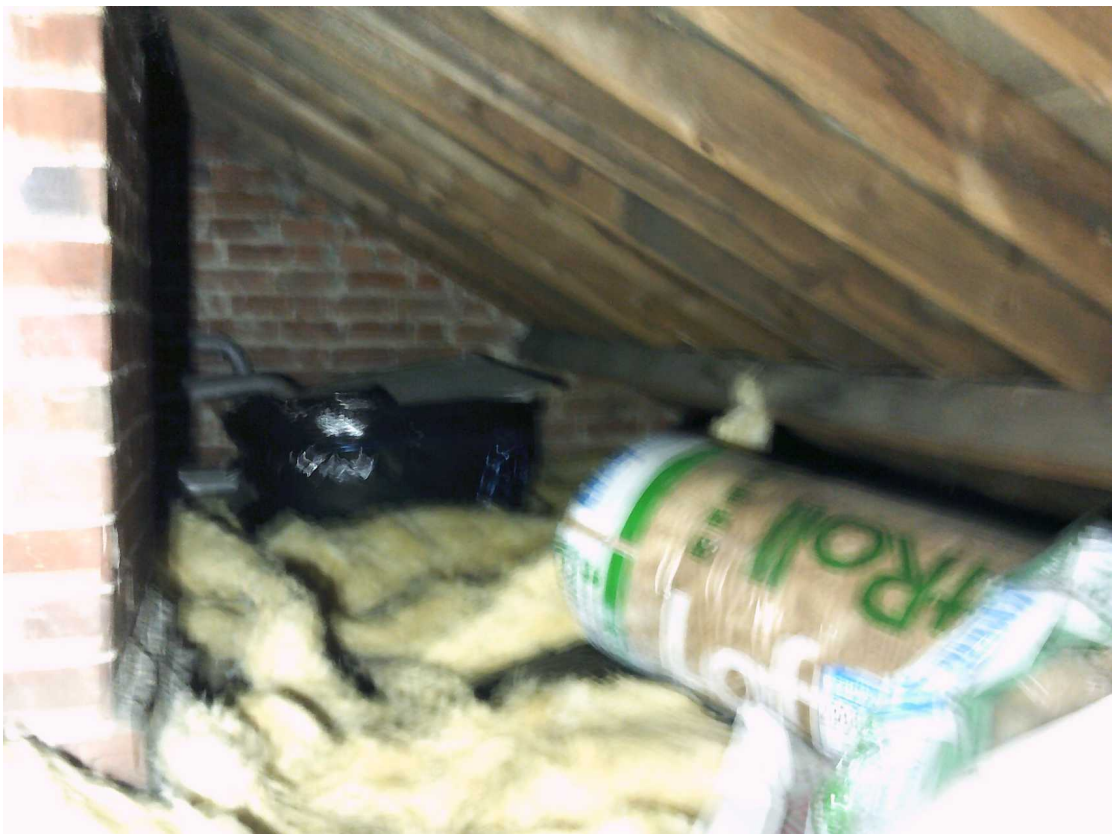
Viewed from the loft hatch, there is evidence of timber staining on the rafters to the front elevation and a deflected purlin. A rafter has been cut out to access the roof space from the loft hatch but the remaining opening has not been strengthened.

Additional strengthening will be required to the roof framing to prevent further deflection to the rafters and purlins. Rotten timbers will need to be replaced and, due to the age of the house, all remaining timbers will need to be treated with preservative.

Currently, the insulation is approximately 250 mm thick and this is considered adequate. Crawl board or a storage platform should be added so that the roof structure can be fully inspected.

I recommend that the loft space is cleared of insulation and that you take further advice possibly from a structural engineer to add additional strengthening to the roof framing.
