# Your survey report

32 Wantage Road, Reading, Berkshire, United Kingdom, RG30 2SE

11/06/2022

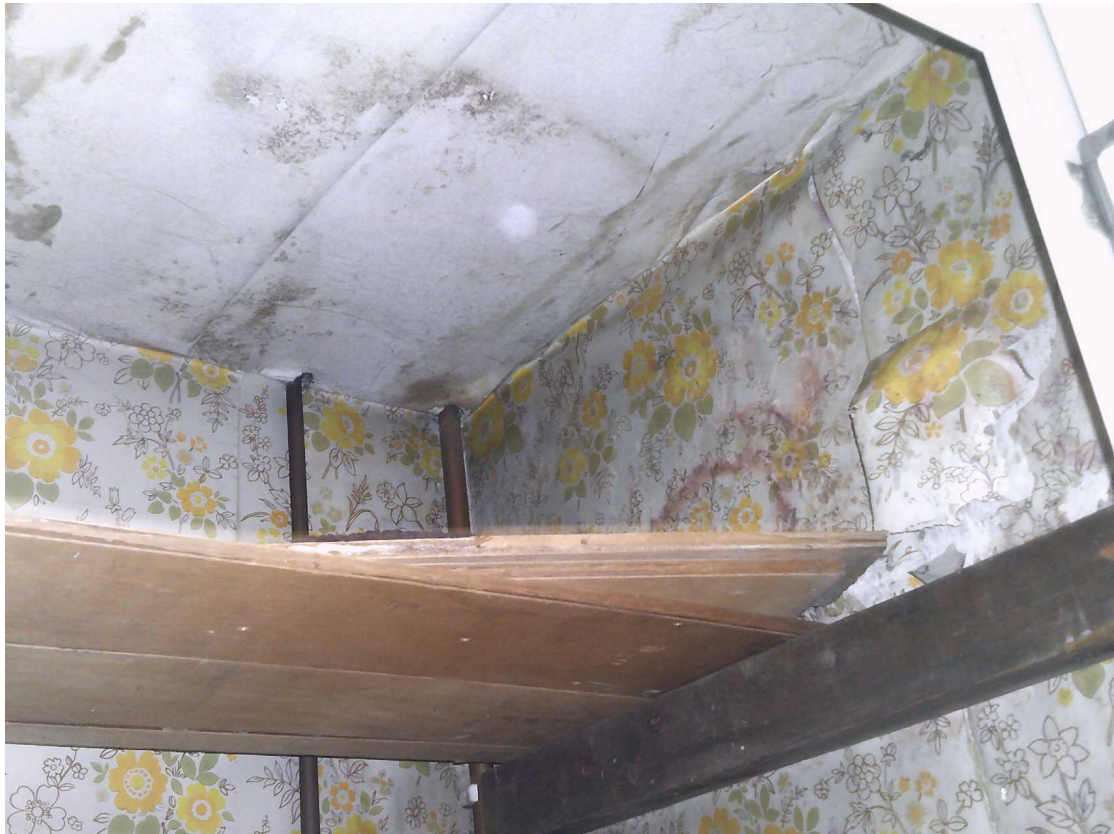
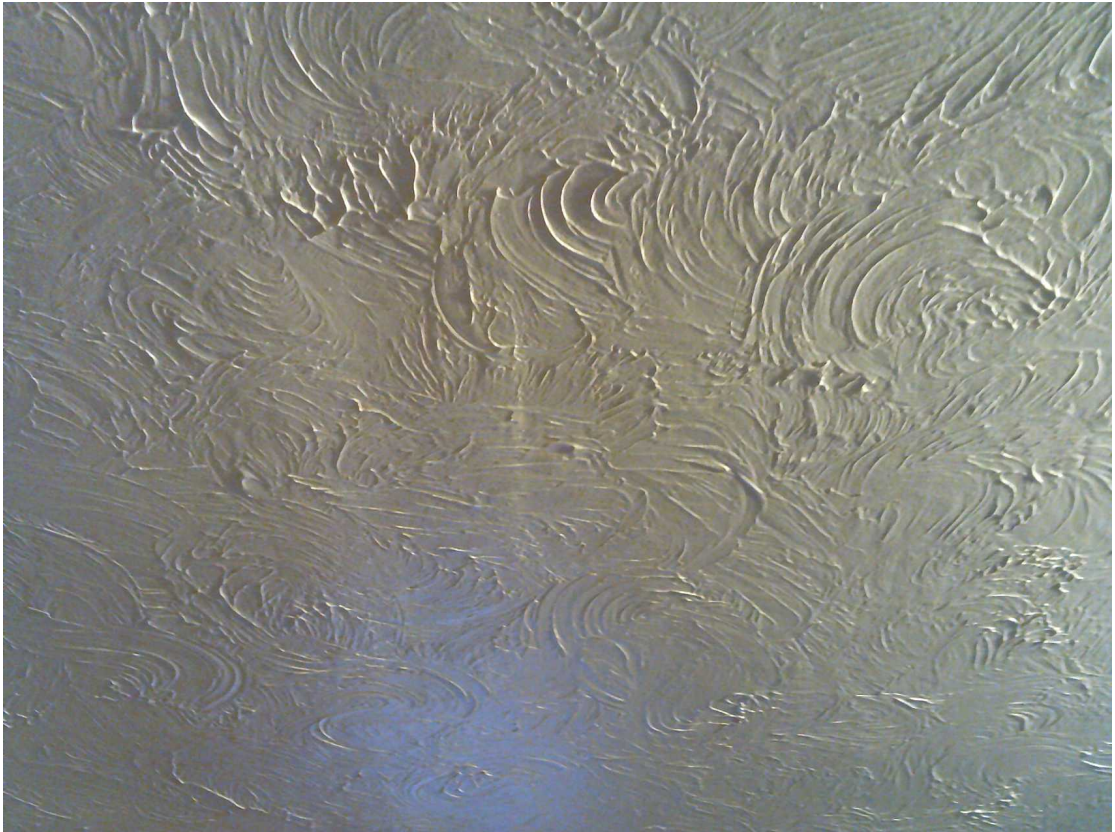
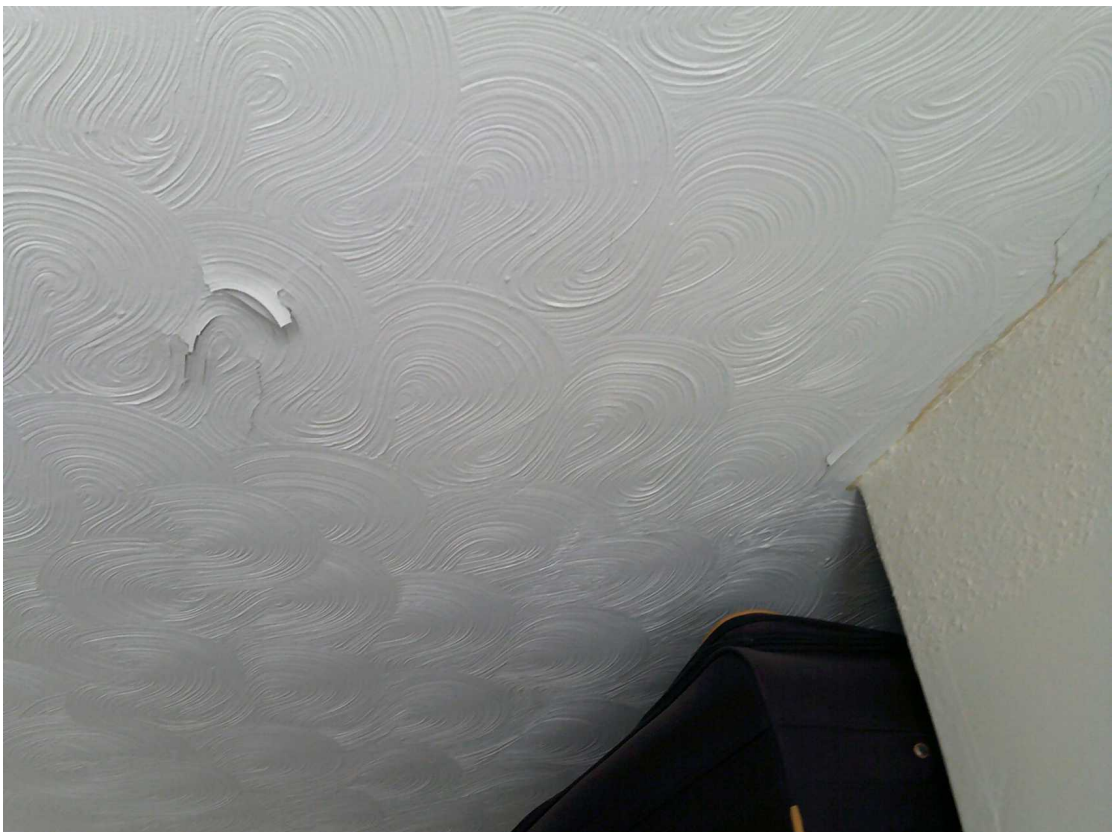
Many areas of the ceilings have been water damaged and this includes the ceiling above the back door, ceilings in the cloakroom and back of the kitchen and ceilings on the first floor in the front and back bedrooms.

Some of the ceilings have been covered with a heavily textured coating. Textured coatings can contain traces of asbestos fibre. You will need to ask a registered asbestos removal contractor to test all ceilings for asbestos fibres before any remedial work is undertaken. If the fibres exist, you will need to remove all coatings before any remedial work is undertaken to the ceilings.

I anticipate that extensive repair work will be required to the ceilings.

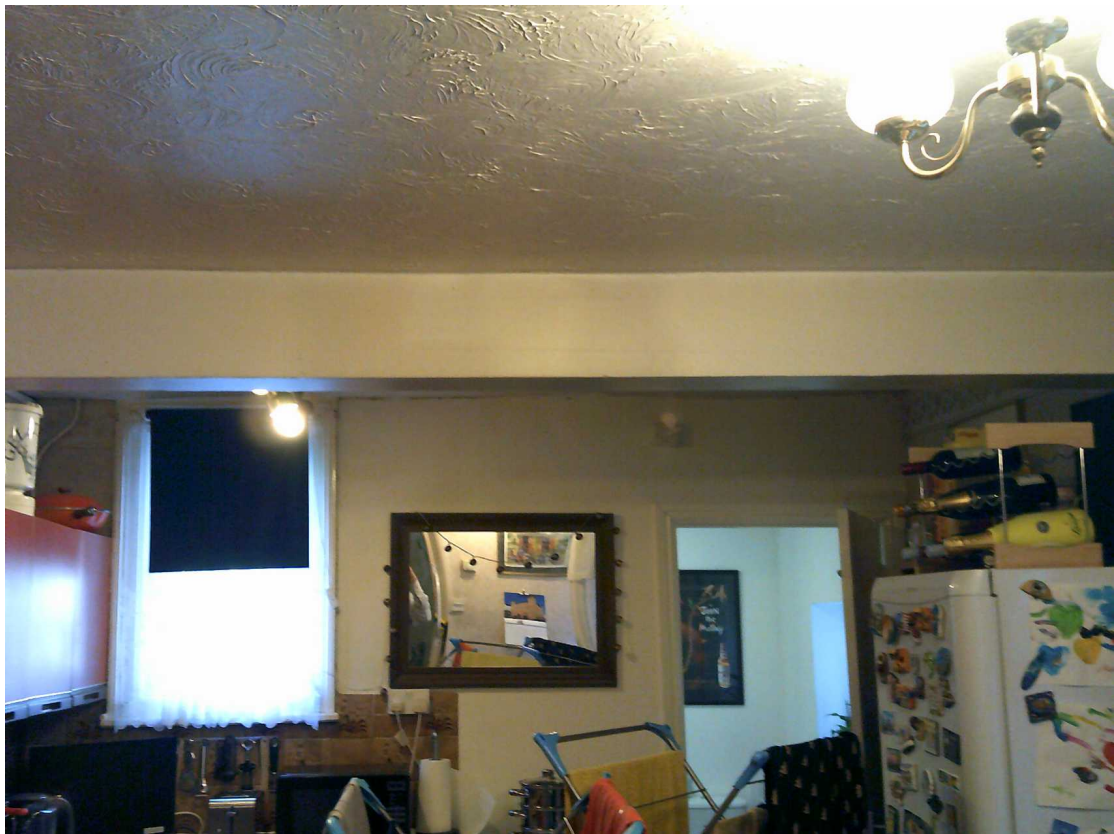
The internal walls are constructed in masonry and finished with plaster. Load bearing internal walls within the kitchen and the divisional wall between the front and back living room have been removed or removed in part and structural beams have been inserted above to support the loads. There is no evidence of any deflection within these beams but because this is a structural alteration, you should obtain copies of the building control completion certificates for this work.

Other internal walls are free from any significant settlement or heave and have reached a state of repose.

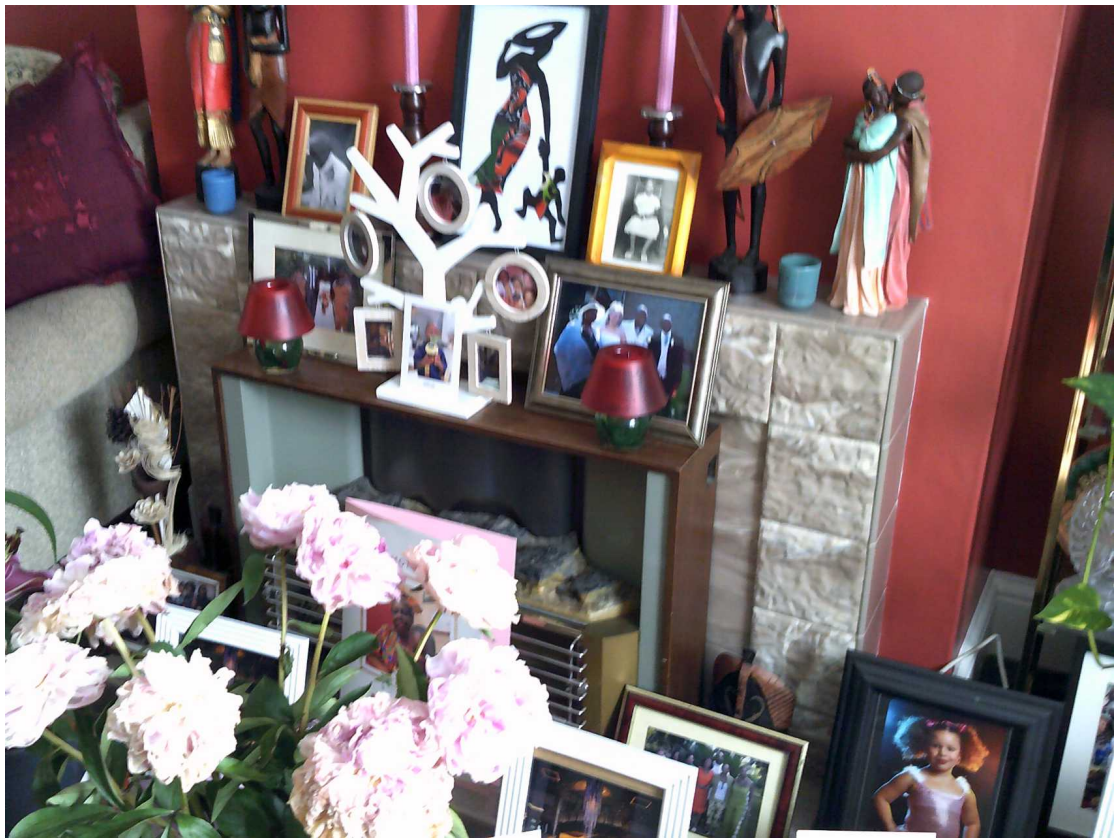
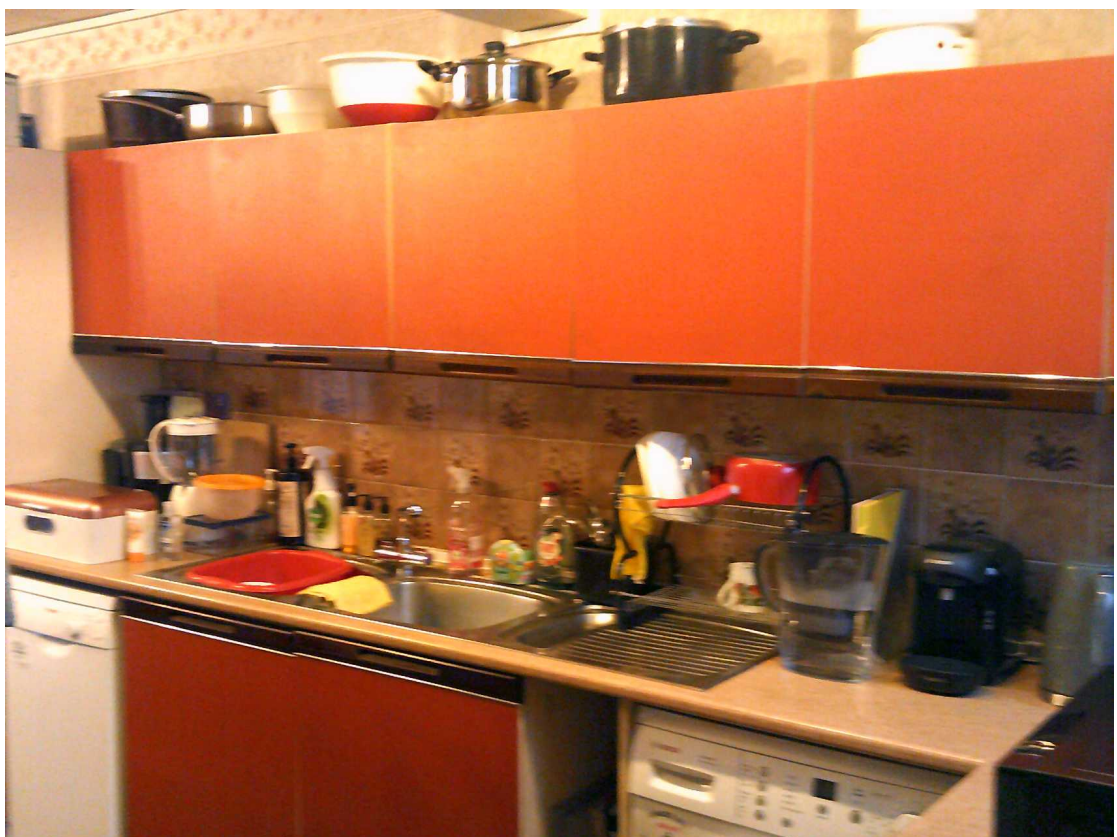
An electric fire has now been installed in front of the fireplace in the front room and this could not be inspected. I anticipate the flue will not be lined and will need upgrading and recommissioning if an open fireplace is required.

The chimney breast and fireplace has been removed from the kitchen. This is a structural alteration and you should ask for a copy of the building control completion certificate for this change to ensure that the chimney breast above is fully supported.

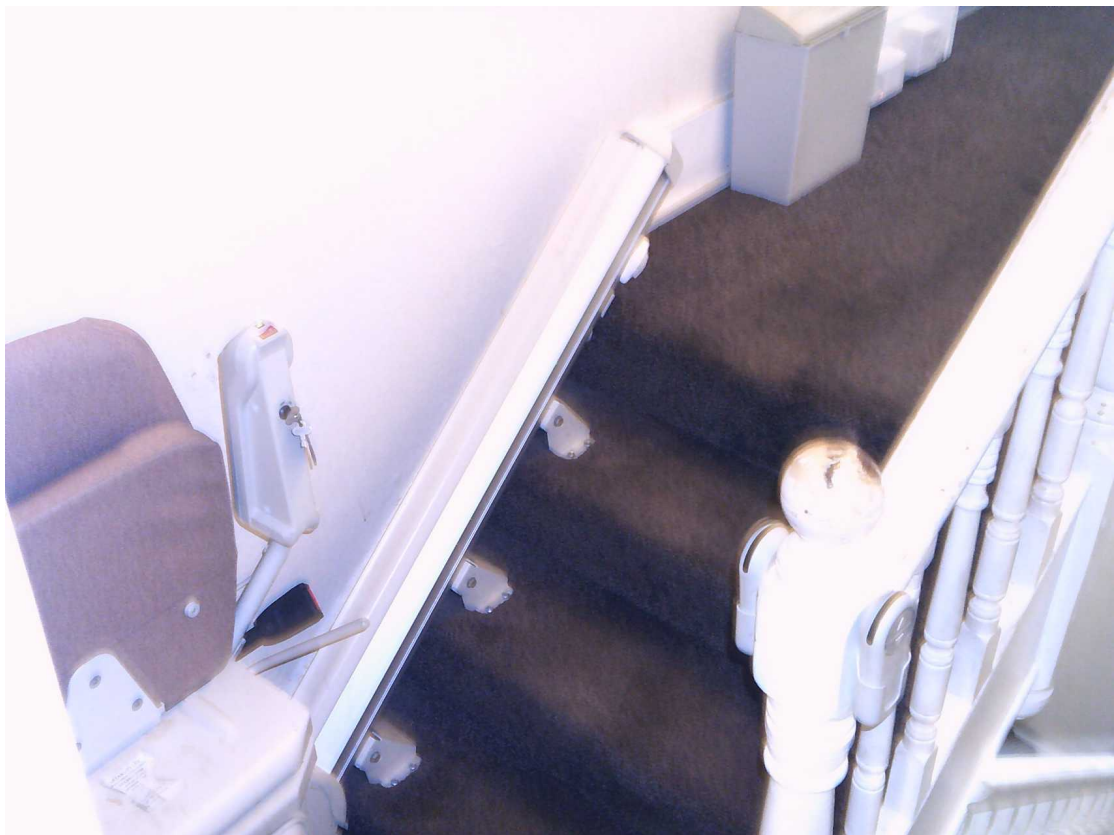
The staircase is serviceable but currently a non-ambulant staircase lift has been fitted. I was told by the vendor that they expect this fitting to be removed before they vacate. Repairs may be required to the staircase after the removal of this fitting.

Most of the internal doors are original and some have been fitted with single glazing that is not safety glass and this represents a health and safety risk. Upgrading will be required.

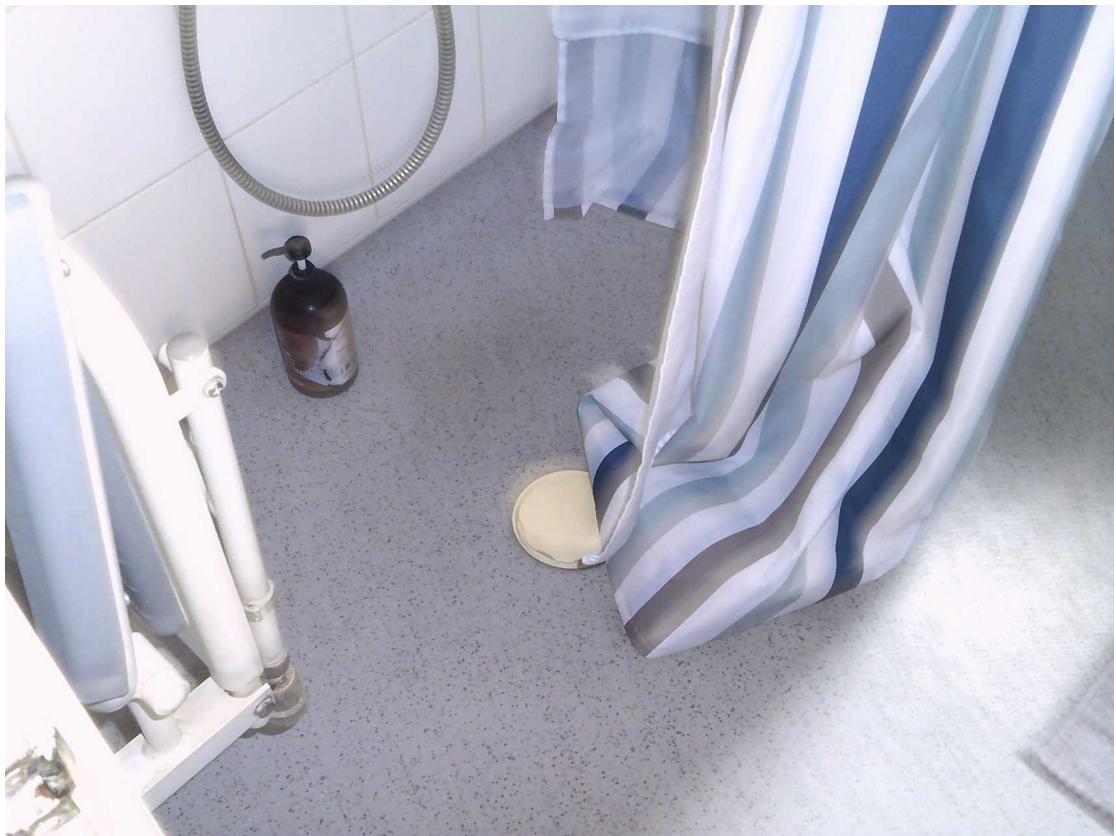
The family bathroom has been converted into a wet room style shower room suitable for non-ambulant people. It includes a shower cubicle with shower curtain and a electric power shower, WC and wash hand basin. As previously mentioned, the ceiling below has deflected and this will be due to leaks in the shower room above.

This includes a WC and wash hand basin. The fittings are serviceable.

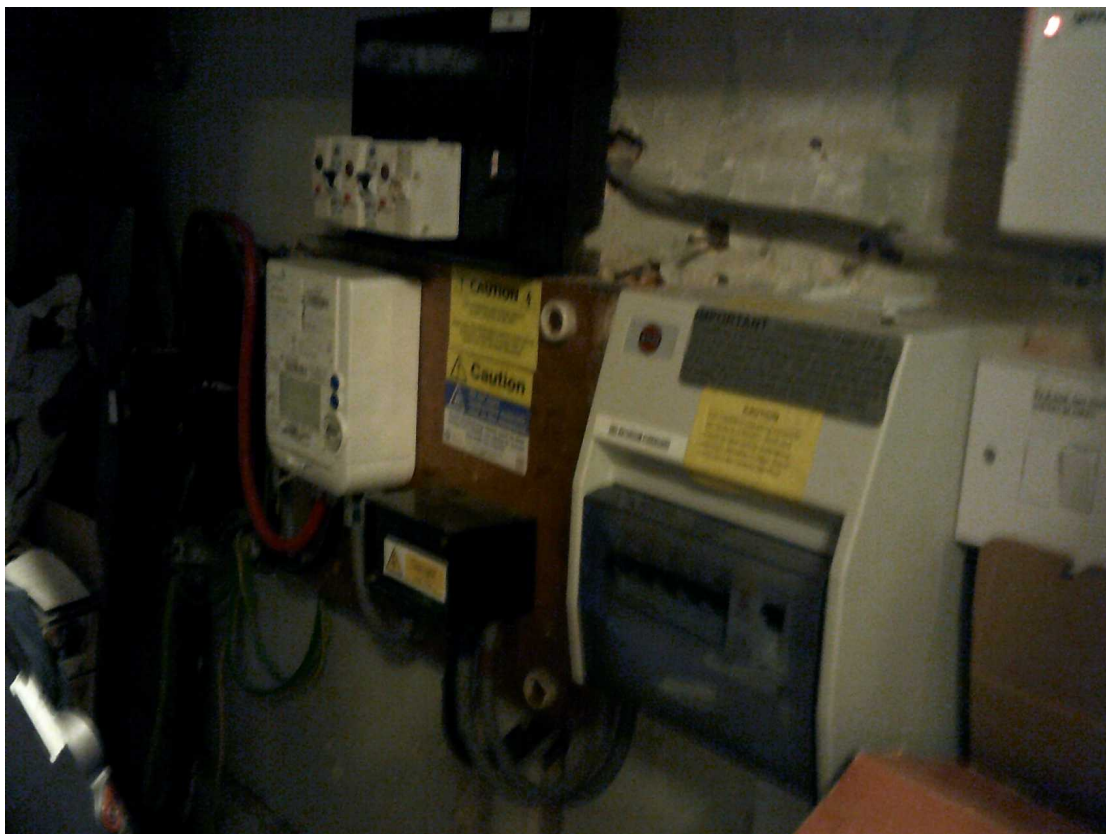
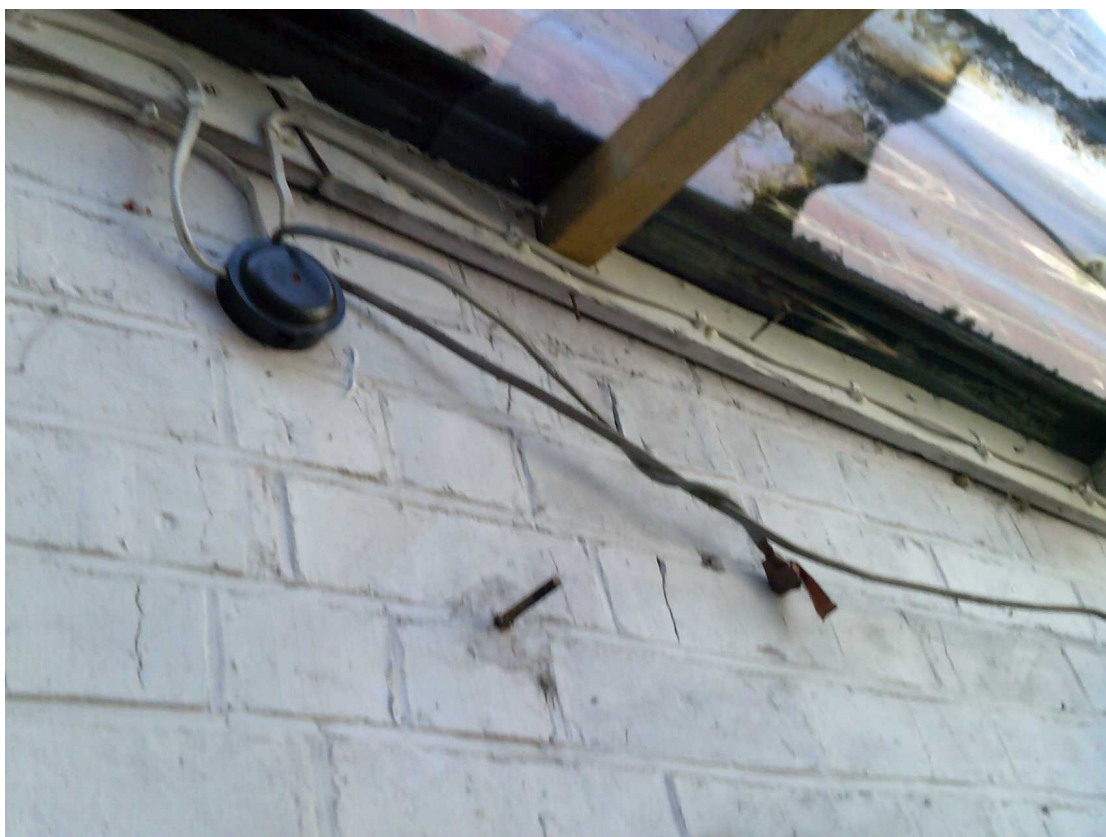
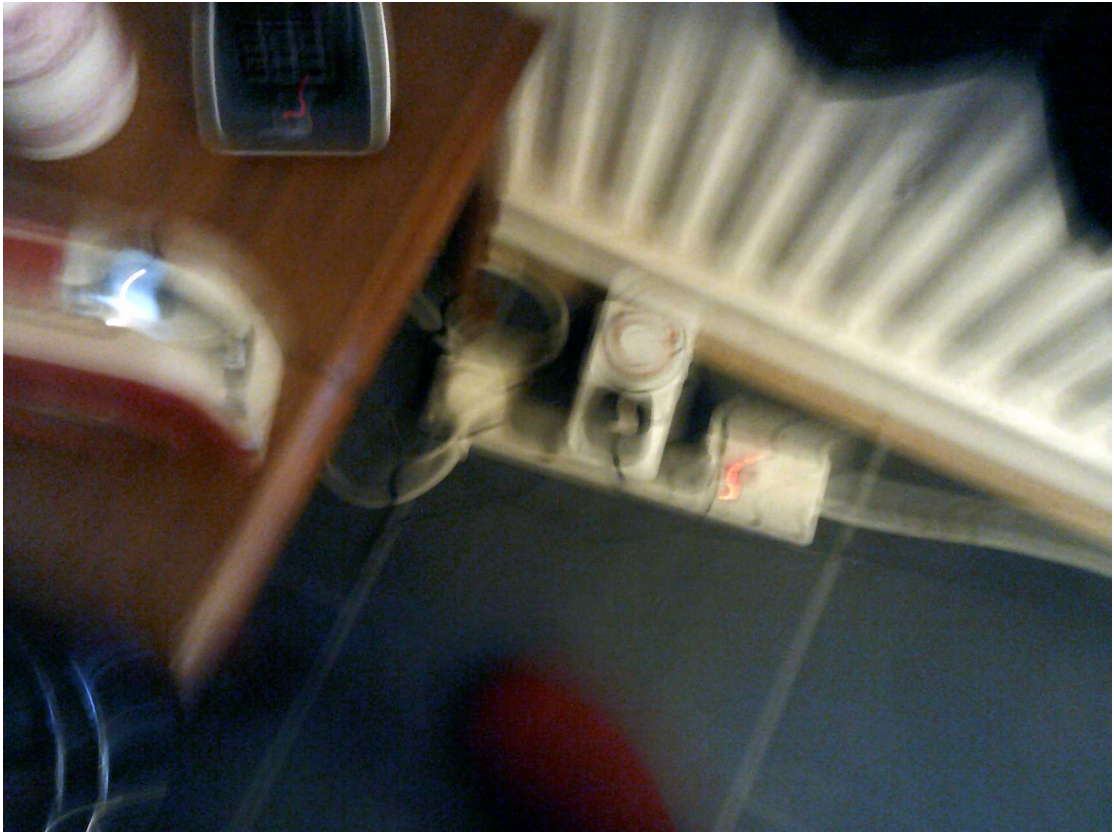
The electricity meter and distribution board is located under the staircase. The distribution board is old and is fitted with fuse carriers and there is only one separate circuit fitted with modern micro-trip switches serving the power shower. There are many extension cables within the property servicing appliances and there is damaged cabling that has been taped over as protection in the rear conservatory/porch.

You should ask for a copy of the test certificate for the distribution board and cabling for the power shower. I do not anticipate that there will be any other electrical test certification.

I recommend that all circuits are tested by a certified electrician and all circuits made safe.

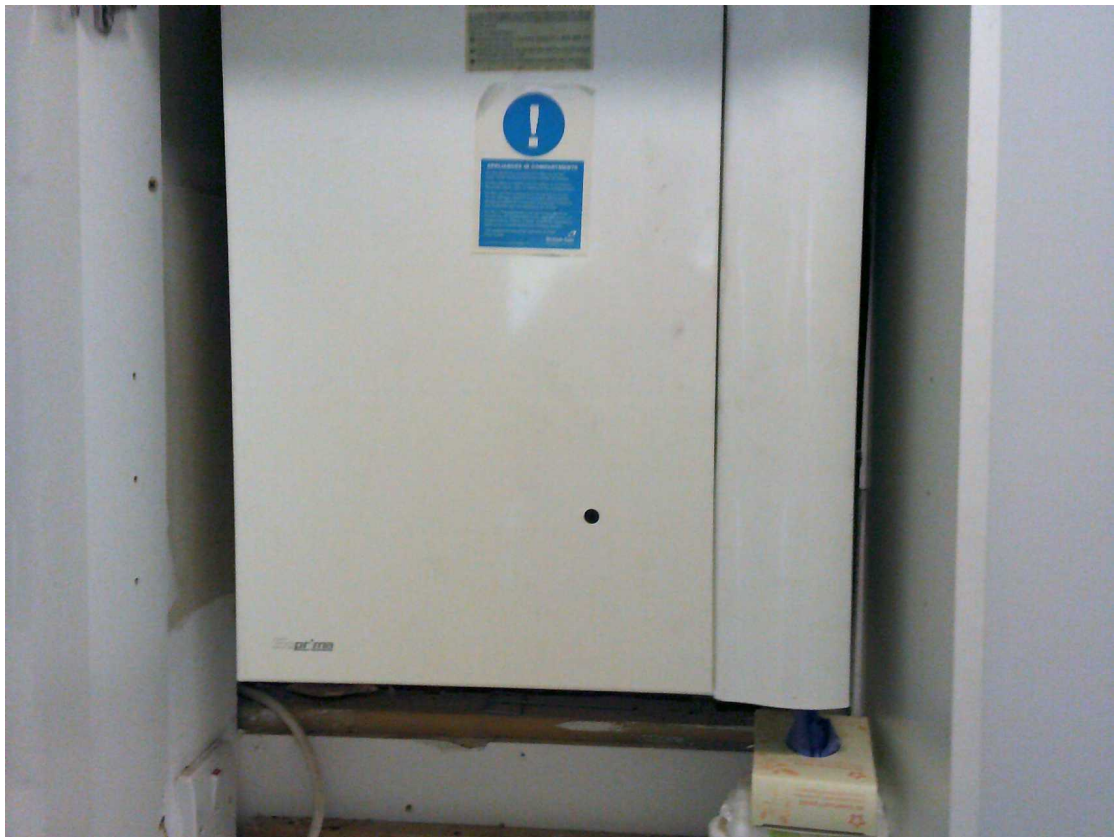
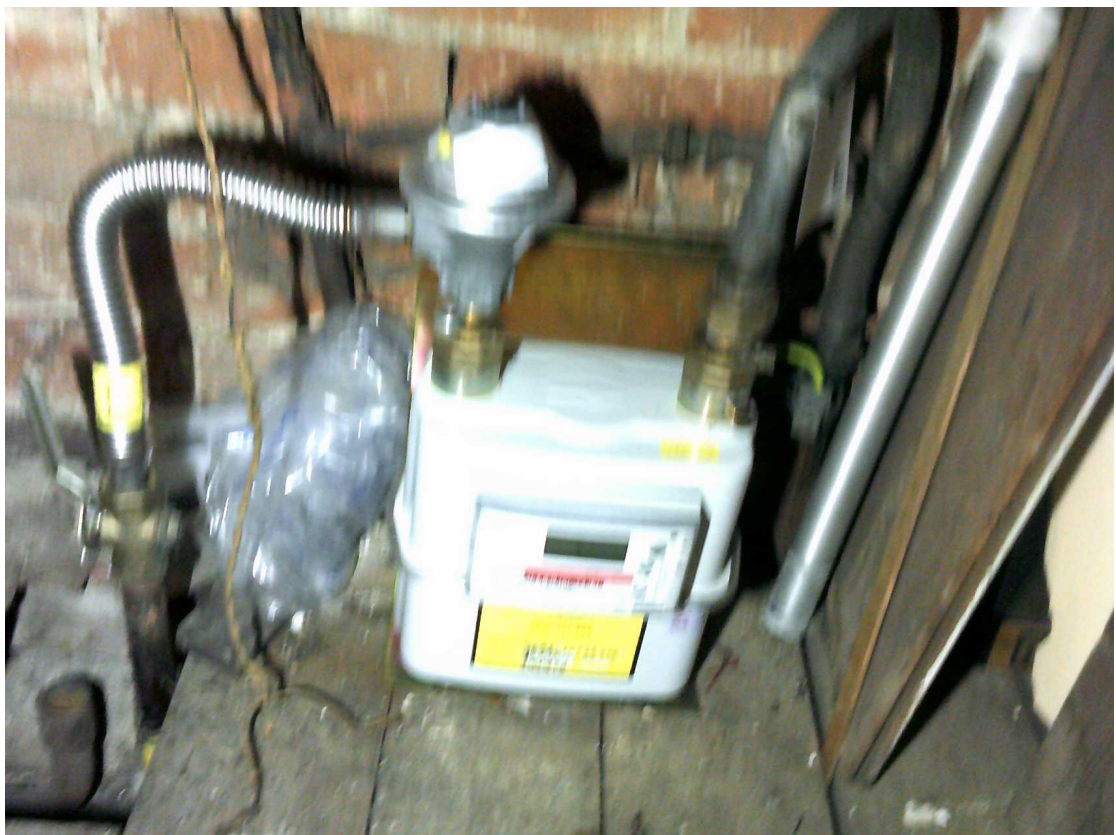
The gas meter is located under the staircase and the boiler is located in the cloakroom. The boiler is an old Potterton Suprima conventional boiler. I anticipate that this boiler will not be efficient and you should consider upgrading the boiler or installing a modern air-based heat pump with a new distribution system.

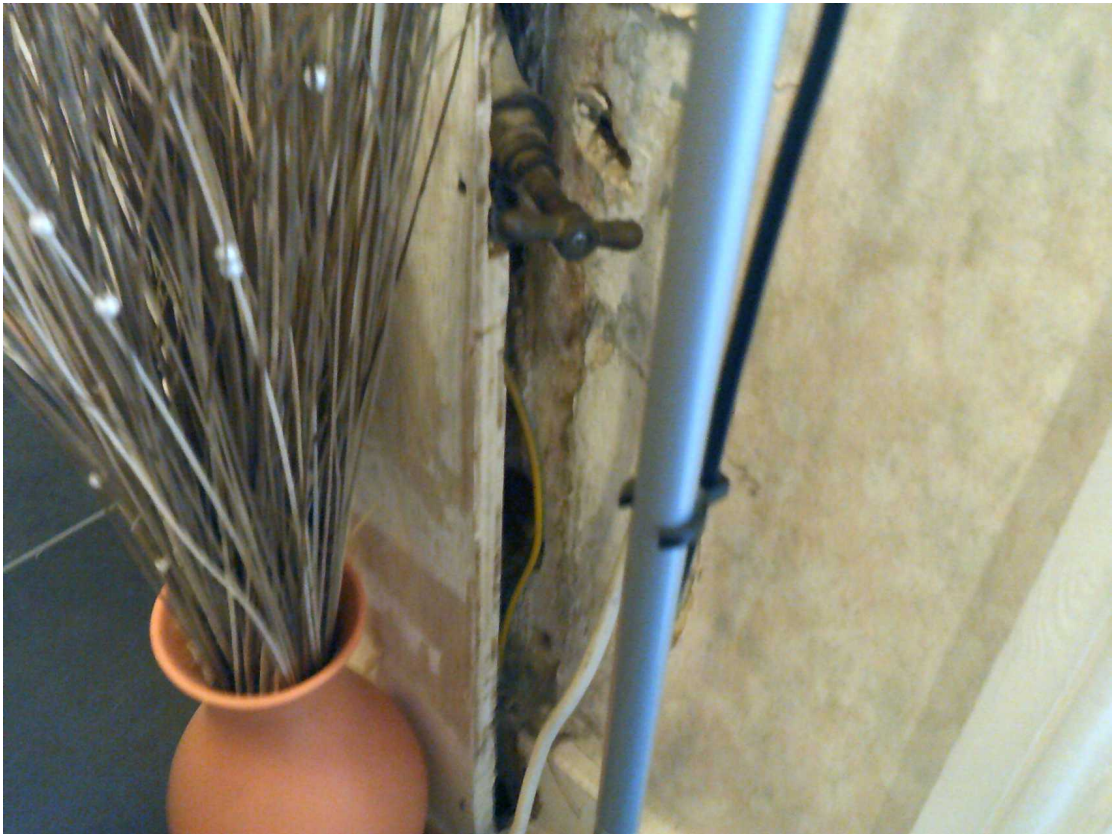
I could not locate the water meter but the water isolator stopcock is located in the kitchen. The pipe boxing was damaged and this is possibly due to a water leak. I could not tell if the mains supply pipe is a copper pipe or if this is connected to a lead pipe located under the ground floor. Further advice will be required to establish where the water metre is and what condition the service pipe is leading from the mains.

The cold water storage tank in the loft looks as if it has been replaced but it has been poorly installed and insulated. Because of the water staining on the external wall due to a running overflow, I recommend that the tank is recommissioned.

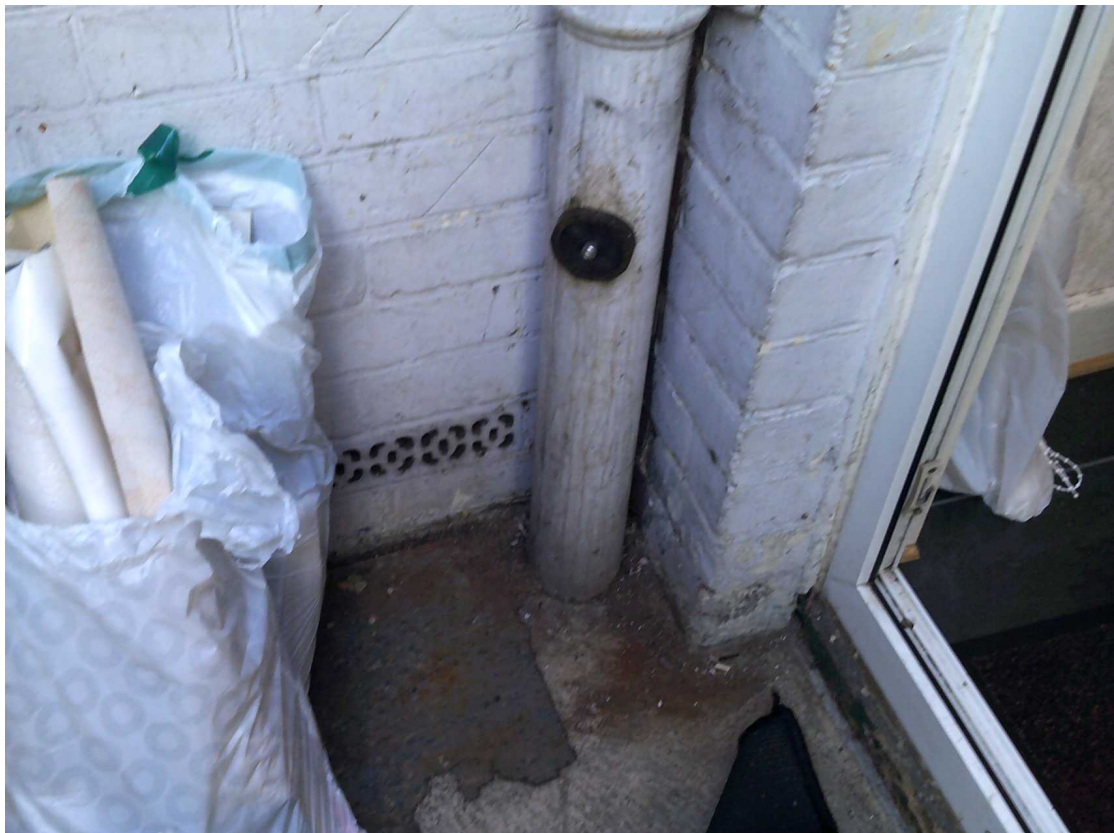
The soil vent pipe is located outside next to the back door. There is evidence that the concrete surrounding the drainage pipe has been broken out and replaced indicating that repairs have been made to the drainage system. There is no inspection chamber but a small inspection hatch has been cut into the soil pipe.

Because there has been some repair to the drainage system, I recommend that you ask a specialist drainage contractor to complete a CCTV survey of the drainage system to identify where the drain runs and to check that it is free from leaks and defects.
