1 Overview, Wall alongside Surley Row

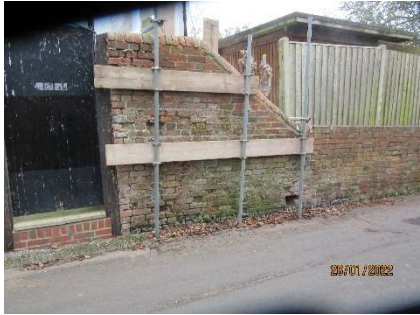
| Defect | Cause/Suggested Repair | Photograph |
|---|---|---|
| Wall unstable and temporarily braced back to scaffold frame.<br>Wall appears to have flint foundation at this point.<br>Canopy/first floor has support posts down onto the wall. | Self-seeded trees have grown/rooted close to back of wall and applied mechanical pressure to wall as they have grown. Remove self-seeded trees / stumps and rebuild wall from foundation upwards. Need to temporary prop building. Provide weep holes to prevent any build-up of water behind wall and if necessary provide concrete backing to improve retaining capacity | |

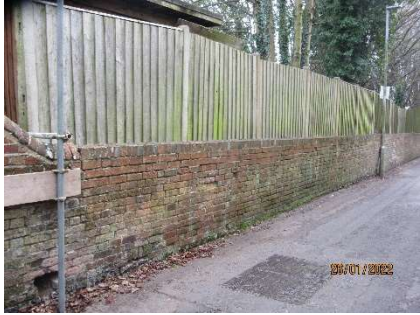
| Defect | Cause/Suggested Repair | Photograph |
|---|---|---|
| Significant deterioration of pointing, some crumbled masonry at the base | Natural weathering, lack of weep holes. Rebuild/repoint. Core drill 50mm weep holes near base at 900mm centres | |

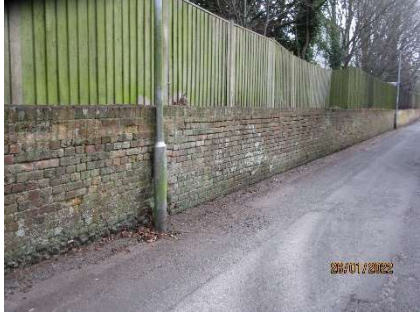
| Defect | Cause/Suggested Repair | Photograph |
|---|---|---|
| Wall lack of verticality, leans to point of touching lamppost. Retained height approx. 1m at this point. End of flint foundation being visible at this point | Some self-seeded smaller stumps behind wall won't have helped but significant wall pressure likely to be caused by large protected tree (see photo above). Anything other than removal of the tree with rebuild of wall plumb will leave an ongoing maintenance requirement and risk of wall collapse (highway and third party safety). | |

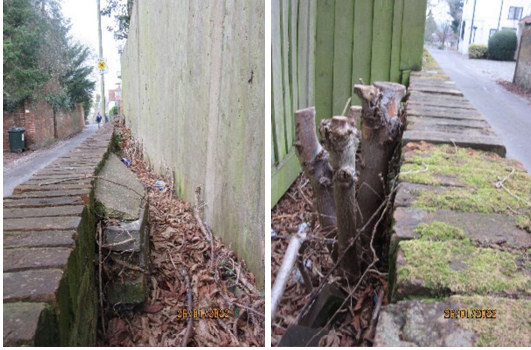
| Defect | Cause/Suggested Repair | Photograph |
|---|---|---|
| Debris and self-seeded stumps behind wall. Piers can be seen but in poor condition along this section | Need cleaning out, stumps removing and piers making good. | |

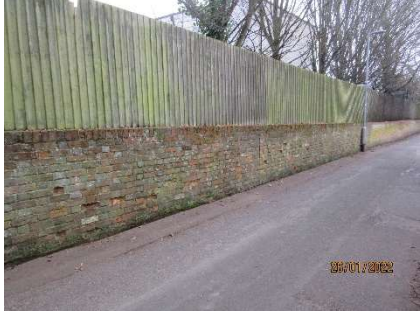
| Defect | Cause/Suggested Repair | Photograph |
|---|---|---|
| This section of all appeared different period of construction and whilst better verticality with vertical movement joints, brick facing and pointing in poor condition | Repoint, replace badly spalled bricks | |
