# Ground Investigation Report

Brunel Retail Park, Kiln Lane, Reading, RG2 0HS

Issue Date: 27 February 2020

REFERENCE: 19.1247/CB/LC

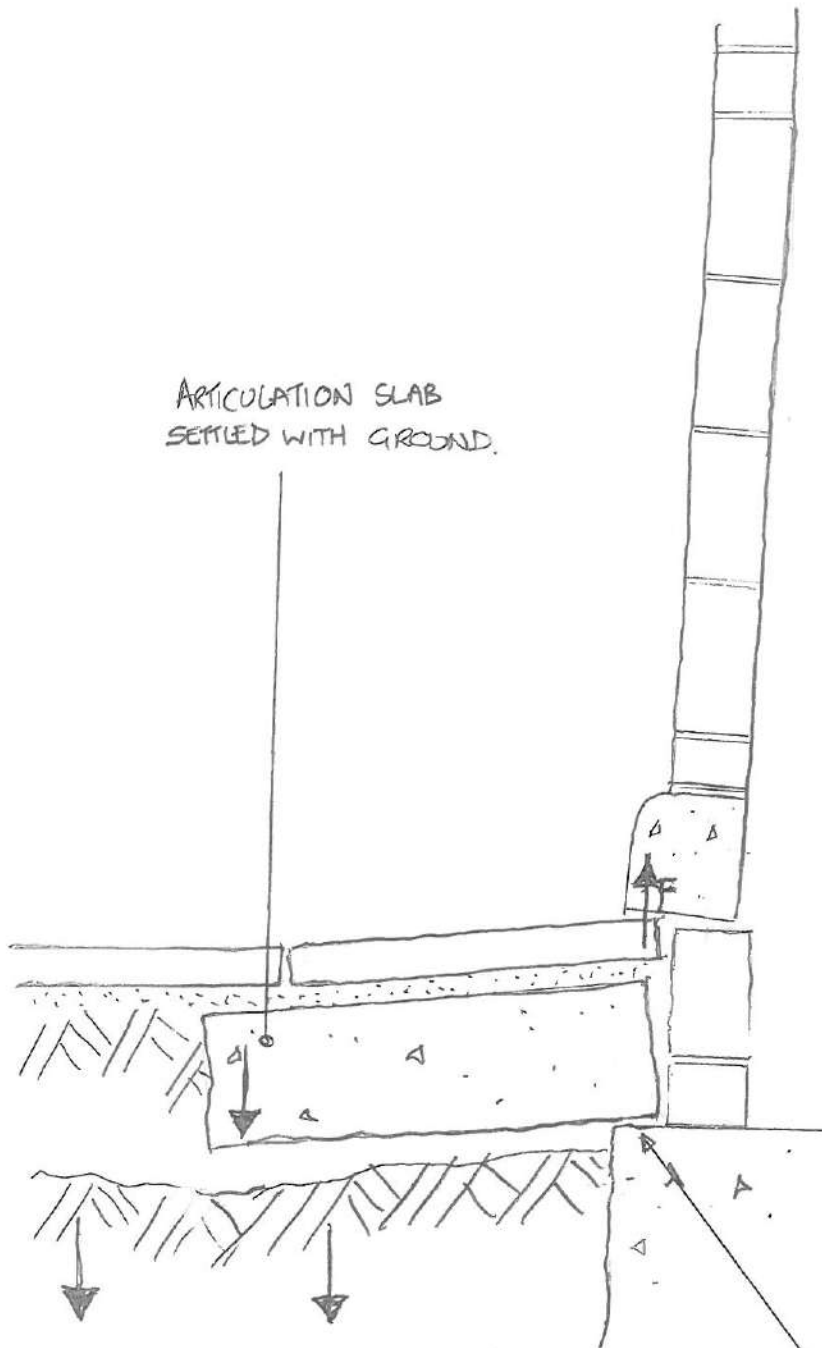
ARTICULATION SLAB  
ROTATED ON FOOTING.  
& APPLIED UPWARD FORCE  
IN THE WALL.

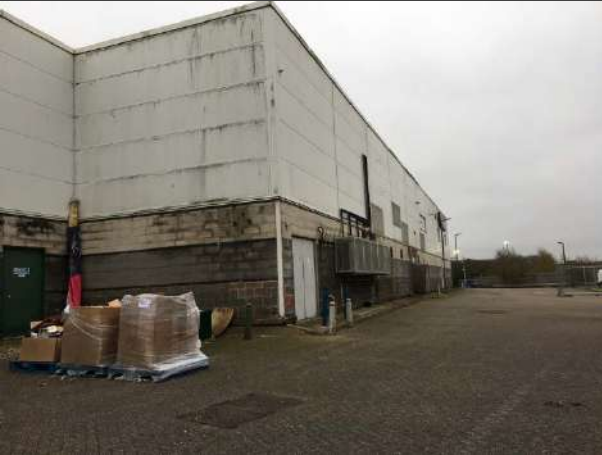
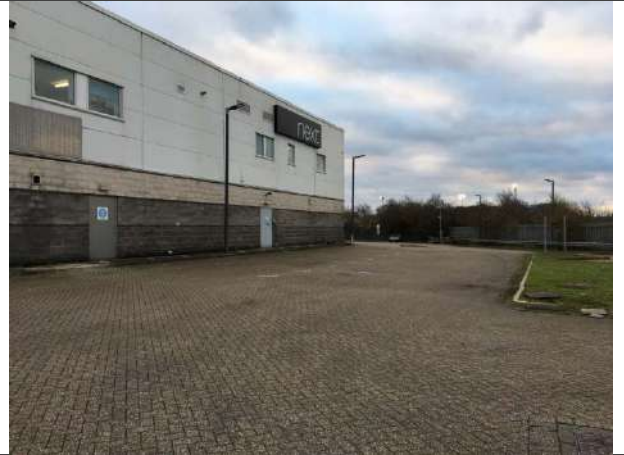
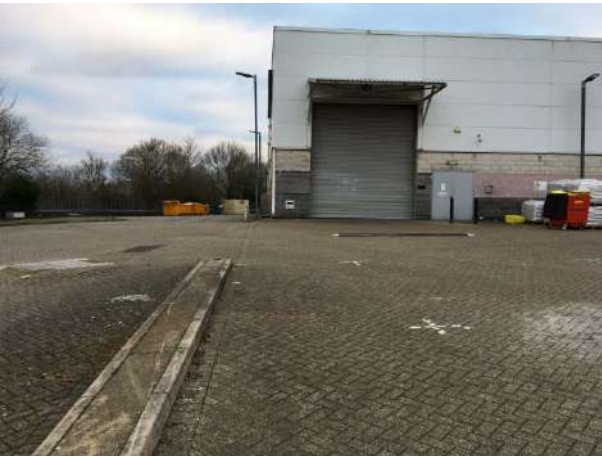
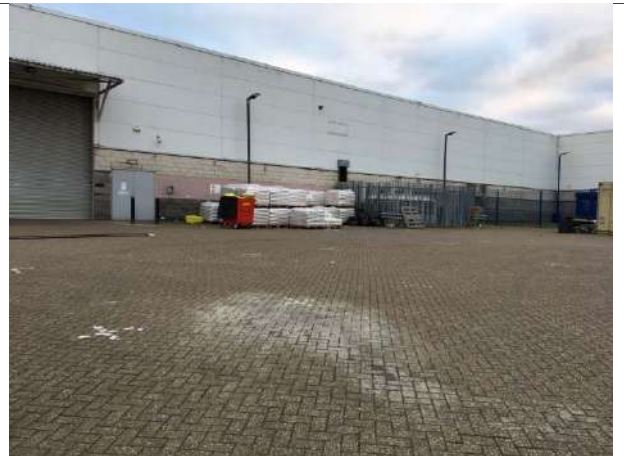
| 4.3.1 | Paragon observed that, in the service yard, there has been movement and approximately 100mm of settlement of the pavement to the rear yard which extends along the back of Units 2, 3a and 3b. This is particularly evident to Units 1 to 3b but is also noticeable to the pavement which continues along the rear of Unit 4, albeit to a lesser extent. This is evidenced by rodent boxes fixed to the rear elevation walls, which were previously sat on the pavement that are now suspended above the ground identifying the extent the pavement has sank. Further downward movement and sinking of the block paving to the yard where abuts the rear elevations of Units 1 and 2 was noted and again this continued to Units 3b, 4 and Unit 5. |
| 4.3.2 | Significant surface settlement of the block paved areas of the wider and subject site was observed. Whilst manhole covers in the north of the site were level with the paving, in the centre and south of the site, various covers were noted to be elevated relative to the surrounding block paving level. Further to this the block paving was noted to drop down from the footpath by the buildings and the surface of the yard was notably uneven. There is a general fall across the southern block paved area from the building to the fence line. It is not clear whether this fall is as constructed or the result of post construction settlement. This has resulted in several of the manhole / inspection chambers now protruding and being higher than the surrounding block paving up to 100mm in some cases. Several undulations and defects, every few metres or so were observed in the service road area that links to the rear subject site; this is particular noticeable when driving. |

01: Rear yard overview

02: Rear yard overview

03: Rear yard overview

04: Rear yard overview

1. Repairs to the settlement in the rear yard area are recommended. As poorly consolidated fill has been identified below the yard area, this would require compaction to create a suitable sub-base with clean down of each paviour prior to relaying. Based on the poorly composed materials below, it is unlikely that a straightforward lift and re-lay approach would be suitable. Therefore, an estimated rate of repair is asserted to be £120/m<sup>2</sup>. It is understood that the site's asset managers indicated that there was approximately 55m<sup>2</sup> requiring localised repairs. Based on the topographical survey completed and using a Geographical Information System (GIS) to measure the impacted areas, Paragon considers the most currently significant / visually obvious areas to be more in the region of 65m<sup>2</sup>. Therefore, the estimated repair costs of these areas would be estimated at £7,800 excluding VAT and professional fees. This estimate covers repair the worst affected areas of the yard only, as opposed to complete replacement.

3. Whilst a localised approach to repair may be acceptable to address areas that have settled more significantly. Under this phased scenario, it would be prudent to undertake regular inspection of the rear yard areas to ensure that if further settlement is identified in future, that it is quickly rectified. Based on the ground conditions encountered, if certain localised areas are remedied / reinforced, then adjacent areas that remain on poorly composed / uncompacted fill may be subject to differential settlement and may drop versus the treated areas particularly where subject to heavy vehicle movements. This could result in further areas needing to be relayed and repair costs could increase significantly.

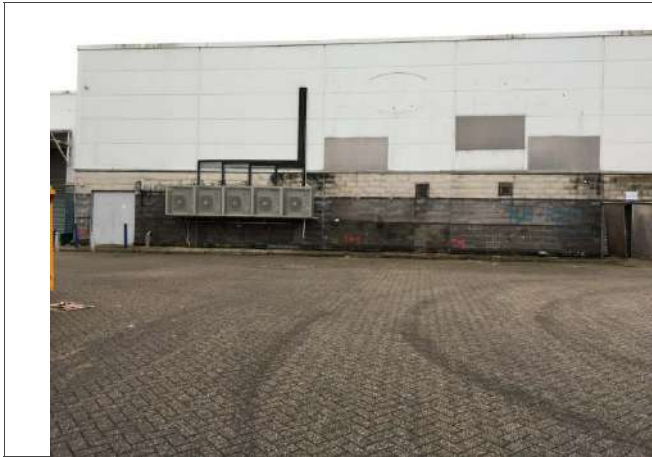
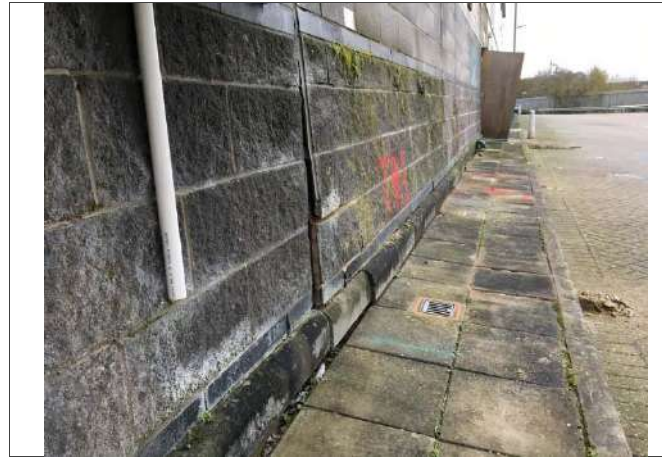
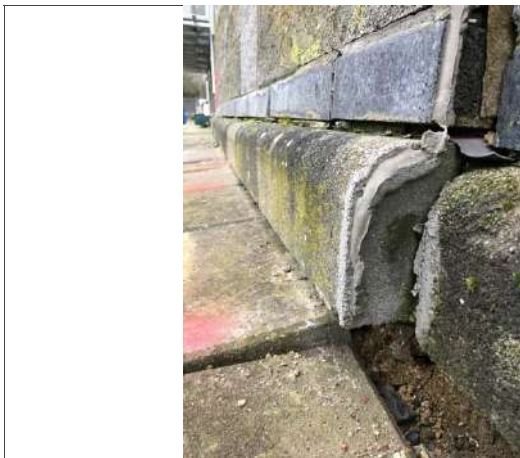
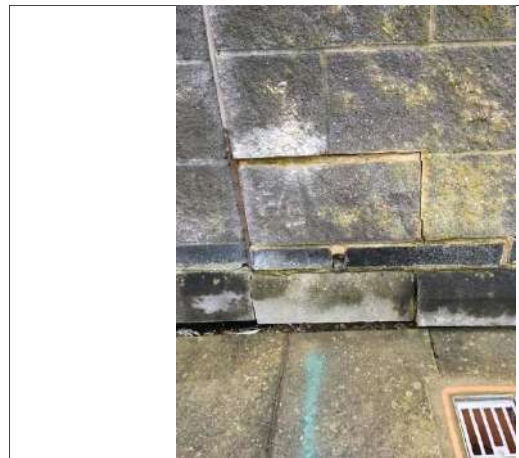
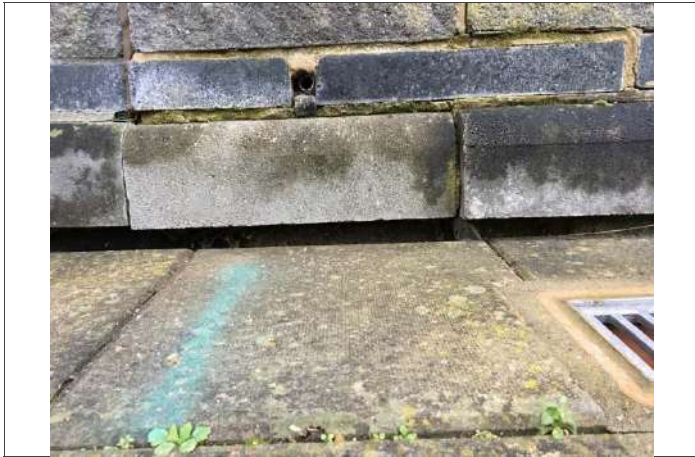
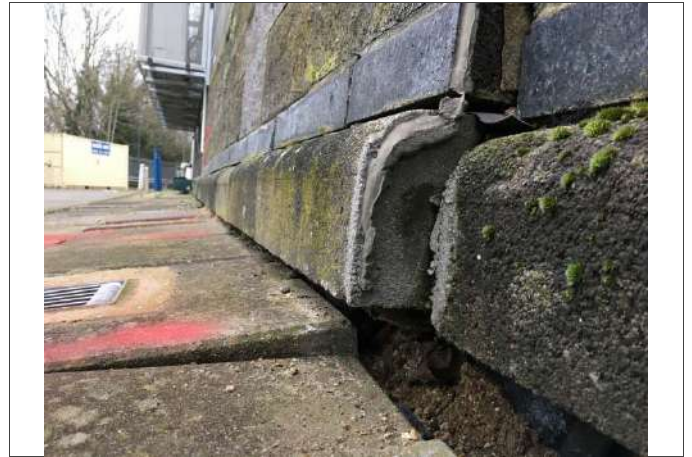
| 15. | <p>One section of the blockwork to the rear of Unit 3a was noted to have deflected outward by approximately 50mm from vertical. It was asserted by others that this was due to internal impact damage by a forklift or similar. From an internal inspection by a Paragon Building Surveyor, it is understood that ancillary accommodation in the form of toilets and an office are located within the building behind this section of the wall and there is no obvious sign of impact damage. Therefore, pits were excavated along this elevation to observe whether there was an underlying issue that could be observed.</p> |

| 4.3.3 | Evidence of structural movement was observed along the rear elevation walls to Unit 3a and 3b. This has resulted in sections of the outer skin of wall becoming displaced and pushing outwards. Movement joints along this section of wall are also displaced and no longer vertical providing a further indication of movement. Cracking was also noted internally within Unit 3a where internal walls meet the inner skin of external blockwork indicating the inner skin has also moved. Deflection of the blockwork by c. 50mm from vertical was noted. It is understood that toilets are located within the building behind this section of the wall. Otherwise the blockwork walls were generally in fair to good condition noting the condition of the block paved surfacing – See 5.1.2. |

05: Section of damaged wall

06: Section of damaged wall

07: Section of damaged wall

08: Section of damaged wall

09: Section of damaged wall

10: Section of damaged wall

6. A budget cost to remove the existing cavity blockwork wall to the rear of Unit 3a, circa 25m<sup>2</sup>, and replace with new including internal finishes has been estimated by Paragon between **£15,000 and £20,000** excluding VAT and professional fees. Note that this rate is subject to survey and agreeing the extent of work required. For example, it would be recommended to inspect the entire length of the articulation slab (by lifting paving slabs by hand) to ensure the rotational effect is not being caused elsewhere, for example by Unit 3b. If identified, additional areas of the articulation slab will need to be broken out to prevent contact with the bull nose kerb at the base of the blockwork and repairs may need to be extended. However, this does not appear to be the case from visual inspections around the remainder of the structure completed to date.

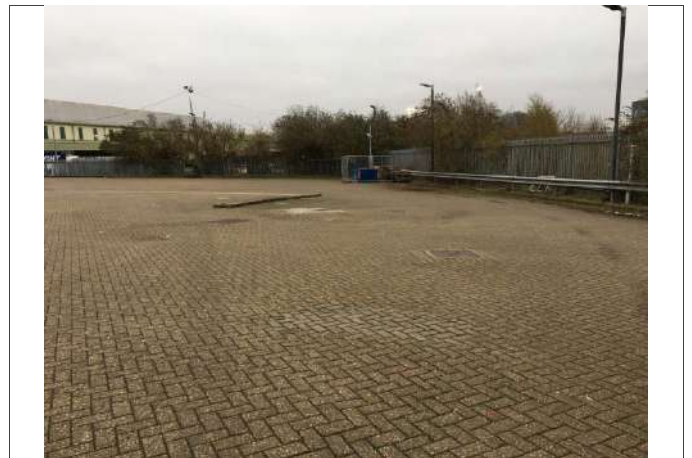
12: Uneven ground surface

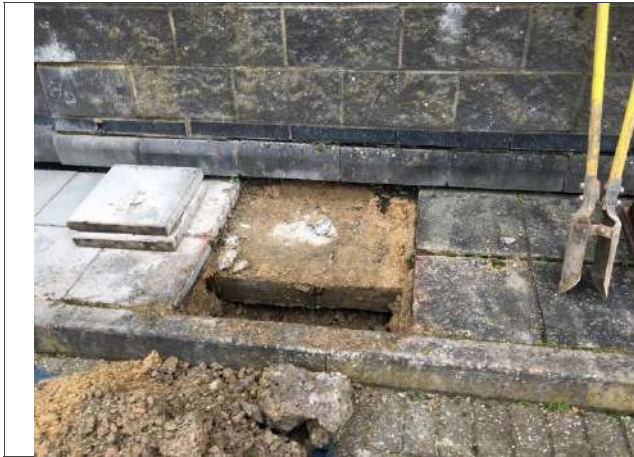
| 16. | A structural engineer from Bradbrook Consulting was present when the trial pits were excavated and an articulation slab was identified within the trial pits running parallel to the building wall. Where Made Ground / fill positioned below this feature has settled, it appears that the articulation slab has dropped causing an uplift affect. This uplift has pushed up against a bull nose kerb at the base of the block work wall and caused the rotational effect as the block work wall was pushed outwards. A sketch was prepared by Bradbrook Consulting to demonstrate the theory and is presented as Figure 4 of Appendix 1. Recommendations have been made below for the repair to this wall section, and localised breaking out of the articulation slab to prevent further contact. |

13: Exposed concrete beam

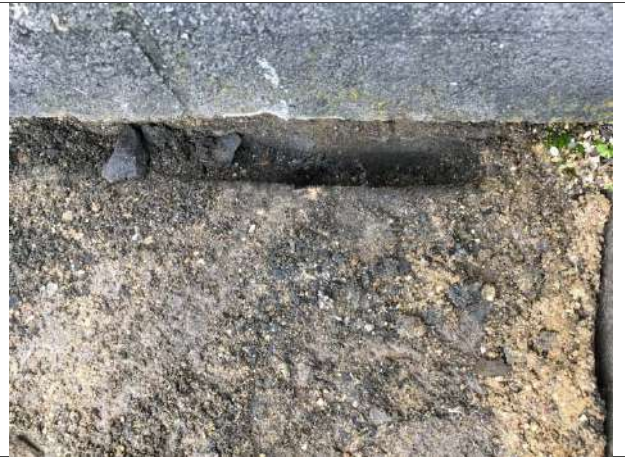
14: Gap between concrete and wall

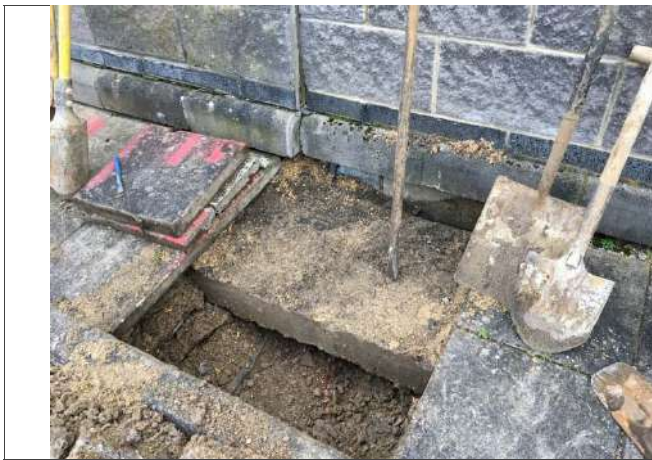
15: Continuation of concrete beam

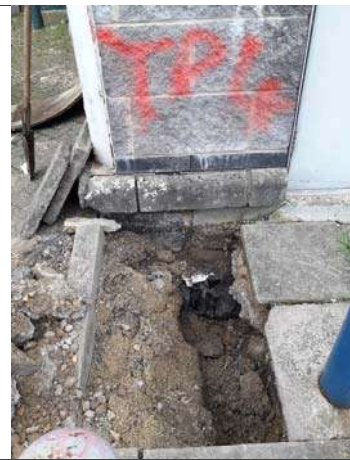
16: Broken through concrete beam

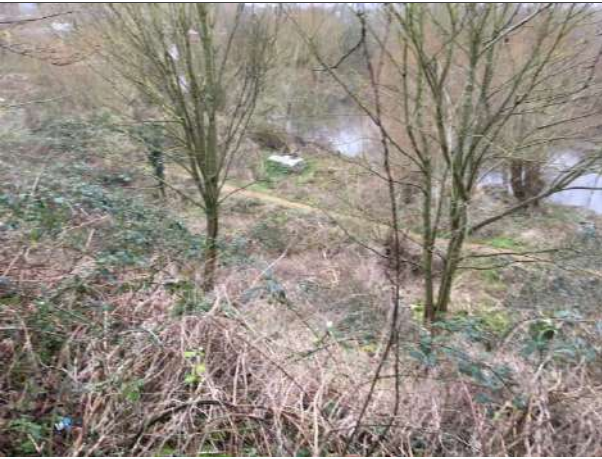
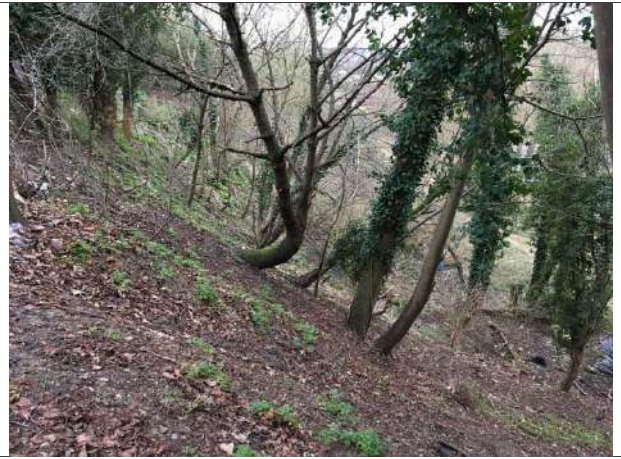
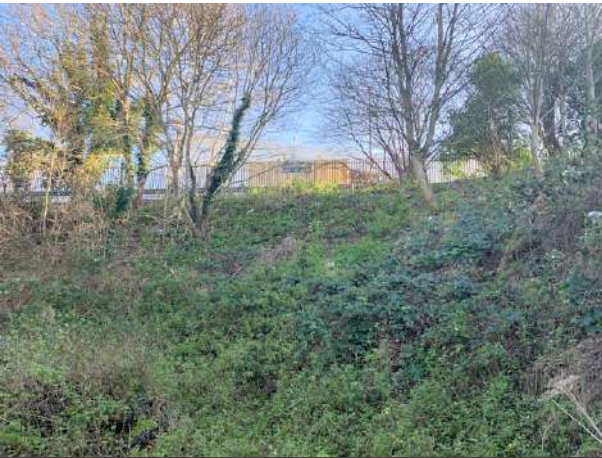
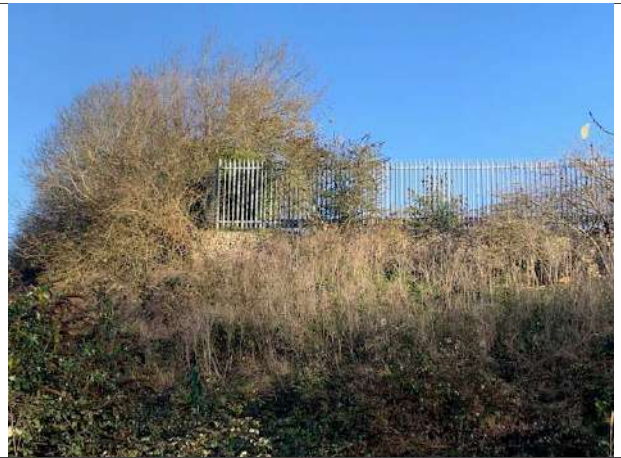
| 11. | <p>Other factors were considered in relation to the movement observed, such as slope failure. The slope to the west of the site was identified to be very steep and a number of bent trees were present indicating some degree of movement has taken place historically. Visual inspections completed as part of the investigations to date by a building surveyor, structural engineer and geotechnical engineer did not identify damage to the building that was definitively attributable to slope failure. The undulation identified to the rear yard area was more consistent with circular depressions rather than a more rigid subsidence effect where large cracks open as a result of lateral movement. As such, settlement is considered to be the more likely cause to the movement observed at the site.</p> <p><b>Potential For Future Settlement</b></p> |

21: Overview of slope

22: Overview of slope

23: Overview of slope

24: Overview of slope
