## ADDENDUM TECHNICAL REPORT

Crawford Reference: SU2003018

38 Holyrood Close, Reading, RG4 6PZ

### **SUBSIDENCE CLAIM**

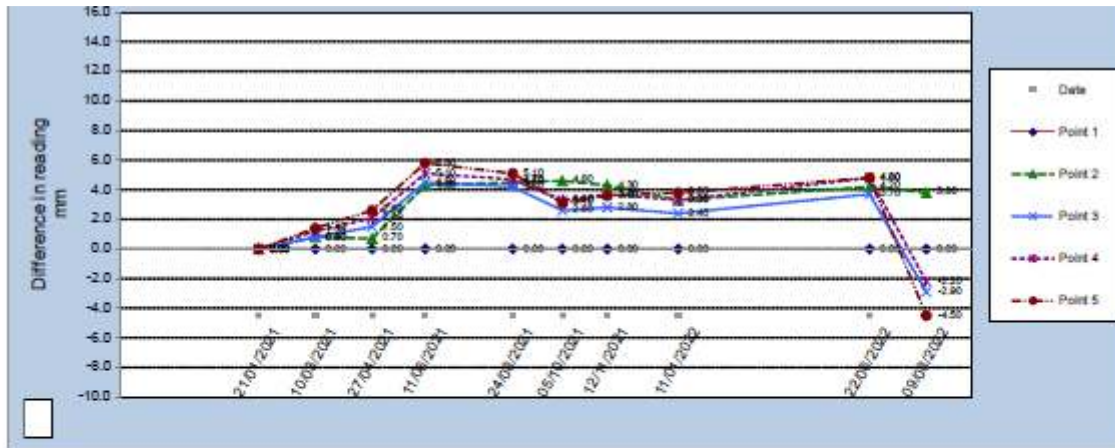
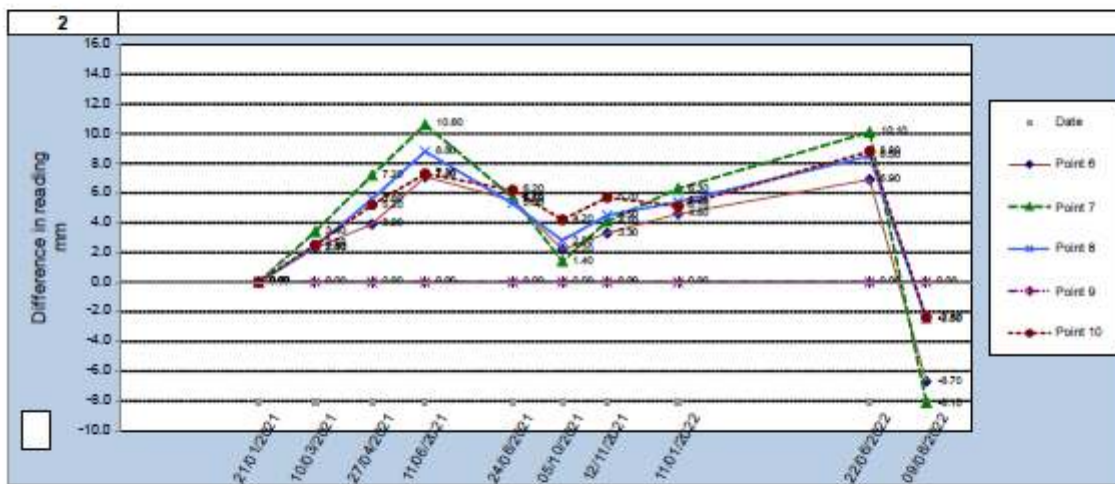
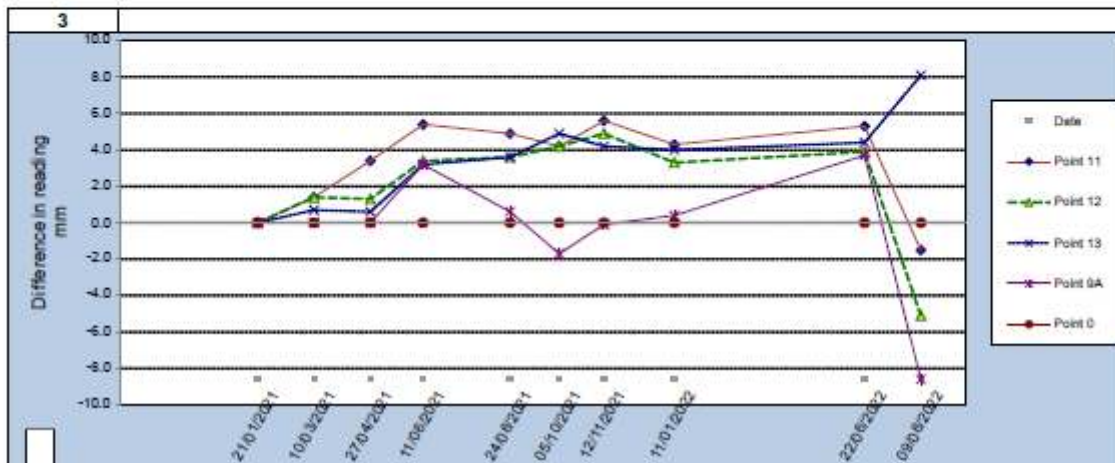
The further monitoring graphs are reproduced overleaf. It is noted there has been significant downward movement of all Points between 22 June and 9<sup>th</sup> August 2022 except at Points 13, which shows an upward movement of 4mm and Point 2, which shows no movement. The reason for the upward movement at Point 13 is that Point 1, which was taken as the datum, is clearly also suffering downward movement. If we correct the results assuming Point 13 is stable, the downward movements are as follows:

The monitoring together with the further damage in the summer months, provides further evidence that the Oak tree is causing the subsidence and mitigation action is now a priority.
