# Ground Investigation Report

Brunel Retail Park, Kiln Lane, Reading, RG2 0HS

Issue Date: 27 February 2020

REFERENCE: 19.1247/CB/LC

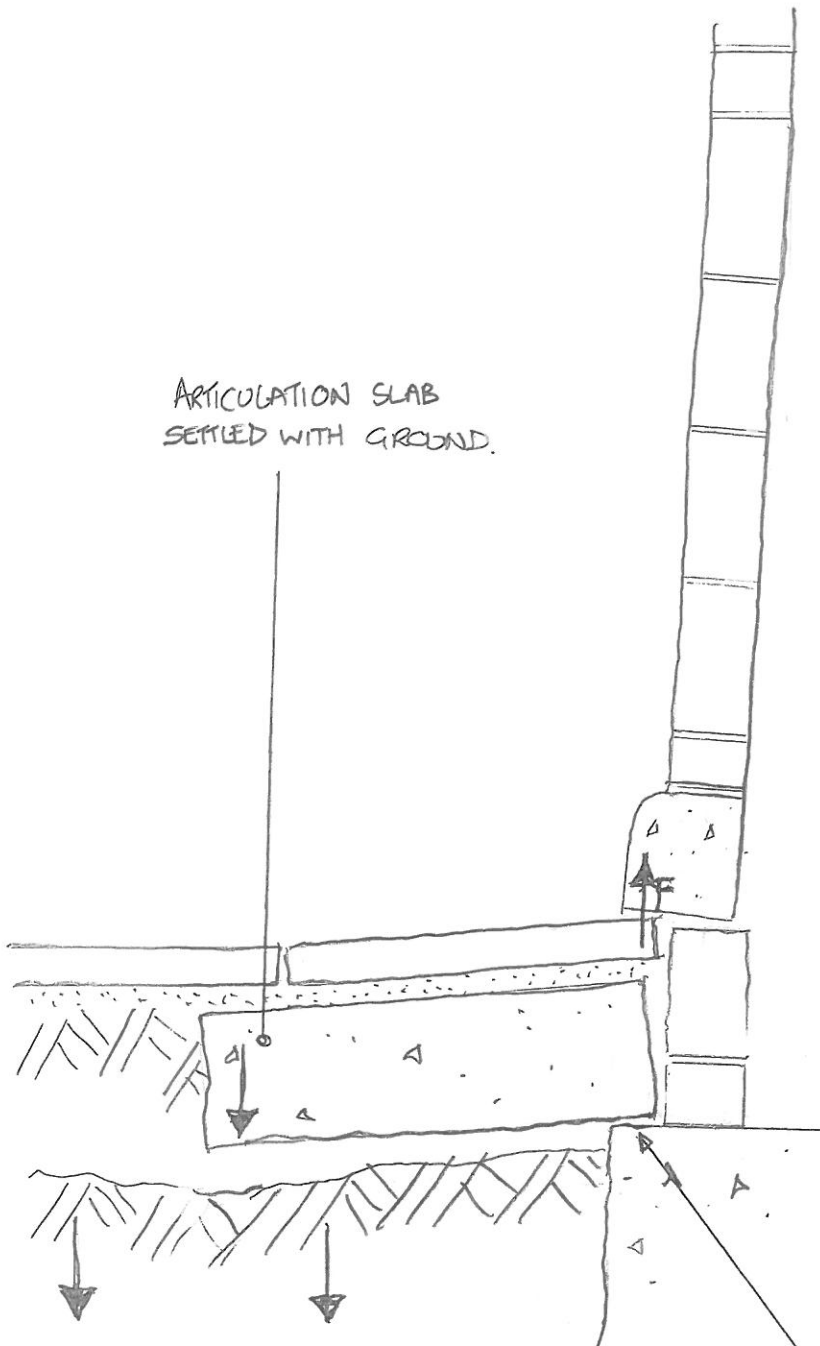
ARTICULATION SLAB  
SETTLED WITH GROUND.

ARTICULATION SLAB  
ROTATED ON FOOTING.  
& APPLIED UPWARD FORCE  
IN THE WALL.

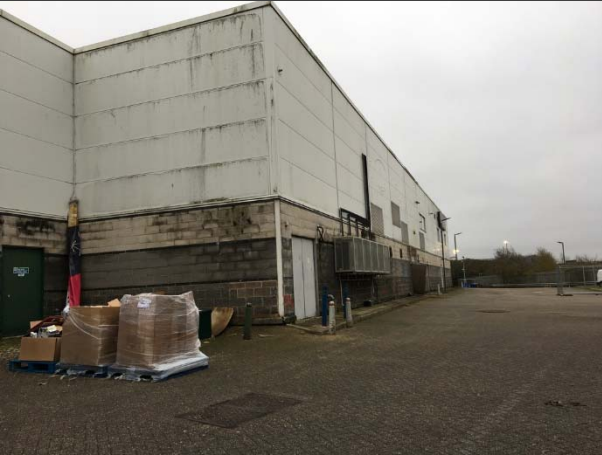
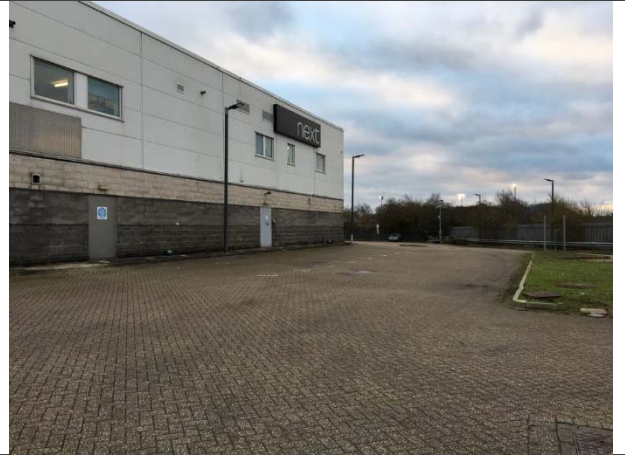
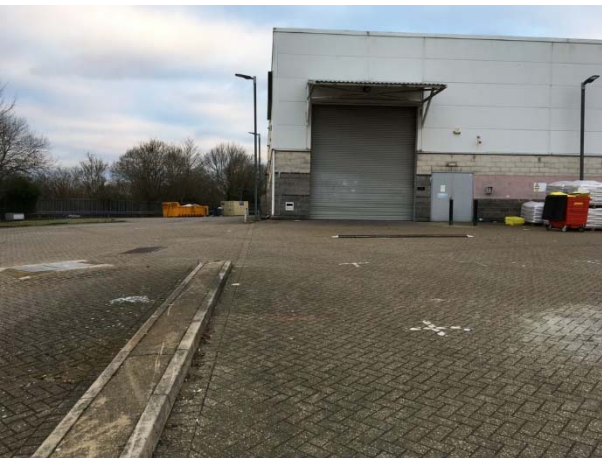
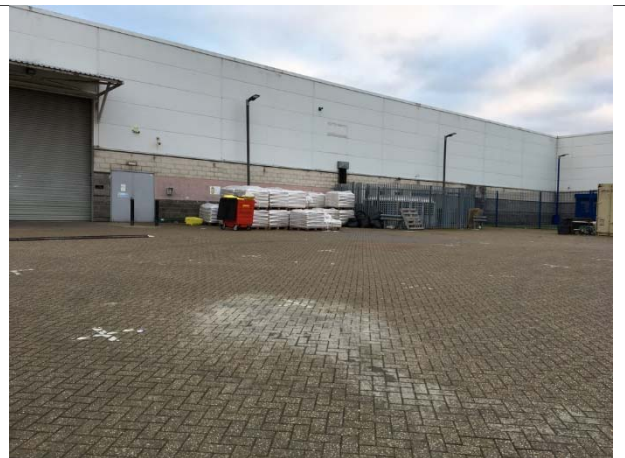
| 4.3.1 | Paragon observed that, in the service yard, there has been movement and approximately 100mm of settlement of the pavement to the rear yard which extends along the back of Units 2, 3a and 3b. This is particularly evident to Units 1 to 3b but is also noticeable to the pavement which continues along the rear of Unit 4, albeit to a lesser extent. This is evidenced by rodent boxes fixed to the rear elevation walls, which were previously sat on the pavement that are now suspended above the ground identifying the extent the pavement has sank. Further downward movement and sinking of the block paving to the yard where abuts the rear elevations of Units 1 and 2 was noted and again this continued to Units 3b, 4 and Unit 5. |

01: Rear yard overview

02: Rear yard overview

03: Rear yard overview

04: Rear yard overview

1. Repairs to the settlement in the rear yard area are recommended. As poorly consolidated fill has been identified below the yard area, this would require compaction to create a suitable sub-base with clean down of each paviour prior to relaying. Based on the poorly composed materials below, it is unlikely that a straightforward lift and re-lay approach would be suitable. Therefore, an estimated rate of repair is asserted to be £120/m<sup>2</sup>. It is understood that the site's asset managers indicated that there was approximately 55m<sup>2</sup> requiring localised repairs. Based on the topographical survey completed and using a Geographical Information System (GIS) to measure the impacted areas, Paragon considers the most currently significant / visually obvious areas to be more in the region of 65m<sup>2</sup>. Therefore, the estimated repair costs of these areas would be estimated at £7,800 excluding VAT and professional fees. This estimate covers repair the worst affected areas of the yard only, as opposed to complete replacement.

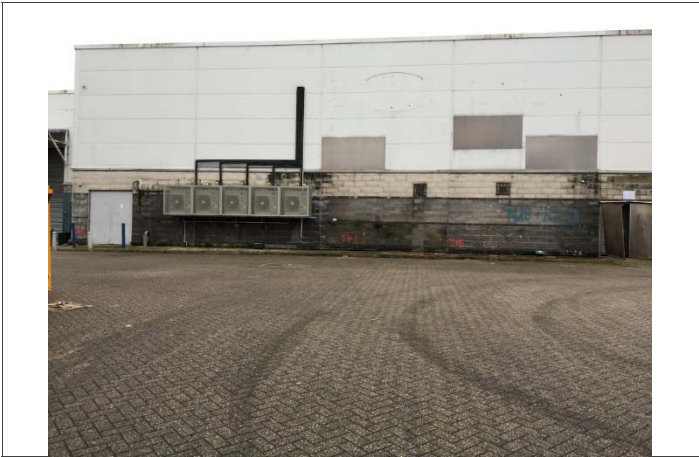
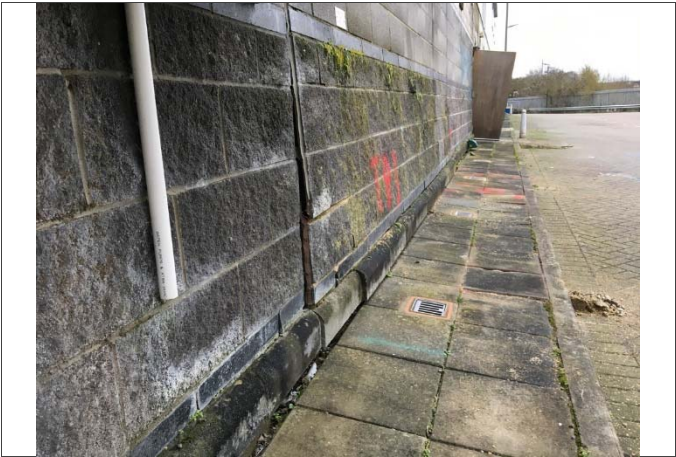
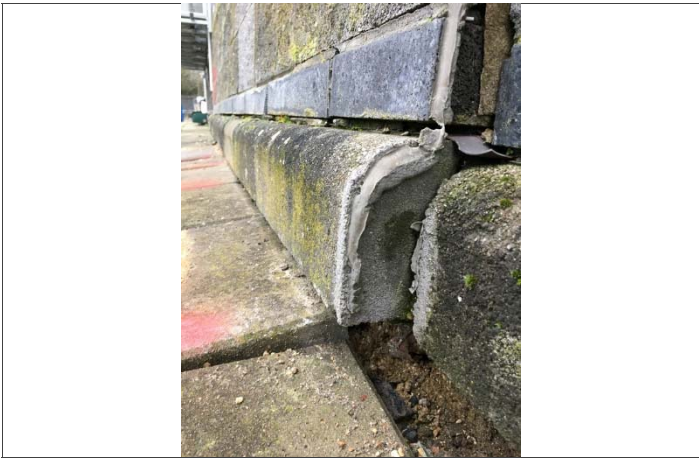
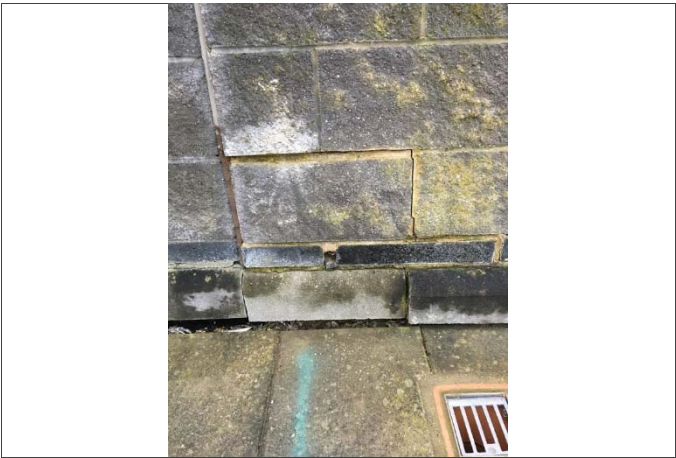
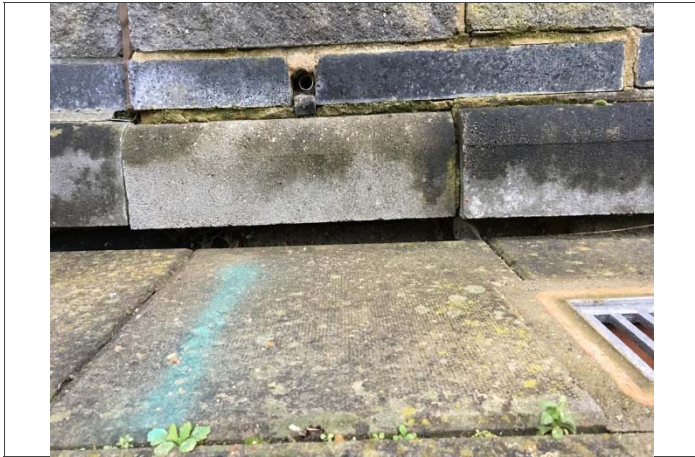
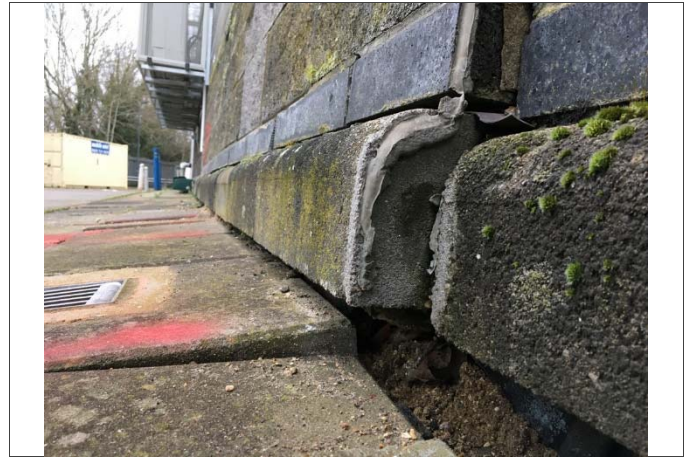
| 15. | <p>One section of the blockwork to the rear of Unit 3a was noted to have deflected outward by approximately 50mm from vertical. It was asserted by others that this was due to internal impact damage by a forklift or similar. From an internal inspection by a Paragon Building Surveyor, it is understood that ancillary accommodation in the form of toilets and an office are located within the building behind this section of the wall and there is no obvious sign of impact damage. Therefore, pits were excavated along this elevation to observe whether there was an underlying issue that could be observed.</p> |

05: Section of damaged wall

06: Section of damaged wall

07: Section of damaged wall

08: Section of damaged wall

09: Section of damaged wall

10: Section of damaged wall

6. A budget cost to remove the existing cavity blockwork wall to the rear of Unit 3a, circa 25m<sup>2</sup>, and replace with new including internal finishes has been estimated by Paragon between **£15,000 and £20,000** excluding VAT and professional fees. Note that this rate is subject to survey and agreeing the extent of work required. For example, it would be recommended to inspect the entire length of the articulation slab (by lifting paving slabs by hand) to ensure the rotational effect is not being caused elsewhere, for example by Unit 3b. If identified, additional areas of the articulation slab will need to be broken out to prevent contact with the bull nose kerb at the base of the blockwork and repairs may need to be extended. However, this does not appear to be the case from visual inspections around the remainder of the structure completed to date.

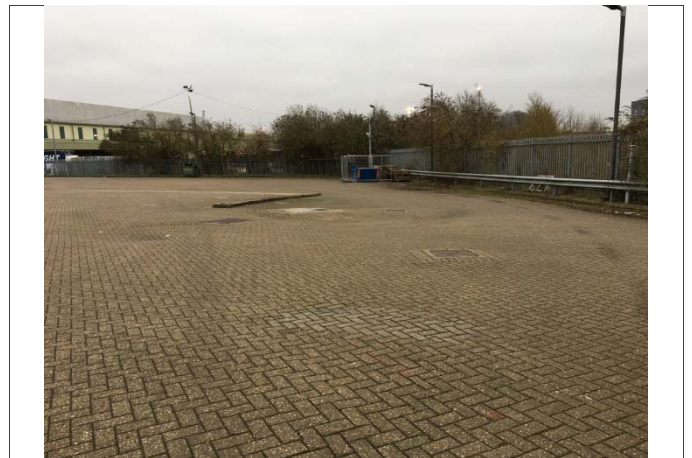
12: Uneven ground surface

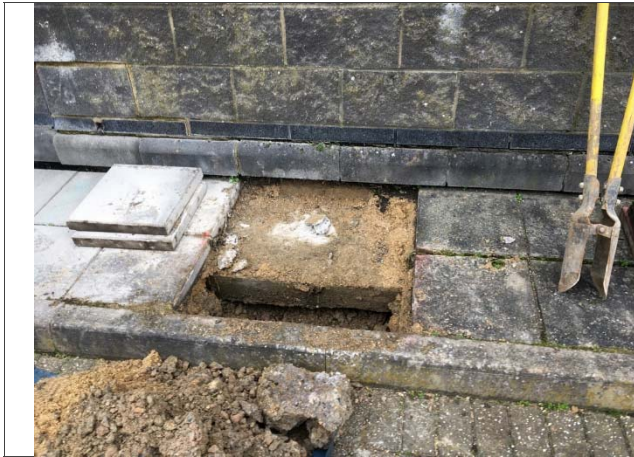
| 16. | A structural engineer from Bradbrook Consulting was present when the trial pits were excavated and an articulation slab was identified within the trial pits running parallel to the building wall. Where Made Ground / fill positioned below this feature has settled, it appears that the articulation slab has dropped causing an uplift affect. This uplift has pushed up against a bull nose kerb at the base of the block work wall and caused the rotational effect as the block work wall was pushed outwards. A sketch was prepared by Bradbrook Consulting to demonstrate the theory and is presented as Figure 4 of Appendix 1. Recommendations have been made below for the repair to this wall section, and localised breaking out of the articulation slab to prevent further contact. |

13: Exposed concrete beam

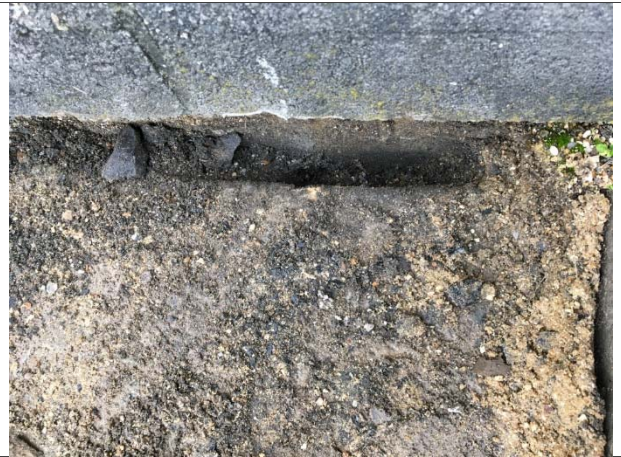
14: Gap between concrete and wall

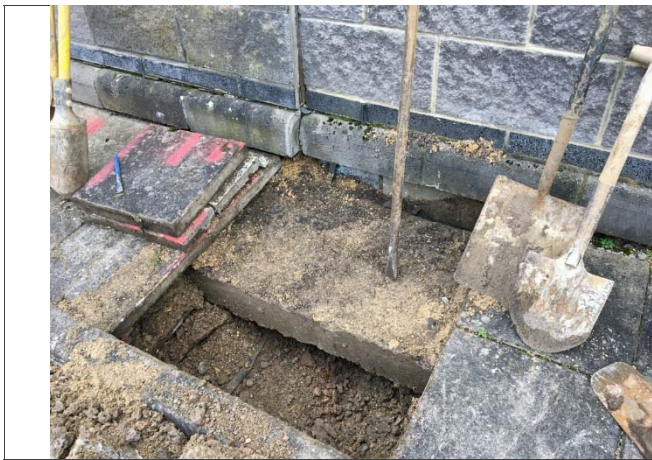
15: Continuation of concrete beam

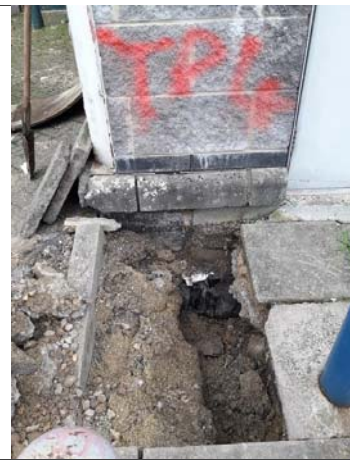
16: Broken through concrete beam

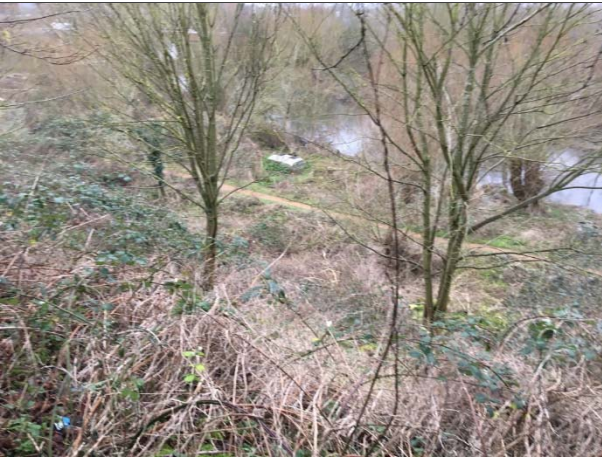
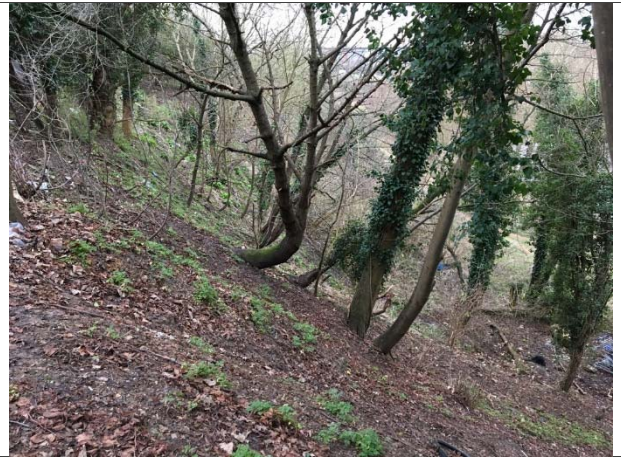
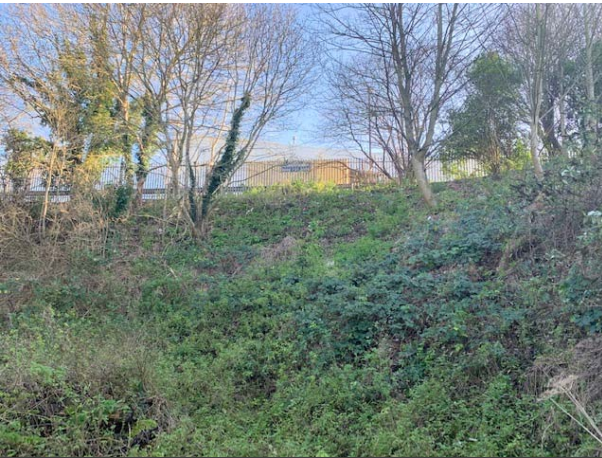
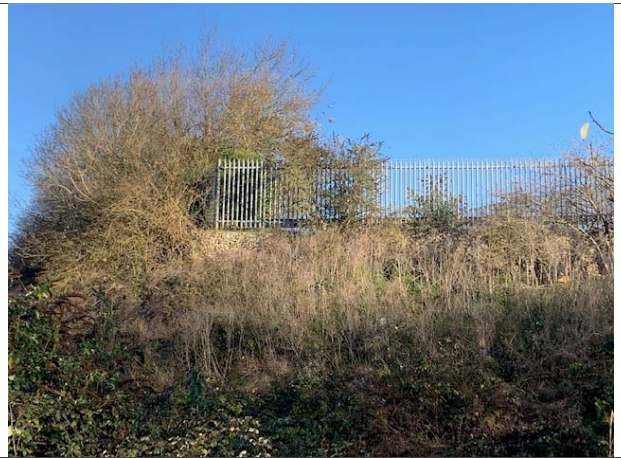
| 11. | <p>Other factors were considered in relation to the movement observed, such as slope failure. The slope to the west of the site was identified to be very steep and a number of bent trees were present indicating some degree of movement has taken place historically. Visual inspections completed as part of the investigations to date by a building surveyor, structural engineer and geotechnical engineer did not identify damage to the building that was definitively attributable to slope failure. The undulation identified to the rear yard area was more consistent with circular depressions rather than a more rigid subsidence effect where large cracks open as a result of lateral movement. As such, settlement is considered to be the more likely cause to the movement observed at the site.</p> |

21: Overview of slope

22: Overview of slope

23: Overview of slope

24: Overview of slope

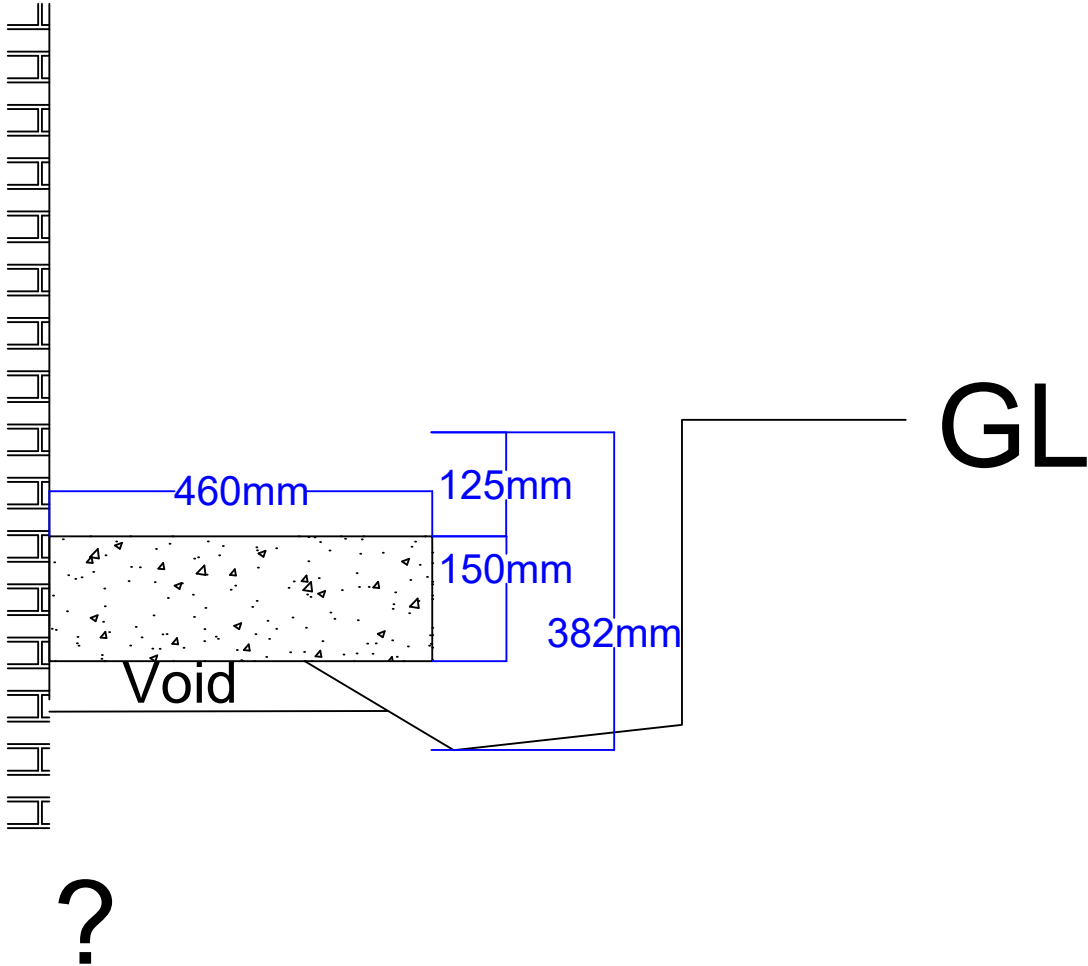
| | Title | Foundation Section | | | | |

"Floating" Concrete beam.  
Beam rotated along length  
disturbing overlying paving  
stones

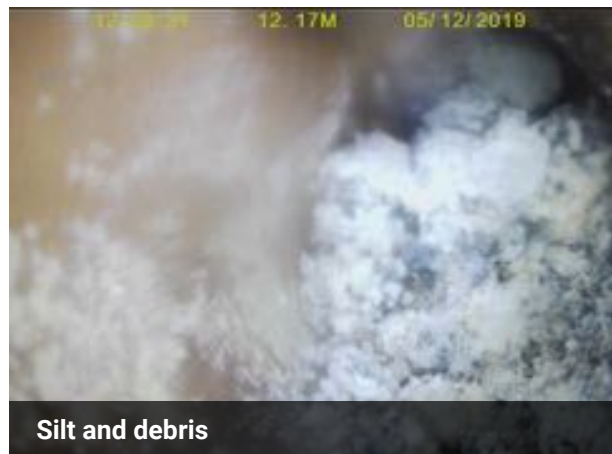
There are accumulations of debris, silt and scale in the below-ground system causing reduced flow and blockages. This has probably occurred through a natural build-up and lack of maintenance. We recommend widespread de-scaling and de-silting works are carried out to restore the full capacity of the system. The most efficient way of doing this is with high pressure jetting in combination with a suction tanker to remove the waste off site.

Silt and debris

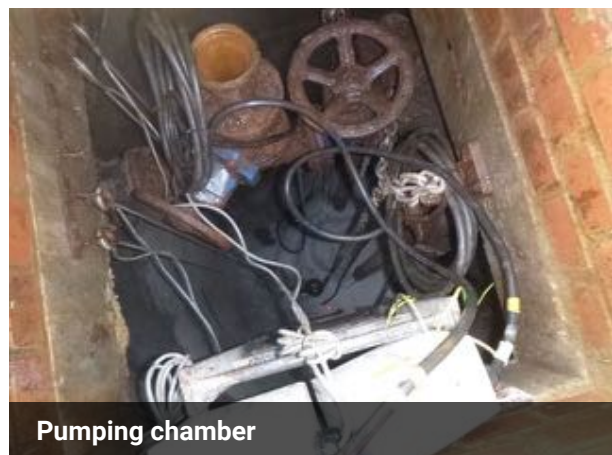
There is a foul pumping chamber at MH31. We have not carried out any electrical tests on the pump but would recommend it is serviced/overhauled if not already part of a regular maintenance programme to keep it in good working order.

Pumping chamber

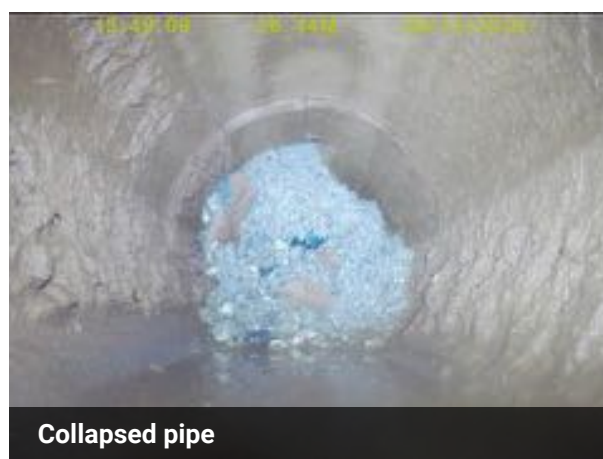
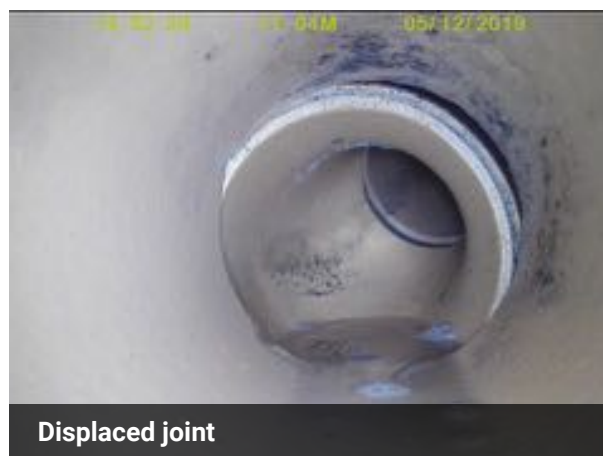
There are also three displaced joints which we recommend are repaired to prevent further deterioration and possible collapse. These can currently be repaired in-situ by patch lining but have the potential to deteriorate and collapse if not dealt with. We recommend one of these (D9) is repaired within the next 3 months to prevent likely collapse.

There is a cracked cover slab at inspection chamber MH15. We recommend this is monitored.

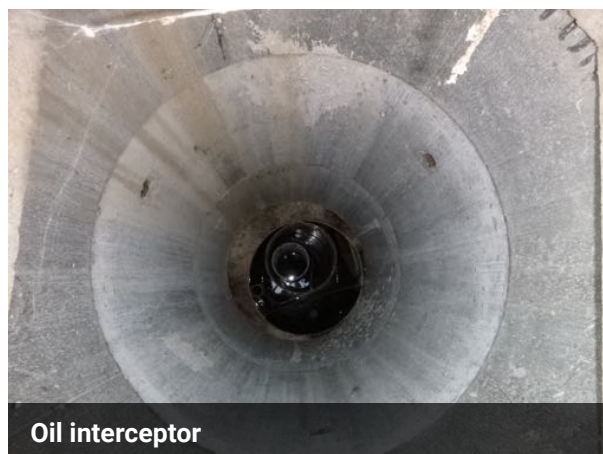
There is one oil interceptor protecting the surface-water system taking the rear yards, however it does not appear to serve the whole site and leaves the main car park unprotected. This would need further investigation to determine for certain but we recommend that consideration is given to retro-fitting an additional interceptor in the carpark downstream of MH7. Oil interceptors need to be well maintained to remain effective and this currently is in need of

Oil interceptor

maintenance. We recommend the interceptor is cleared out with a suction tanker and disposed of Hazardous Waste. Oil interceptors are not a legal requirement but present a sensible precaution against causing environmental pollution via the drainage system.

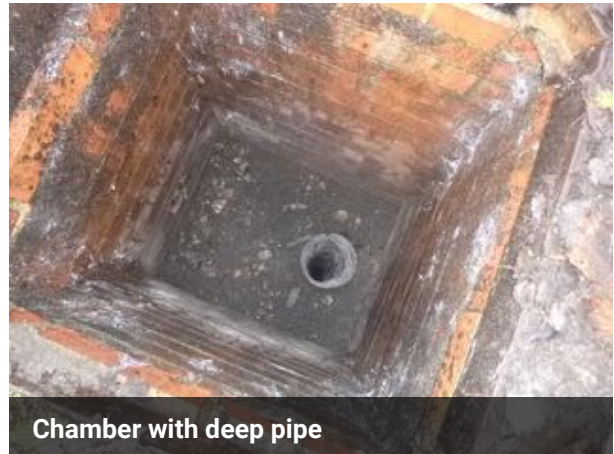
We noted several chambers with a vertical pipe visible which extends approximately 10m down to some water at the bottom. We are not certain of the purpose of these pipes but do not think they are related to drainage.

**Chamber with deep pipe**
