## Condition overview of 75-77 London Street Reading

This report looks at the condition of the building as it stands today.

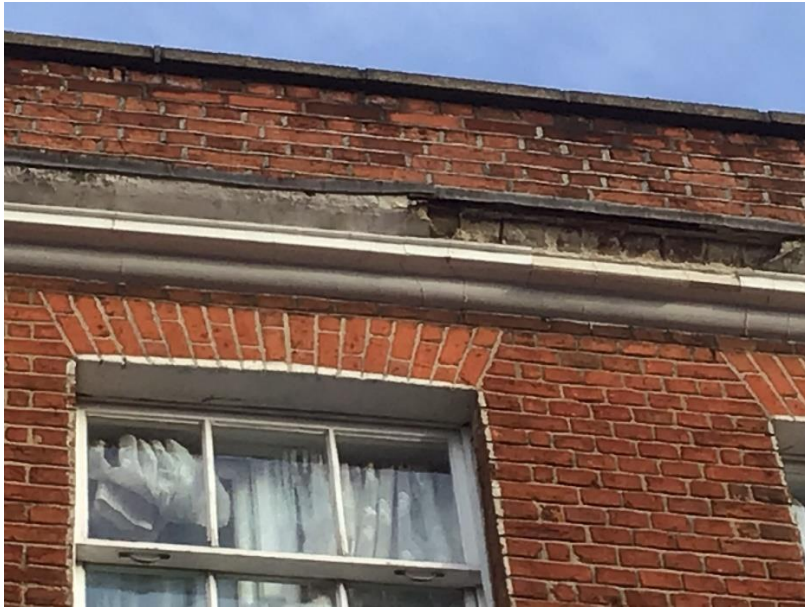
Cornice over second floor windows deteriorating

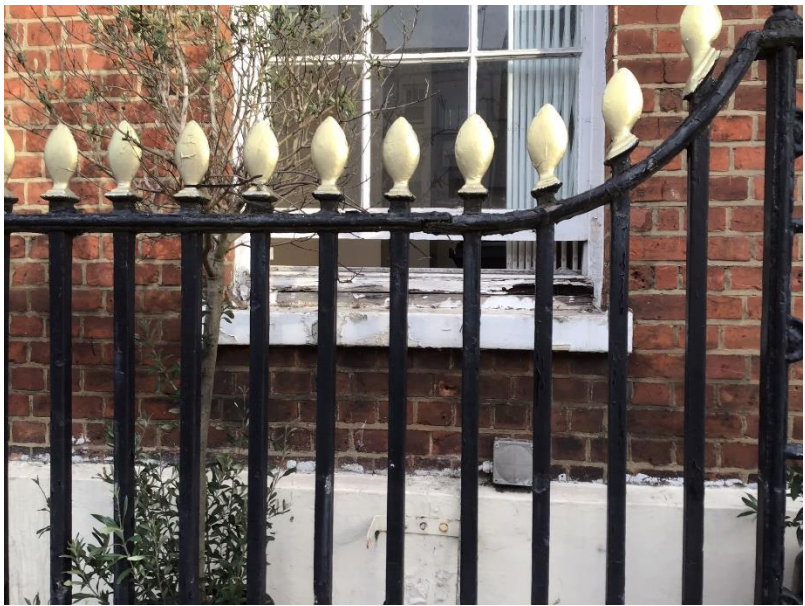
Rotten box sash on ground floor.

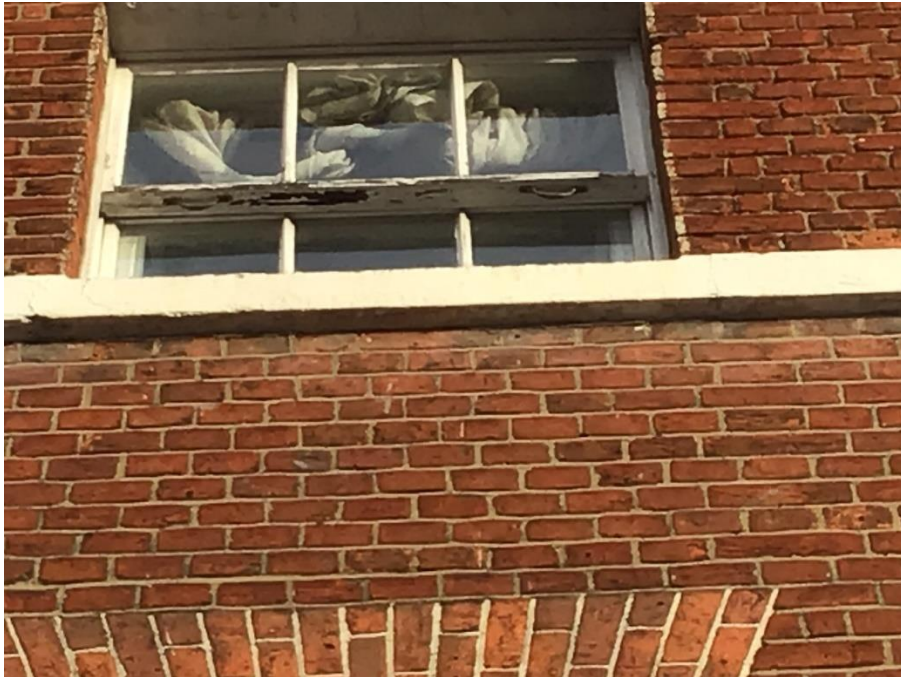
Rotten sash on second floor

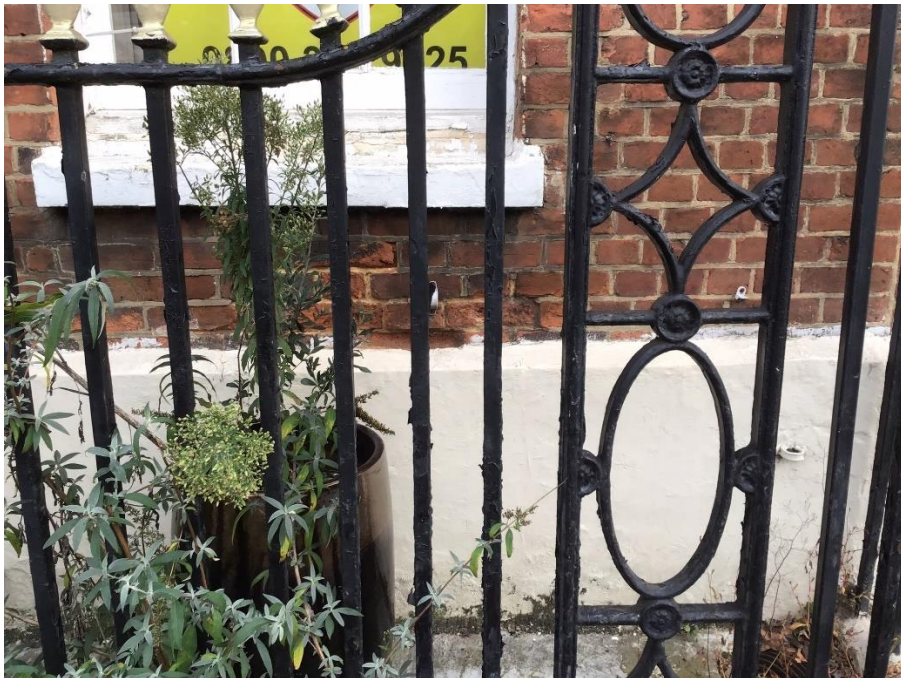
Spalling brickwork above plinth

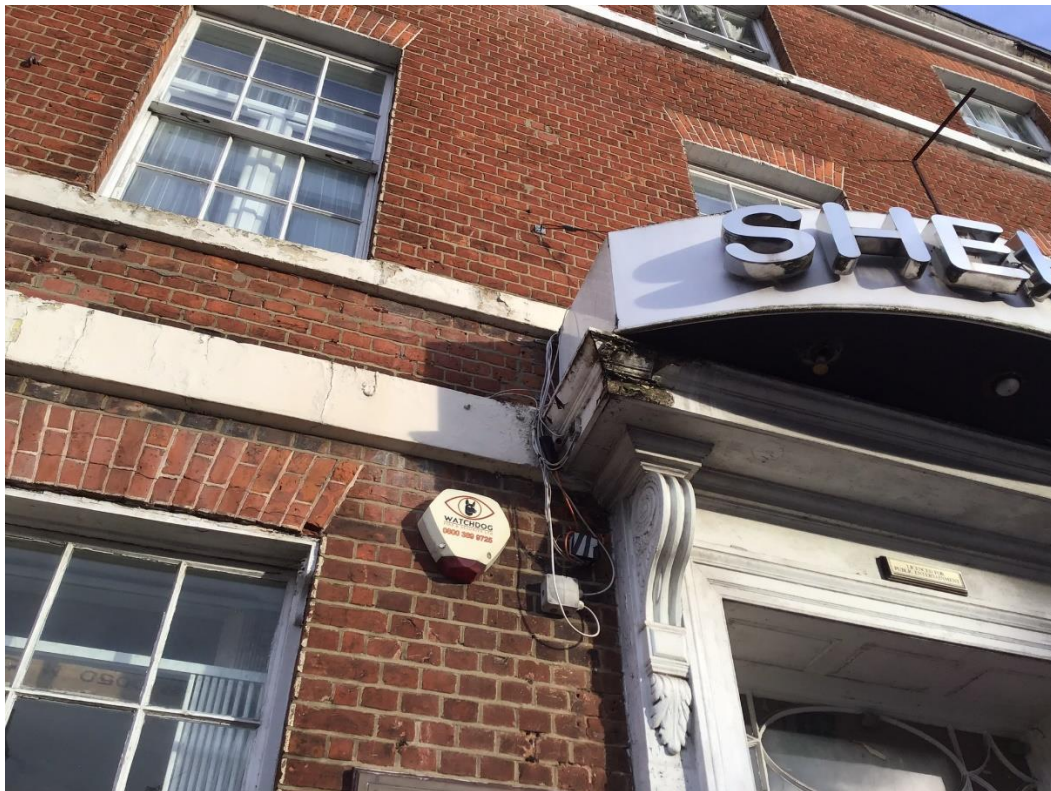
Front canopy, corner rotting

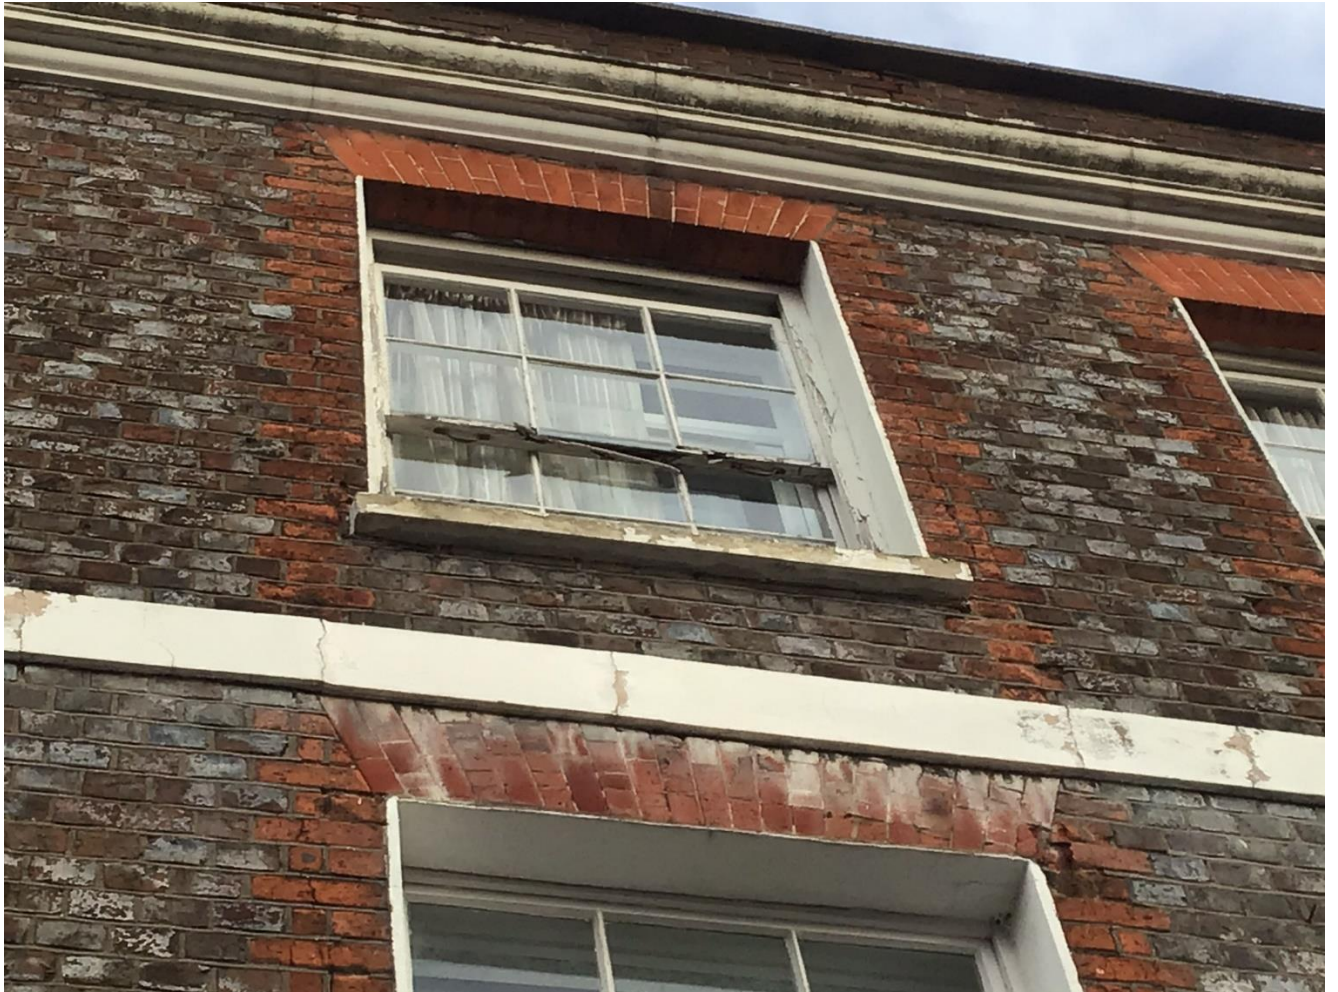
Rotten sash to second floor window, vertical fracturing of brickwork & string course to left of frames.

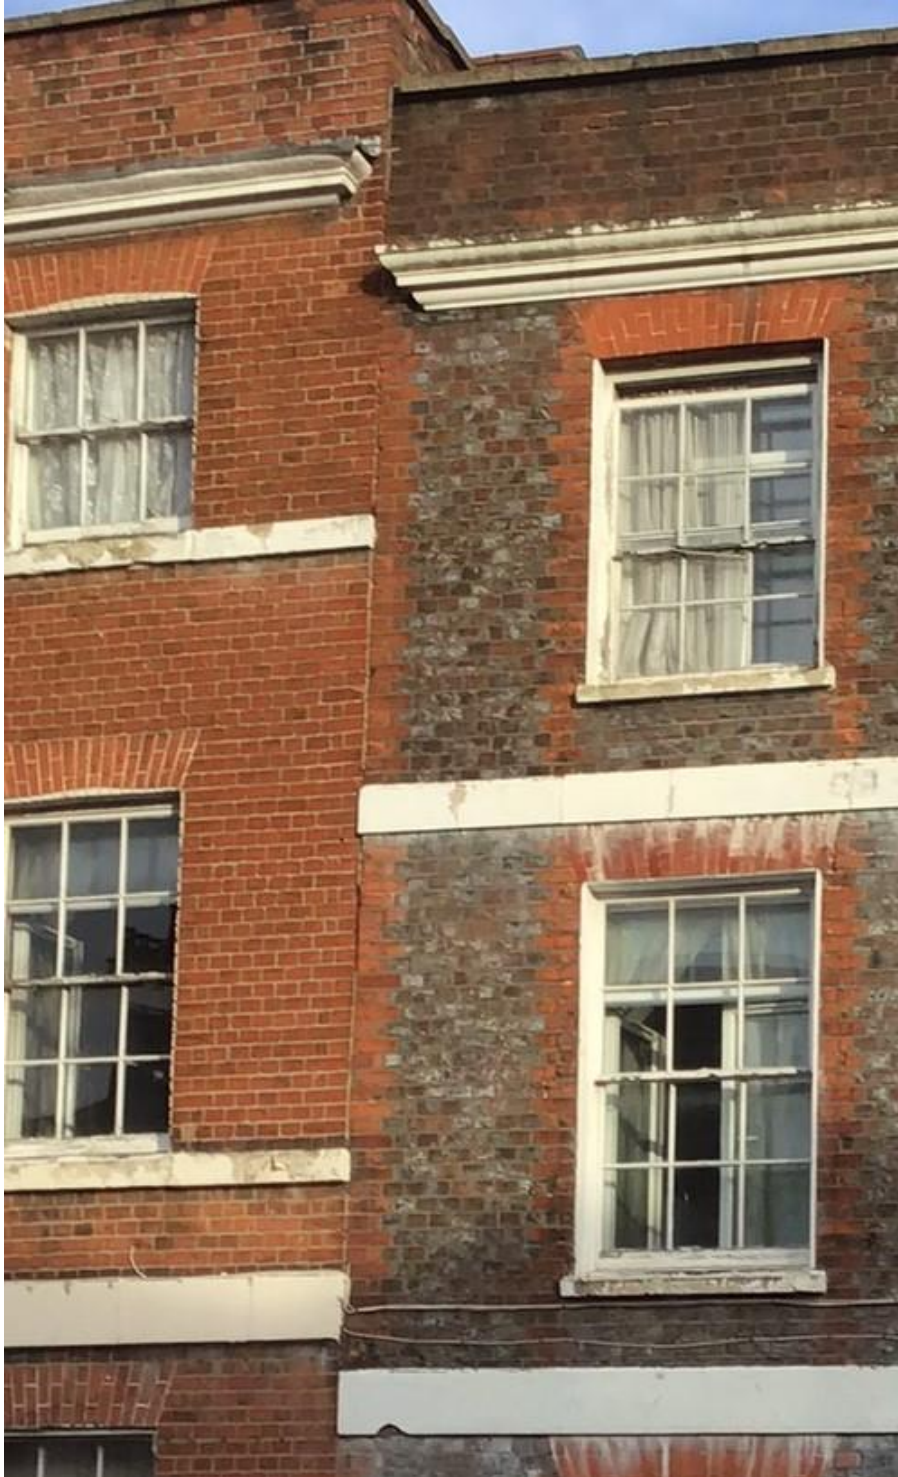
Lateral movement of front elevation between first & second floor string course at vertical joint to 75 London Street.

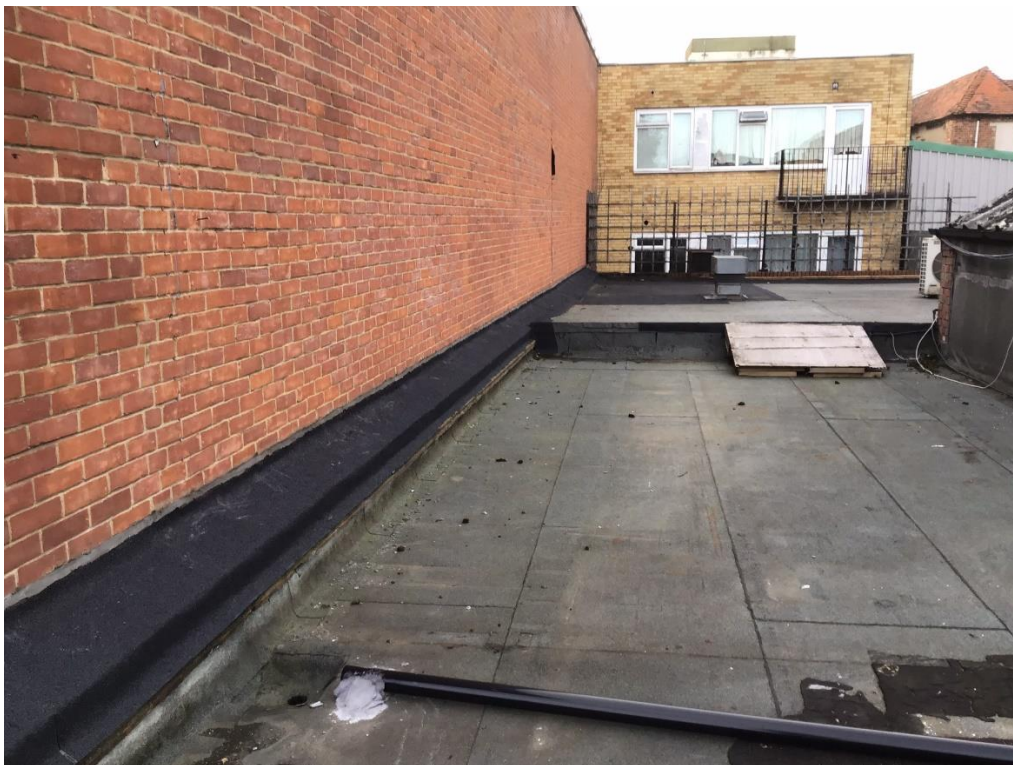
View of the left hand flat roof section looking from the rear showing repaired sections.

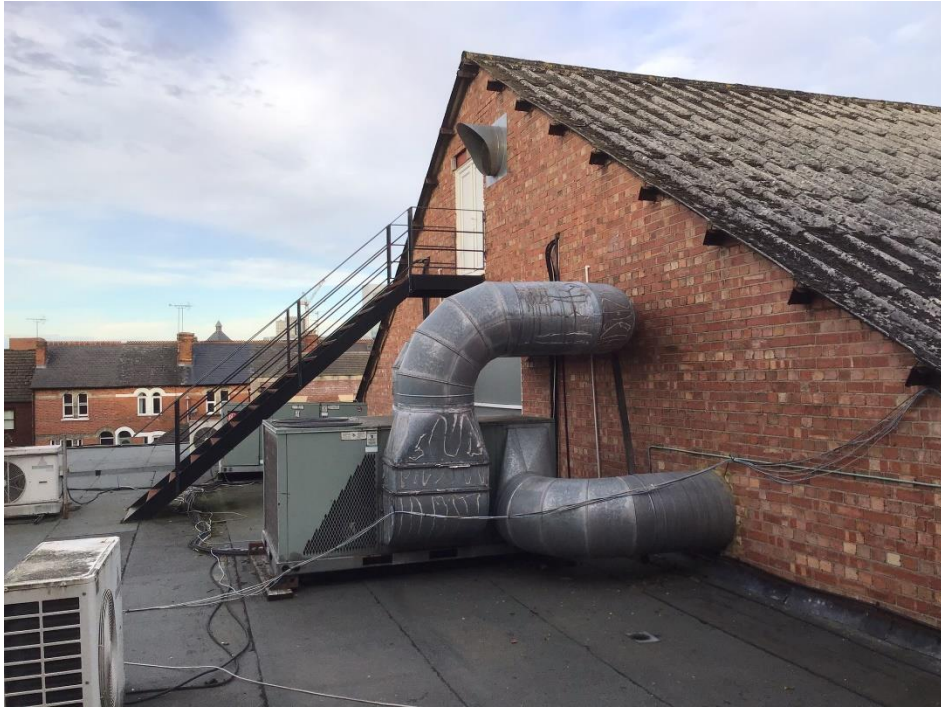
View of corrugated cement, possibility asbestos based roof sheeting.

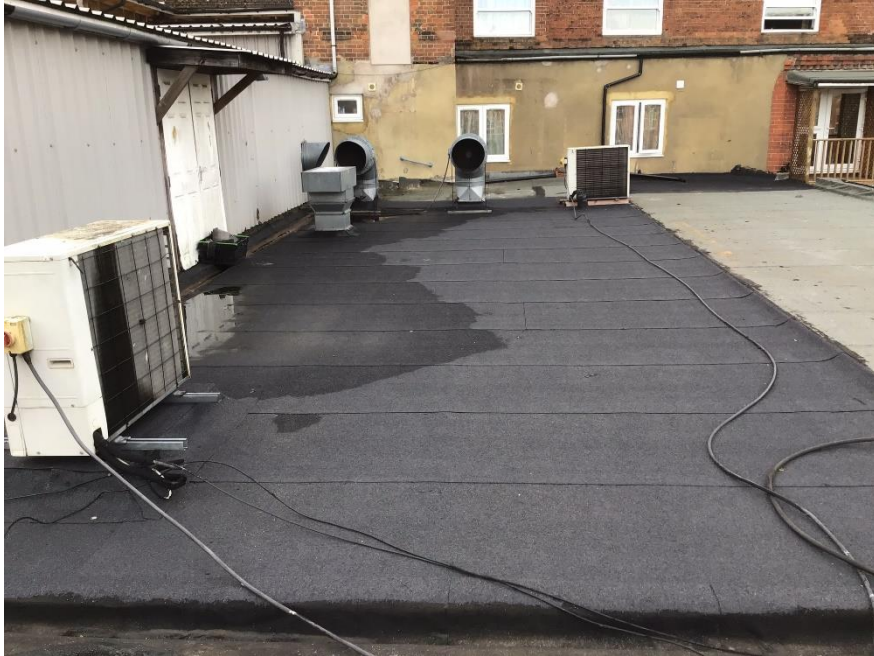
Various sections of roof repairs.

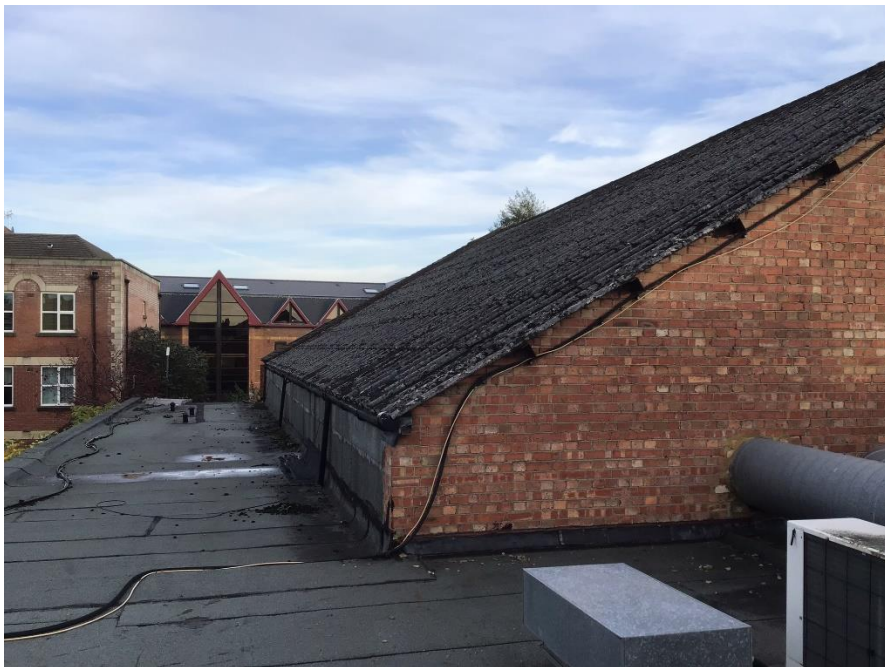
Various areas of roof repairs

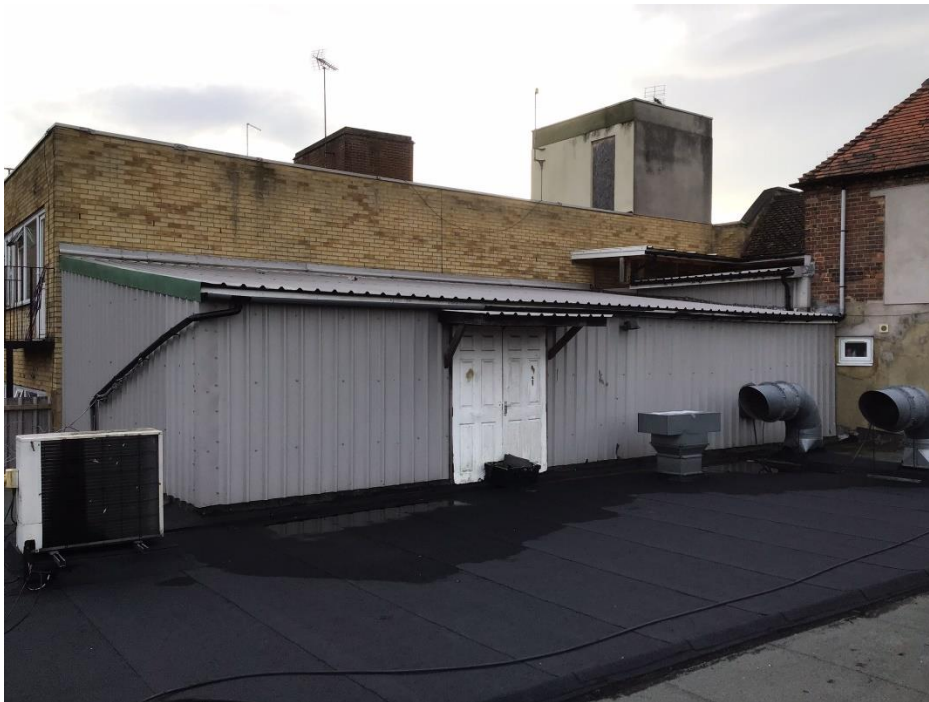
View of corrugated cement, possibility asbestos based roof sheeting.

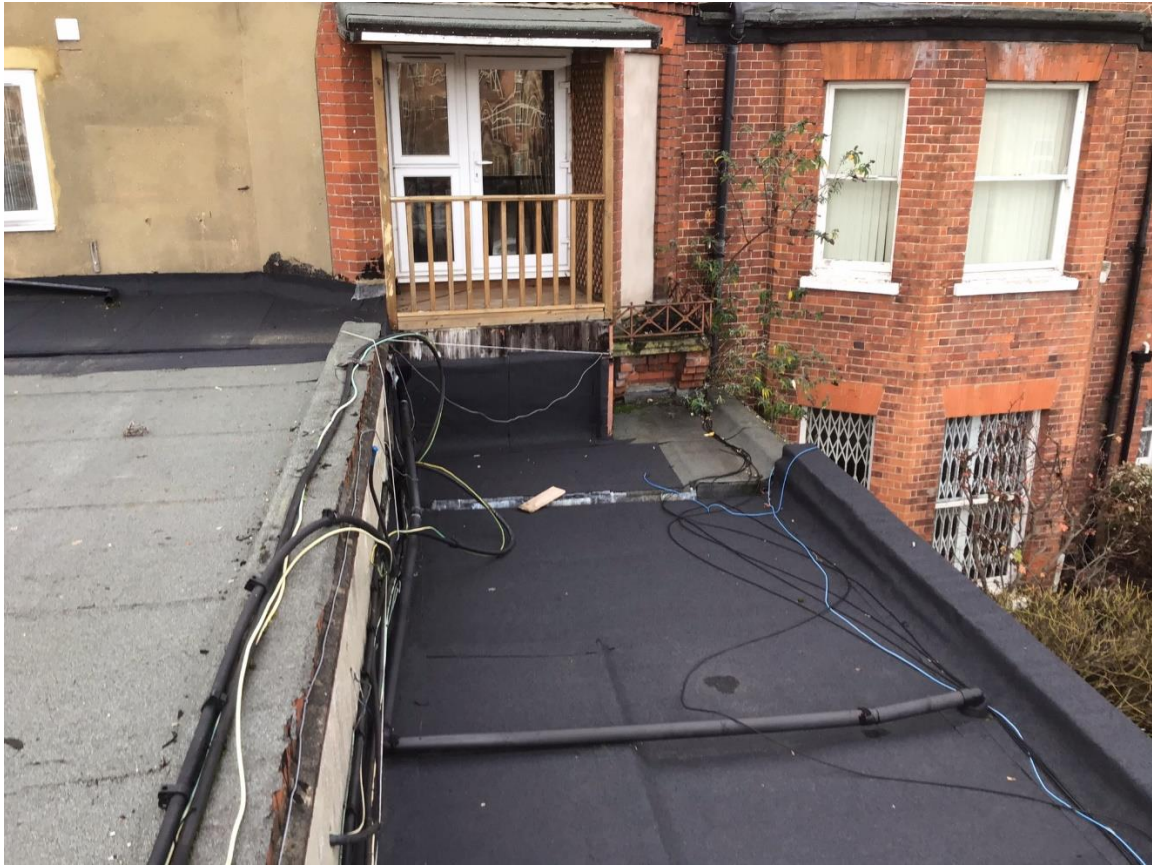
Various area s of roof repairs.

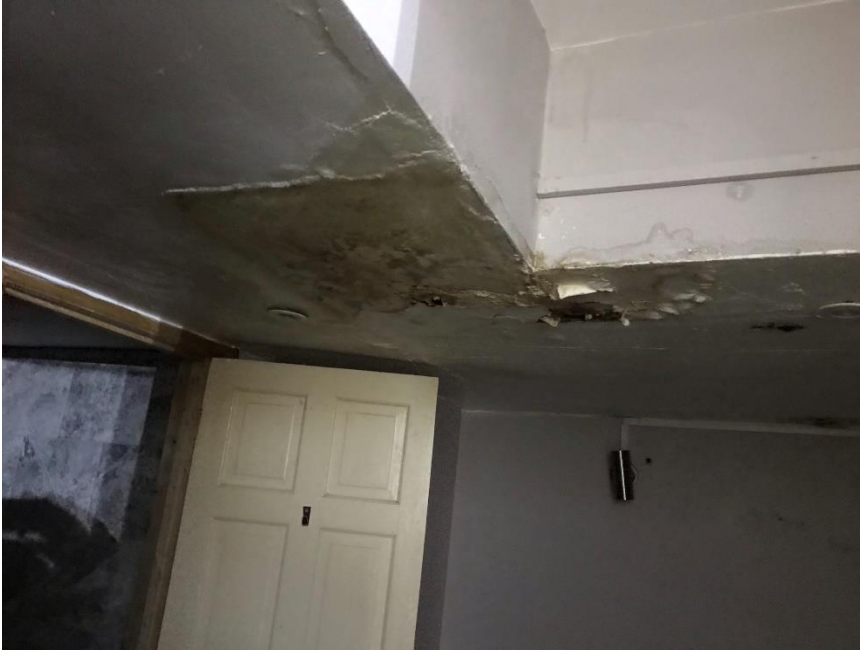
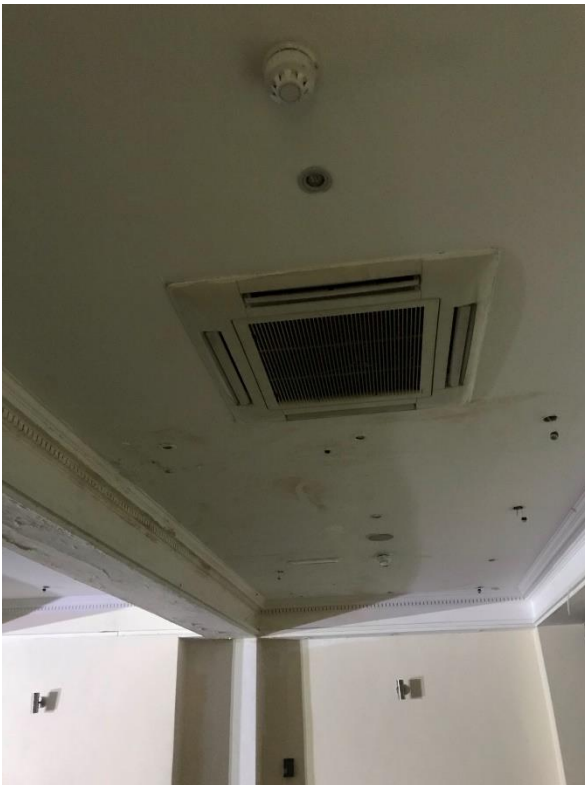
Various areas of roof repairs.

Ceiling of wcs under flat roof.

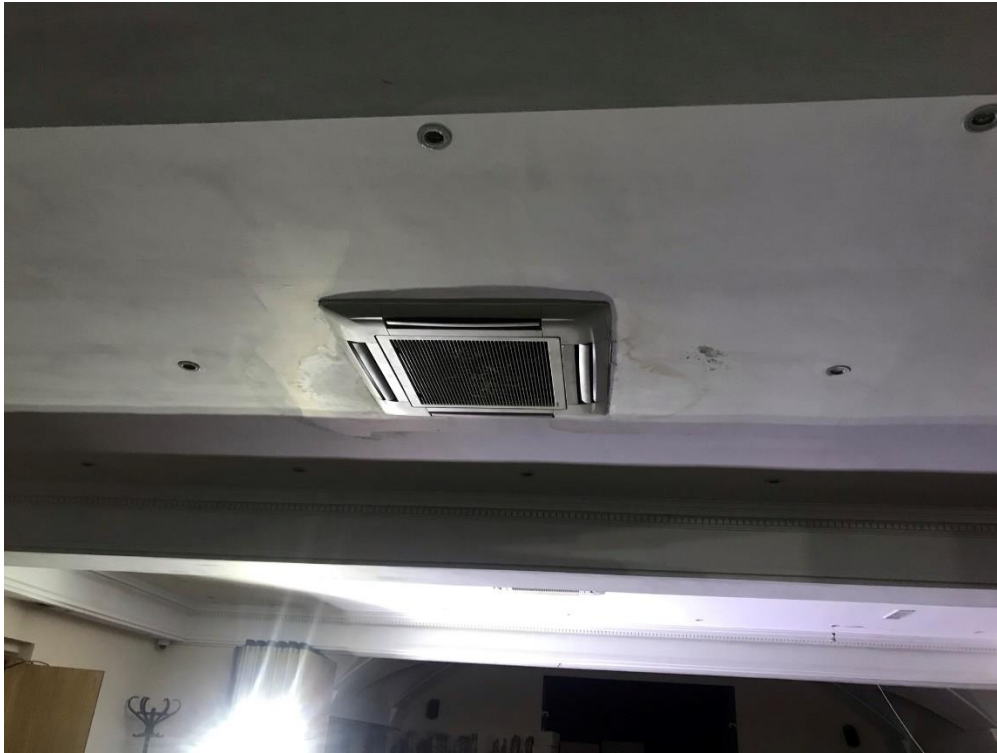
Leaking flat roof around a/c unit under flat roof

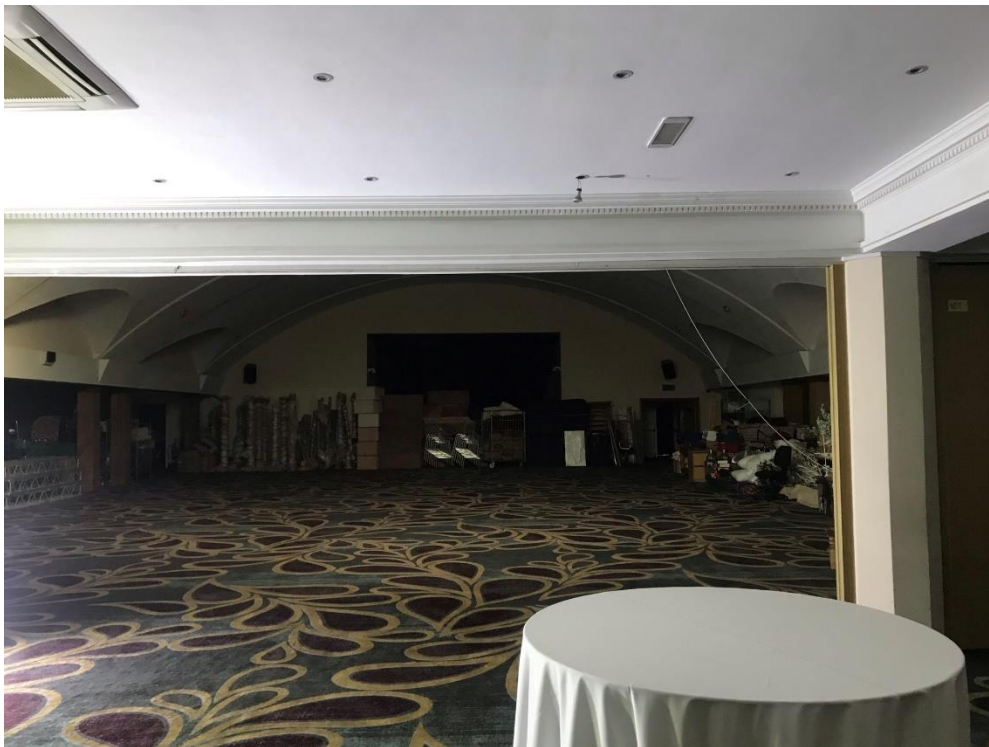
Leaking roof around another a/c unit under flat roof

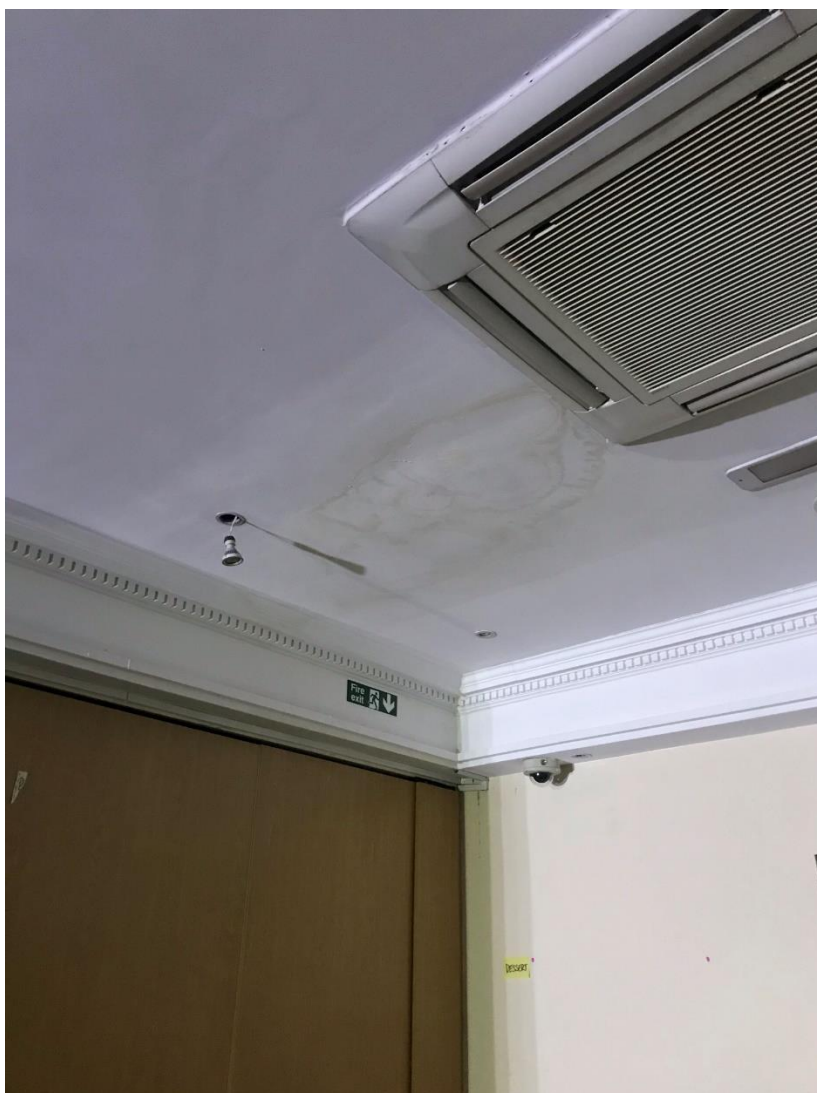
View of main dance floor under corrugated pitch roof

Leaking around another a/c unit under flat roof
