Ref: 0683

## Level 1 Condition Report

Old Grove House  
St Barnabas Road  
Emmer Green  
Reading

25<sup>th</sup> January 2022

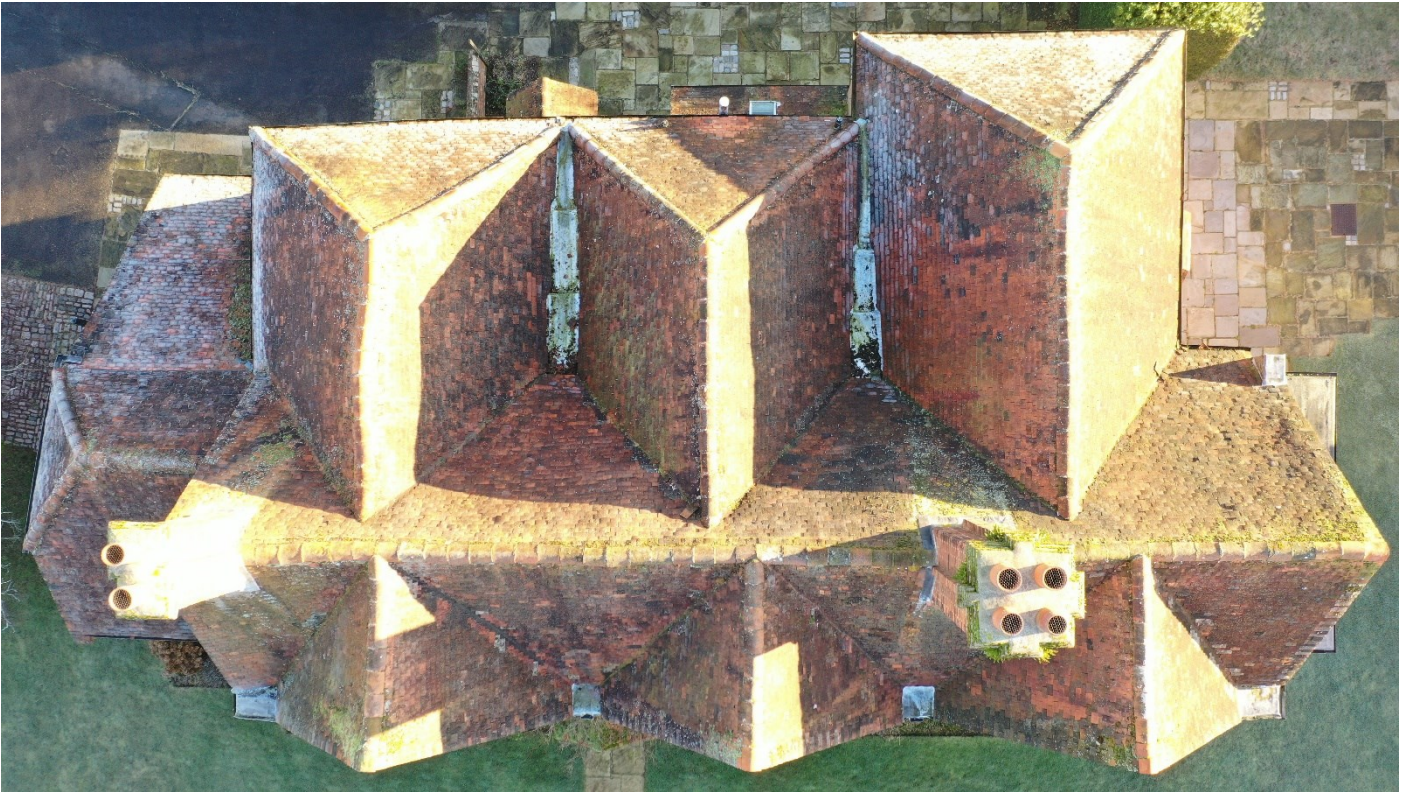
*Image 1: Roof Covering*

The entirety of the main roof was re-covered last in a single phase of development, as evidenced by the presence of non-permeable bitumastic sarking felt, which probably took place in the 1970s or 1980s.

The roofing tiles used at that time appear to have been a mixture of salvaged units, probably those deemed reusable from the previous roof covering, and new. There is then a disparity of condition between old and new tiles, with many of the former exhibiting moderate to acute spalling - which essentially means they have eroded due to weathering which has compromised their structure.

Many internal repairs were noted to the sarking felt and it was seen to be fraying and perishing in places, which is common when the felt is of significant age. Several slipped and missing tiles were also noted across the roof covering itself along with historic patch repairs externally.

Overall, therefore, the roof covering is showing signs of advanced age including the beginnings of nail fatigue – when the mechanical fixings fail - which is terminal once it takes hold.

Whilst the roof's life expectancy could be extended by undertaking a phase of repair and maintenance. The evidence suggests that it is now coming towards the end of its serviceable life and will require replacing within the next 5, or certainly the next 10 years.

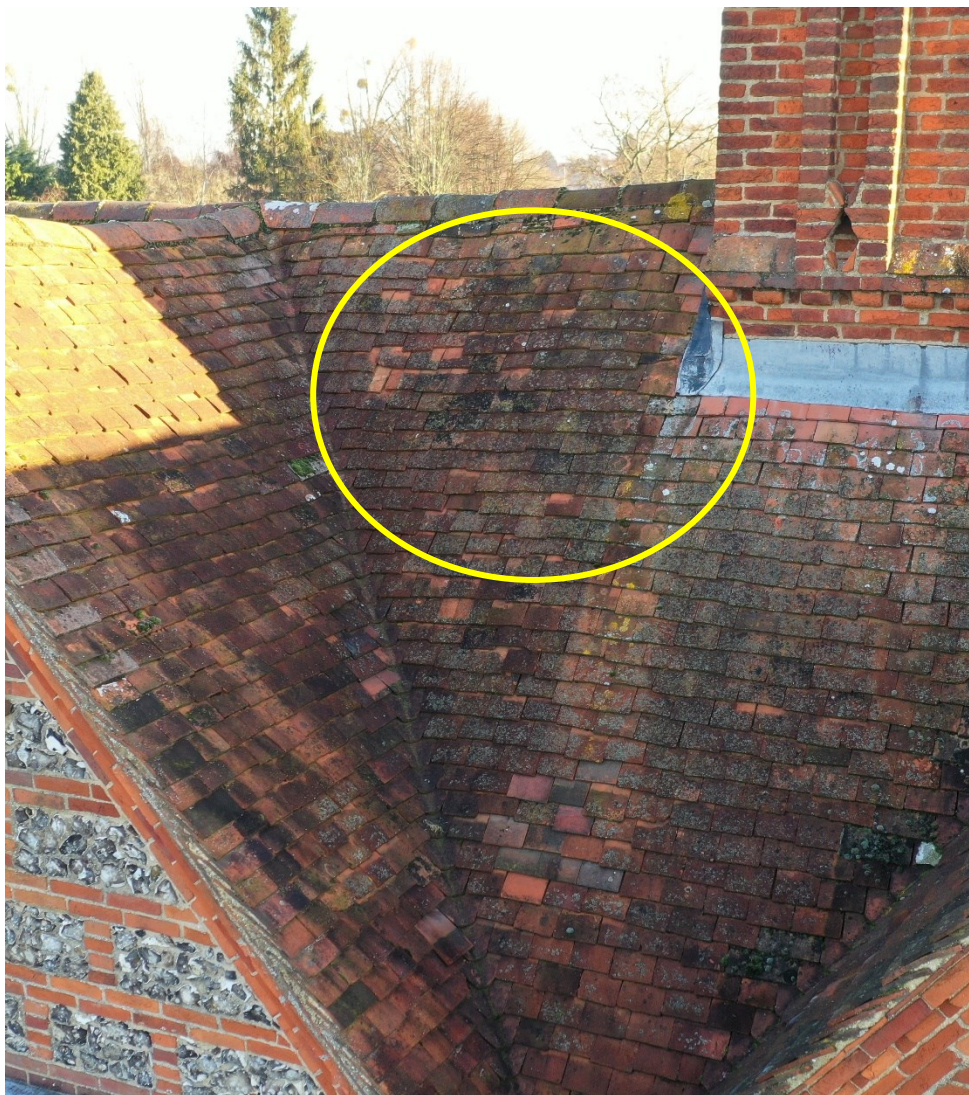
*Image 2: Slipped/Slipping Tiles to Front Elevation*

It may therefore be better to undertake necessary repairs to ensure the roof's ability to effectively shed water for a short period of time – which may be achievable from a MEWP (cherry picker) - or simply leaving the roof in its current condition if a re-roofing project can be undertaken in the next 2 – 3 years.

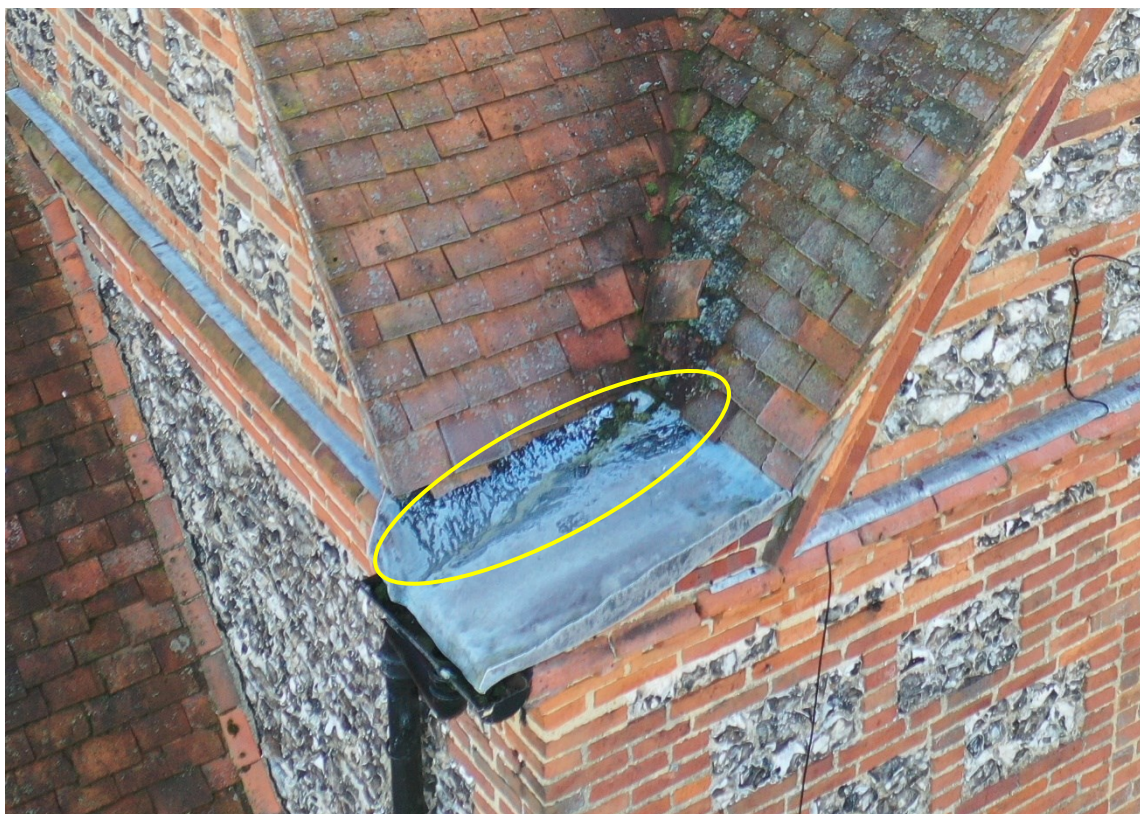
water ingress was noted relating to it, it is almost certainly thinning and cracking which will lead to water ingress. Indeed, several historical bitumastic repairs to prevent water ingress can be seen on the lead.

Tile abutments exist between the kitchen block and the main building. Whilst this is normally a very good and robust detail, in this case the tiles appear to have been bedded in cement (which is a very brittle material and doesn't accommodate movement) and large linear cracking has appeared between the tiles and the flint gable wall which presents a direct route for water ingress.

*Image 3: High Level of Surface Patina & Past Bitumastic Repairs to Lead*

In the short term, it would be prudent to fill the cracking between the kitchen roof and the main house gable. All the weather flashings, including the lead, however, require replacing as soon as possible to prevent water ingress and possible decay of the timber structure.

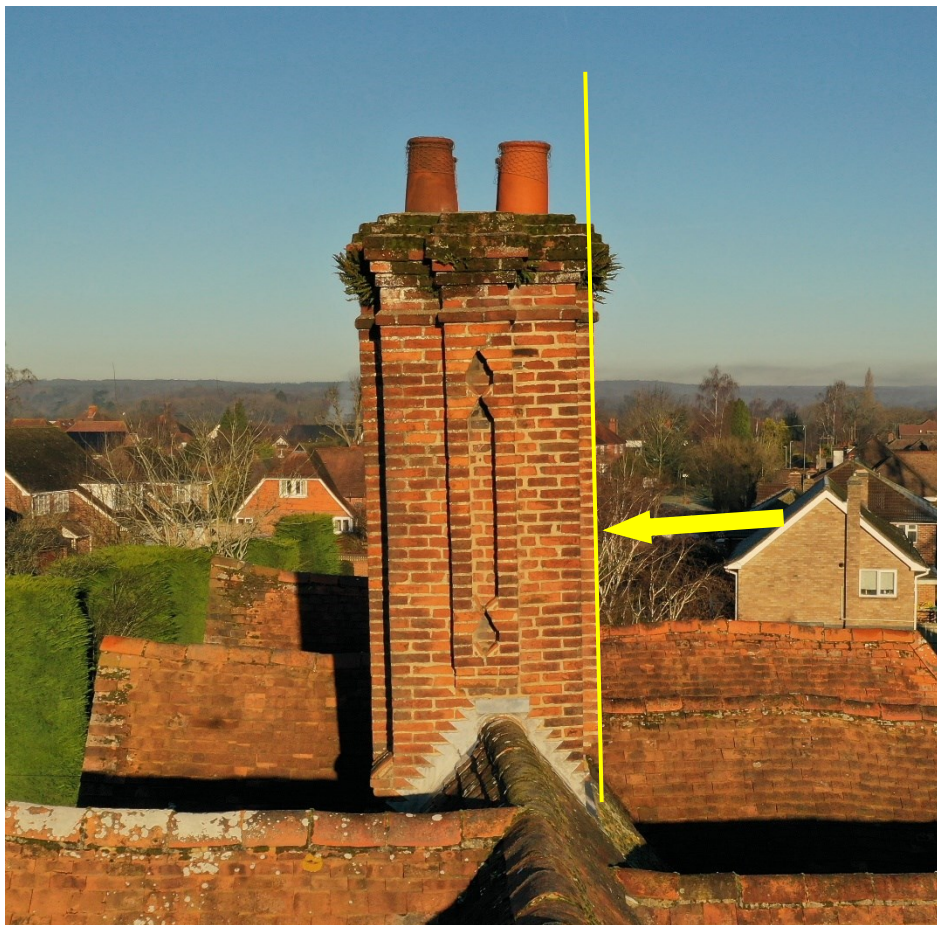
The larger central stack exhibits an outwards lean, but this is quite common on larger units such as this and there is nothing to suggest it is experiencing any significant structural failure.

*Image 4: Lean to Central Stack*

Though there are no immediate concerns, the lean of the central stack should be monitored, and any changes or cracking noted to an engineer or surveyor.

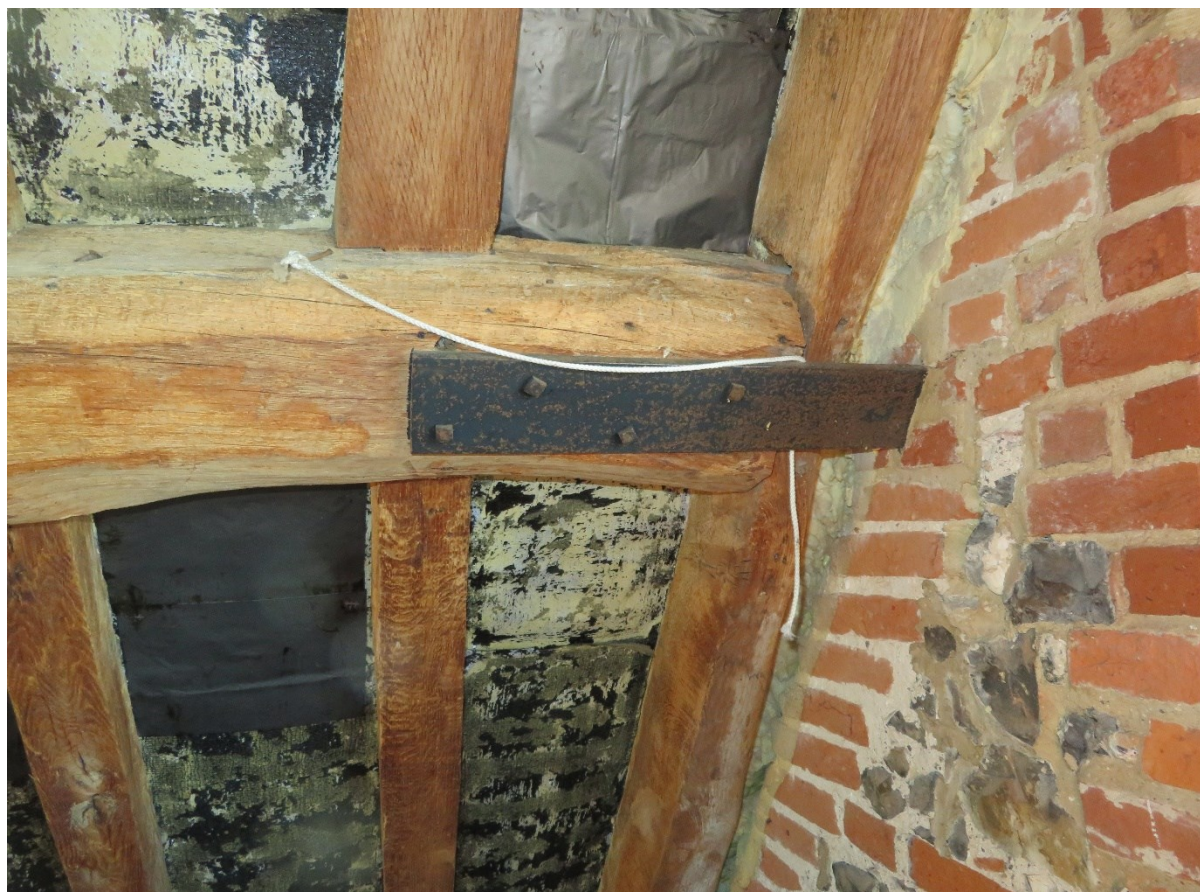
It should be borne in mind that much of the roof structure is very old – likely original – and therefore is not going to be in pristine condition. Indeed, several phases of past intervention associated with structural movement can be seen in the fabric, probably dating back two hundred years.

*Image 5: Historic Repair to Roof Structure*

Though there isn't any evidence of impending collapse, some current movement is visible, and I do feel at this juncture that another phase of structural intervention, which will probably include the addition of metal straps or pins (though these would need to be specified by an engineer) is required to provide long term confidence in the roof from a structural perspective. Removing the roof covering will provide the perfect opportunity to do this correctly, so these works should be undertaken concurrently with this.

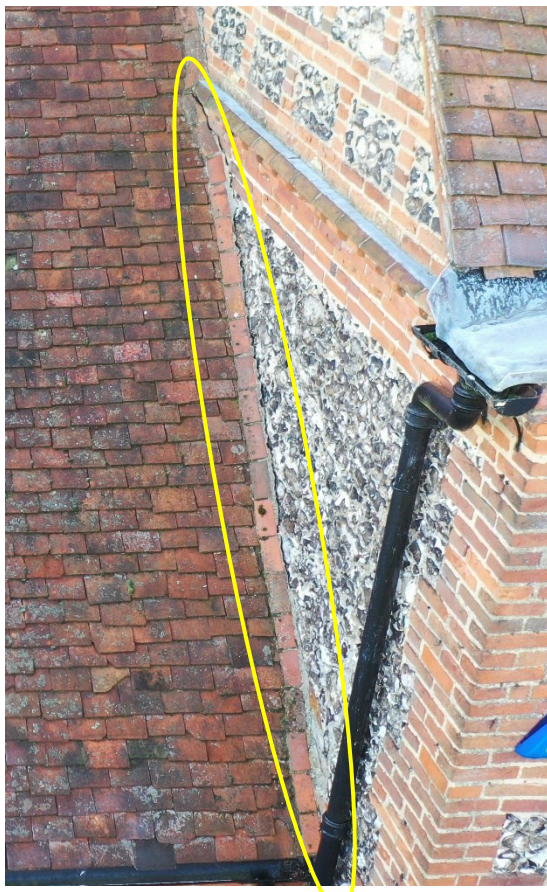
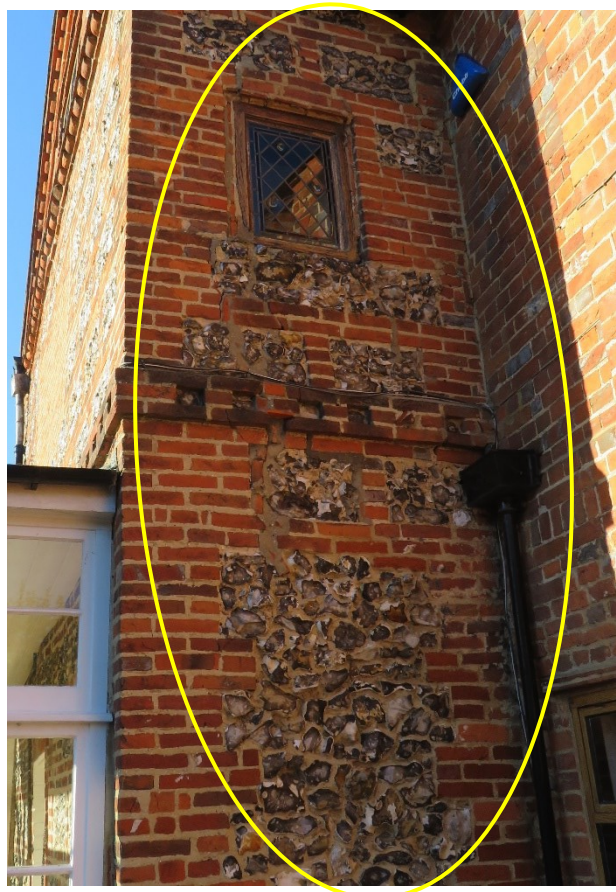
There is evidence of past structural movement which has been arrested through the installation of several pattress plates/wall ties – which appear to have been largely successful. I do however feel that there is some minor current structural movement which can be seen at the junction between the kitchen block and the gable of the main house – see also [Tile Abutment Detail](#) - and the south-east corner – where a tie plate already exists.

*Images 6 & 7: Cracking Consistent with Structural Movement to the Kitchen Block/Gable Wall Junction & South-East Corner Respectively*

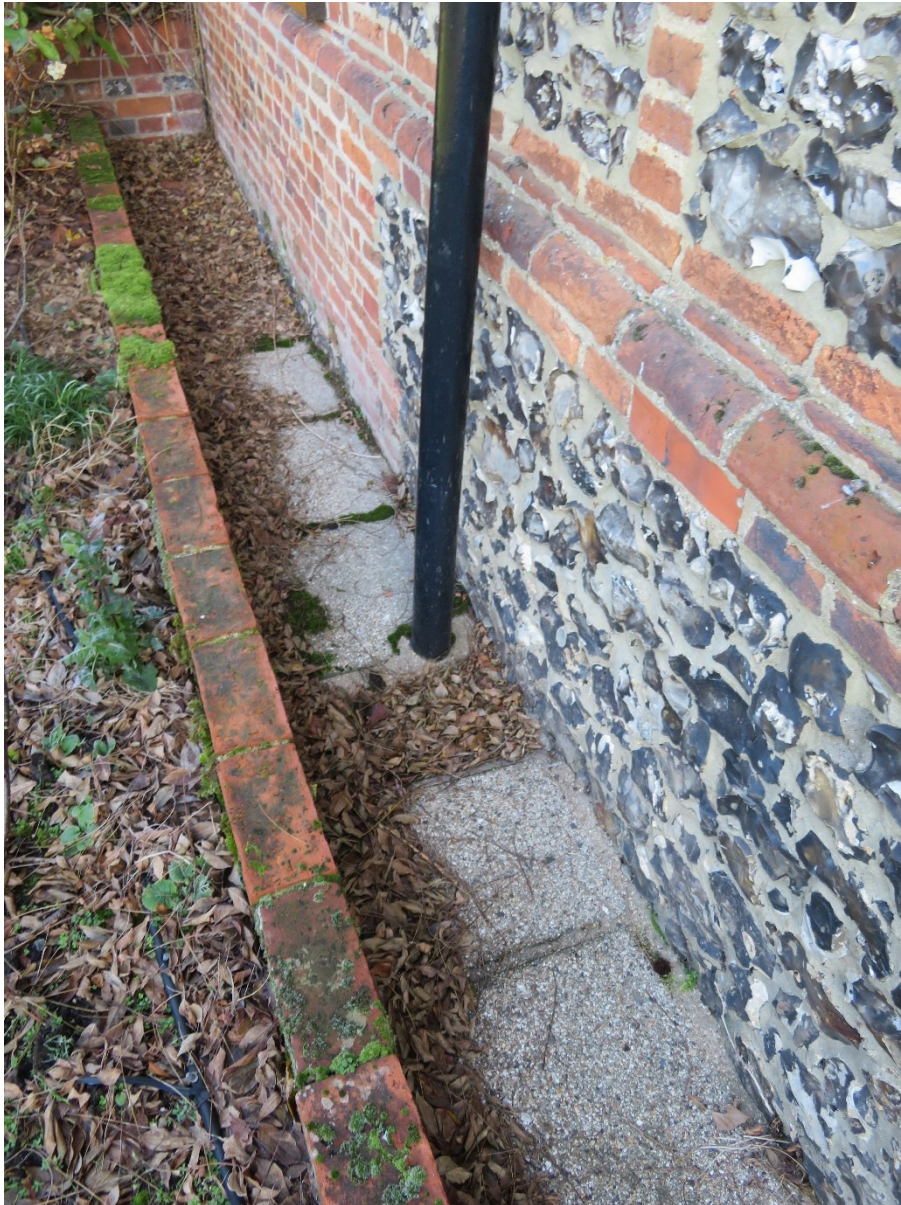
When the incorrect mortar is specified – one that is denser and less porous and absorbent than the surrounding masonry - it effectively blocks up the joints, which act like the pores of a building, and prevents moisture from escaping through them. For trapped moisture, the path of least resistance is then through the face of the masonry itself which can lead to spalling of the bricks or decay of surrounding fabric.

*Image 8: Hard Cementitious Mortar at Low-Level to Front Elevation*

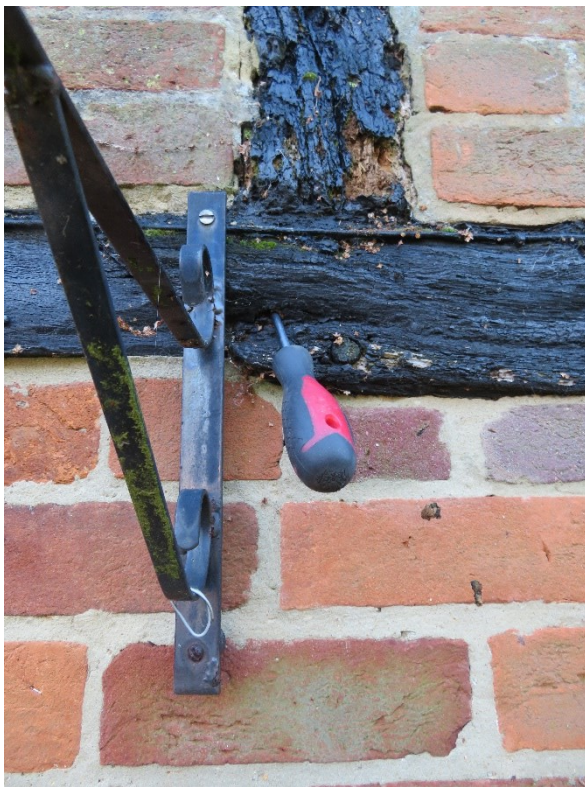
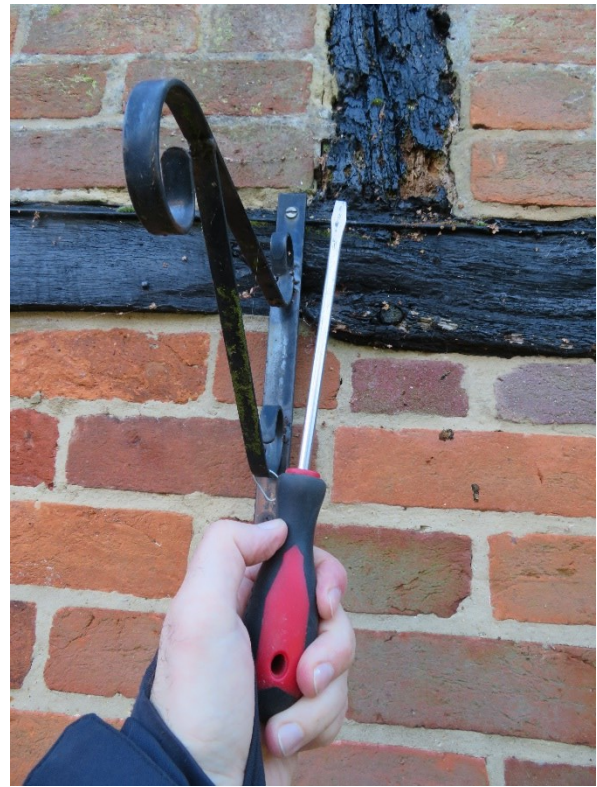
Generally speaking, the condition of the frame is fair, and there is certainly nothing to suggest that it is close to widespread failure or collapse. However, several localised areas do exhibit elevated moisture contents and associated decay caused principally by wood boring insect (Deathwatch and Common Furniture). There is also evidence of past repair using cement – see [Masonry & Mortar](#).

I do suspect that much of the decay is being caused by defective [Rainwater Goods](#).

*Images 9 & 10: Timber Decay Above Kitchen Door*

Ideally a full survey of the timber frame would be undertaken, though at this stage of the sale it is another cost paid out at risk. It is apparent though that *some* joinery repair is required and it maybe better to revise the offer being made to account for the repairs and any perceived risk.

Cementitious mortar surrounding the timbers should be carefully removed and replaced with an appropriate lime mortar.

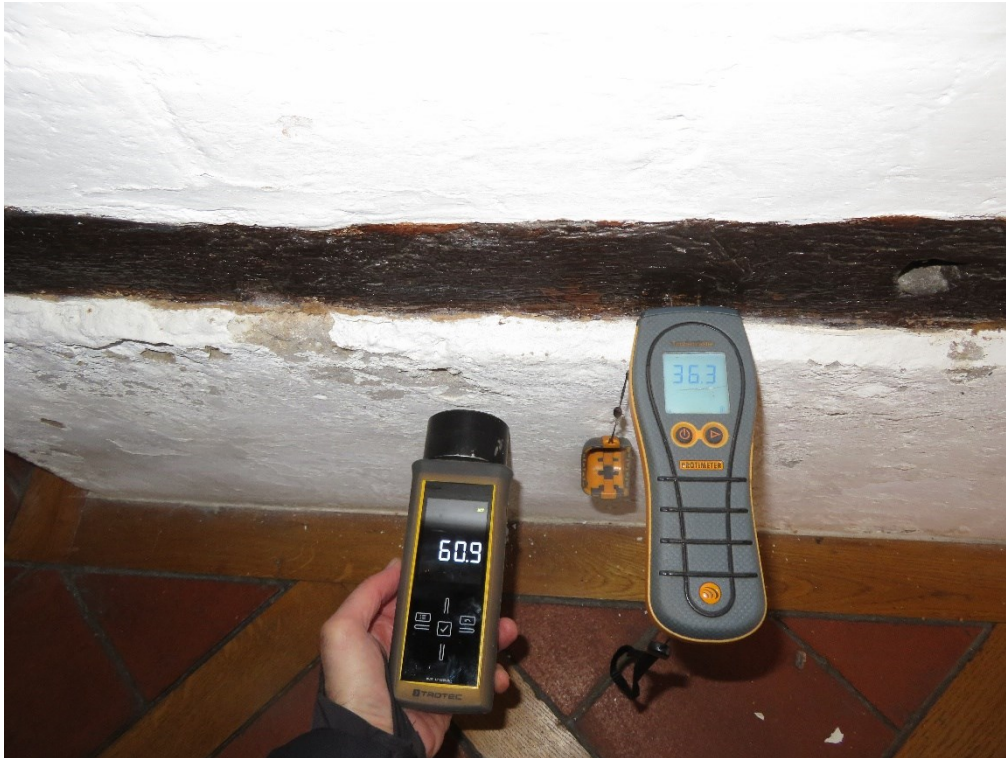
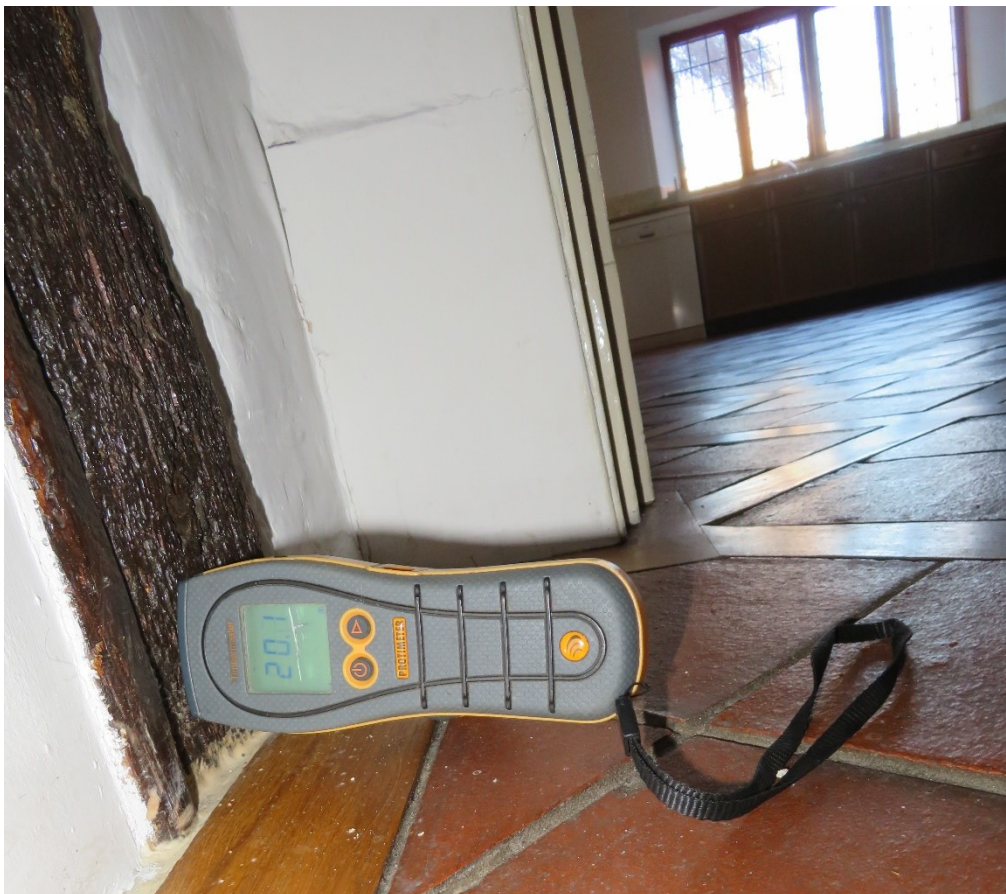
Whilst there is no evidence of defect to the concrete floors themselves, retrospectively installed concrete floors have a very low permeability coefficient and are at odds with the technology employed by traditionally constructed buildings as a response to water. They effectively push groundwater to the side - and as any damp proof membrane installed beneath the floor cannot be chased into solid walls - up the base of the wall.

High moisture meter readings associated with this phenomenon were indeed detected, but perhaps more worryingly and certainly of higher risk, high moisture meter readings were detected to the base of the historic timber posts relating to the original phase of construction - which can precipitate decay.

*Images 11 & 12: High Masonry Meter Reading (60.9 when 40 is Normal) & Timber Moisture Meter Reading (36% when Under 15% is Normal) – in Kitchen*

Unfortunately, the only solution to the issue with the concrete floor is its removal and replacement with a floor system based on an insulative lightweight aggregate (recycled foam glass or LECA balls) – and a limecrete slab – which could also include underfloor heating.

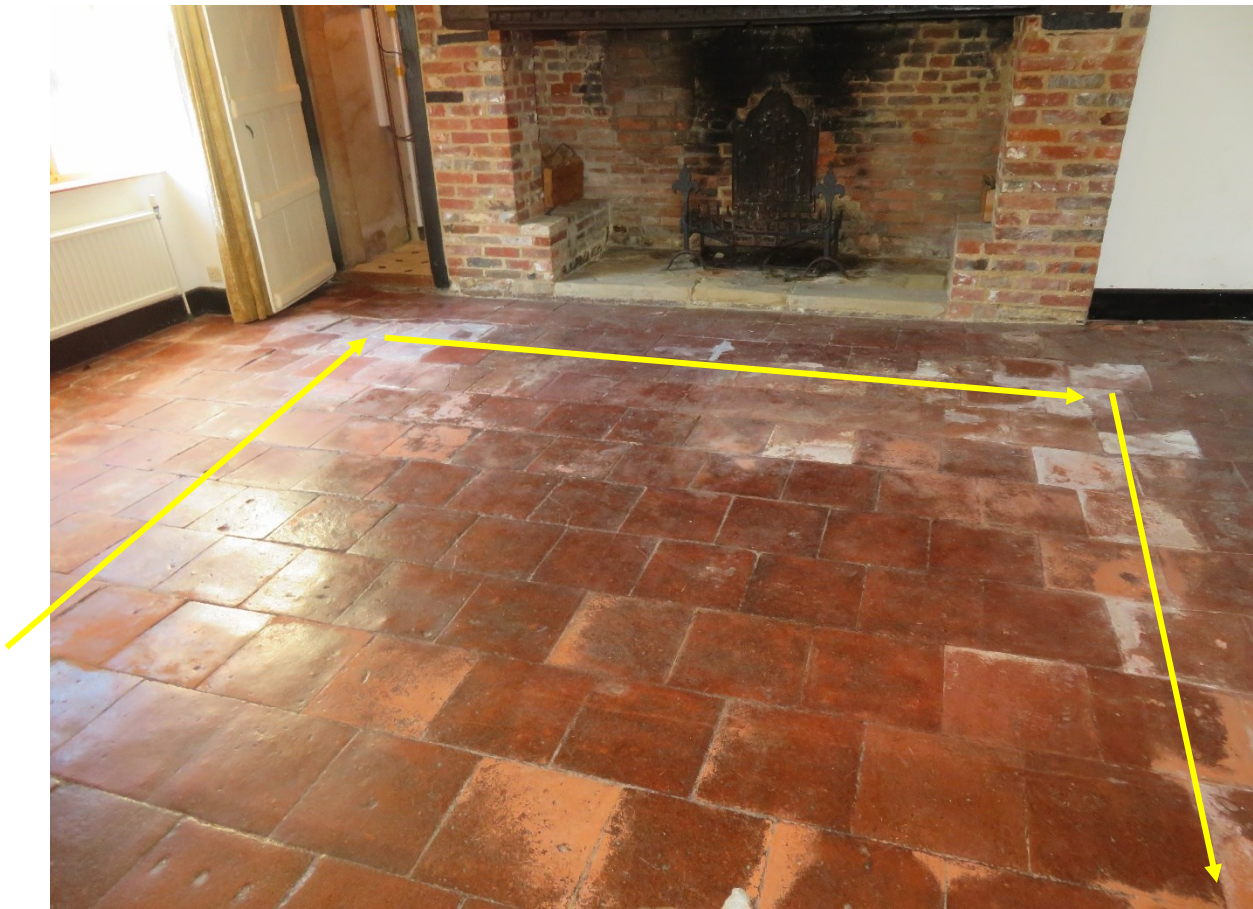
The clay tiles within the reception hall exhibit a very curious pattern of salt efflorescence – which in itself is a clear sign of excessive ground water. The pattern runs around the room approximately 50cm from the perimeter walls in a square and there is definite – although localised - subsidence of the tiles to at the right angles.

*Image 14: Pattern of Salt Efflorescence to within the Reception Hall*

Above the pattern being caused by excessive water, it is difficult to determine what is causing it. It may be for instance that there is a now defunct drainage system, or it possibly represents the foundations of an earlier structure.
