### **Tree Hazard Assessment**

### **Reading Bridge House**

**November 2021**

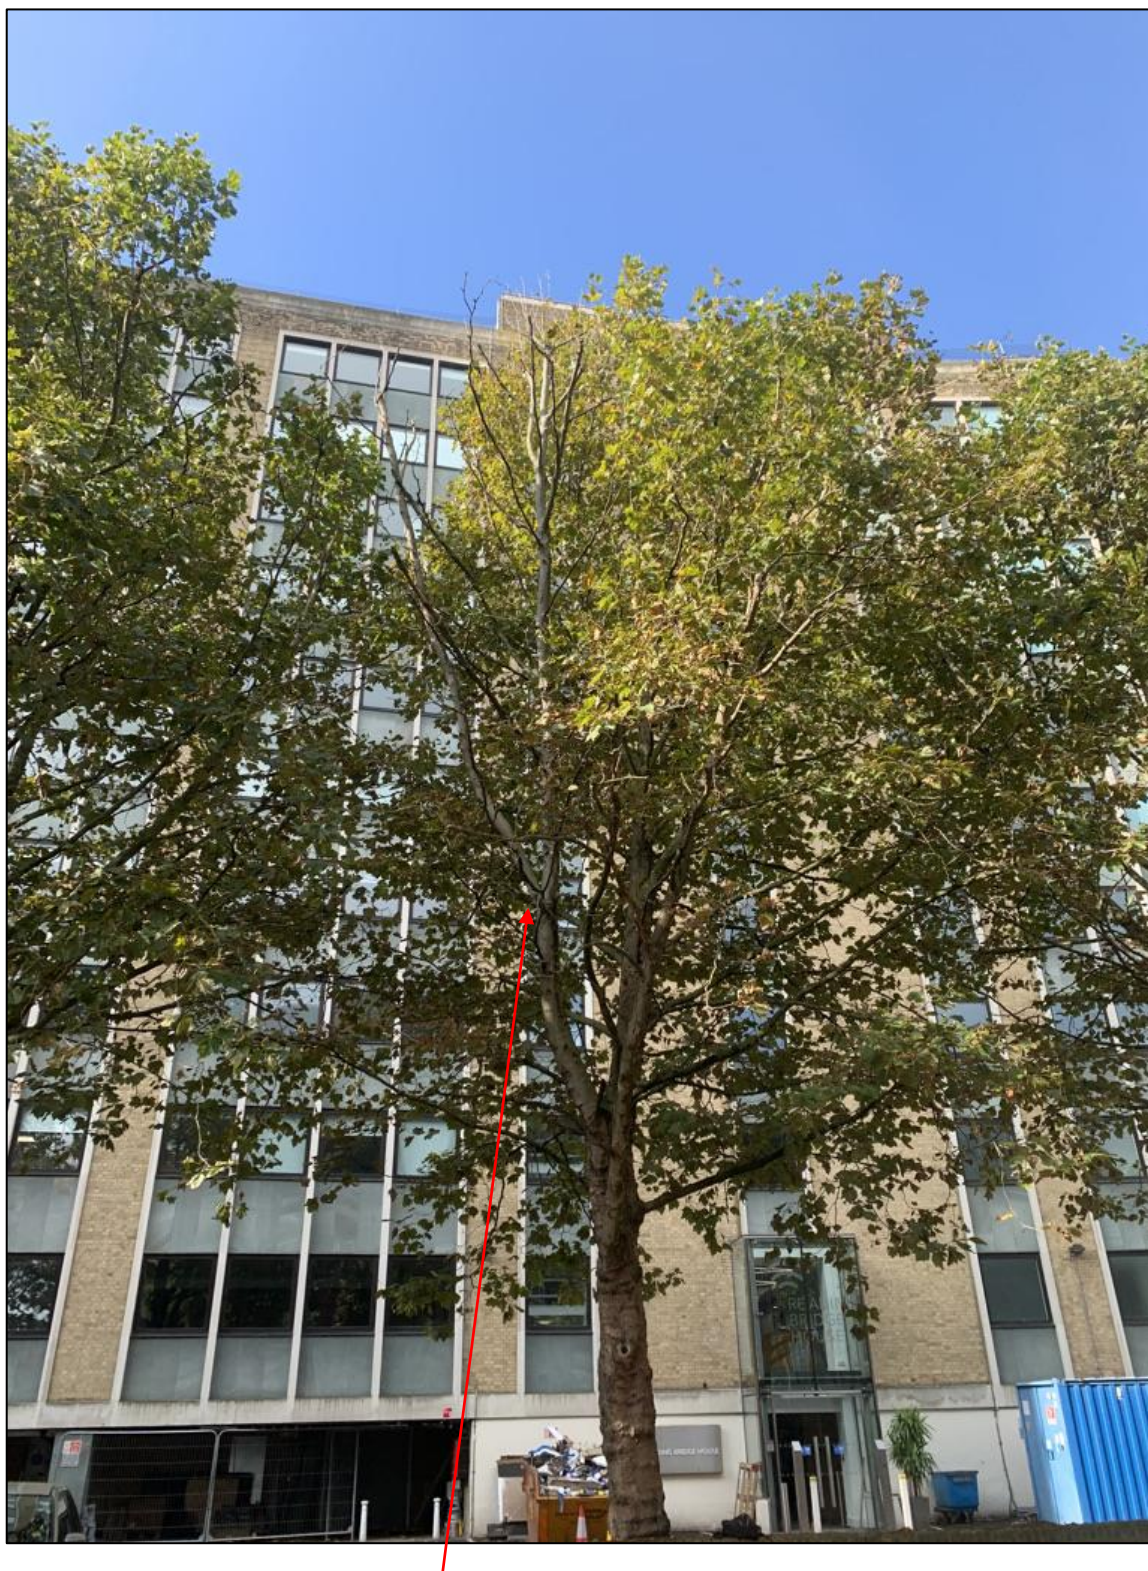
Appendix four - London plane 02570

| Tree Ref No. | Species | Age | Height (m) | Defects | Defect Comments | General Comments | Action | Action Comments | Work Priority |
|---|---|---|---|---|---|---|---|---|---|
| 02570 | London Plane | SM | 10-15 | Dieback | The tree subdivides into two stems at 4m above ground level. The stems are orientated perpendicular to the targets. The fork is U shaped. The eastern stem has died back. | The tree has had a recent overall crown reduction using drop crotch thin methods. The regrowth emanating from the pruning wounds is <25mm in diameter and <2m in length. | Deadwood | Remove major deadwood and declining stem. | M<br>3 months |

Stem with dieback.

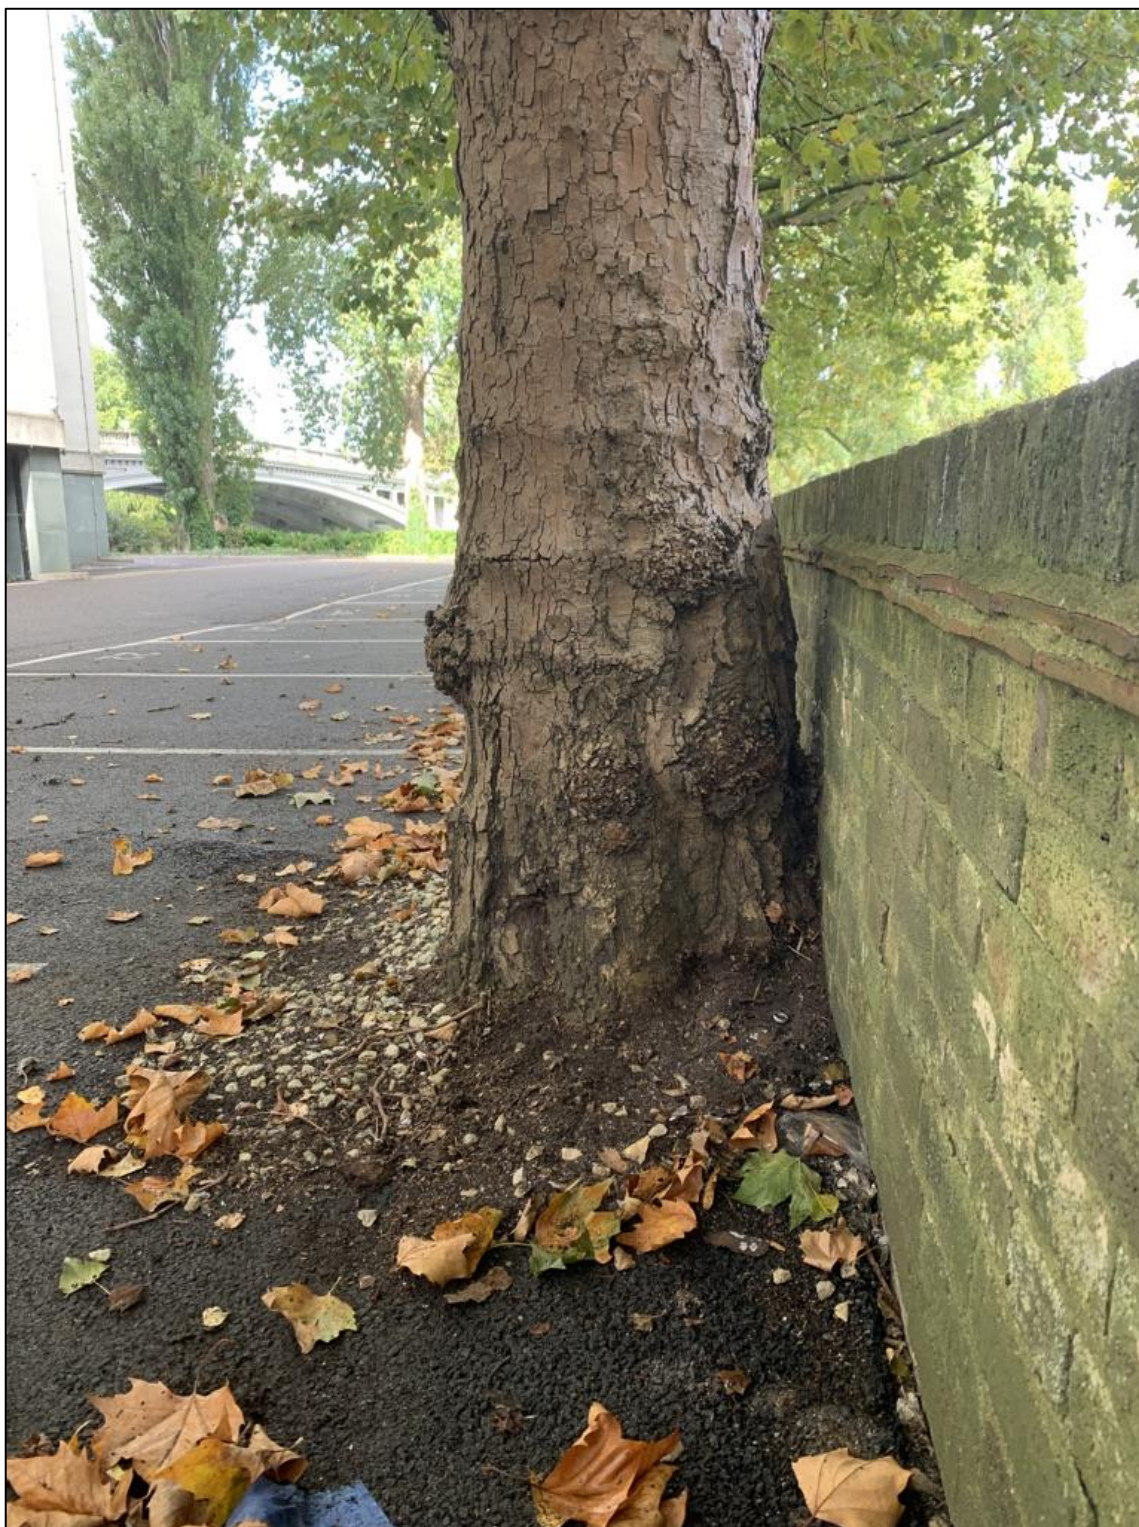
Appendix five – London plane 02571

| Tree Ref No. | Species | Age | Height (m) | Defects | Defect Comments | General Comments | Action | Action Comments | Work Priority |
|---|---|---|---|---|---|---|---|---|---|
| 02571 | London plane | SM | 10-15 | Deadwood | Minor to moderate sized deadwood distributed evenly throughout the crown, typical of the species. | Due to the juxtaposition with the wall, the continual radial expansion of the stem is likely to put pressure on the wall and potentially cause damage. Some stepped cracking was observed. | Deadwood | Remove major deadwood. | M<br>3 months |

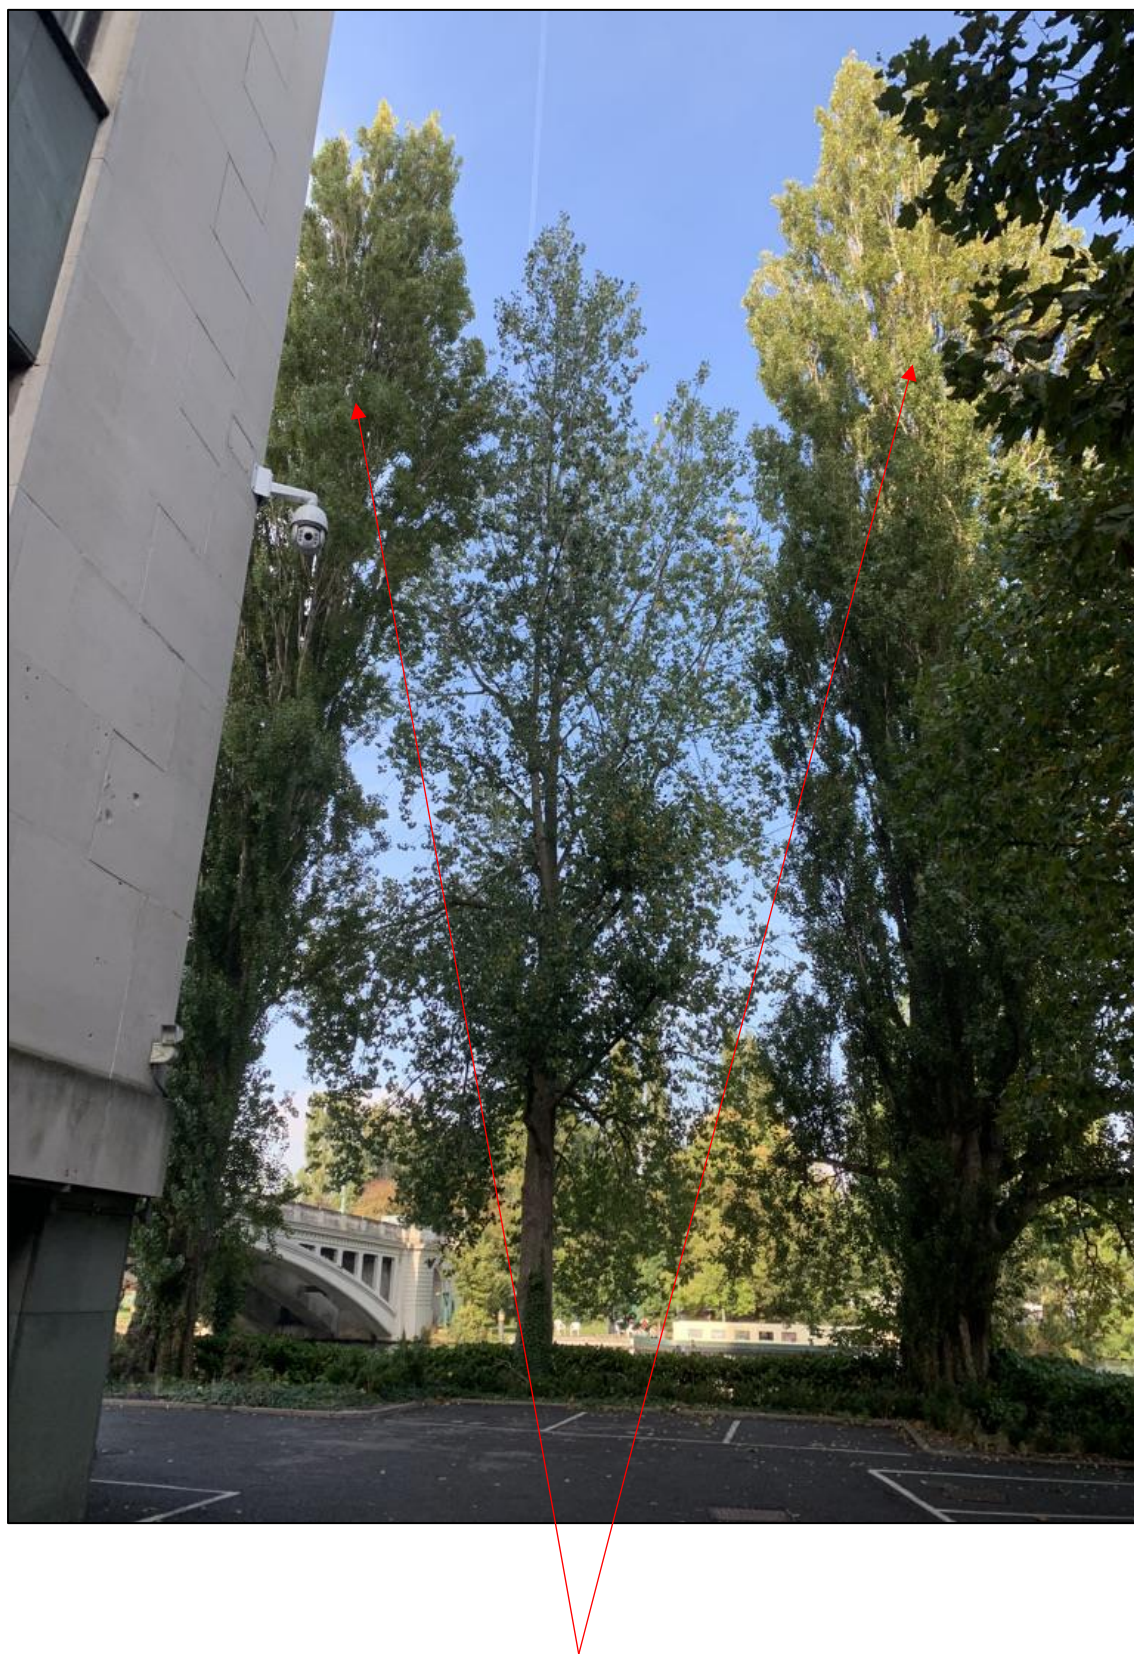
Appendix six – Lombardy poplar 02578 and 02580

| Tree Ref No. | Species | Age | Height (m) | Defects | Defect Comments | General Comments | Action | Action Comments | Work Priority |
|---|---|---|---|---|---|---|---|---|---|
| 02578 | Lombardy poplar | M | 20+ | Other | A detailed inspection of the crown structure is restricted due to dense foliage. The crown cannot be inspected in detail. | Growth habit indicates that crown reduction works have previously been undertaken. | Re-inspection | Undertake a visual inspection of the crown structure during winter 21-22 once leaves have abscised. | O<br>Undertake inspection during winter 2021/22 |

| Tree Ref No. | Species | Age | Height (m) | Defects | Defect Comments | General Comments | Action | Action Comments | Work Priority |
|---|---|---|---|---|---|---|---|---|---|
| 02580 | Lombardy poplar | M | 20+ | Other | A detailed inspection of the crown structure is restricted due to dense foliage. The crown cannot be inspected in detail. | | Re-inspection | Undertake a visual inspection of the crown structure during winter 21-22 once leaves have abscised. | O<br>Undertake inspection in winter 21/22 |

Dense foliage restricting a detailed inspection of the crown and structure. Trees appear to have had a previous reduction. A winter re-inspection is required once leaves have abscised.
