Market Hosier Street, Reading  
[Ecological Light Survey](#)

[Prepared for:](#) Blue Collar Group  
[Date:](#) 14<sup>th</sup> September 2022

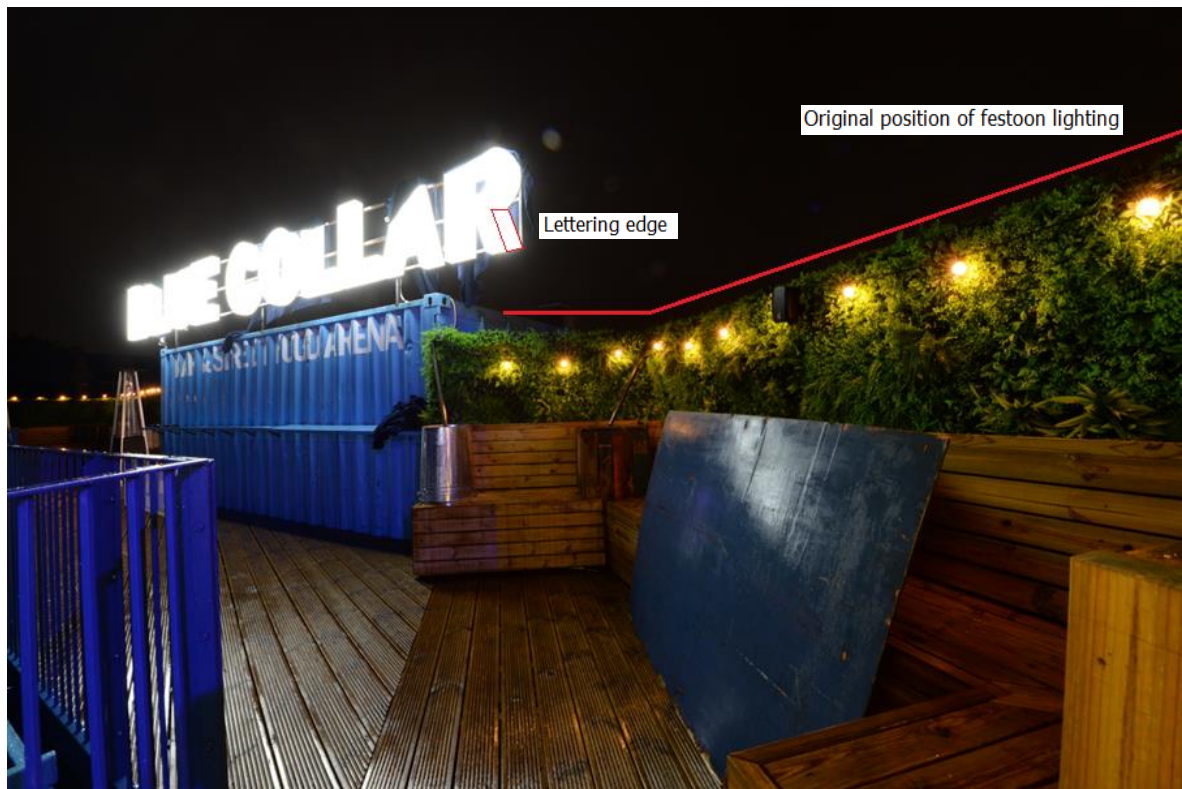
- 6.1 As set out in (Table 5.1), there are exceedances in achieving the 1 lux light spill criterion. It will therefore be necessary to introduce suitable mitigation measures. As discussed in Section 5, the main light sources associated with the Development contributing to the levels of light spill are the edge faces of the illuminated lettering and the section of festoon lighting between the stair core and management cabin. Therefore, mitigation to control light spill will only be required to these sources.
- 6.2 The following mitigation measures will be required to achieve the 1 lux light spill criterion:
- the section of festoon lighting between the stair core and management cabin shall be lowered to fall in front of the green wall and to the Development side; and
  - the side faces of the illuminated lettering shall be masked off using a material having zero light transmittance.

- 6.3 Whilst it was possible to temporarily lower the festoon lighting during the light survey, it was not possible to mask off the sides of the illuminated lettering. However, for the purpose of undertaking the survey, this effect was simulated by draping blankets over the rear of the illuminated lettering.

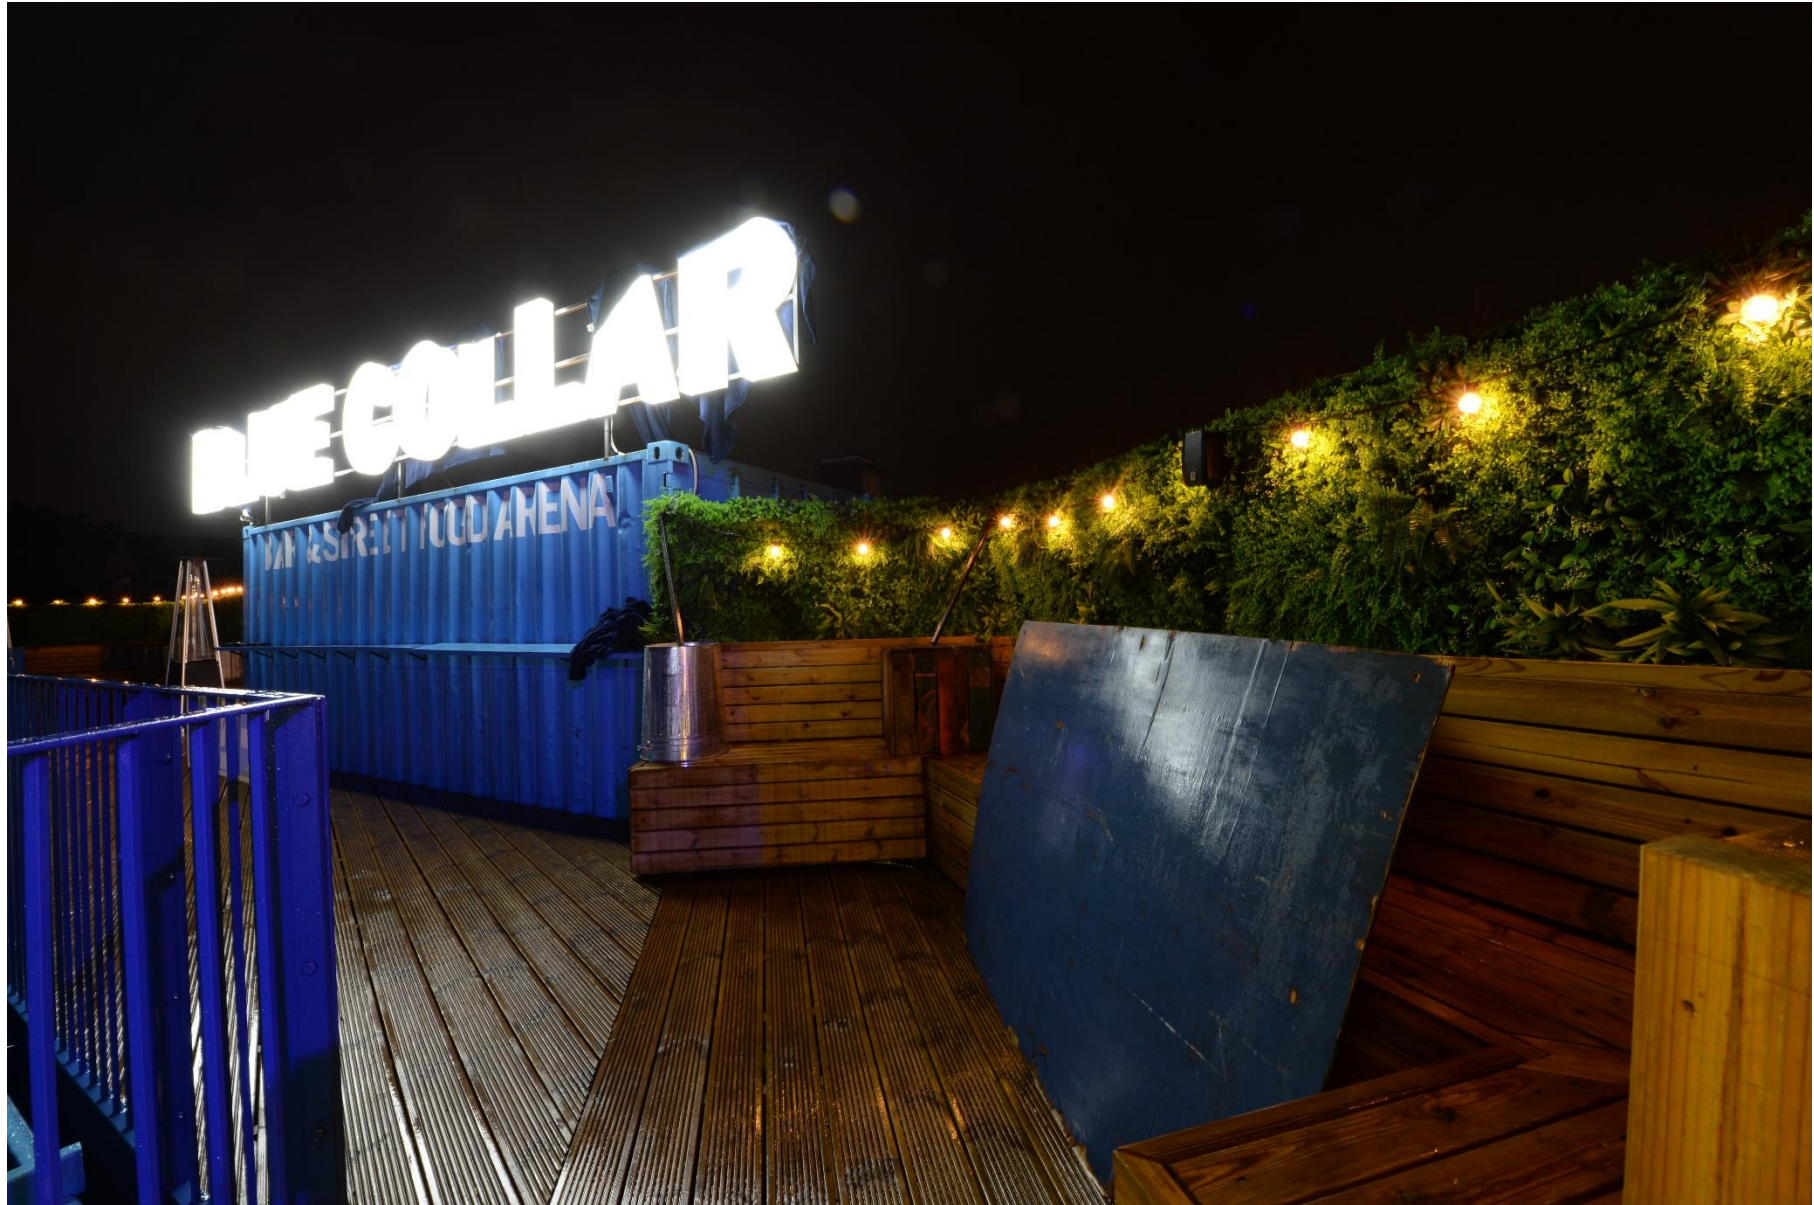
**Appendix A – Site Photographs**

- 2.4 Wide-angle long exposure photography was also undertaken using a full frame DSLR camera. The quality and extents of the photography were unfortunately very limited due to heavy rain for the duration of the light survey. Photographs are appended to this report in Appendix A.
