| BUILDING NUMBER, STREET | | 34 St Mary's Butts / Vacant | |
| PROPERTY DETAILS | | | |
| Date of Survey | 08/04/2021 | | |

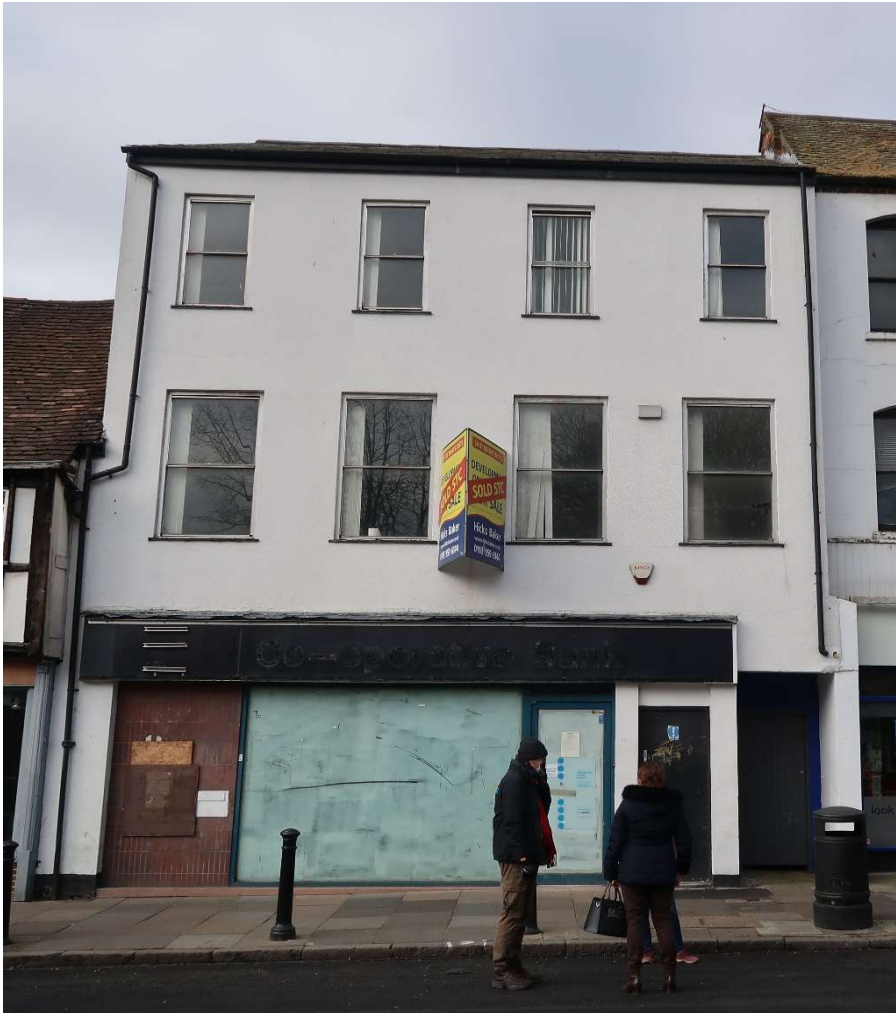
| Overall Condition | Fair | | |
| New sash windows in frist floor / Level across to be maintained / Metal RWP in right side of façade / Flat panel door as entrance to first floor / Window cills need repairing / Gutters to be cleared / Some loose slates in roof / Historically central door / Original under carriage passage / Modern infill to be removed | | | |
