12 Brooklyn Drive  
Emmer Green  
READING  
RG4 8SS

**INSURANCE CLAIM**

**CONCERNING SUBSIDENCE DAMAGE**

**ENGINEERING APPRAISAL REPORT**

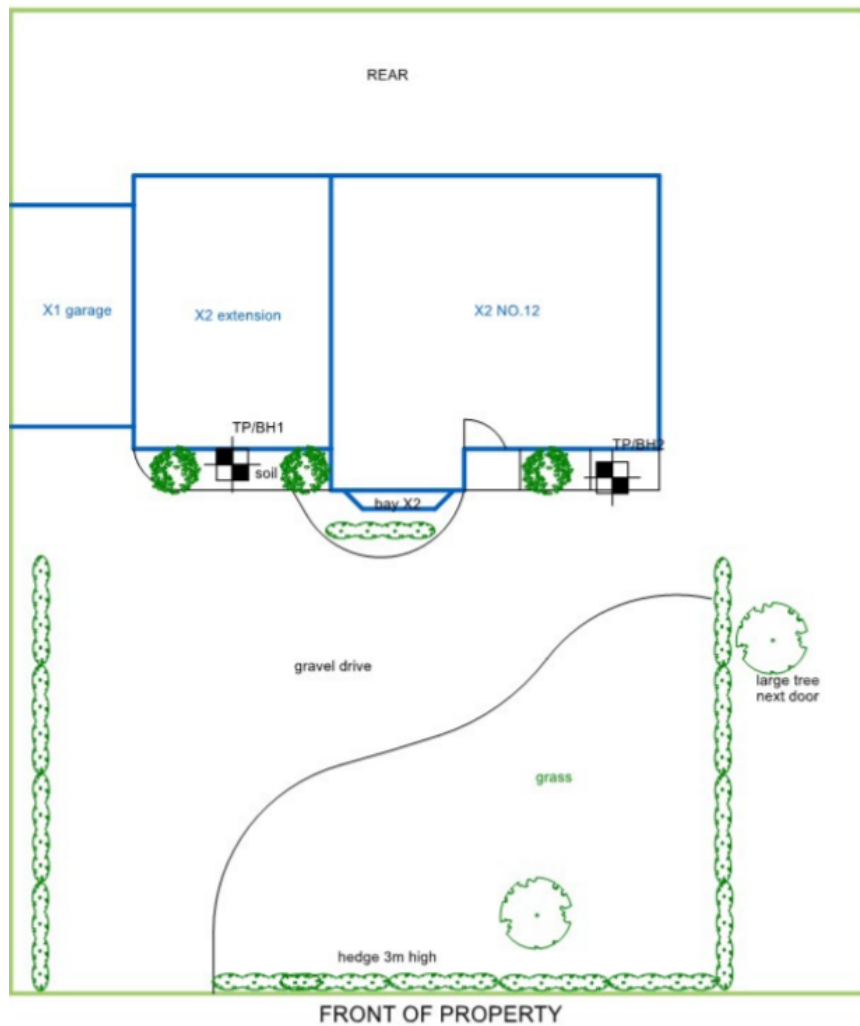
The subject property is a detached house, in a suburban location, on a plot that is level. The overall layout is recorded on our site plan.

The ground investigation was carried out by Auger on 23/11/2020, or details of the trial pit and borehole locations please see plan above.

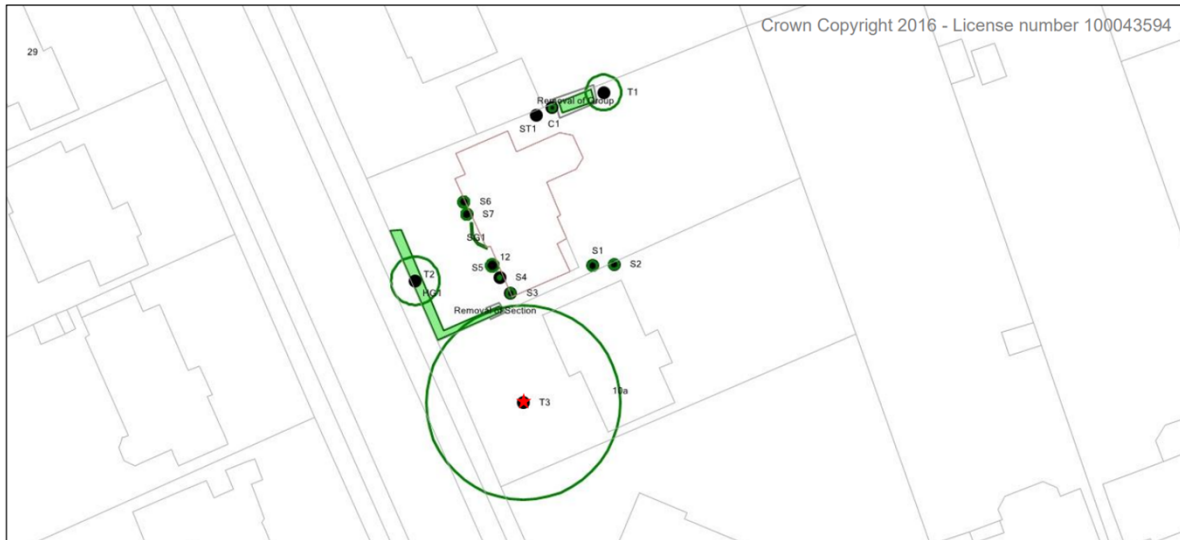
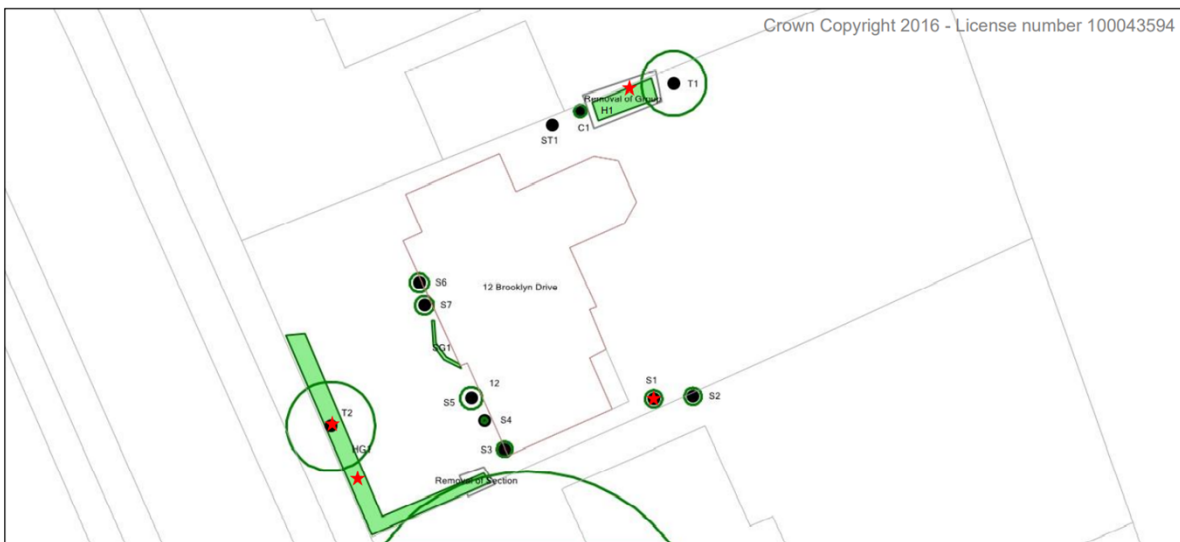
Subsequent Arboriculturalist advice identified a Laurel, Photinia, and Willow tree (all under Mr Hamilton-Bowker's ownership) together with a Pagoda tree (under neighbours' ownership) to be within influential distance and recommendations made towards their removal.

The Pagoda tree was identified as having a Tree Preservation Order in place.

| Tree No: | Species | Works Required |
| H1 | Laurel | Fell and treat stump (deciduous). |
| S1 | Photinia | Fell and treat stump (deciduous). |
| HG1 | Laurel | Remove section of hedge group and grind stumps to allow a minimum clearance of 3m from the front RHS corner of the property. No work to remaining hedge in group. (Total 1.5m in length to remove). |
| T2 | Willow | Fell and treat stump (deciduous). |
| T3 | Pagoda Tree | Fell and treat stump (deciduous). |

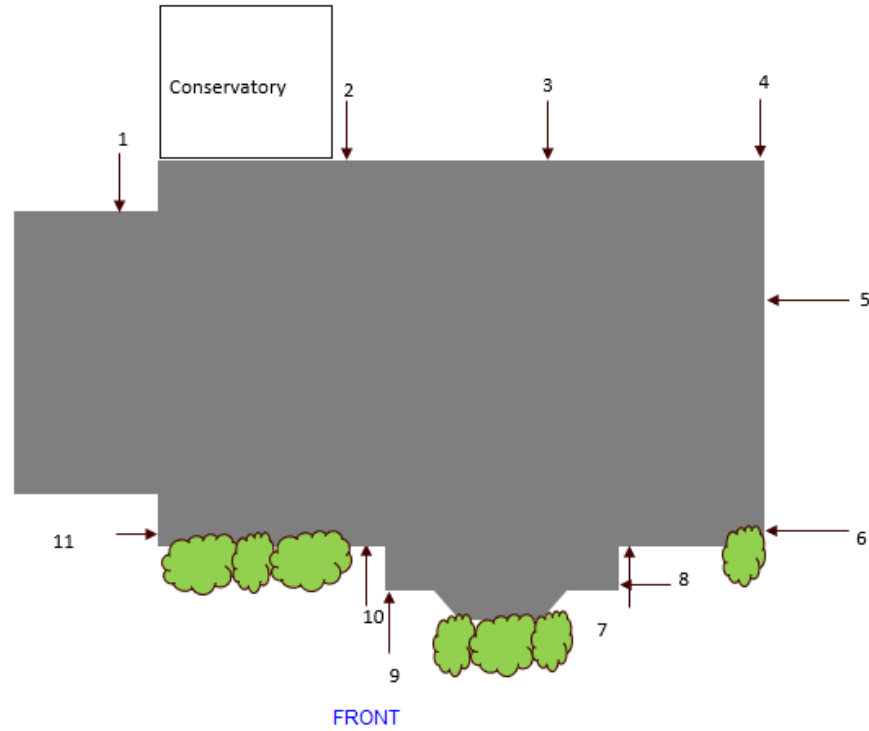
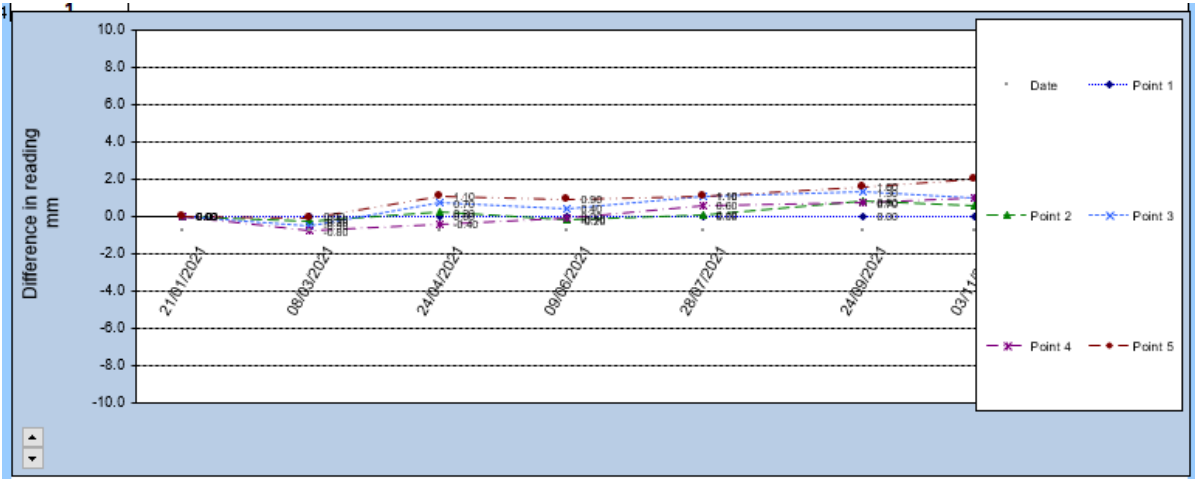
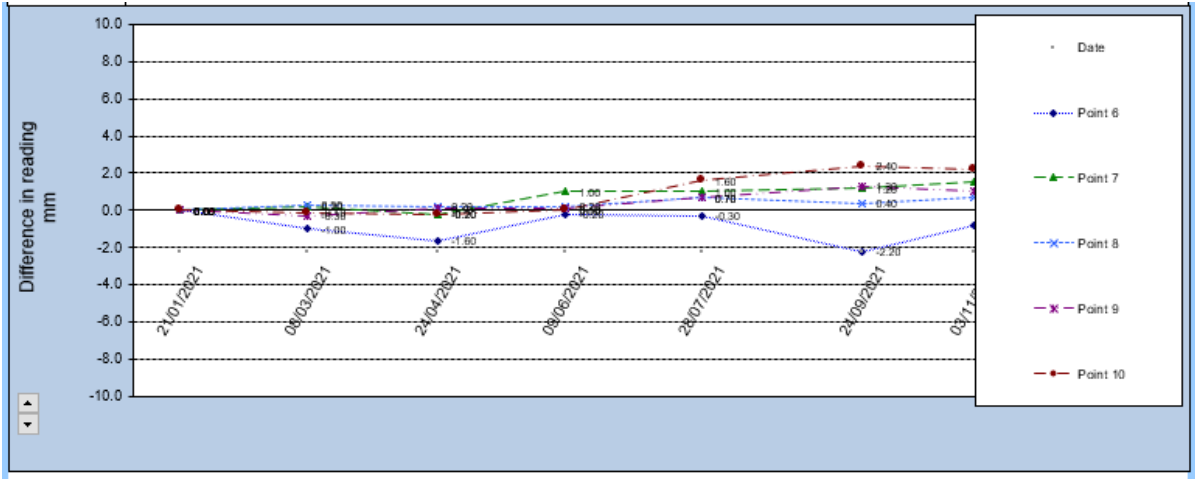
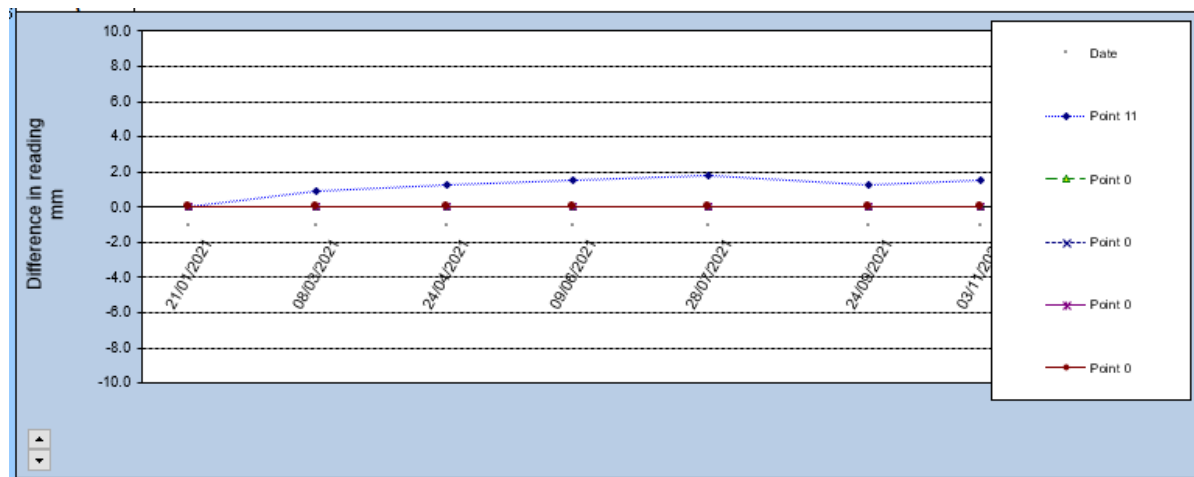
We considered that level monitoring would be required. This is to confirm the operation of root exacerbated clay shrinkage (cyclical movement).

A period of level monitoring between January 2021 and November 2021 has in general seen a slight cyclical movement through the summer months of 2021, with the greatest degree of movement (2mm of downward and recovery movement) observed to the front right corner of the property – monitoring Point No 6 closest to the Pagoda tree.
