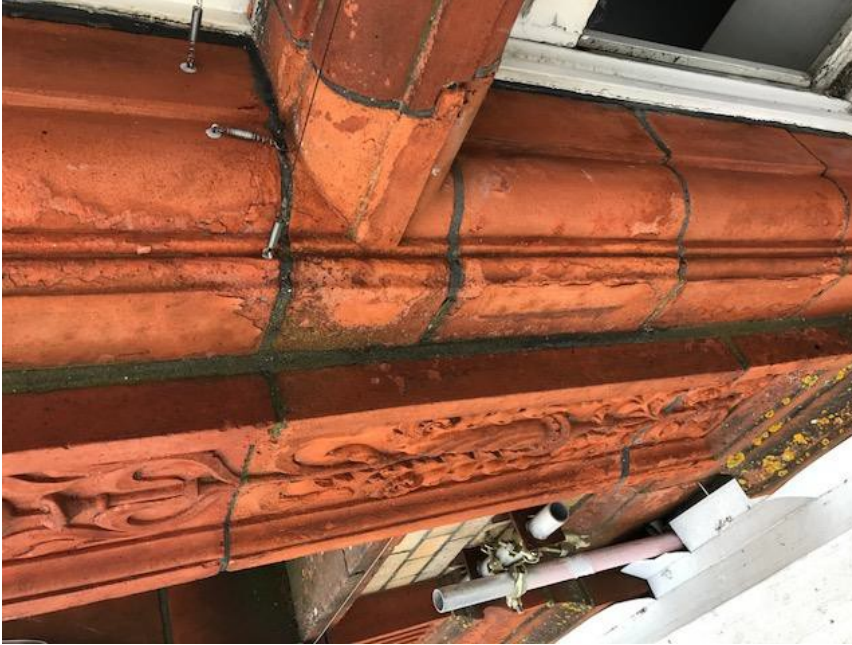
The terracotta generally is heavily weathered but is not in bad condition for its age and exposure to the elements. Overall there are units that need replacing, or lifting and re-bedding and pointing. The brickwork to the rear of the gables is generally in poor condition and needs careful repointing and re-bedding in places. The terracotta has been severely compromised by being previously pointed in neat cement pointing which has damaged and split the adjacent arrisses and caused numerous other areas to fail. This same problem occurs with the majority of the brickwork that forms the supporting substrate to the gables. We would recommend removing all the cement pointing from the terracotta and brickwork and replacing in a lime mortar. If this is not an option for financial reasons, then the minimum we would recommend is to replace the cement with lime where it has currently failed.

Cement pointing causing failure of the terracotta.

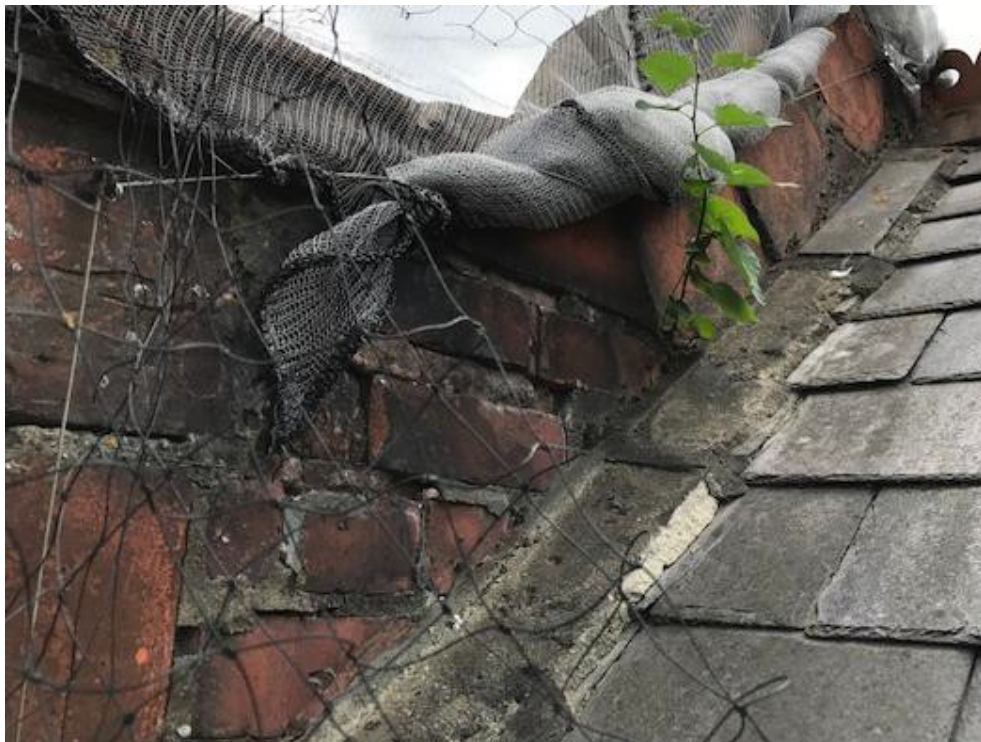
Cement pointing to failed brickwork supporting small gable.

There is presently a large cement fillet (see photograph above) to the joint between the gable brickwork and the slate roof. This is a bad feature that has failed and been poorly patched in numerous areas. There is evidence of damp ingress internally where this joint has failed and it has the potential to compromise (rot) the timber roof structure. We would recommend that this fillet removed and replaced with a properly chased in lead flashing.

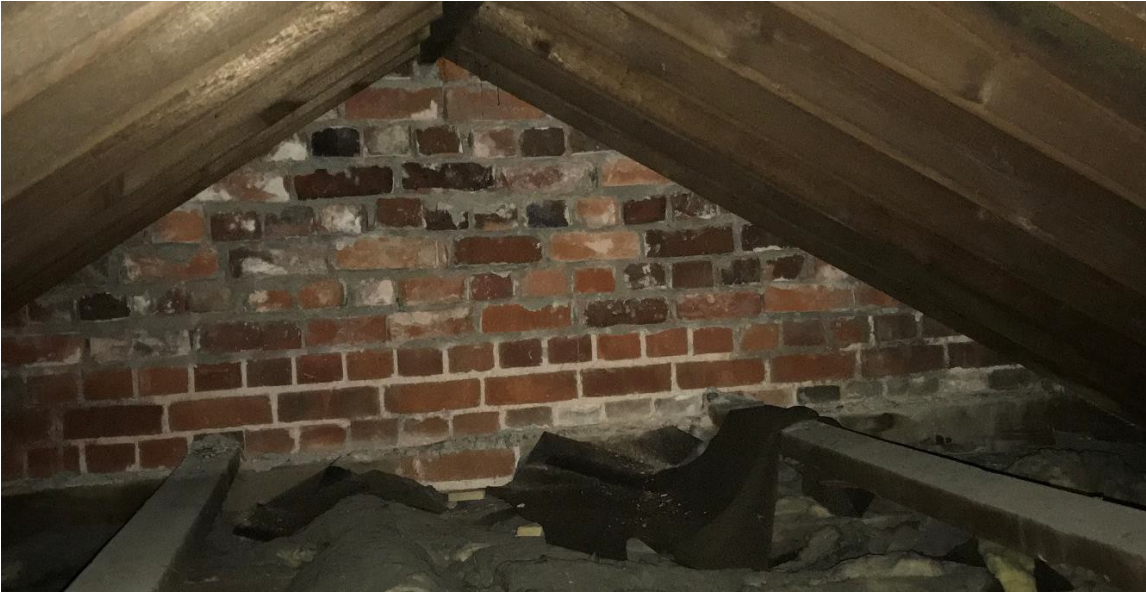
Signs of damp penetration internally to gable brickwork from failed joint above.
