# Drainage Investigation Report

103981.2.ICC

| Visit date | 09/04/2020 |

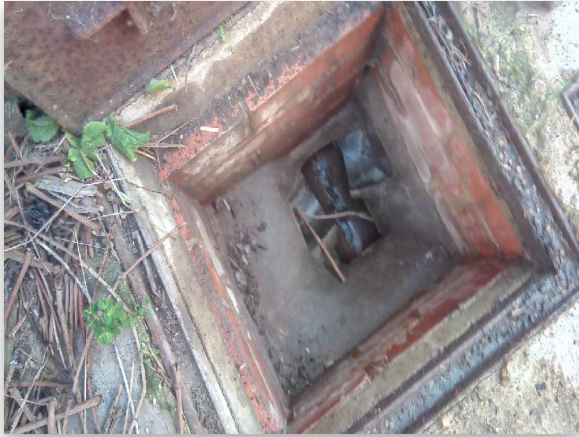
Fig 2.1: LWA SW MH

Our survey of line 1 revealed that there were no defects which could be allowing the escape of water. This was noted to be an LWA shared line.

Our survey of line 2 revealed a collapse at 2.5m d/s of the manhole. This is an LWA shared line and we would advise that they are contacted to resolve this issue.

Our investigations revealed that there is an issue in the local water authority (LWA) section of pipework. We would recommend that the customer contact their LWA in order to further investigate and resolve the issue.

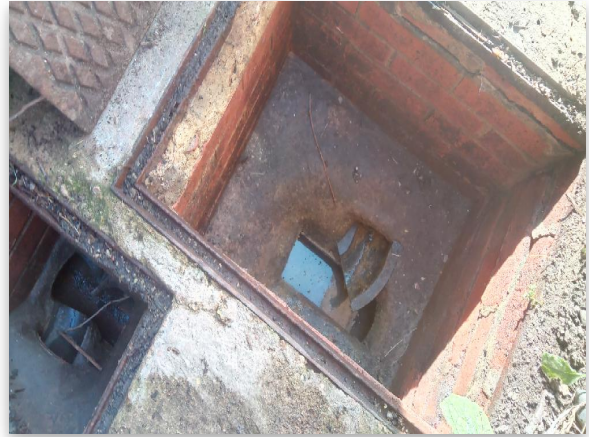
Fig 2.2: LWA FW MH

Our survey of line 3 revealed that there were no defects which could be allowing the escape of water. This was noted to be an LWA shared line.

Our survey of line 4 revealed that the LWA mainline was blocked and backing up. We would advise that the customer contacts the LWA to rectify the issues to this line.

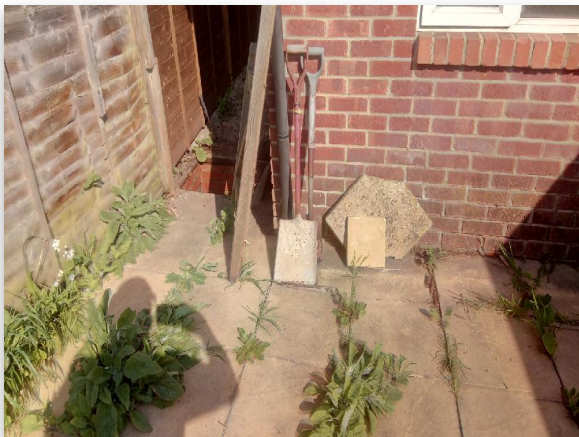
Fig 2.3: RWP2

Our survey of line 6 revealed that there were no defects which could be allowing the escape of water. This line was seen to be free flowing and serviceable.
