## **Inspection and Rectification Report For The Ventilation Services Installed**

**Pepes Piri Piri  
109b Oxford Street Reading  
RG1 7UD**

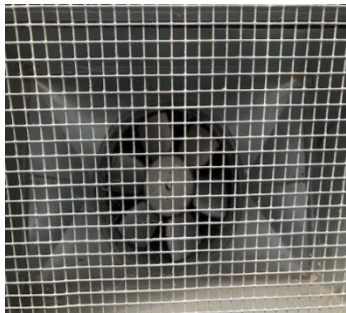
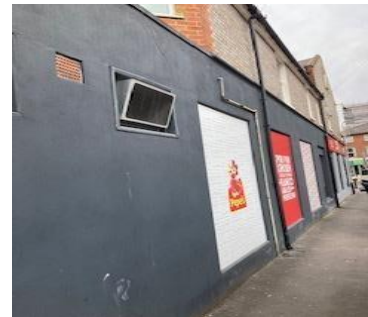
Noise becomes an issue when the fresh air system is run because:

- a. A plate fan has been used which connections directly behind the intake louvre with no attention used – Fan to be changed and attenuation to be installed see below
- b. Fresh air intake located over walk way on side road – no attenuation at present.

- We proposed to take out the plate as installed and supply and install a new inline fan with suction and discharge attenuation to achieve a noise decibel rating of 35dBa @ 3metres – see sketch below:
