**23 Woodcote Road  
Caversham  
Reading  
Berkshire  
RG4 7BA**

# **Preliminary Bat Roost Assessment**

**Ref: R3034/a**

**February 2022**

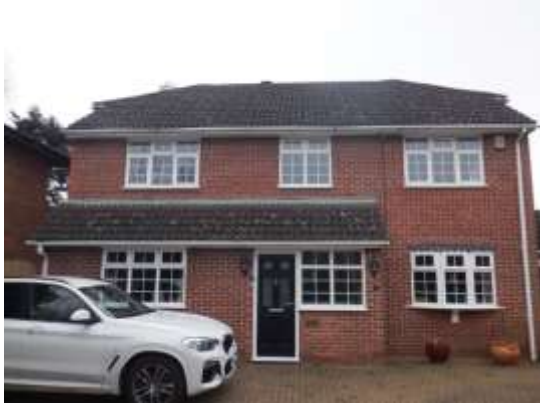
- 4.2.1** The detached house was of modern brick cavity wall construction with a half-hipped roof (**Photographs 1 & 2**). The roof was covered with tight interlocking tiles on all elevations with a fully mortared ridge, hips and vent brick (**Photographs 3 & 4; Target notes 1, 2 & 3**). Whilst the lead flashing around the fluepipe on the north facing section of the roof was tight with no visible gaps, the flashing was lifted on the front porch, however, the crevices were large and the brick wall could be seen behind (**Photographs 5, 6 & 7; Target note 4**). The UPVC soffit was tight to the brick wall around the entire property with no gaps observed (**Photograph 8; Target note 5**).

**1. Front of the house viewed from the northeast.**

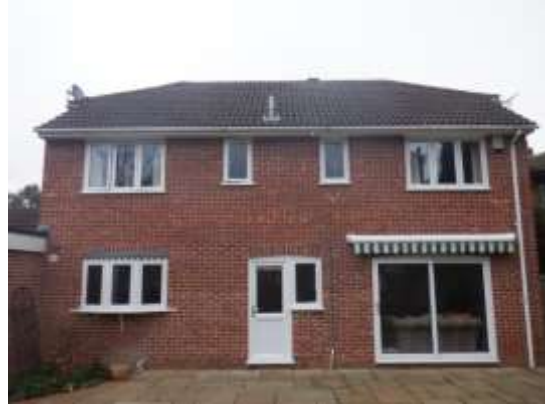
**2. Rear of the house viewed from the southwest.**

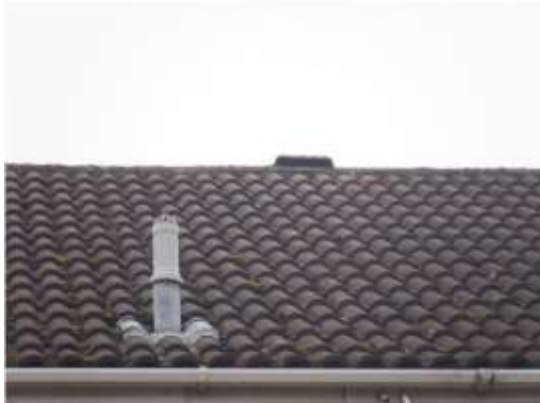
**3. Tight interlocking tiles with a fully mortared ridge and vent brick, viewed from the southwest.**

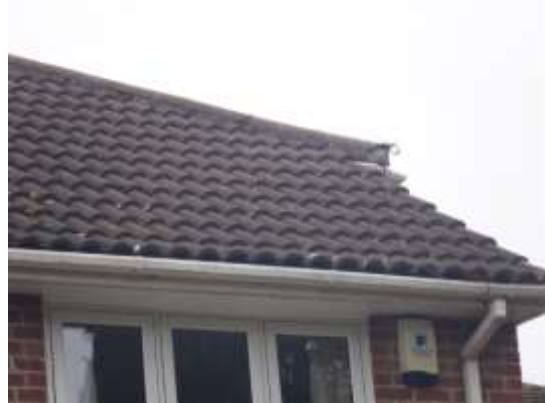
**4. Fully mortared hips viewed from the southwest.**

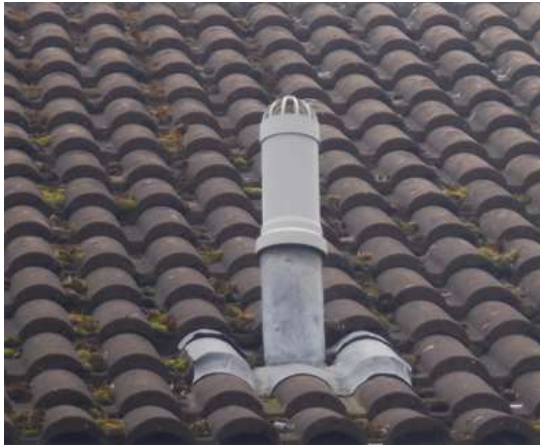
**5. Lead flashing around the flue pipe tight to roof tiles, viewed from the southwest.**

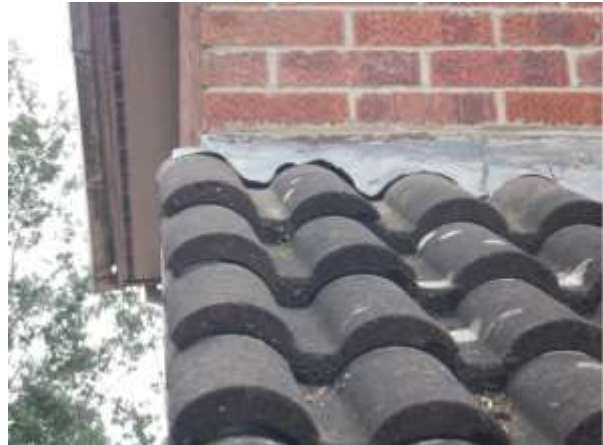
**6. Lifted lead flashing with brick wall visible behind, viewed from the northeast.**

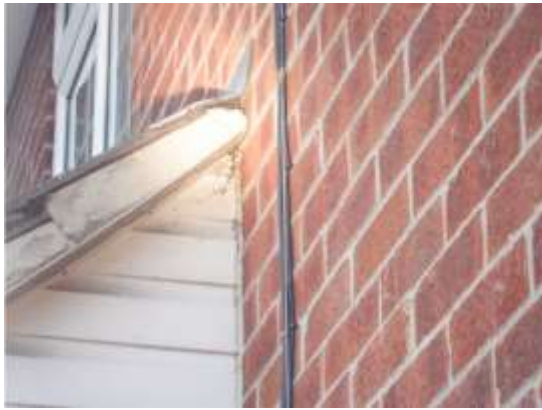
**7. Lifted lead flashing with brick wall visible behind, viewed from the northwest.**

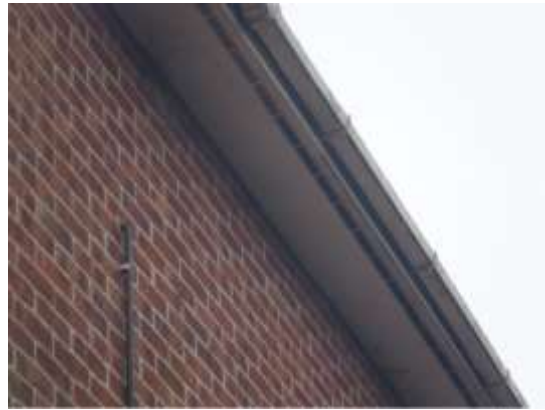
**8. UPVC soffit tight to the brick wall, viewed from the north.**

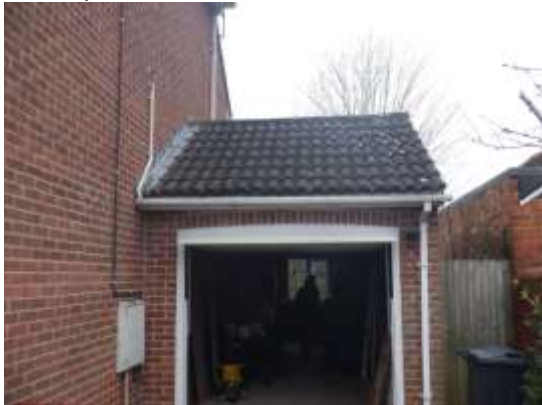
- 4.2.2** No evidence of roosting bats was observed at the time of the external inspection of the house.
- 4.2.3** The garage was partly attached to the eastern wall of the house with the northern section being a flat roof and the southern section having a pitched, tiled roof (**Photographs 9 & 10**). The northern flat roofed section was tight to the soffit with no visible gaps; the southern section was covered with tight interlocking tiles and had a fully mortared ridge (**Photographs 11 & 12; Target notes 6, 7 & 8**). The tiles had capped end and occasionally these had moved leaving the tile end open, they were closely inspected and unsuitable for bats (**Photograph 13; Target note 9**). The lead flashing between the garage and the main house was fitted closely to the wall with no gaps observed (**Photograph 14; Target note 10**). The UPVC soffit was generally tight to the brick wall of the garage; however, the soffit on the flat roof section did not fully connect to the main property (**Photograph 15; Target note 11**).

**9. Front of the garage, viewed from the northeast.**

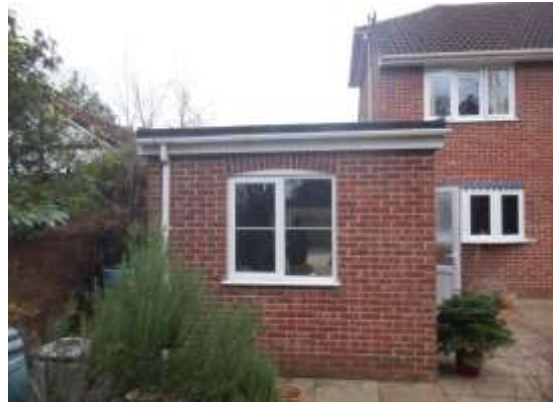
**10. Rear of the garage, viewed from the southwest.**

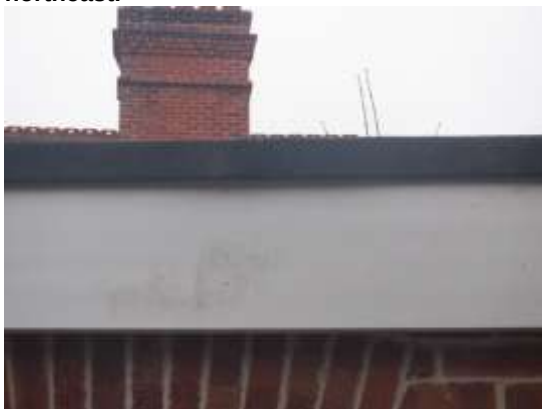
**11. Felt tight to the UPVC soffit, viewed from the southwest.**

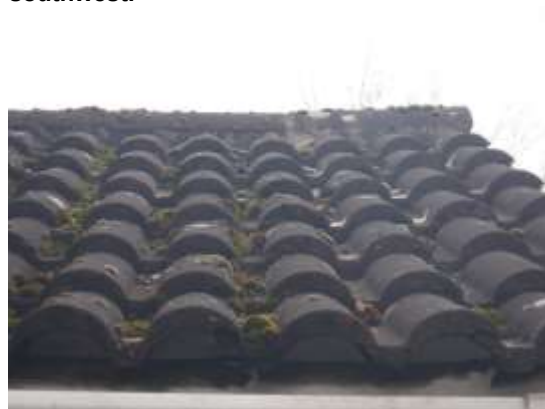
**12. Tight interlocking tiles with a fully mortared ridge, viewed from the northeast.**

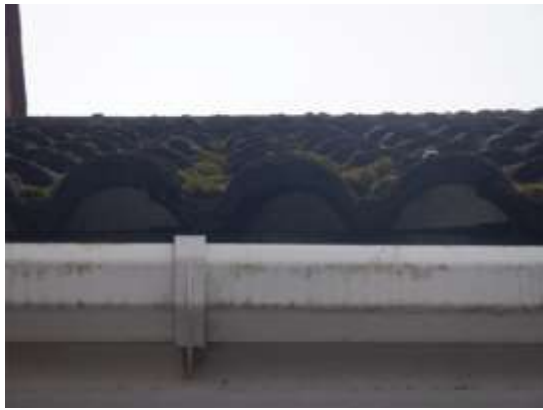
**13. Open caps on interlocking tiles, viewed from the northeast.**

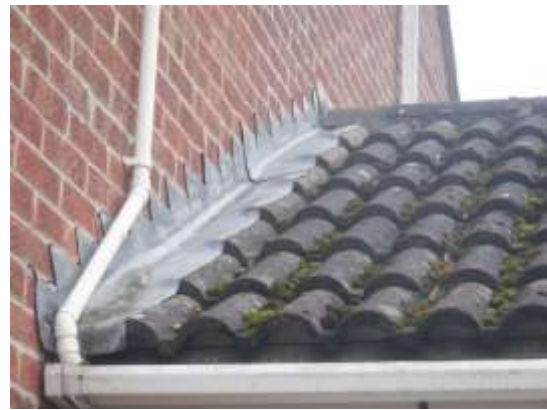
**14. Lead flashing tight between garage and main house, viewed from the northeast.**

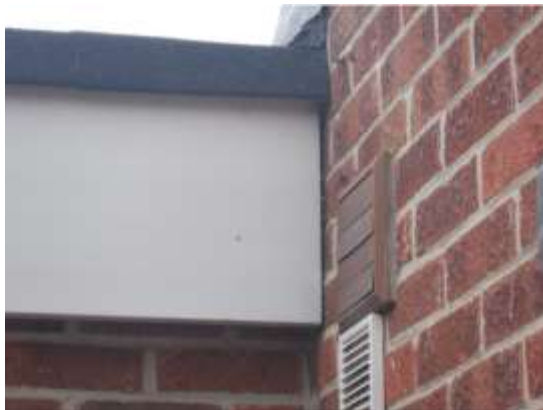
**15. UPVC Soffit not fully attached to brick wall of the main property, viewed from the southeast.**

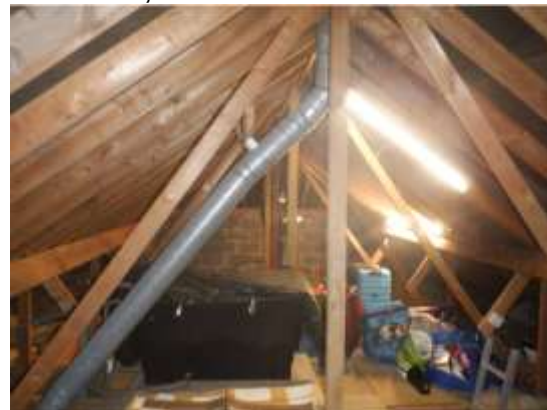
- 4.3.1** The roof void was accessible via a loft hatch with an approximate ridge height of 2.5 metres and was of 'cut and pitch' roof construction (**Photograph 16; Target note 12**). The roof was cobwebbed throughout and lined with generally tightly fitted bitumen felt although there were small sections of roof tiles exposed where the felt overlapped and through occasional tears (**Photograph 17; Target note 13**). The ridge was cobwebbed throughout the void (**Photograph 18; Target note 14**). The blockwork of the half-hipped gable ends was filled with foam cavity wall insulation; however, they did not reach the ridge with a large opening at the top where the soffit was visible behind (**Photograph 19; Target note 15 & 16**). A large gap in the felt with surrounding wire was also visible where a pipe passed through the felt (**Photograph 20; Target note 17**). The floor was boarded with fibreglass insulation beneath, filling some of the eaves whilst others were left open, and daylight could be seen (**Photograph 21; Target notes 18 & 19**).

**16. Cut and pitch roof construction.**

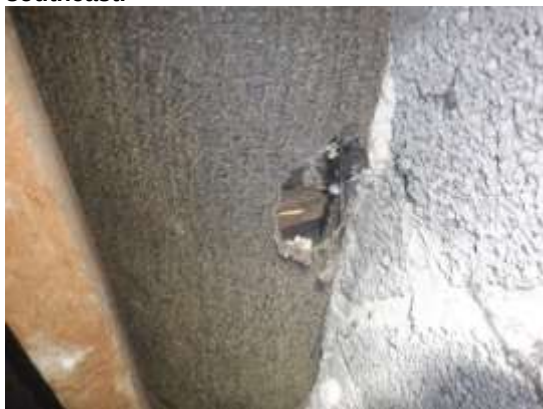
**17. Small tear in bitumen felt.**

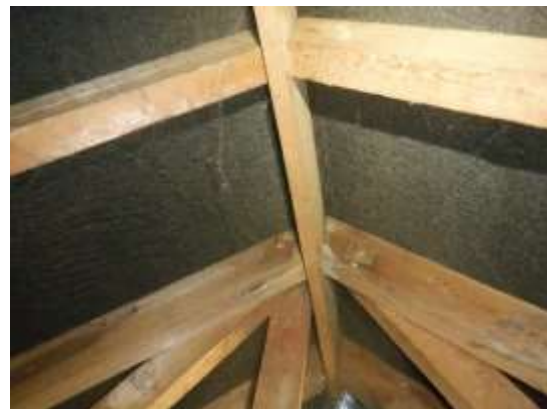
**18. Cobwebbed ridge throughout void.**

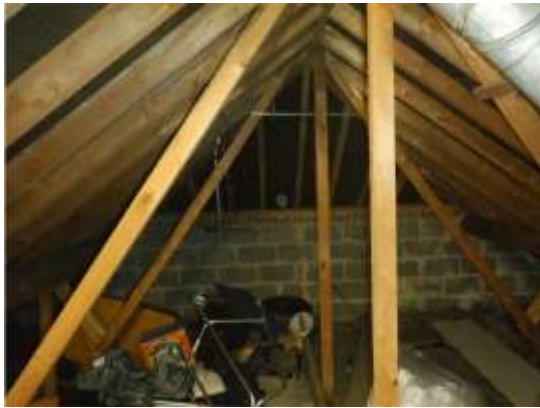
**19. Stone block half-hipped gable end with soffit visible behind.**

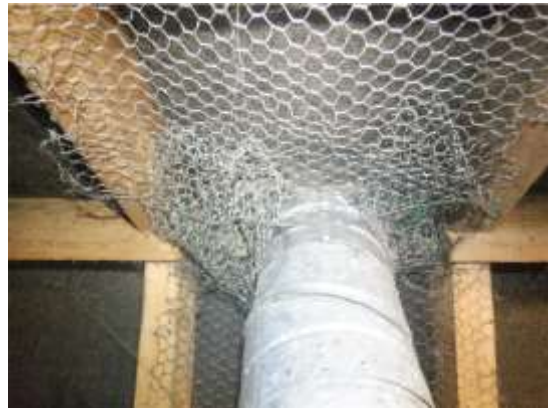
**20. Large gap in bitumen felt with surrounding wire where pipe passes through**

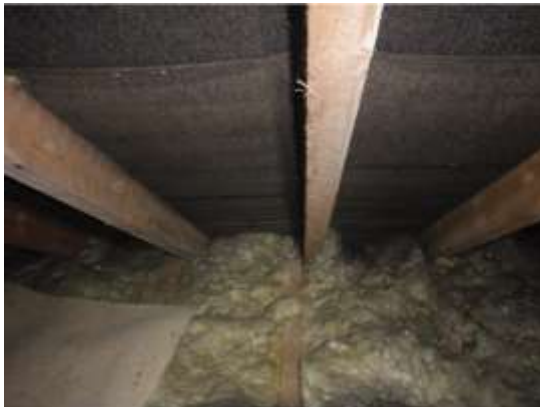
**21. Some eaves left open whilst others filled with fibreglass insulation.**

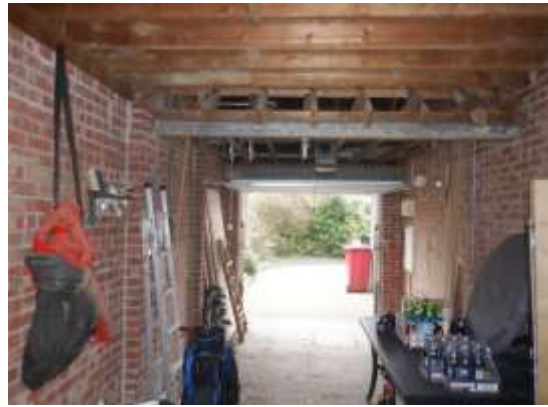
- 4.3.2** No signs of roosting bats were observed during the internal inspection of the house.
- 4.3.3** The garage had an open roof and was used for storage, accessible via a large, up and over door to the front, and a smaller rear door to the garden (**Photograph 22; Target note 20**). The roof was lined with a mixture of tightly sealed bitumen felt on the northern tiled section and wooden boarding on the southern flat roof section (**Photograph 23; Target note 21 & 22**). The garage was cobwebbed throughout, and timbers were tight to the wall with occasionally mouse droppings present throughout (**Photograph 24; Target note 23 & 24**). Daylight was however observed through the timbers where the external soffit did not fully connect to the main property (**Photograph 25**).

**22. Garage with open roof space being used for storage.**

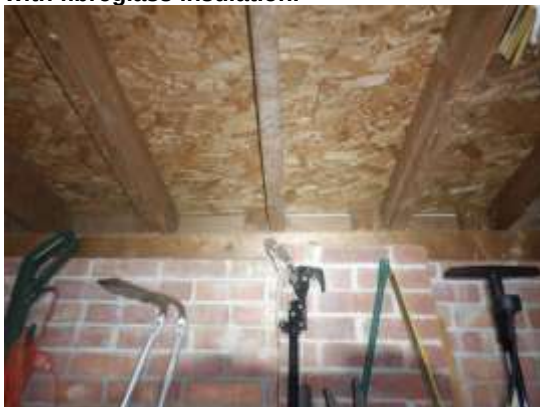
**23. Wooden boarding on flat roofed section of the garage.**

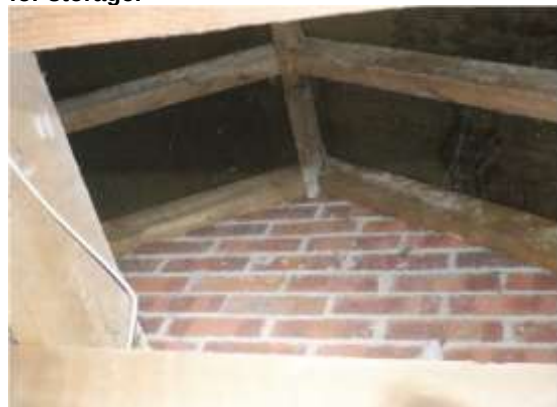
**24. Timbers tight to the brick wall.**

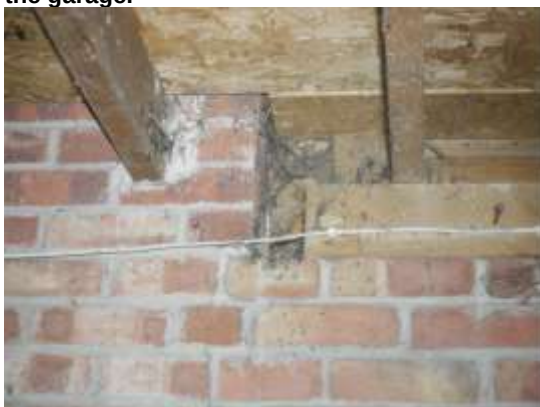
**25. Daylight between soffit and wall of garage and house.**
