**20 Rosehill Park  
Emmer Green  
Reading  
Berkshire  
RG4 8XD**

# **Preliminary Bat Roost Assessment**

**Ref: R3040a**

**February 2022**

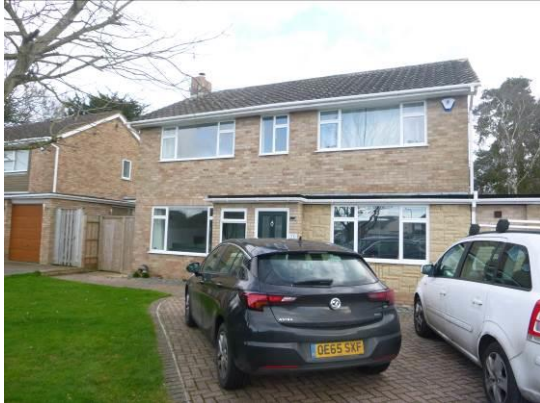
1. Front of the house viewed from the west.

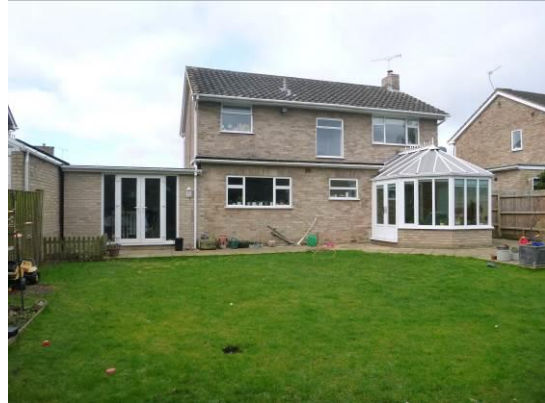
2. Rear of the house viewed from the east.

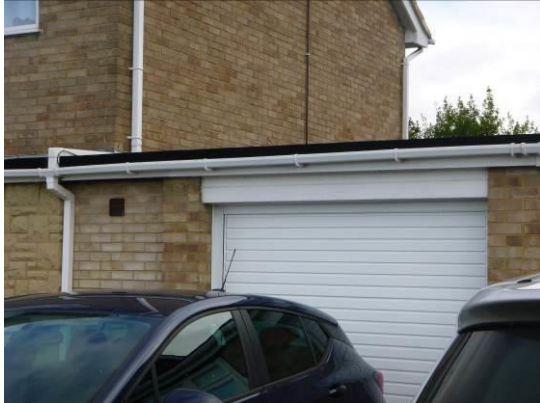
- 4.2.1** The detached house was of modern brick wall construction, with a pitched roof (**Photographs 1 & 2**). There was a flat roof garage, which connected to the neighbouring property to the south, a flat roofed porch and rear extension and a conservatory to the rear (**Photograph 3**).

3. Flat roof extension to the front of the house.

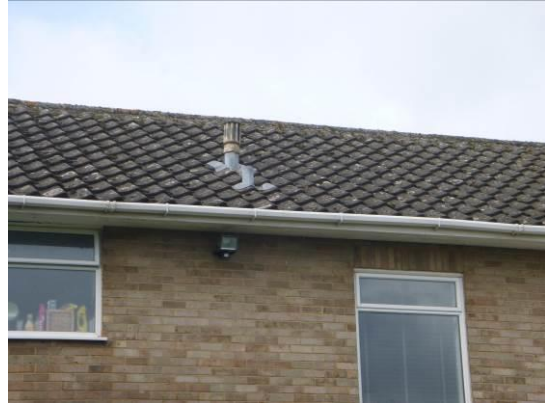
4. Interlocking roof tiles in place and tight on the roof.

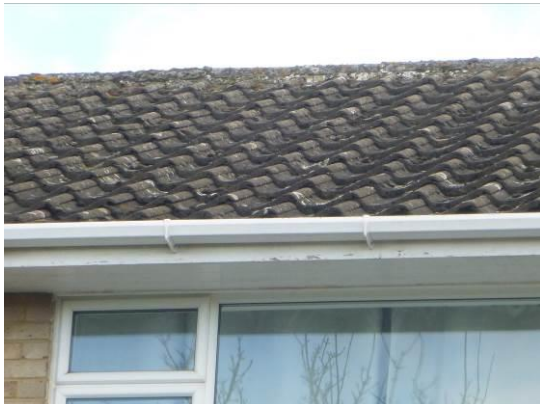
5. Ridge tiles in place and mortared.

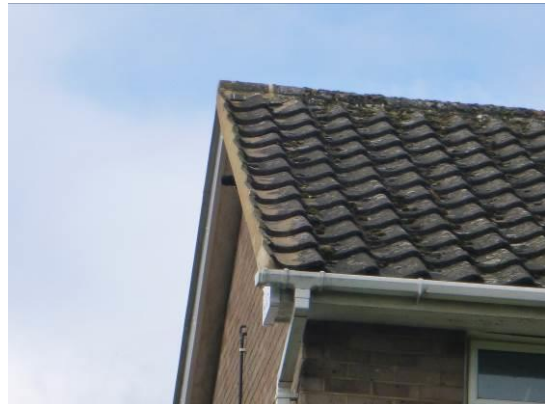
6. Newly mortared ridge tiles and verge tiles at the southern end of the roof.

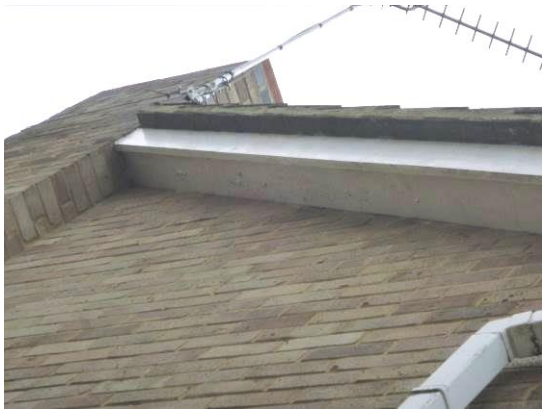
**7. Verge fully mortared at the northern end of the house.**

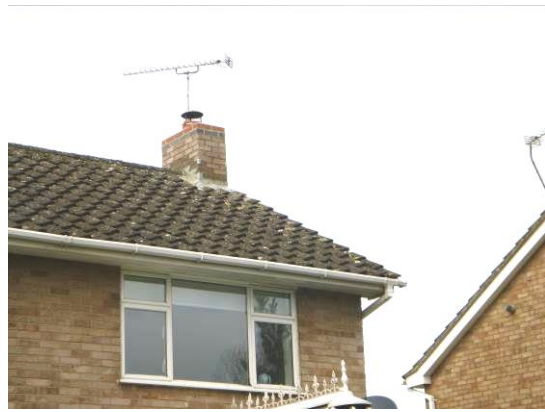
**8. Lead flashing and new mortar tight around the chimney.**

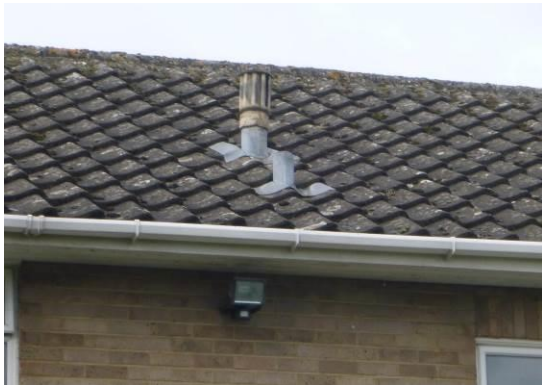
**9. Lead flashing tight around the base of the flue pipe.**

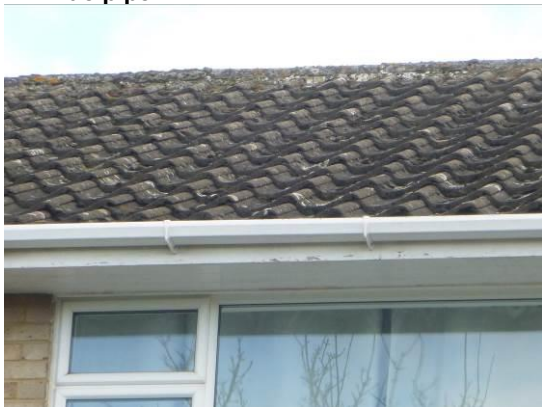
**11. Soffits mostly tight around the eaves.**

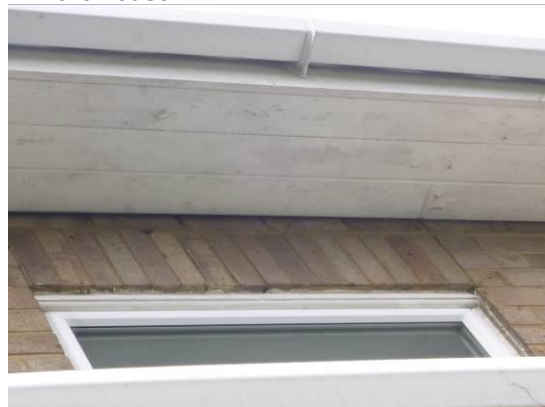
- 4.2.2** The main roof of the house was covered in interlocking concrete roof tiles, which were tightly fitted (**Photograph 4; Target note 1**). The ridge tiles were all in place and fully mortared (**Photograph 5; Target note 2**). The verges at both gable end and end ridge tile at the southern end had been recently repaired (**Photographs 6 & 7; Target note 3**). There was a newly mortared chimney at the northern end of the house and a flue pipe, which both had tightly fitted lead flashing around the bases (**Photographs 8 & 9; Target notes 4 & 5**). The soffit boxes were mostly flush to the walls along the eaves of the house, apart from a narrow gap above a window to the rear and to the front of the house (**Photographs 10 & 11; Target notes 6 & 7**). A gap was also present at the edge of the soffit box where it joined the edge of the chimney (**Photograph 12; Target note 8**).

**12. Gap behind the soffit box to the front of the house.**

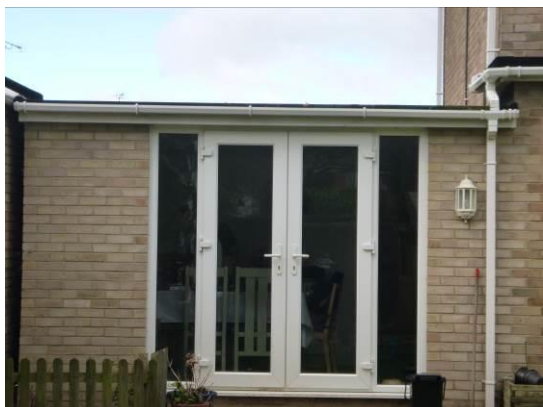
- 4.2.3** The flat roofed extensions were all tightly fitted with a roof lined with bitumen felt and uPVC soffits (**Photograph 13; Target note 9**).
- 4.2.4** No evidence of roosting bats were observed on the house during the external inspection.

**13. Flat roof covered tightly with bitumen roofing felt.**

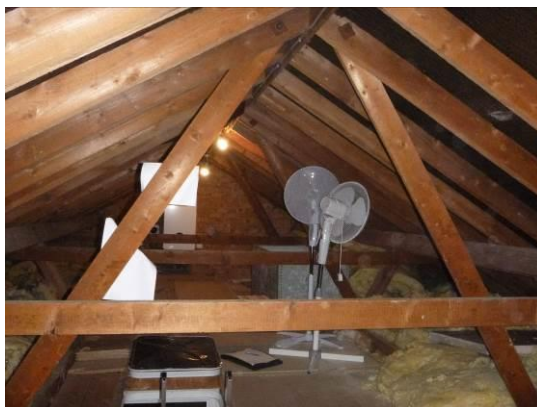
**14. Internal view of the roof space.**

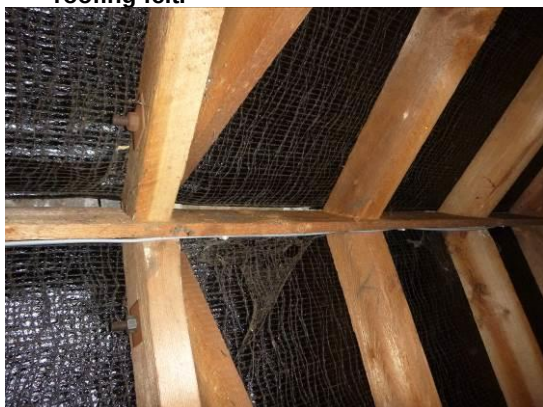
**15. Ridge cobweb free in places.**

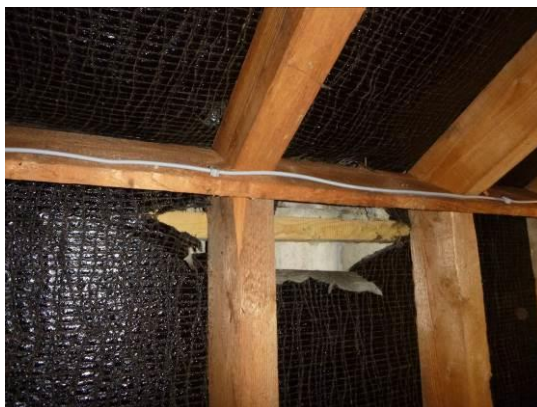
**16. Large tear in roof felt.**

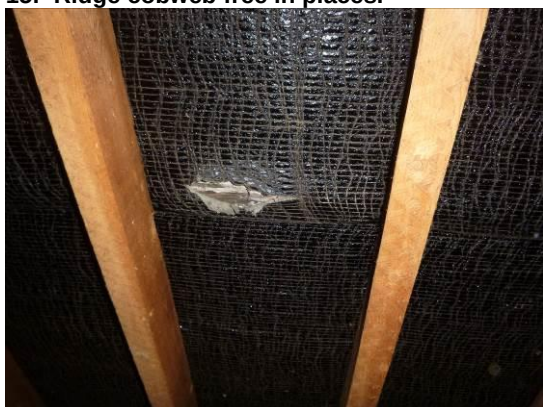
**17. Large tear in roof felt.**

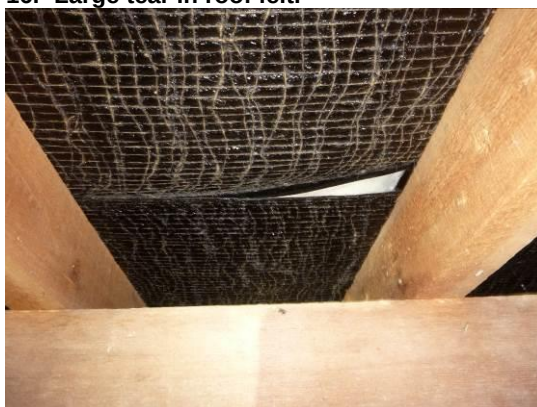
**18. Roof tiles exposed where the sheets of felt overlapped.**

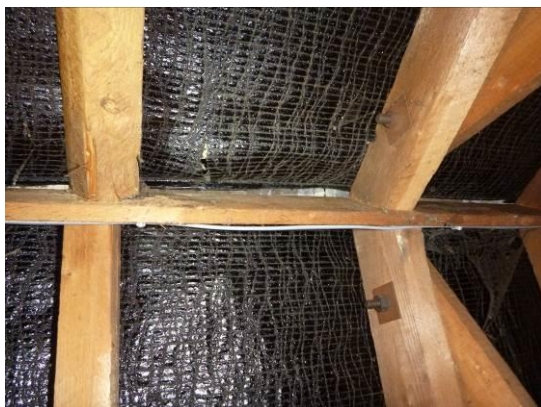
**19. Roofing felt loose along the ridge.**

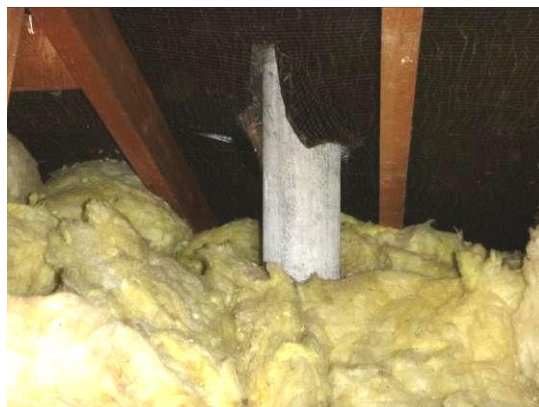
**20. Roofing felt loose around the flue pipe.**

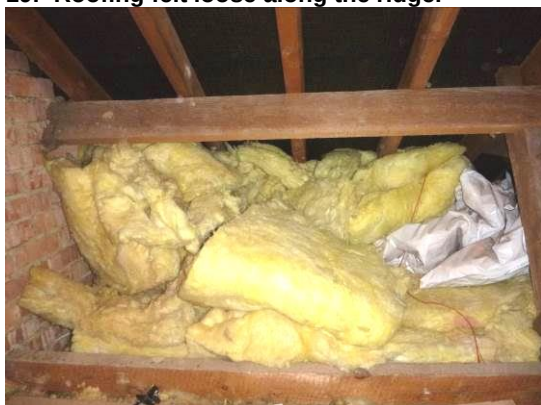
**21. Roof lined with fibreglass and vermiculite.**

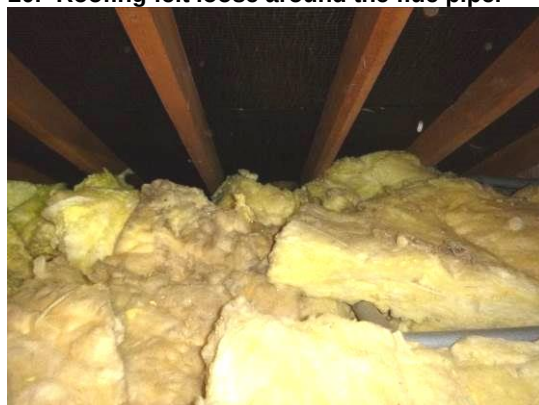
**22. Eaves open in places.**

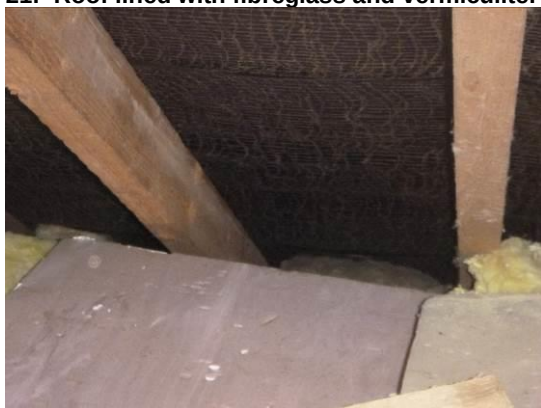
**23. Eaves filled in places.**

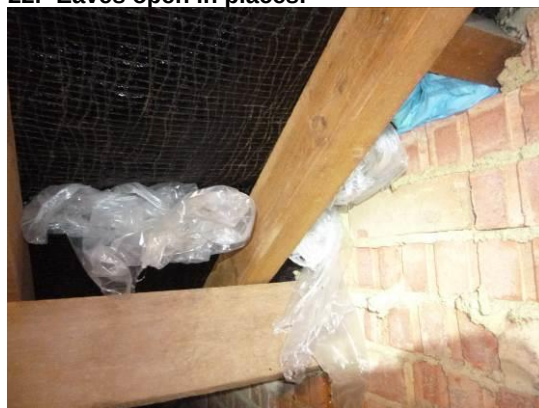
**24. Gaps filled with plastic at the edges of the brickwork at the southern gable end.**

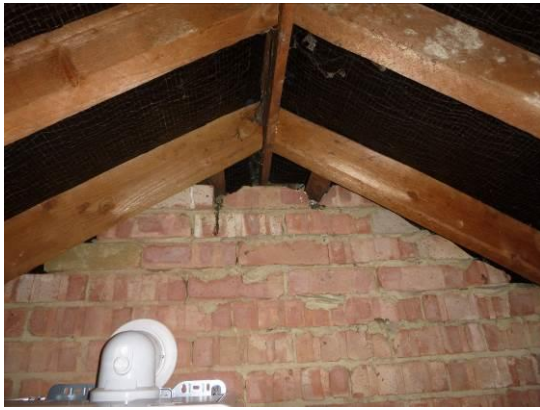
**25. Large gap at the apex of the southern gable end.**

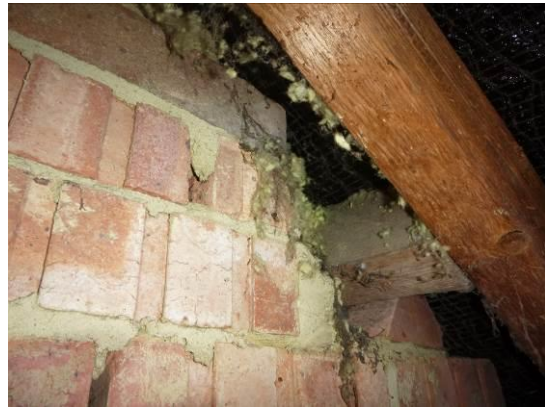
**26. Shredded fibreglass visible in the southern gable end.**

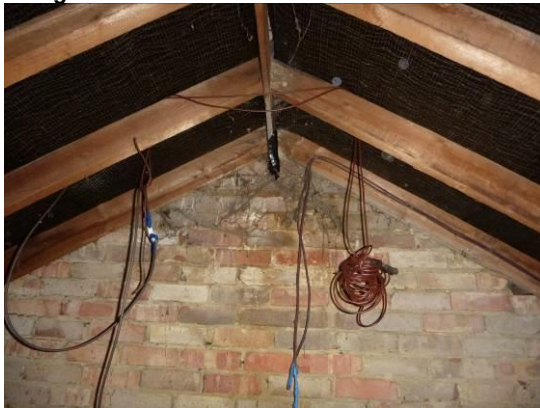
**27. Gaps between the end rafter and brickwork at the northern gable end.**
