# Site Investigation Report

121420.1.USI

| Client | Sedgwick |
| Visit date | 11/05/2021 |

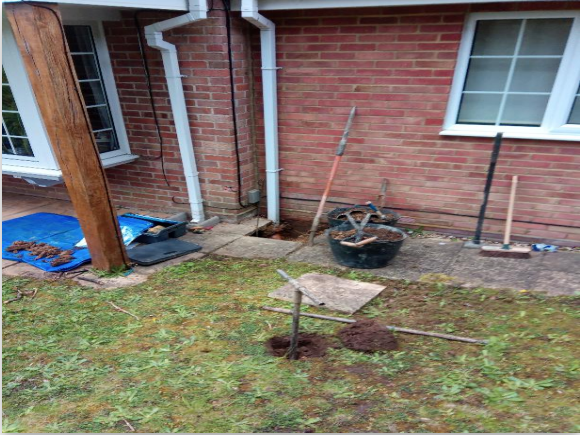
| Trial Hole 1 | |
|---|---|
| Fig 1.1: Trial Hole 1 Location | Fig 1.2: Trial Hole 1 Footing |

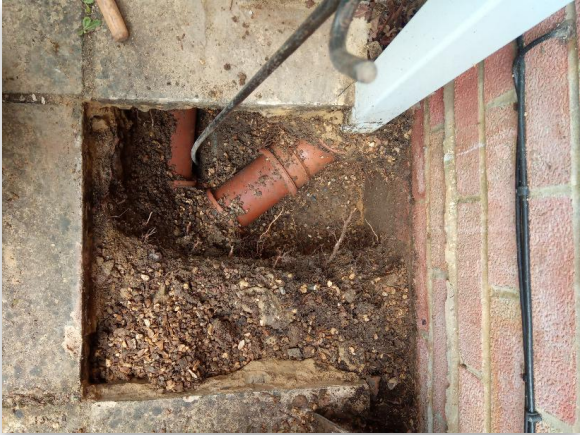
| Findings | |
|---|---|
| | Within TH1, we also took footing measurements from the <b>Main house</b> . These measurements are shown in Trial Hole Log 1b below. |

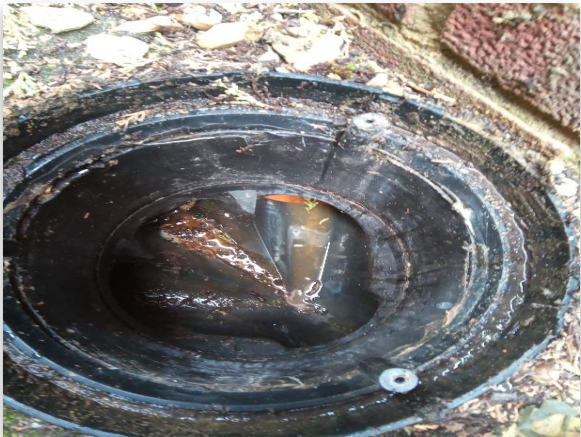
Fig 3.1: Plastic IC1

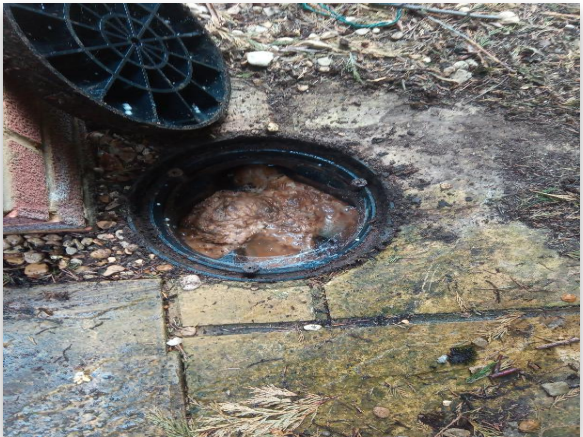
| Findings | |
|---|---|
| | <p>We were unable to survey downstream from IC2 due to water holding within the line, however, we discovered that this pipework was of plastic construction.</p> <p>Our survey revealed that the guttering for RWP1 and 2 leaks when water flows through it and the guttering for RWP3 was found to be defective allowing a large escape of water.</p> |

Fig 3.2: Plastic IC2

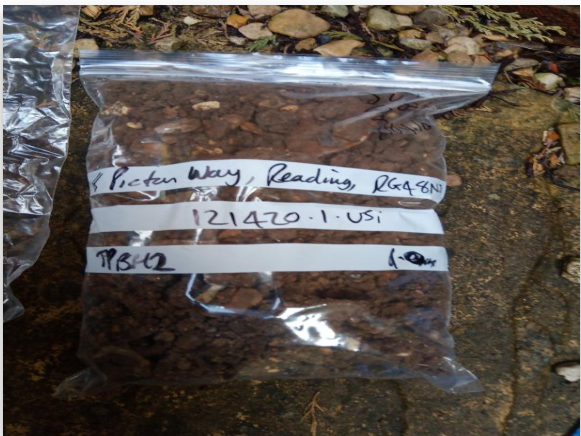
Fig 3.3: Soil samples collected

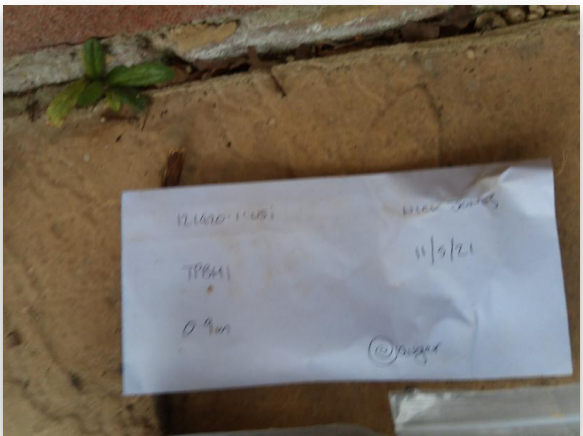
Fig 3.4: Root samples collected

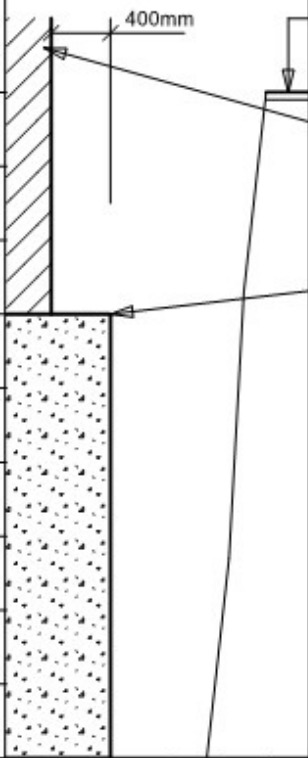
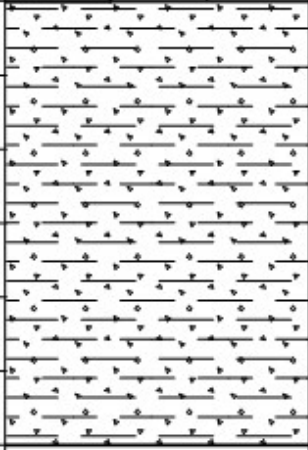
# Trial Hole Log No.1

| Depth<br>(m) | Symbolic Log | Strata Description | Insitu Tests | | Soil<br>Sample | Root<br>Sample |
|---|---|---|---|---|---|---|
| 1.0 | | Dry dense Brown sandy gravelly<br>silty CLAY with angular stone inclusions | 150blows | | Soil<br>@ 0.9m | Root<br>@ 0.9m |
| 1.5 | | TRIAL HOLE TERMINATED | 150blows | | Soil<br>@ 1.4m | |

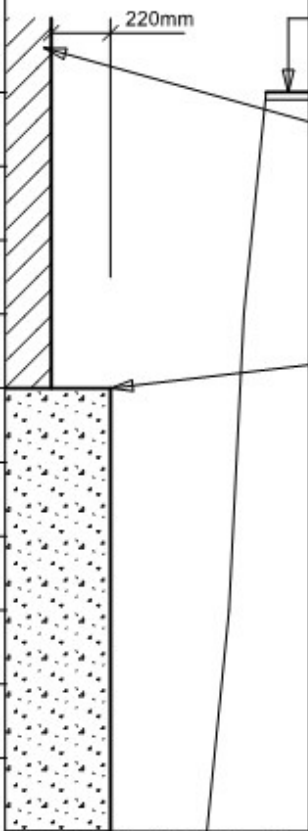
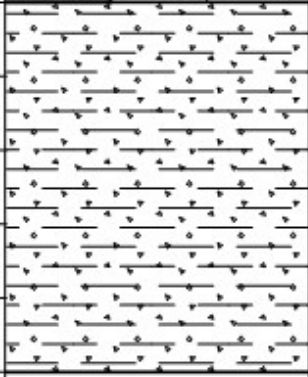
## Trial Hole Log No.2

| Depth<br>(m) | Symbolic Log | Strata Description | Insitu Tests | | Soil<br>Sample | Root<br>Sample |
|---|---|---|---|---|---|---|
| 1.0 | | <p>Dry dense Brown sandy gravelly<br/>silty CLAY with angular stone inclusions</p> | 150blows | | Soil<br>@ 1m | Root<br>@ 1m |
| 1.5 | | TRIAL HOLE TERMINATED | | | | |
