# CAPITAL STONE

Site : Queen Victoria Street,  
Reading,  
RG1 1TG

### **METHOD STATEMENT FOR THE REPAIRS OR REBUILDING OF THE HIGH LEVEL GABLES.**

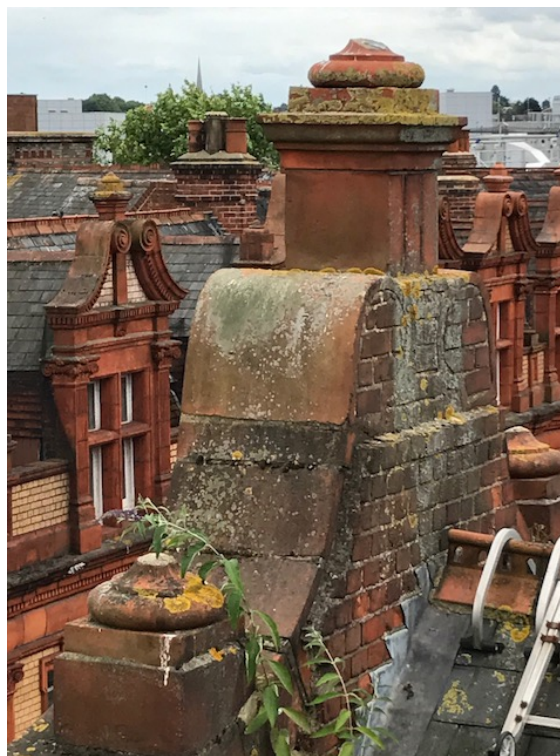
The high level gables are constructed of imperial red stock bricks, over clad with ornate terracotta units and faced to the front elevations with imperial yellow/white gaunt bricks. The terracotta units are in poor condition having suffered general weathering decay and spalling due to movement and modern cement mortar splitting the arrises. Several of the gables have moved from the vertical and the cause of this is not immediately obvious. All the ornate exposed finial or urn toppings to the gables and their shoulders have been previously removed (presumably for safety reasons).

The mortar joints have failed generally as has most of the lead flashing and mortar flaunching.

Our plan would be to carefully demolish a single gable to learn how it was constructed and to try to establish whether there are any fundamental causes of the various failures (old iron fixings, rotting timbers etc)

1. We would carry out a full photographic and dimensional survey of a gable and record all its details on one of the drawings already completed.
2. We would carefully demolish the gable by hand, brick by brick and store all the components in bags within the building to prevent loading out the scaffold.

3. We would take the gable down to window or parapet level to try to expose all likely internal structural items such as lintels and timber joists. All demolishing works will be photographically recorded and logged on site.

4. Any damaged terracotta items that are salvageable will be carefully removed and repaired using reconstituted terracotta mortar with stainless steel wire re-inforcing resin fixed in position. An example of these repairs will be presented to the Conservation Officer for approval.

5. Any terracotta units that are beyond repair will be carefully recorded prior to removal and then we will manufacture a mould and re-cast a new unit. A sample of the replacement units will be presented for approval prior to manufacture.

6. Once the rebuilding starts all bedding and pointing mortar will be natural hydraulic lime. We will test a sample of the original mortar the endeavour to match this as closely as possible.
