**Tree Inspection University of Reading - Ginkgo**  
**Client University of Reading, Rupert Taylor**

8<sup>th</sup> August 2022

Ref Climbing Inspection/cable bracing feasibility study of Ginkgo at London Road Campus

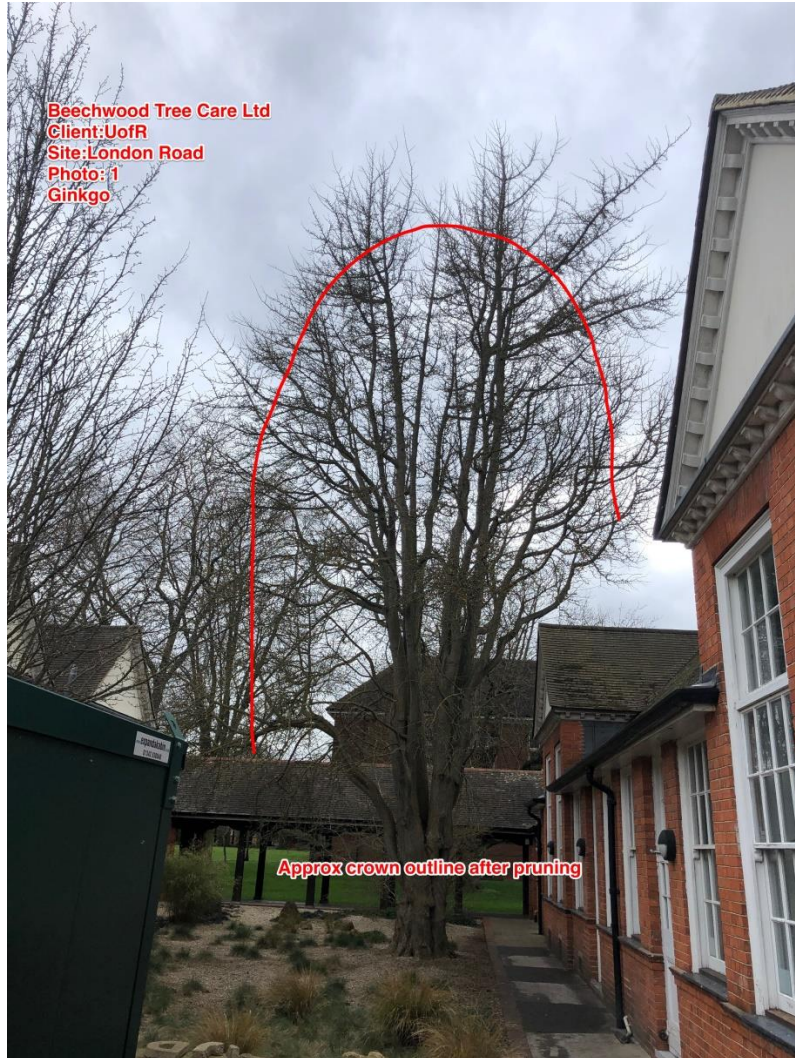
Photo of the tree with pruning line.

9.1 Crown reduce by approximately 25% of leaf area (this equates to the removal of approximately 1.5m-2m of the crown spread and the removal of approximately 2-3m of the height), see photo for approx. crown outline after the reduction (please note this image is only a rough guide), leaving tree with natural crown shape for species in line with BS3998. The trees dimensions after pruning will be approximately Radial Crown spread 5m Height 17-18m

Install 3 dynamic non- invasive cable braces between the 3 main stems at  $\frac{2}{3}$  -  $\frac{3}{4}$  of the height of the included unions to the top of the crown, after reduction pruning.

Install 1 dynamic non- invasive cable braces between the 2 secondary stems on NE main stem at  $\frac{2}{3}$  -  $\frac{3}{4}$  of the height of the included union to the top of the crown, after reduction pruning.
