**No 27/33 Christchurch Road,**

**Reading, Berkshire**

**Listed building Appraisal and Heritage Impact assessment**

**J F Missenden CEng FRSA**

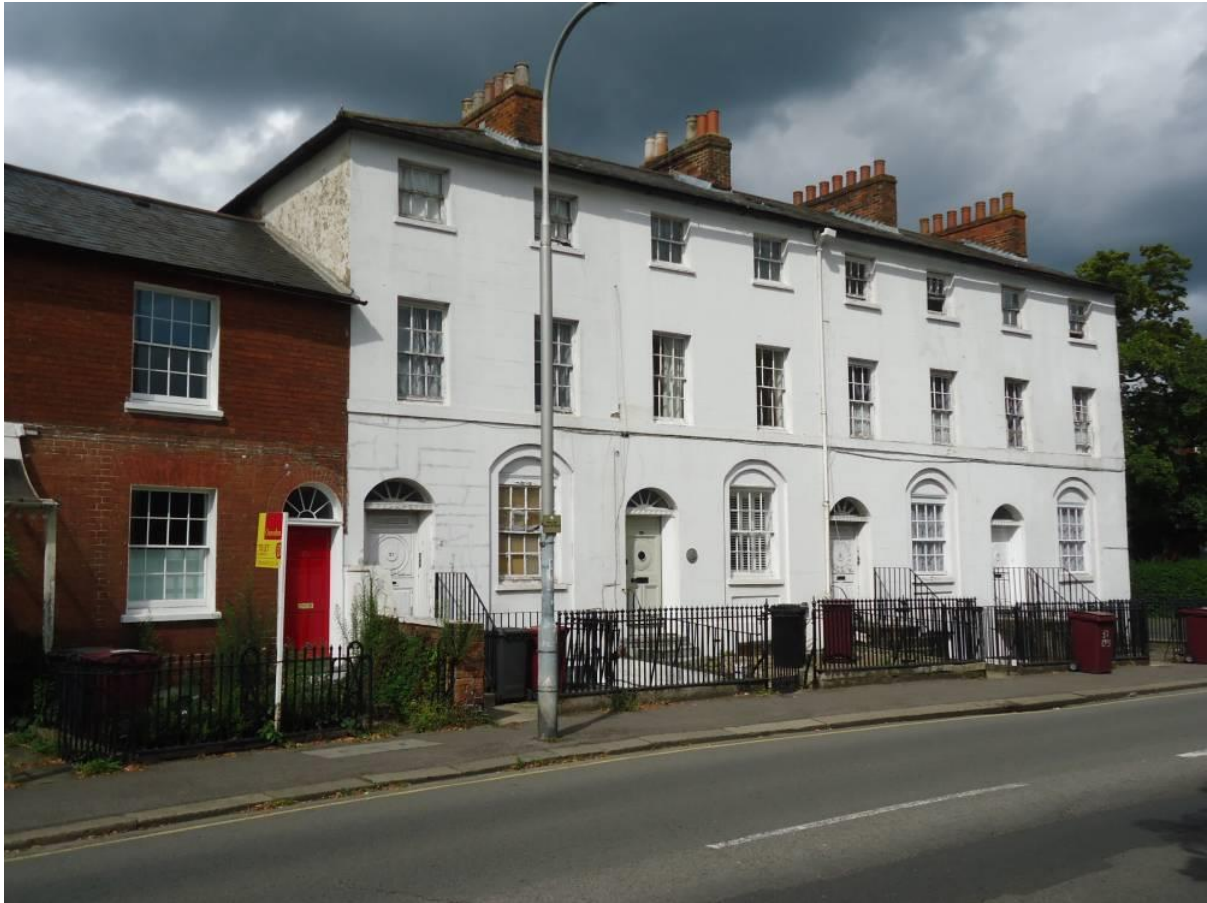
**Figure 2: Nos 27, 29, 31, 33, South Facade**

Figure 2 shows a brick terrace fronted in stucco, scribed to represent stone ashlar (showing the change in fashion from red brick) three storeys, with first floor string course. There are 16 pane sash windows to ground and 12 to the first floors, although No 27 has had unsympathetic uPVC replacement with wrong glazing bars. The ground floor windows are in segmental arched recesses, with smaller, square wall attic windows. There are good West front doorways flanked by fluted quadrants with panelled doors with roundels and radiating segmental fanlights above. The stacks are to the East side of each house. The houses have a basement which forms the ground floor at the rear because of the falling ground level. There are iron railings that appear contemporary with the houses.

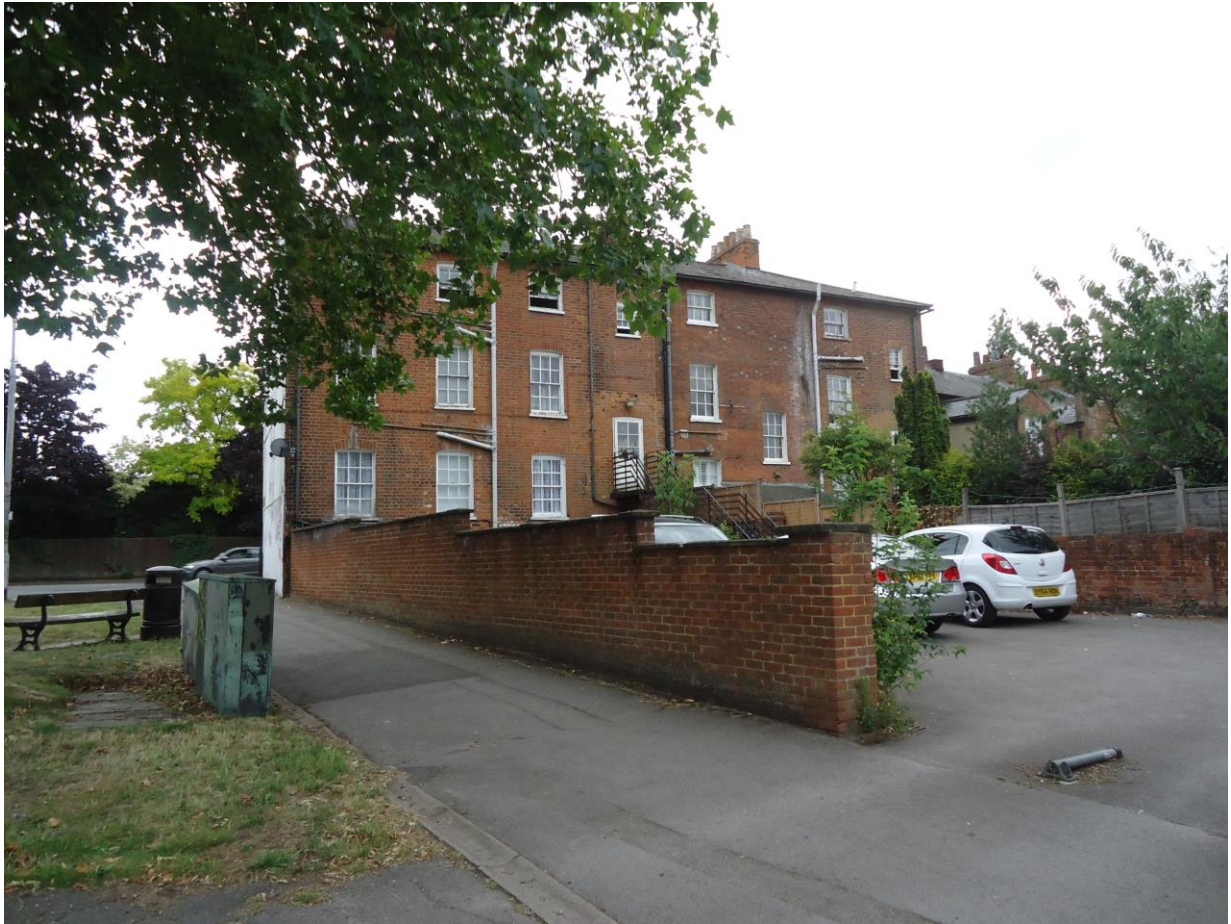
**Figure 3: North (rear) Facade, from Kendrick Road**

The East side is also rendered but the rear is of brick with (now) irregular fenestration, partly later (Figure 2). The window openings have cheaper shallow arches of brick headers rather than the flat dove-tails of gauged, rubber brick that would be seen on a frontage (as seen on Nos 15 – 25). While this view was not originally meant to be seen, it is now an important frame to the top of Kendrick Road and its poor condition merits improvement. It appears that the original window pattern was; a single attic window on the East side, a single piano nobile window again on the East side, repeated on the ground floor. The basement had irregular single storey extensions from the C19, leaving a poor rear ground level appearance. Additional windows have been inserted, added to those listed above. Some are attempts at matching the original windows in size and symmetry, others are of various sizes reflecting the internal adaptations and two intrusive rear exits with stairs that have been inserted. This

gives the rear a jumbling unkempt appearance, worsened by the DIY surface drains that have been added and then leaked over a period, staining the brickwork. This is particularly regrettable as the rear flanks the top of Kendrick Road, framing the church, one of Reading's finest views.

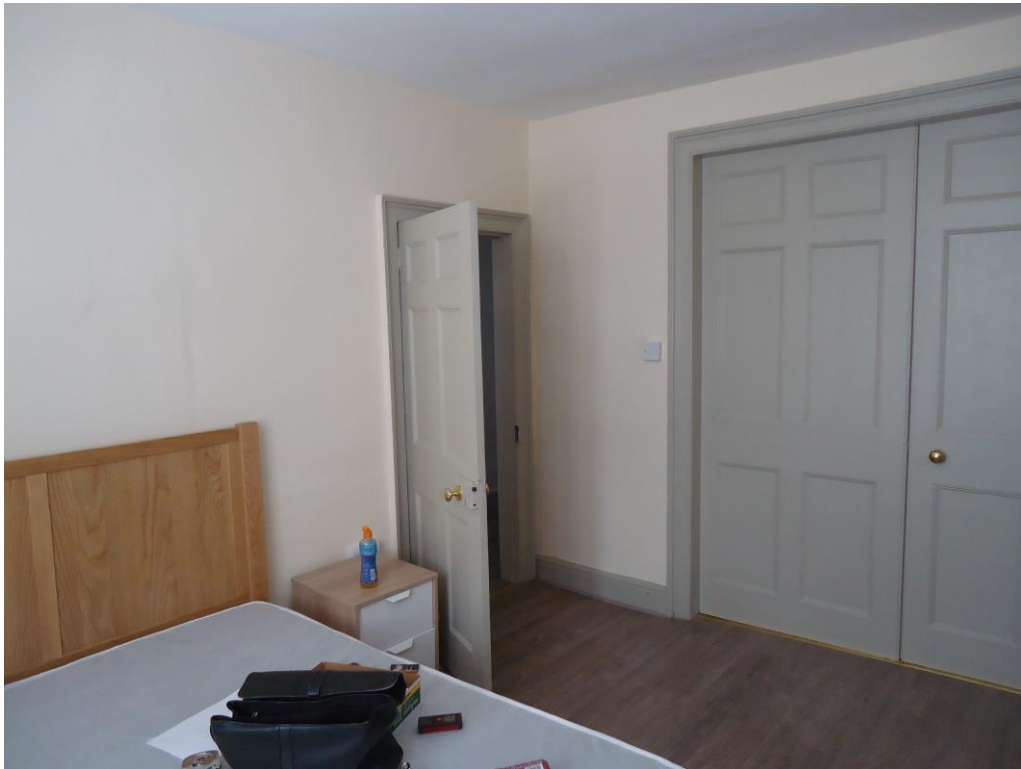
**Figure 4: Ground Floor reception room showing some elegant panelling**

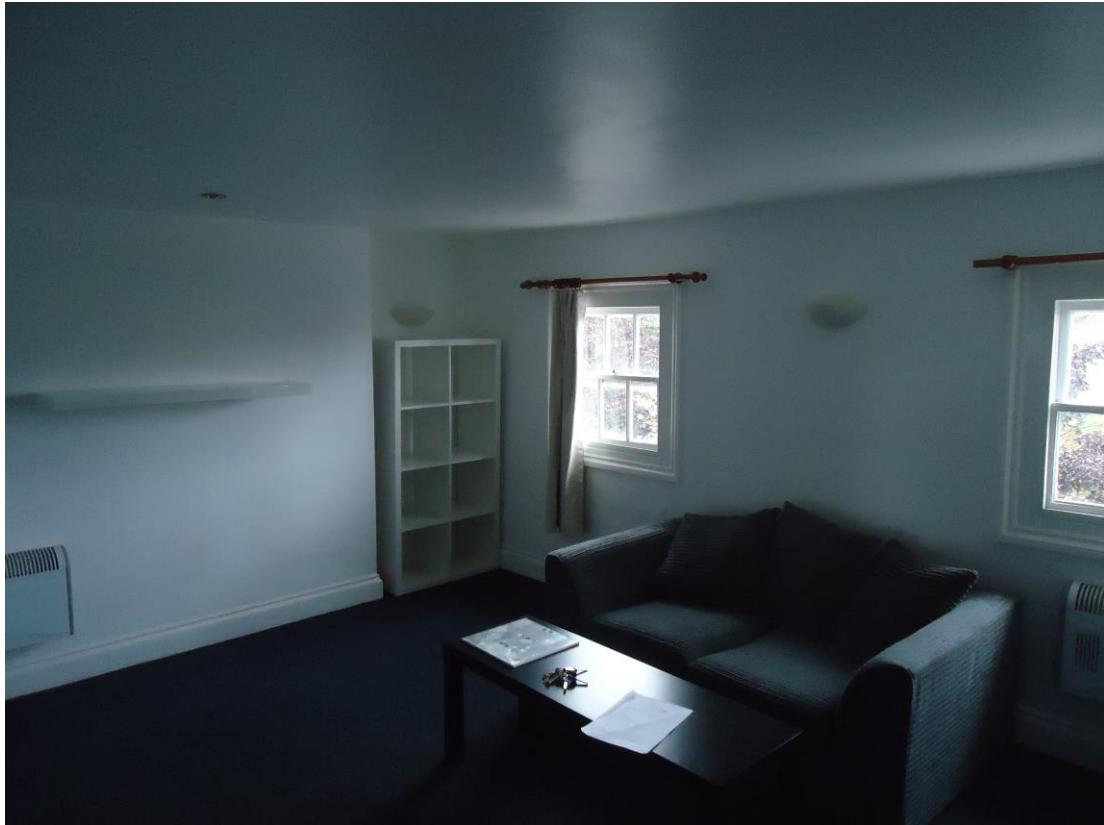
**Figure 6: Rear Attic Bedroom of No 33, showing possible extra left window.**

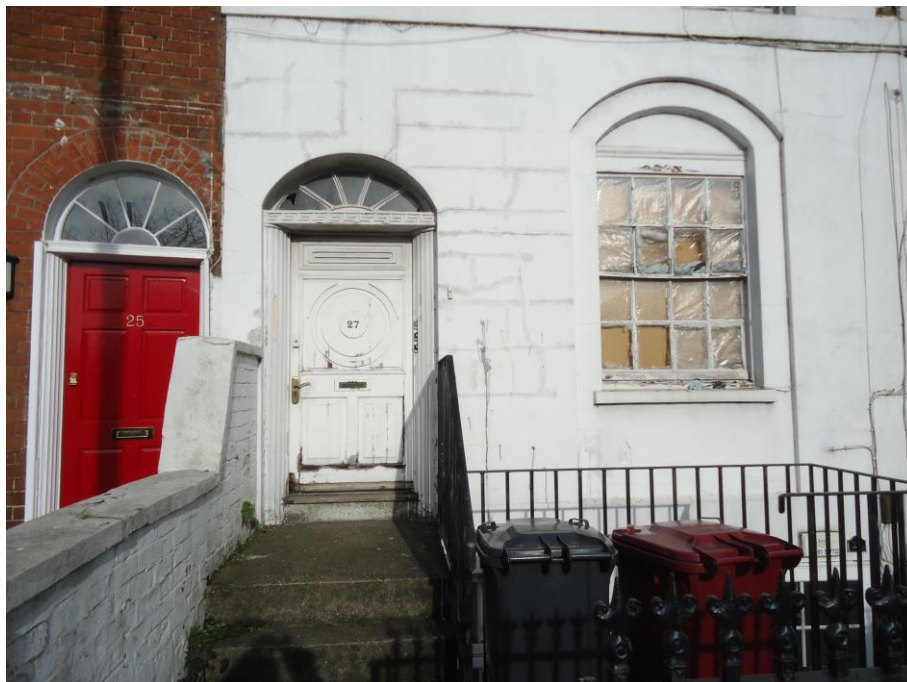
No 27's frontage has been marred not just by neglect but by window replacement, as shown in the “before” image in Figure 4 and the “after” image of Figure 5.

**Figure 4 Image of South frontage of No 27 prior to window replacement**

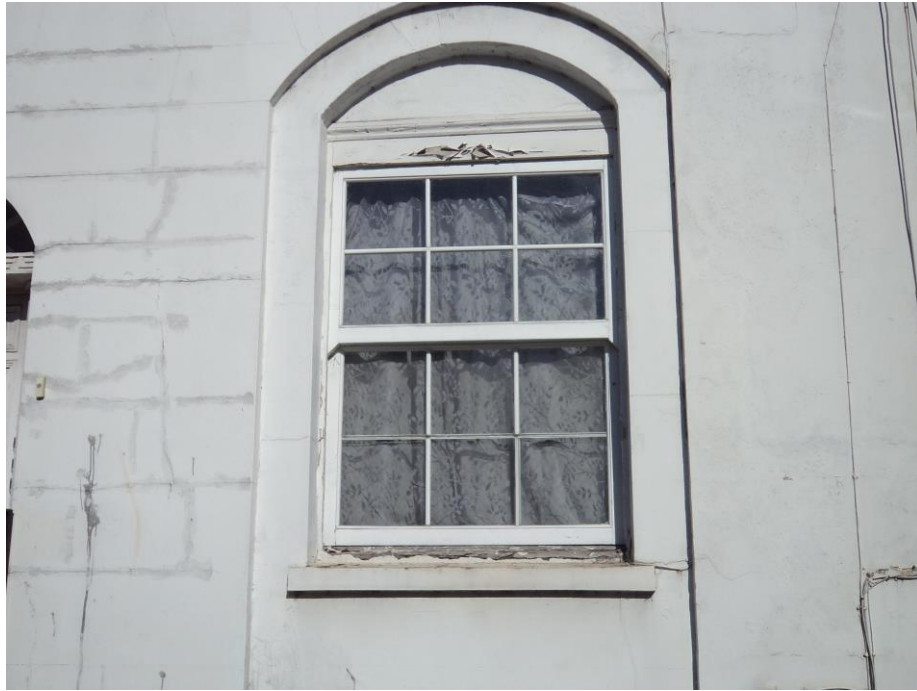
**Figure 5: Present day window replacement, with incorrect glazing bars.**

The sash windows should be repaired (and re-instated in the case of No 27). The frames probably only need new sills and the sashes may be repairable or replaced by the novel 8mm gap double glazed units now locally available (see the repair of the iconic 46 Redlands Road). These would have the added attraction of reducing road noise penetrating into the South facing rooms. The stucco should be prepared for repainting, recovering the scribing where possible. Both a breathable white, or a Bath Stone colour would be suitable. The entrance doors and doorways are particularly important and the original doors should be repaired where possible by removing wedges, dismantling and replacing rotten panels rather than wholesale replacement. Where new mortar or plaster is required this should be of Lime without Portland cement to allow breathing. This will be particularly important for the basement and exterior walls.

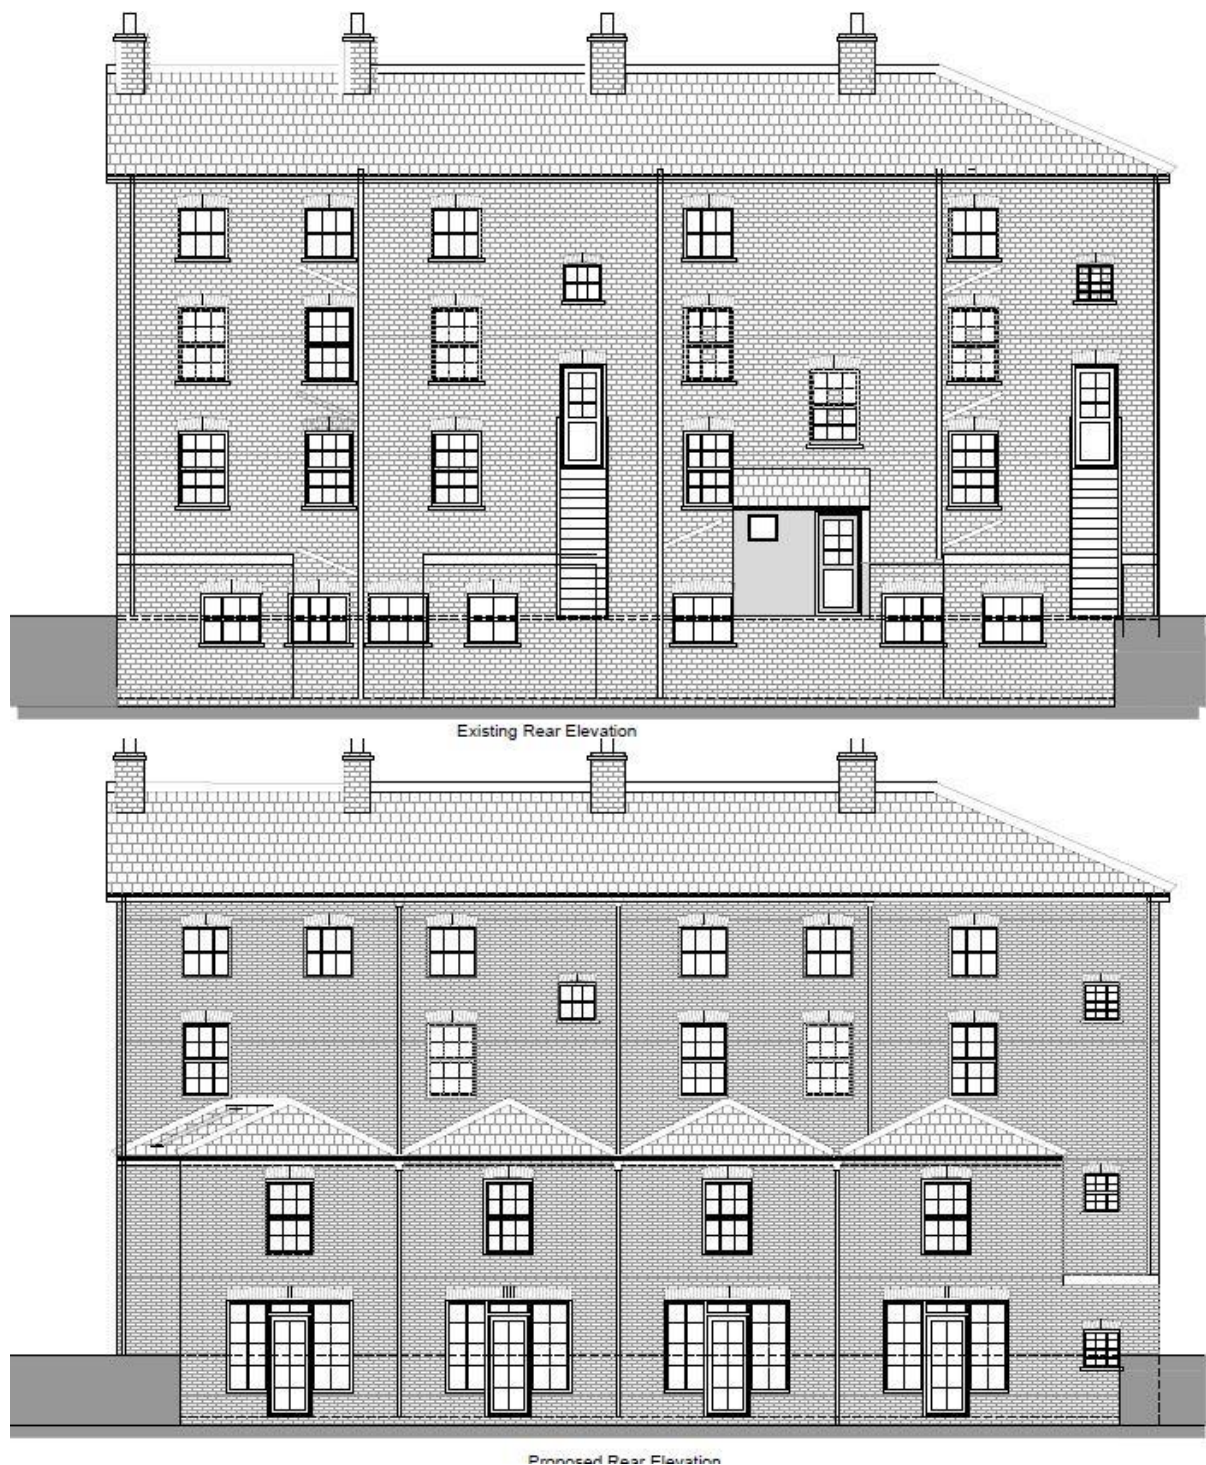
**Figure 6: Existing and Proposed rear (North) Facades**

The original features may mostly be detected through regular repetition although some early alterations to suit individual occupiers are possible. This suggests that the leftmost windows on each floor of each house were part of the original symmetrical composition. An extra attic

window is present in No 33. This must be early as it matches the details on the others as does its middle floor window (which is proposed for removal). The smaller windows on Nos 27 and 31 must be much later as they do not respect the symmetry and so may be dated to c1900.

Nos 27 and 31 have intrusive rear entrances at first floor level which suggest post 1945 conversions. No 29 has an added half landing window and all have untidy basement rear extension contributing to the present jumbling untidy appearance which is difficult to maintain.

The proposed alterations consist of removing some of the additions, raising one first floor window and adding one attic window (both No 29). Three of the smaller added windows are retained for lighting of the internal spaces. Also the untidy basement level is cleared and a two-storey extension is proposed. The reason for this is that the classic Georgian plan is for two rooms on each floor with a side- or centre- stairwell. This is particularly difficult to adapt to modern purposes in smaller houses, where bathrooms and kitchens are required on ground and first floors. The upper floor plans are satisfactory for bedrooms. A previously proposed flat roof has been rightly replaced by a shallow pitched slated roof of a type appropriate to the era.

Considering the upper two storeys, the proposed elevation provides much tidying with removal of external drains and some sympathetic window alterations. The addition of a second attic window to No 29 balances the others and consideration might be given to adding similar to Nos 27 and 29 where the internal plan allows. Similarly, the necessity and expense of adding the first floor window to No 29 might be questioned as it has not been seen necessary in neighbouring identical proposed layouts. This would give the upper floors more symmetry and marginally improve the rear facade. Against this might be set the generally satisfactory nature of the proposal and the argument that this might be conjectural restoration, although it would be for internal planning consistency. It is a minor issue that should not affect the outcome of the application.
