# Health & Safety Duty of Care Report©

**Site:** Caversham Lock, Thames Side, Reading, RG1 8BP

**Client:** Environmental Agency

**Date:** September 2021

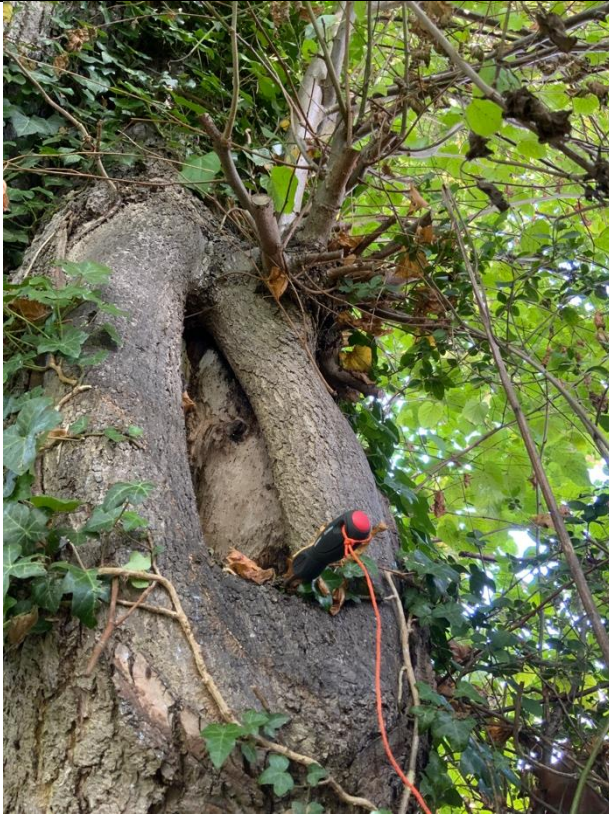
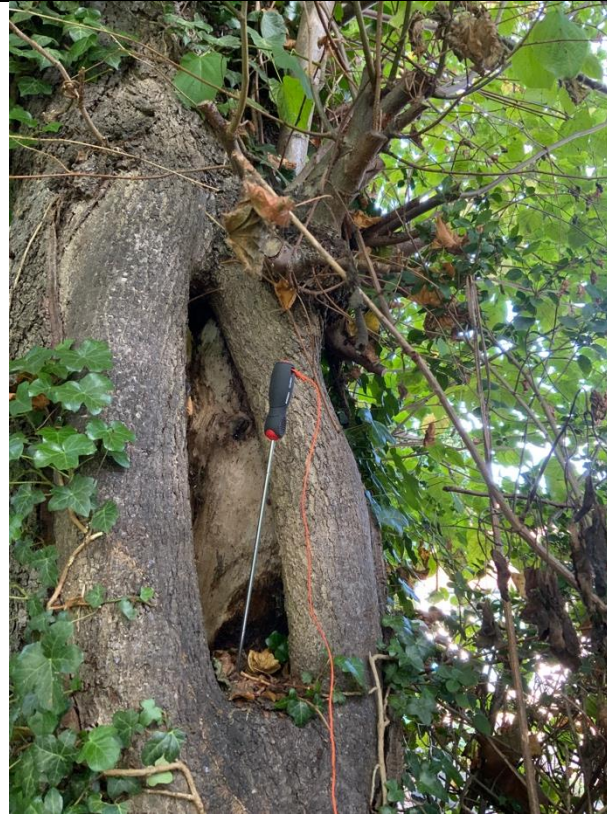
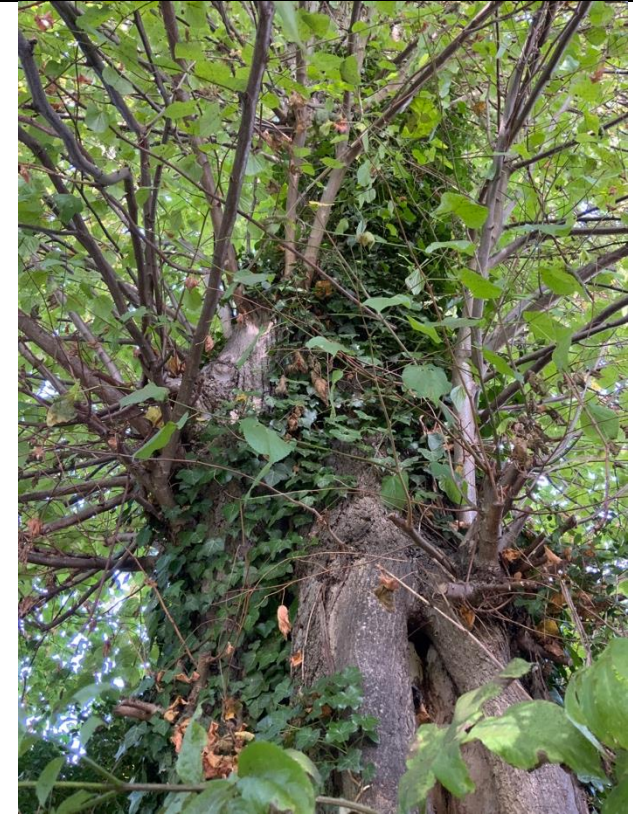
| T7 | Lime | M | 14 | F | F | <p>Ivy and epicormic growth obscuring full VTA of basal area.</p> <p>Growing in close proximity to metal fence.</p> <p>X1 large cavity observed on south-eastern aspect at approx 2.5m, possibly result of previous limb loss or pruning wound. Probe inserted reveals a lateral ingress into trunk of 500mm &amp; 100mm downwards into the stem. Unable to get a longitudinal measurement further up from this wound site to ascertain extent of cavity ingress extent.</p> <p>Re growth at approx 1m above identified cavity that is obscuring visual assessment of potential cavity.</p> <p>See pictures below.</p> <p>Management technique of high pollard has been employed to mitigate any potential structural forces imposed on lower trunk at cavity site.</p> <p>Previously heavily pruned with resultant regrowth on high pollard heads at approx 10m.</p> | <p>Sever ivy from base to aid future VTA.</p> <p>Remove epicormic growth from base to main scaffold as a course of continued maintenance pruning.</p> <p>Remove resultant regrowth from previous high pollard works, due to this being the recognised cyclical management technique &amp; to reduce likelihood of failure from potentially weak attachment points.</p> | 2<br>2<br>2 | 6 | 3 months |

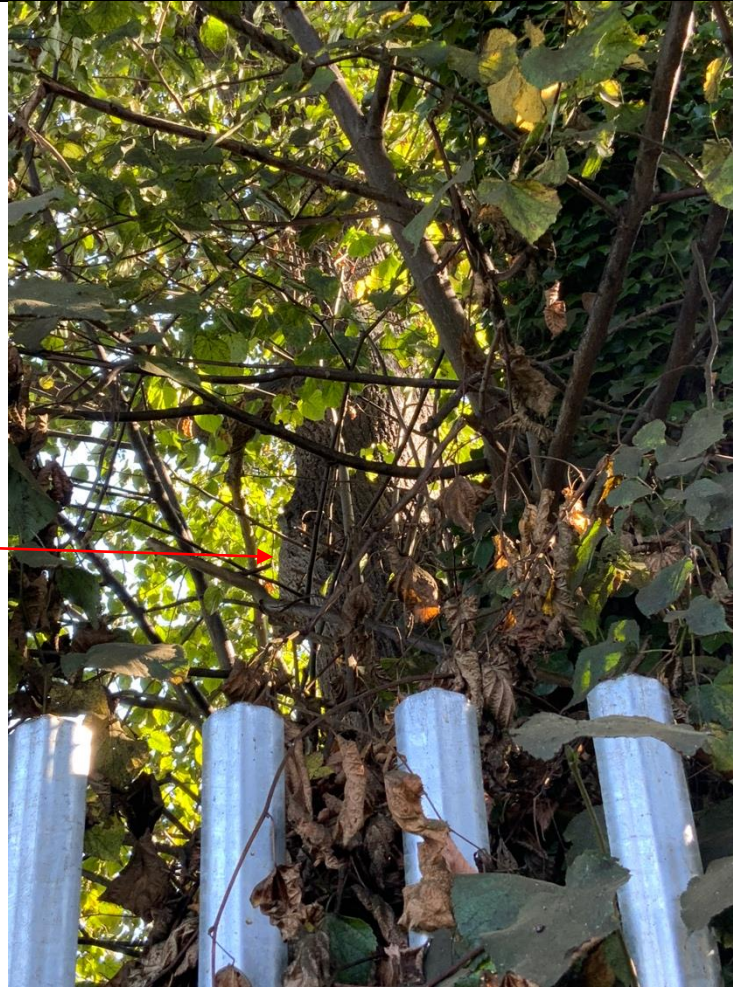
| T8 | Lime | LM | 22<br>.5 | G | F | <p>Ivy present with limited physical access due to lock island weir side wall.</p> <p>Epicormic basal growth and up trunk to approx 4m.</p> <p>Evidence of previous pruning works.</p> <p>Low branches over weir north-western side.</p> <p>Potential cavities at site of previous pruning, unable to ascertain extent.</p> <p>Moderate deadwood over public footpath.</p> <p>Low branch growing towards services pole to south.</p> <p>See picture for site of wounding to be climbing inspected.</p> | <p>Remove basal epicormic and epicormic growth up to approx 3m to maintain clearance over footpath to southwest and weir side lock island wall.</p> <p>Climbing Inspection of potential cavities on weir side.</p> <p>Maintain clearance of low southern branch by removing up to 3m of lateral growth.</p> <p>Remove moderate deadwood observed over footpath to reduce likelihood of failure.</p> | <p>1<br/>1<br/>2</p> | 4 | 6 months |

Potential cavity decay site
