# St Mary's House Reading

Aberdeen Standard Investments

Planning Statement

ISSUE 3 8 June 28th 2021

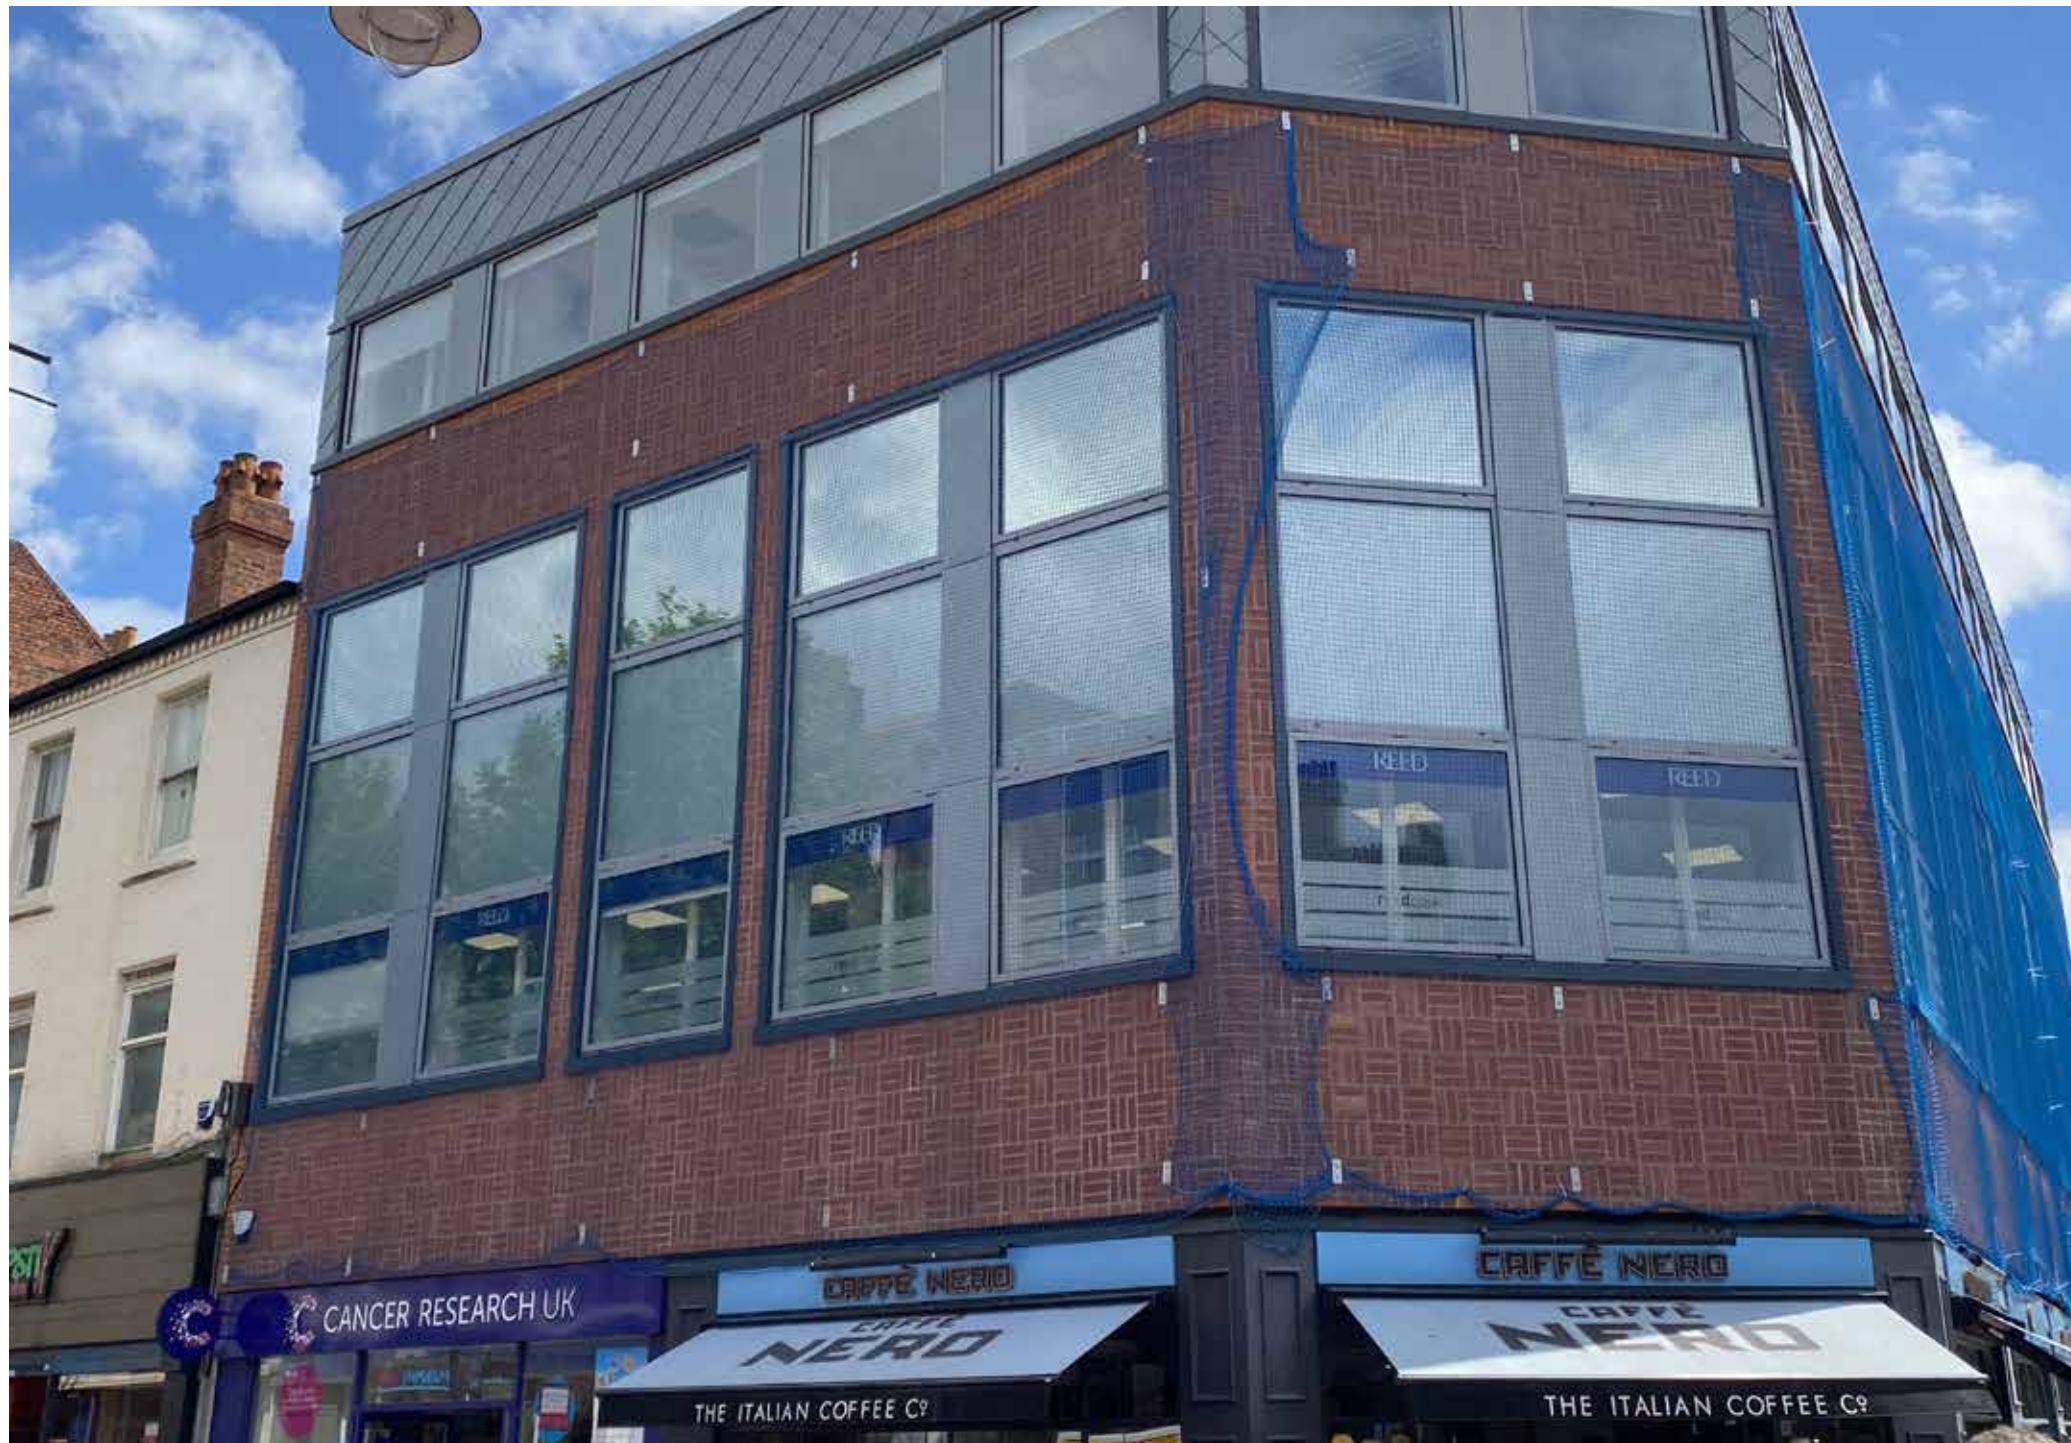
**Figure 1** St Mary's House, June 2021, showing safety netting over brick slip cladding

As a result, the entire brick slip portion of the façade is now netted to protect the public from falling debris.

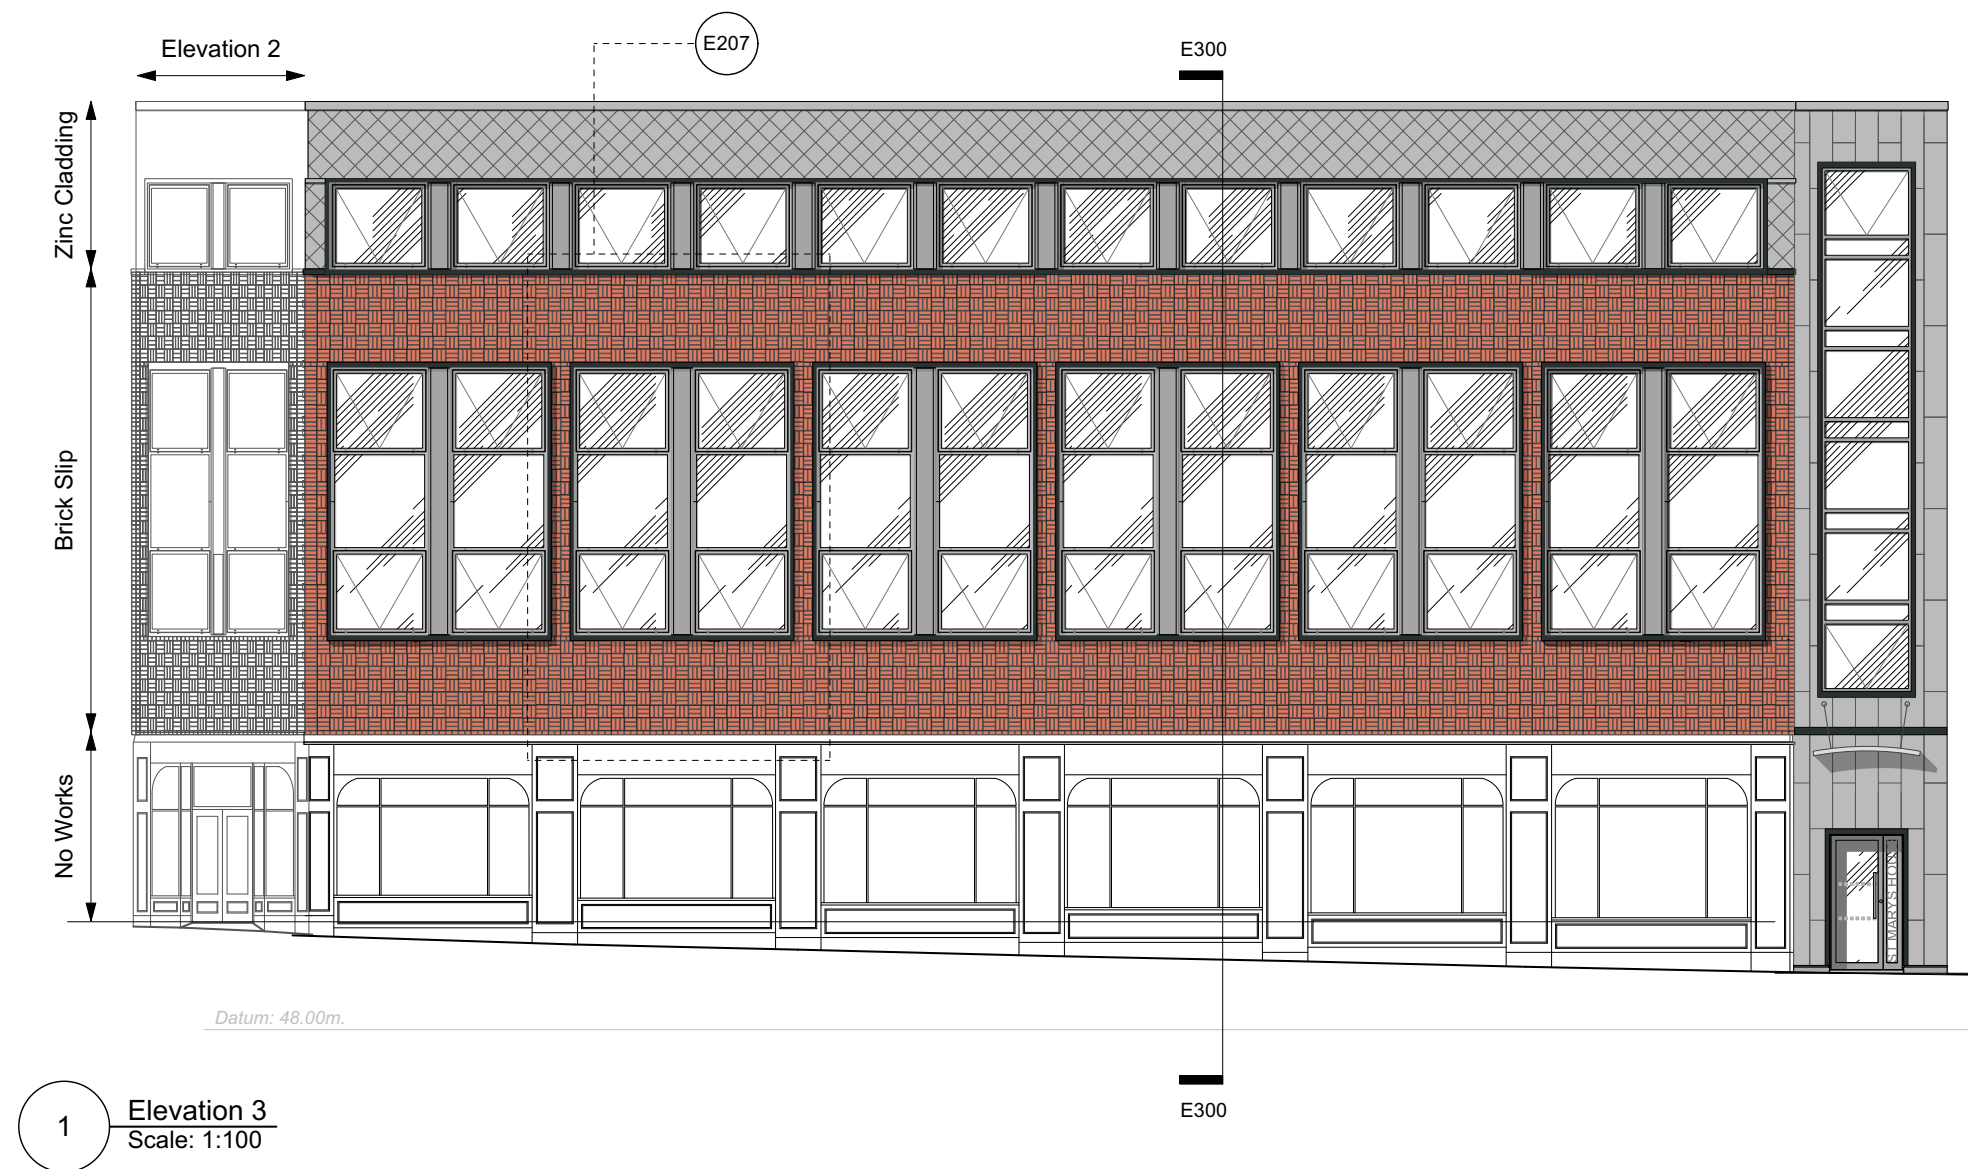
**Figure 2** Existing Brick Slip Cladding - St Mary's Butts Elevation

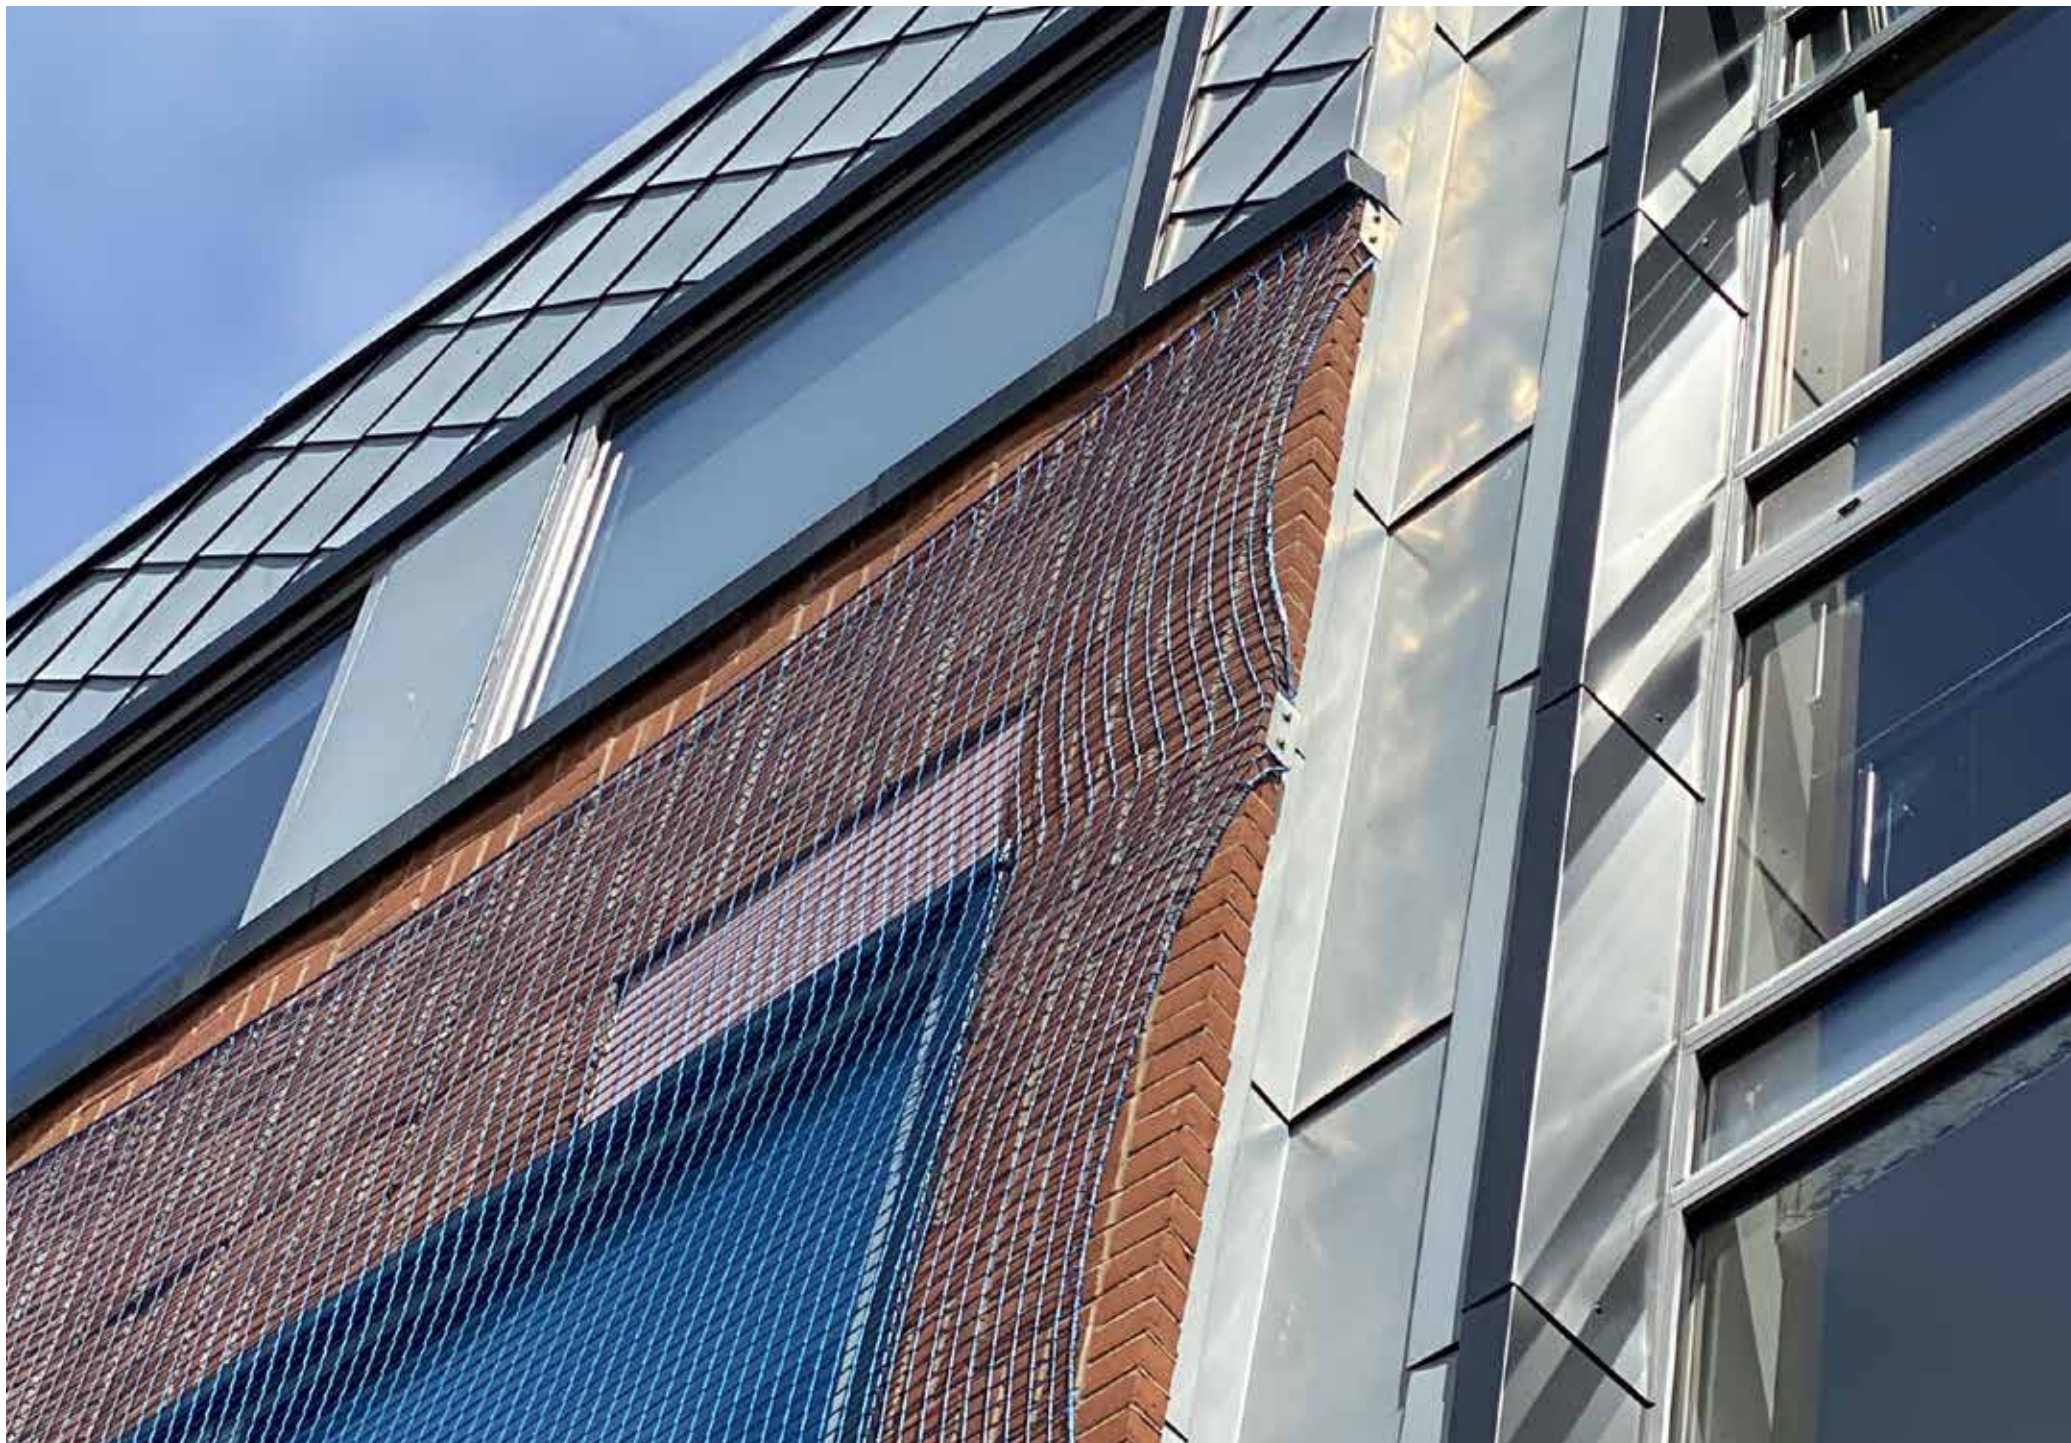
**Figure 3** Location of cladding investigation, on St Mary's Butt elevation. - note repeated bowing of panels

The Wintech report concludes that the backing board to the brick slips failed due to moisture absorption which led to expansion of the boards. This became apparent on the St Mary Butts elevation, where the investigation took place, but is not an isolated problem. Panels are bowing across the entire brick slip clad portion of the façade. The movement of the panels has been exacerbated by an absence of any designed in expansion joints – which is standard practice in rainscreen façades.

It can also be seen from street level that the 135° corners at the splay on the corner of Broad Street and St Mary Butts is ragged. This is in part due to the construction method, where panels have been site cut and mitred to form the splay. This has likely been exacerbated by the expansion of the panels and lack of movement joints in the facade.

Remedial works to the existing cladding would not be effective therefore the entire brick clad section of the elevations is required to be stripped off and replaced with a new system, from the structural frame outwards.

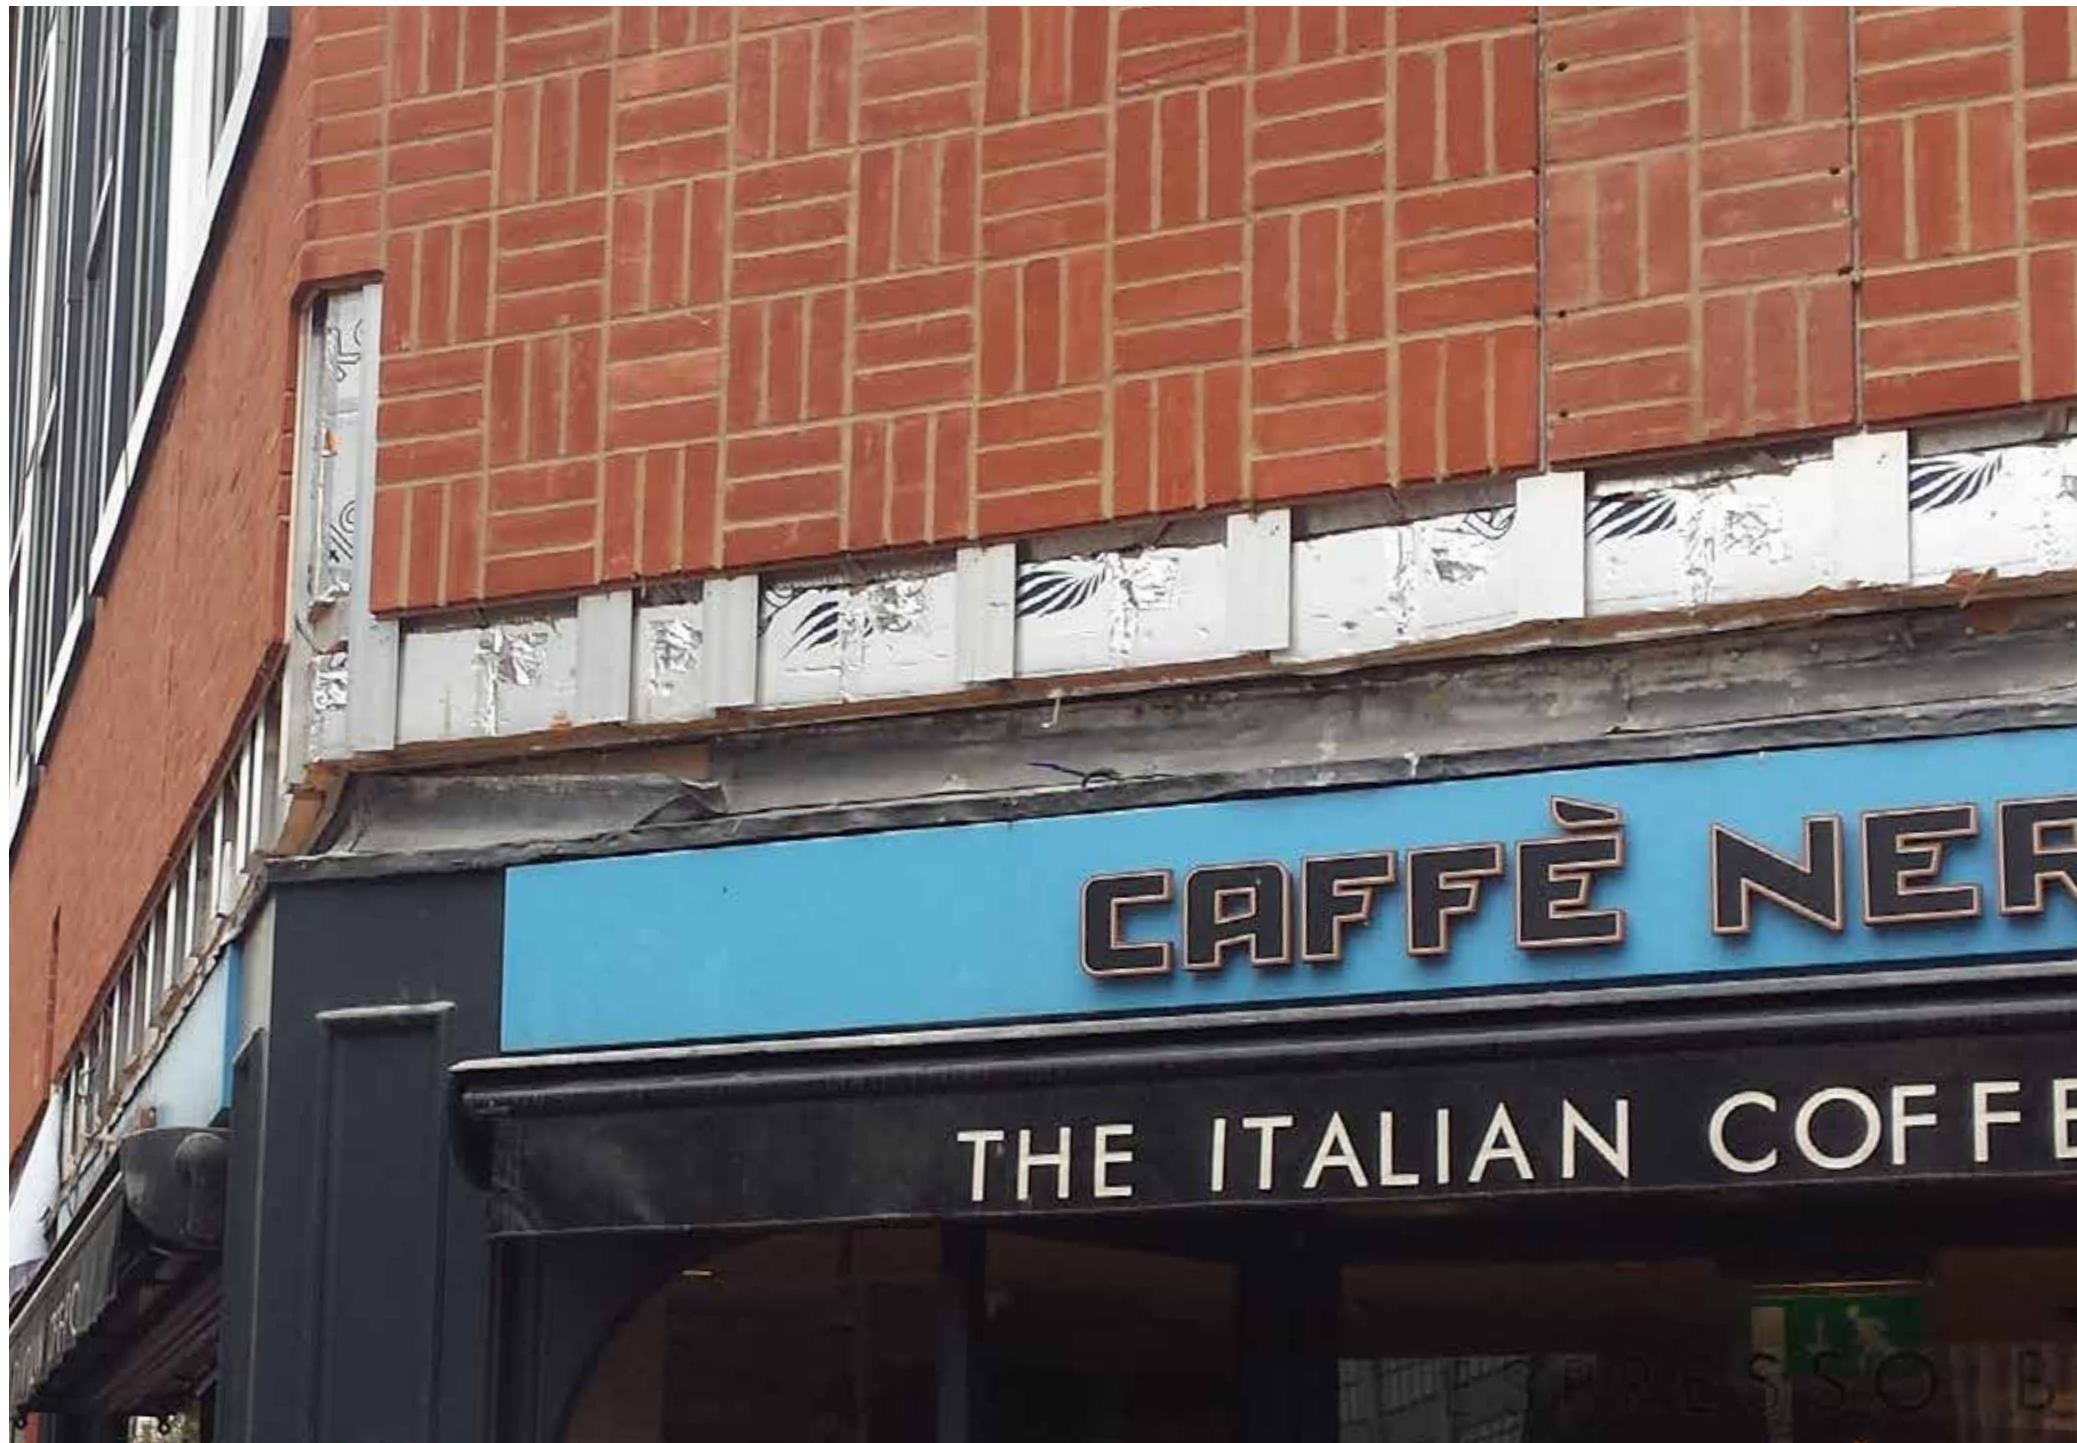
**Figure 4** St Mary's House near completion showing existing cladding and phenolic Insulation

Additionally, in the description of the build-up behind the brick cladding the Wintech report highlights the use of a phenolic insulation within the cavity. This is a combustible material and while it was and remains compliant with the building regulations for a building of this type and height the market is moving towards elimination of combustible materials in cladding generally.

The original architectural design specification called for a mineral fibre product, which would have been non-combustible, it is a thicker material for equivalent thermal performance. It is understood from conversation with the contractor who completed the original project that the available cladding zone, from face of structure to building line was less than expected. Even with the reduced thickness of cavity insulation installed the clear ventilated cavity is, in some areas, below the minimum of 25mm recommended by the cladding industry body, the CWCT.

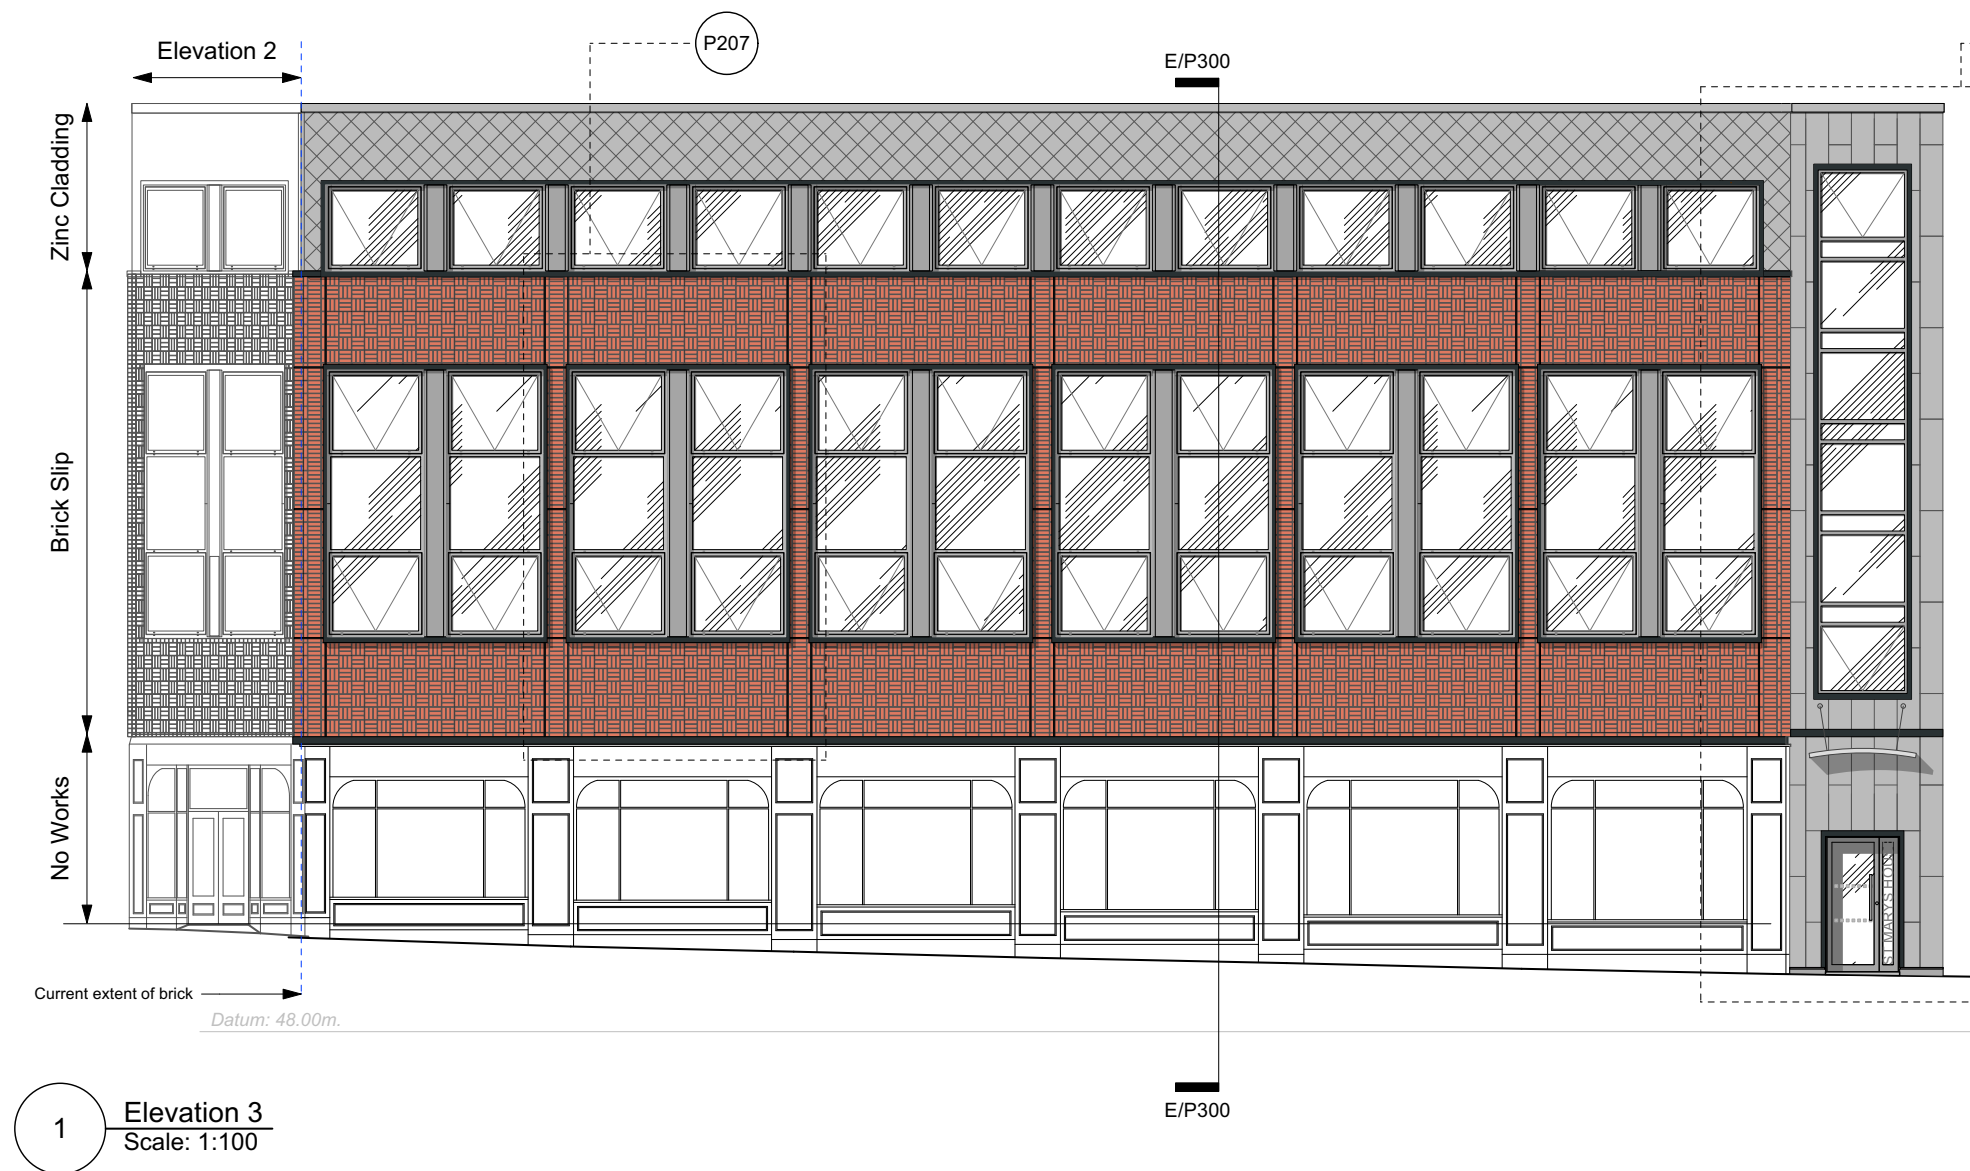
**Figure 5** Extract from S+N drawing 431 - Note Steel angles to Support outer windows.

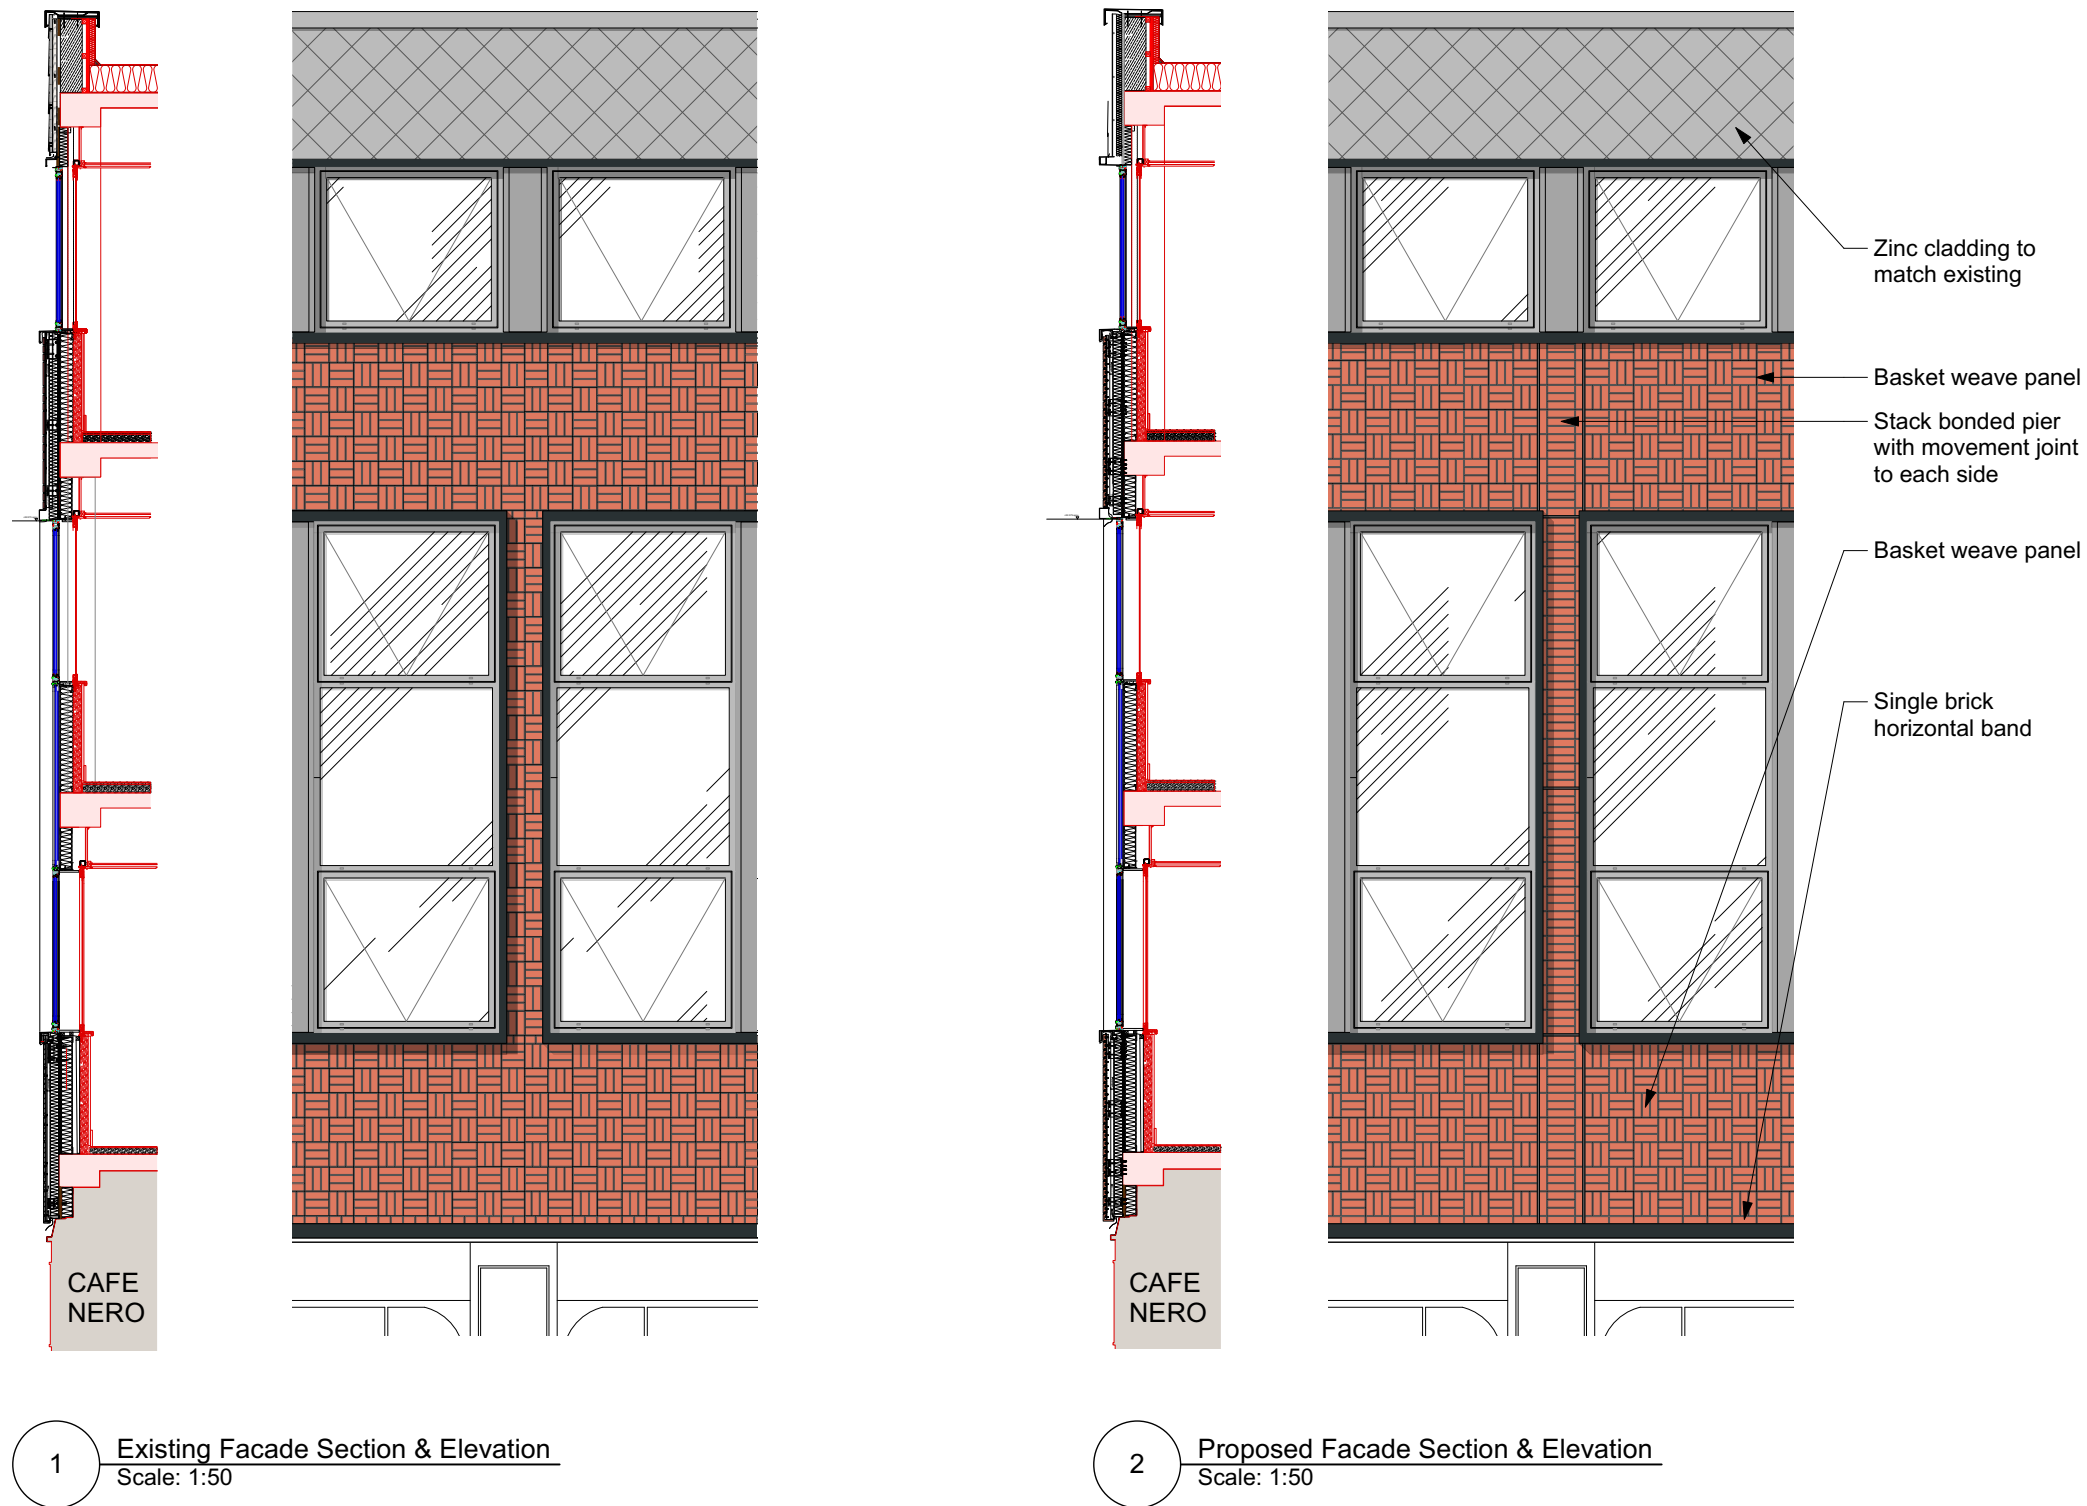
**Figure 6** Extract from HFM drawing P301 - showing existing and proposed cladding bay's side by side.

To make the building safe a mechanically fixed brick tile system is proposed to replace the existing bonded brick slips while matching the existing as closely as possible, while being safe, making allowance for building movement and improving the existing corner detail by eliminating cut brick slips of the existing façade. Although the cladding will be set on metal rails it is also capable of replicating the previously consented 'basket weave' brick pattern. The proposed system is Corium which is formed with extruded clay tiles coloured to match the existing brick as closely as possible, while at the same time introducing a number of features such as the movement joints and stack bonded piers. These feature both improve the construction and, by clearly acknowledging the construction visually enhance the facade.

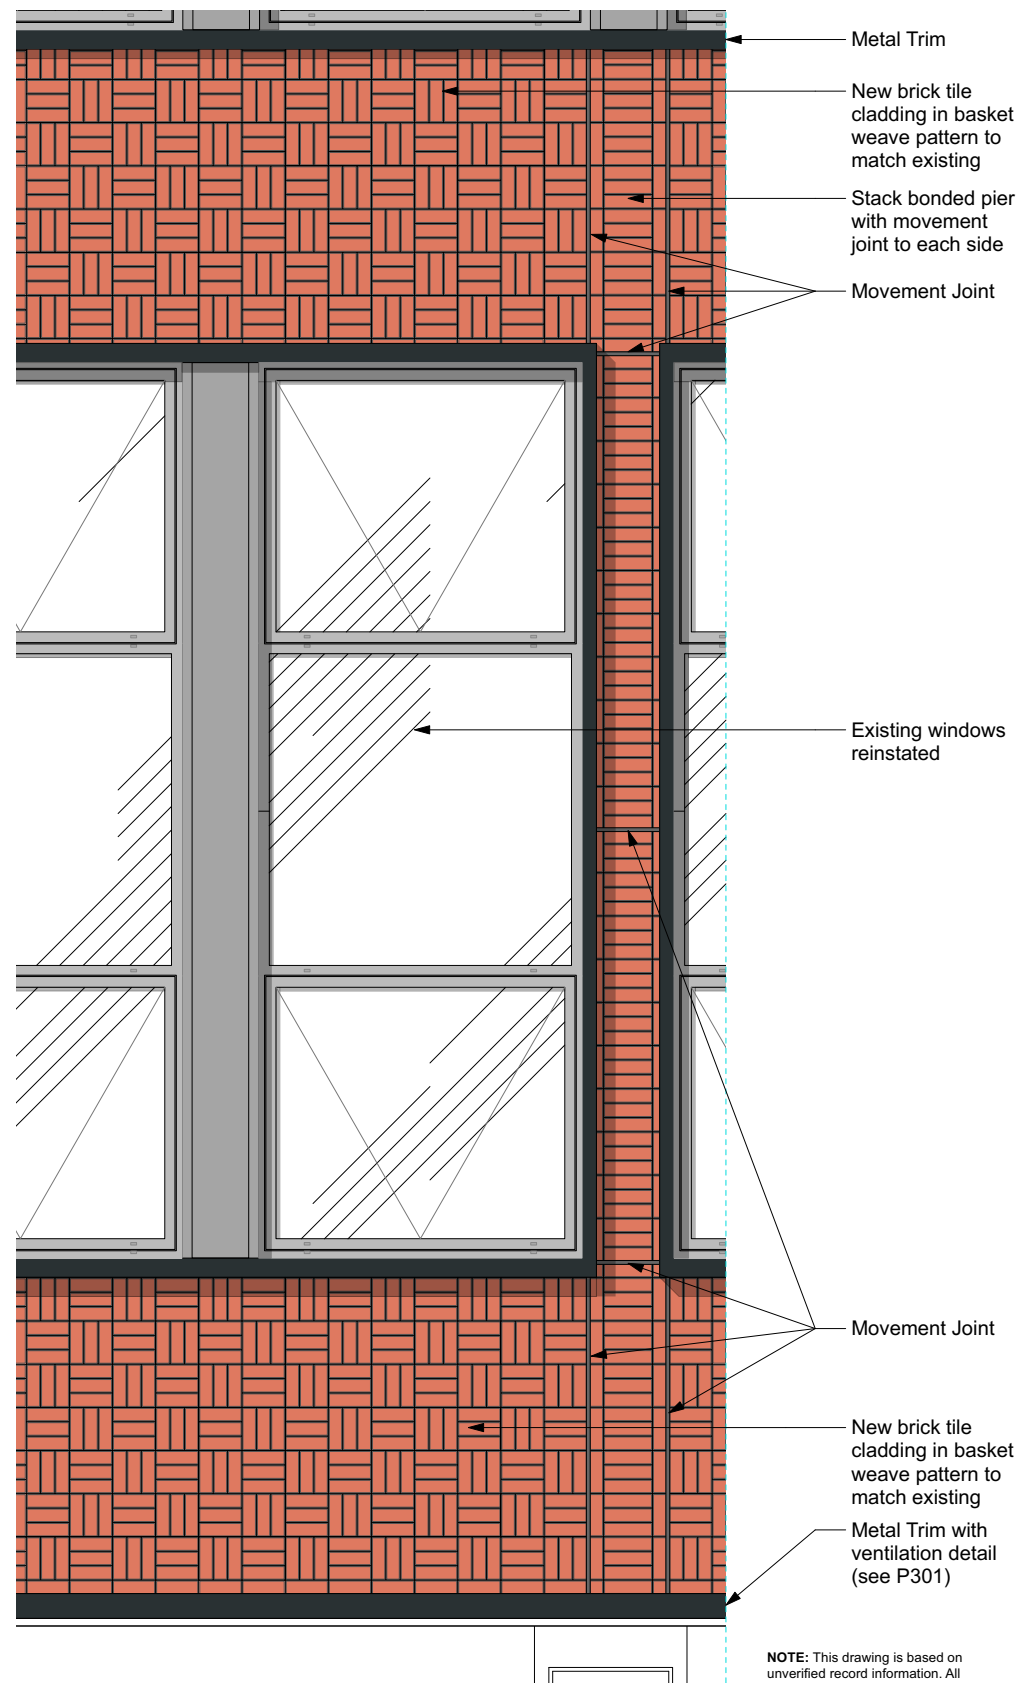
Figure 7 Extract from HFM drawing P207 - showing detail of proposed brick tile cladding bay.

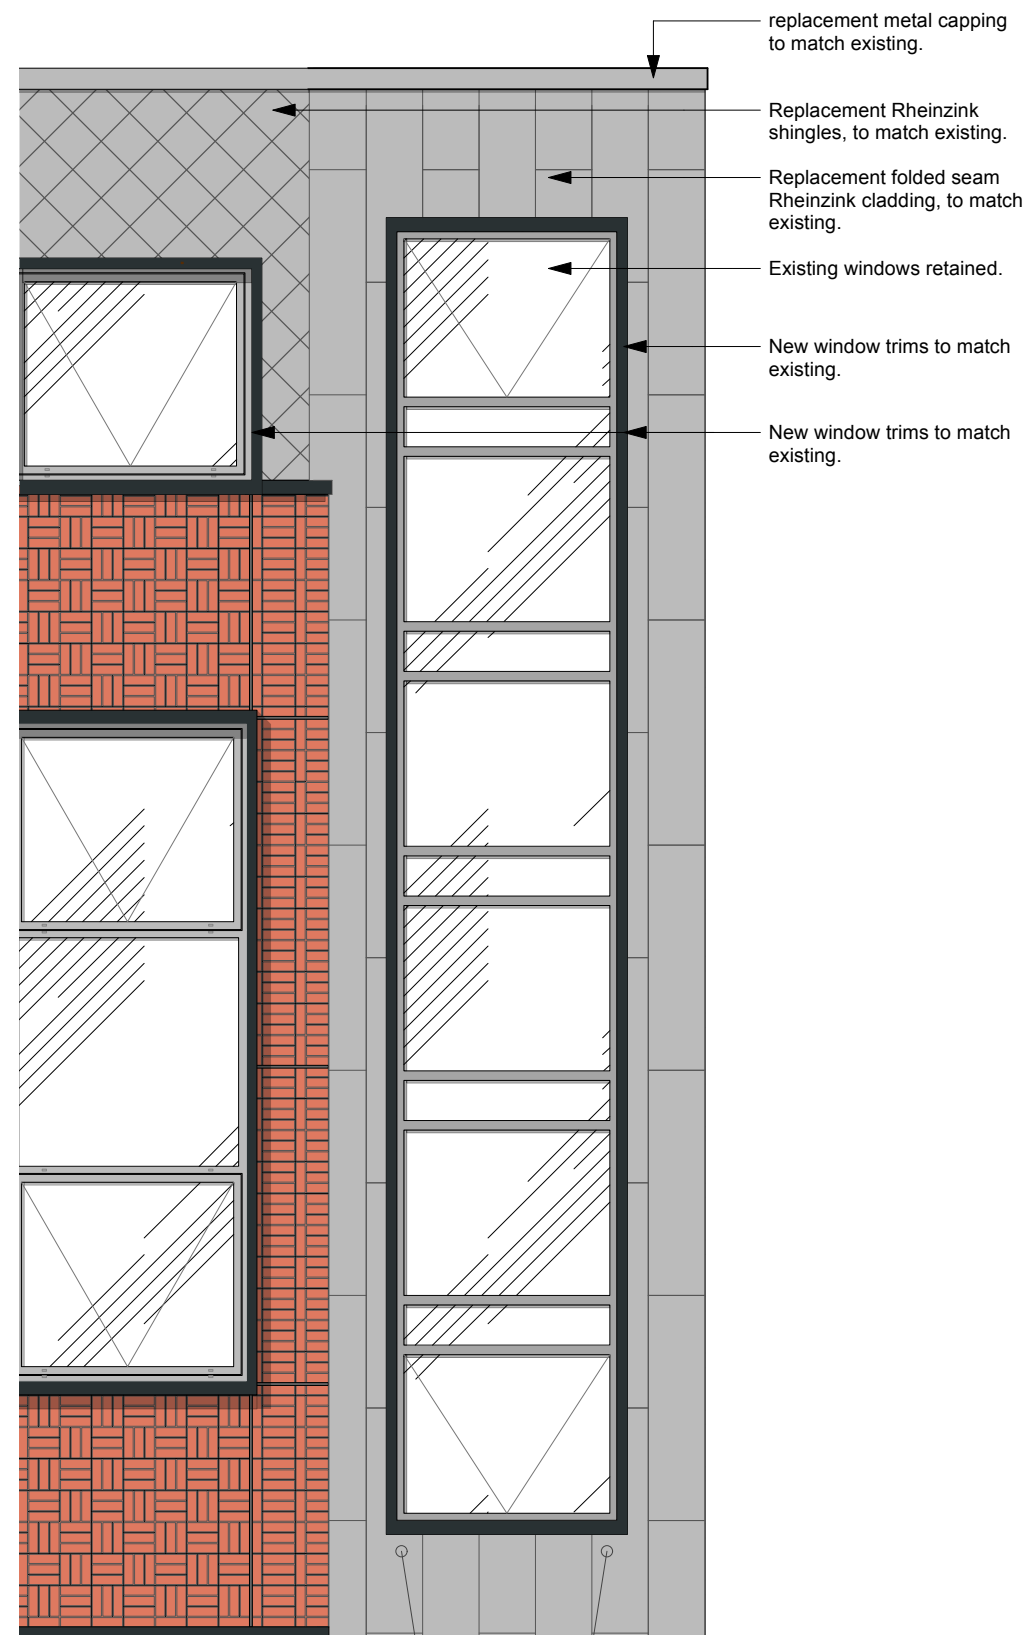
Figure 8 Extract from HFM drawing - showing detail of proposed Like-for like Zinc cladding.

In addition, the existing Rheinzink cladding is to be replaced like-for-like with Rheinzink cladding on non-combustible framing and support sheeting. The scope in the brick slip areas is as follows;

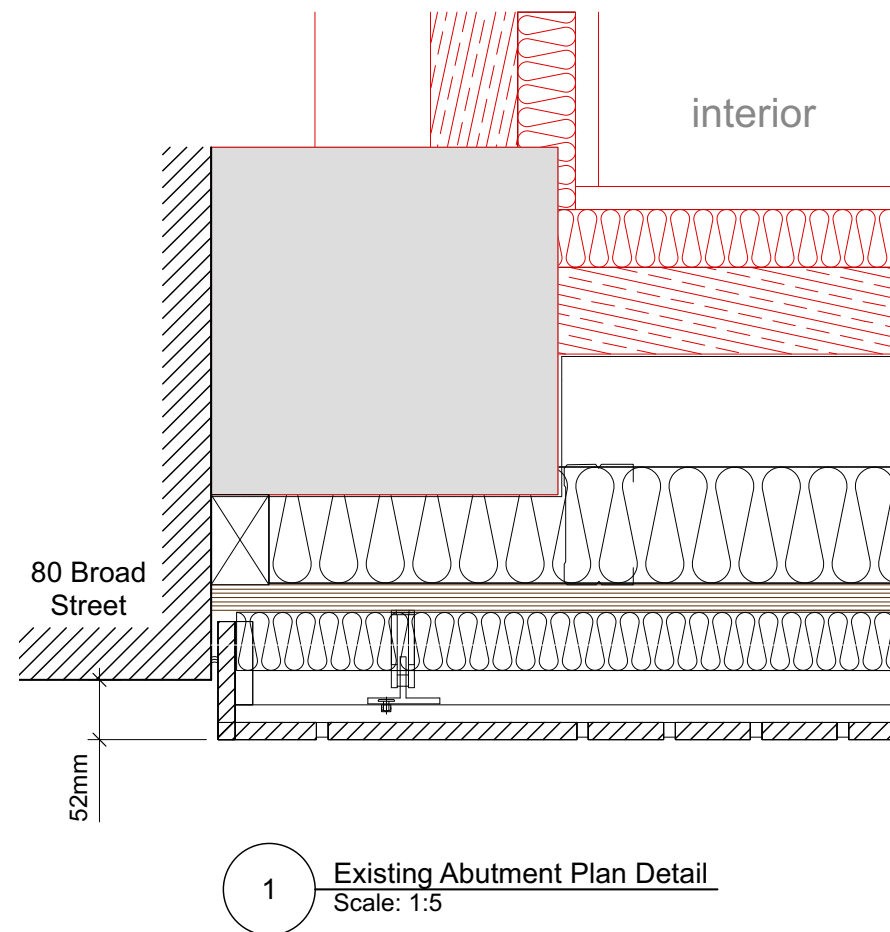
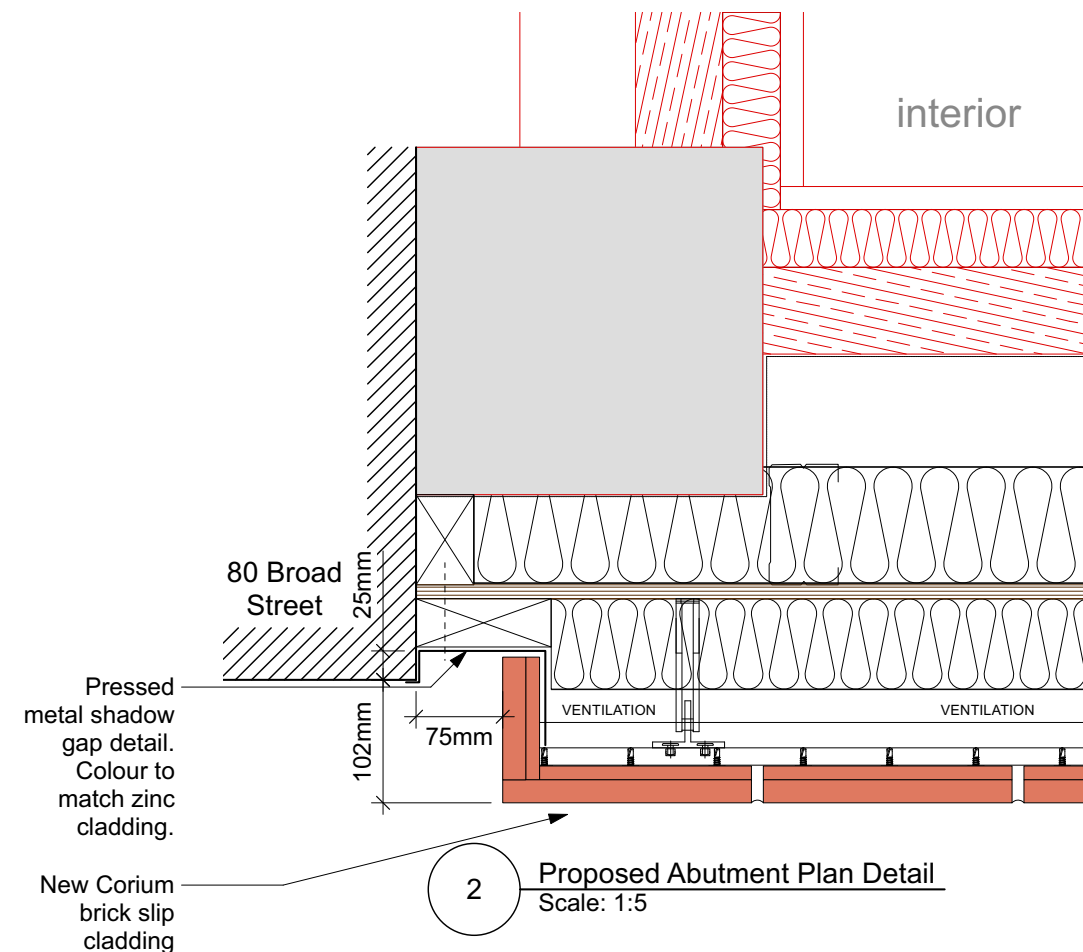
Figure 9 Extract from HFM drawing P503 - proposed abutment with 80 broad Street
