# St Mary's House Reading

Aberdeen Standard Investments

Planning Statement

ISSUE 3 8 June 28th 2021

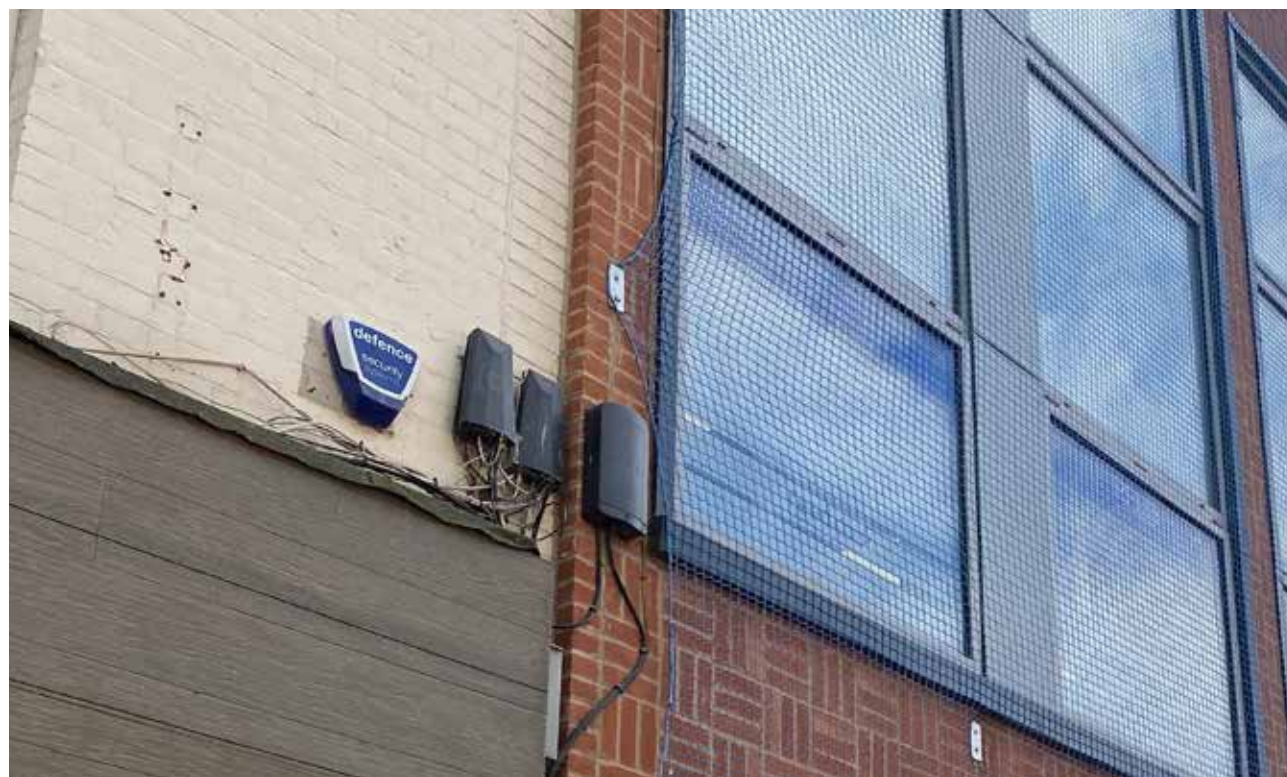
Figure 10 Photograph of existing abutment with 80 Broad Street.

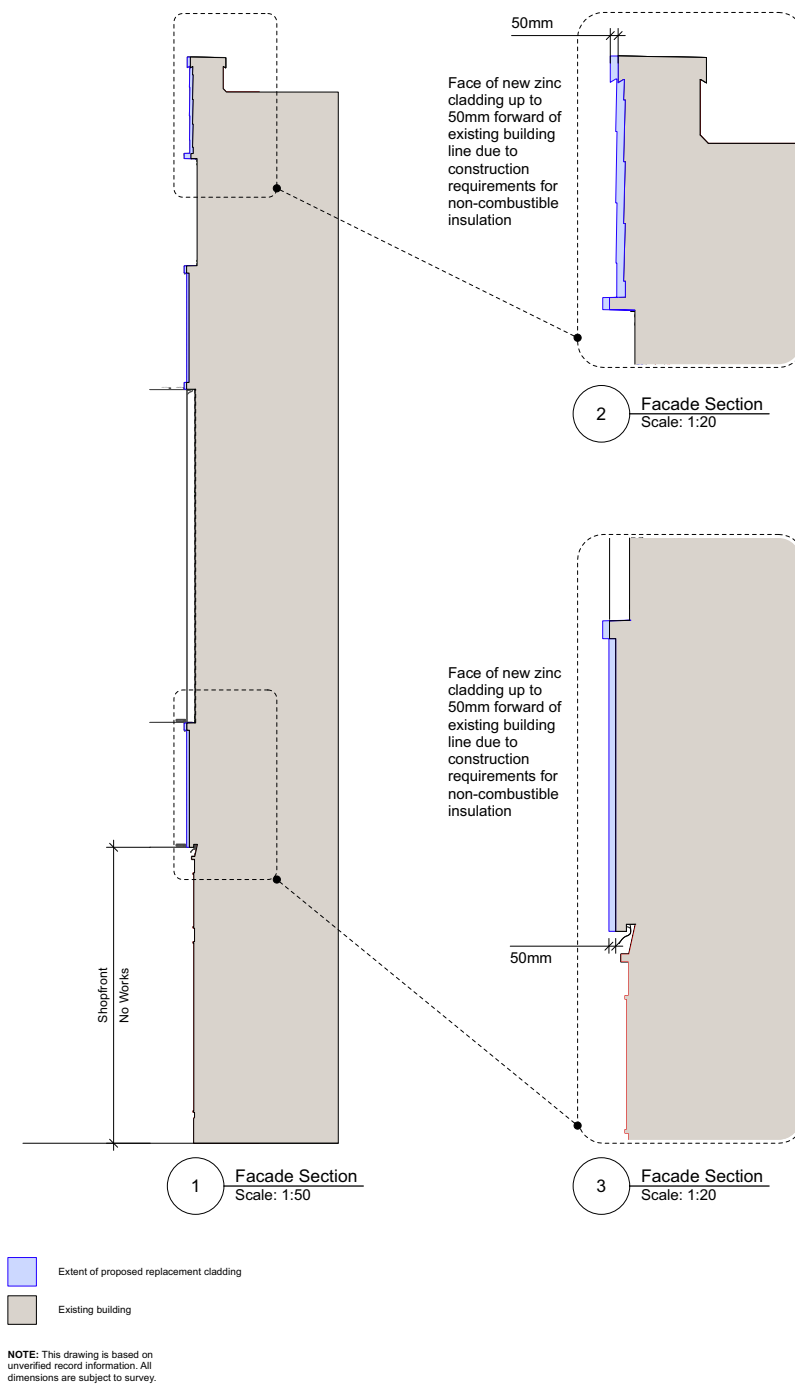
Due to the modifications to the zinc cladding to eliminate combustible materials this will also project slightly further than the existing condition. The intention in this instance is to retain the existing relationship between brick slip and zinc as closely as possible. The impact of this slight alteration to the building line can be seen on drawing P300..

Figure 11 Extract from HFM drawing P300 indicating extent of proposed cladding

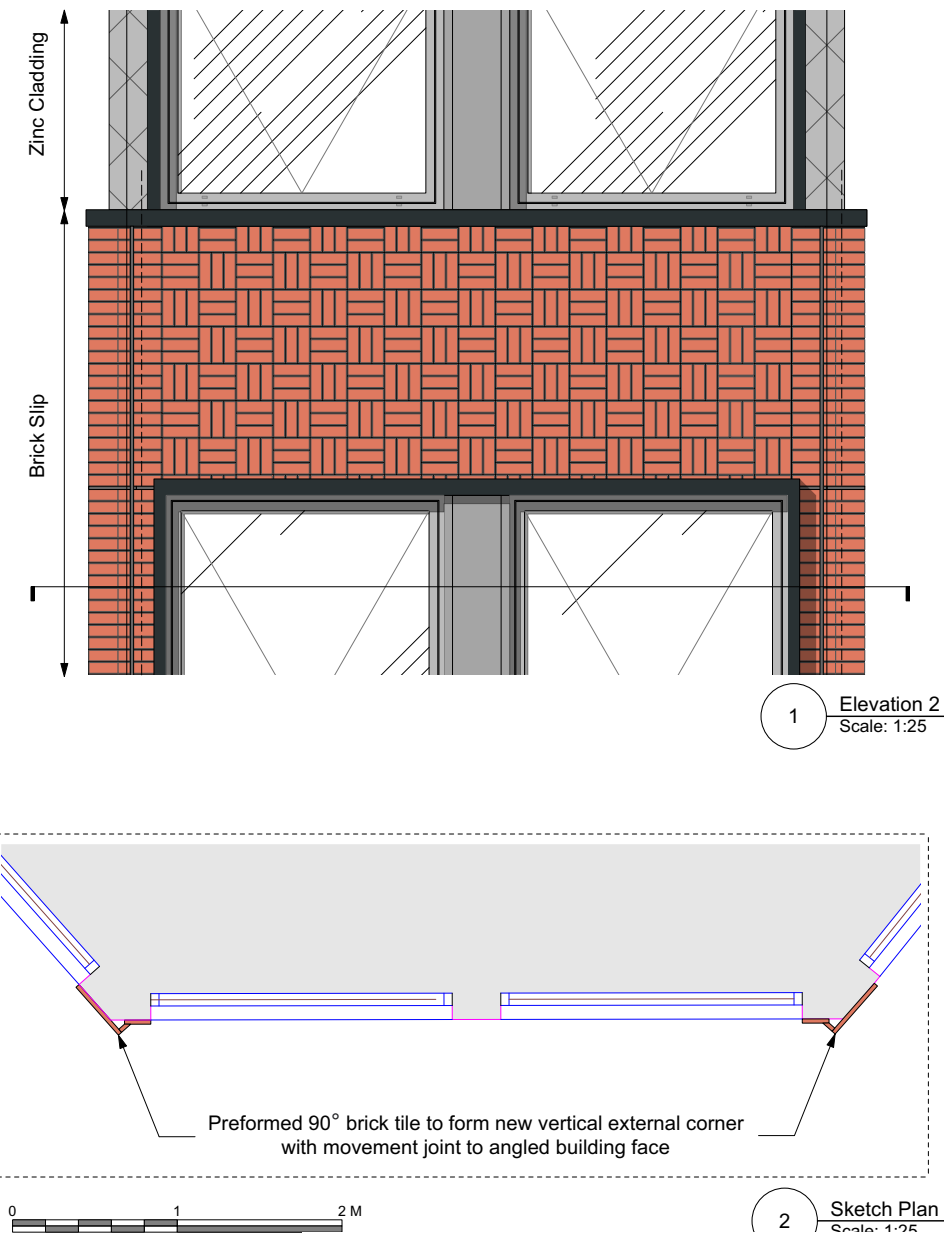
Figure 12 Extract from HFM drawing P21 I - showing proposed chamfered corner detail..

We have also introduced detail changes, which will help introduce movement joints and provide additional assistance with matching existing structure panels and accommodating dimensional tolerances. These include acknowledging the glazing pattern with 'piers' of stack bonded brick tiles, with movement joints either side. At the chamfer corners the current cut brick detail is ragged, which was the nature of a cut bricks required by the existing cladding system. In our proposal we have introduced an oversail, this allows for the use of 90° corner tiles that will give a crisp, sharp detail. These will close against the splayed brick with a flexible joint.
