**Re: Health and Safety Tree Survey Relating to University of Reading - Various Sites**

**Health and Safety  
Tree Survey  
and  
Arboricultural Report**

University of Reading -  
Various Sites

AR4936

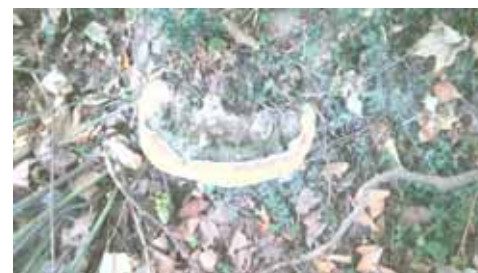
Large *Ganoderma* decay fungi bracket**Observations****Roots**

Well buttressed with pockets of decay between buttress roots and large *Ganoderma* decay fungi bracket. Picus results indicates moderate decay with sound buttress roots.

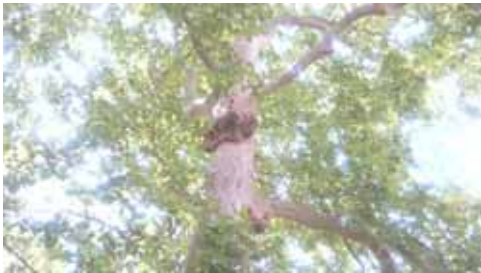
Large trunk Canker on eastern side at 7m

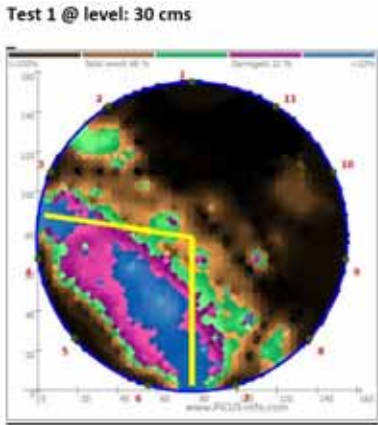
Picus results indicates moderate decay with sound buttress roots

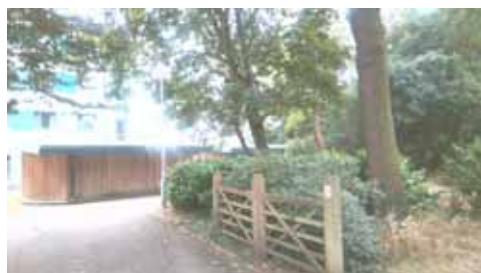
Sounding hammer indicated stem decay on southern side.  
Picus results indicates decay with sound buttress roots.

Stem showing target area

| Remove and replace to allow adjacent trees to thrive. | |

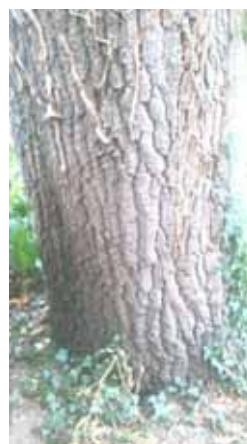
Lower stem with dark sap exuding and staining stem

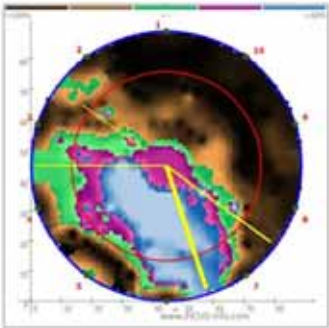
Test 1 @ level: 20cms approximately from ground level.

Picus results indicate decay with  
sound buttress roots

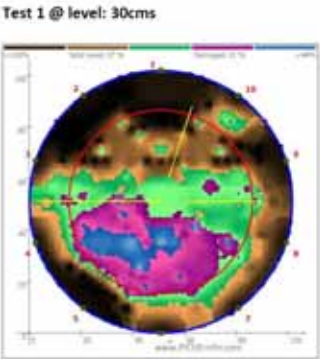
Well buttressed with decay between buttress roots.  
Picus results indicates minor decay with sound buttress roots.

Picus results indicates minor decay with sound buttress roots

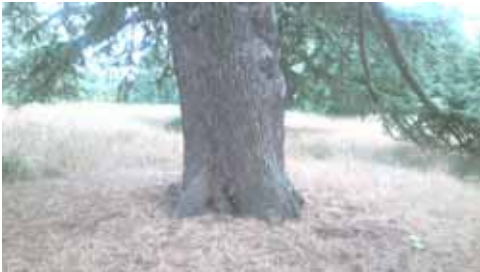
Well buttressed with decay pockets between buttress roots. Picus results indicates moderate decay with sound buttress roots.

Stem base

Crown reduce by approximately 2m to prevent limb failure.  
Maintain reduced mowing cycle to reduce access to trees.

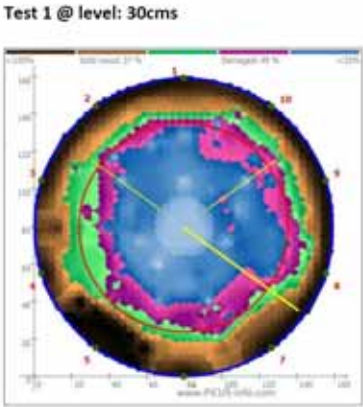
Picus results indicates moderate decay with sound buttress roots

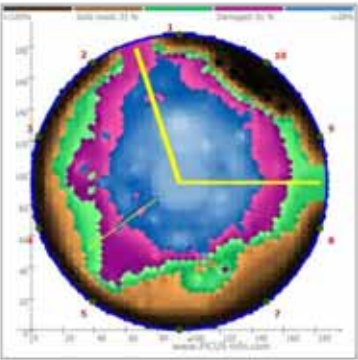
Test 1 @ level: 30cms approximately from ground level.

Appears sound and stable with numerous well occluded wounds.  
Topped at 14m with decay present.  
Picus results indicates moderate decay with sound buttress roots.

Picus results indicates moderate decay with sound buttress roots

Crown reduce by approximately 2m to prevent limb failure.  
Maintain reduced mowing cycle to reduce access to trees.

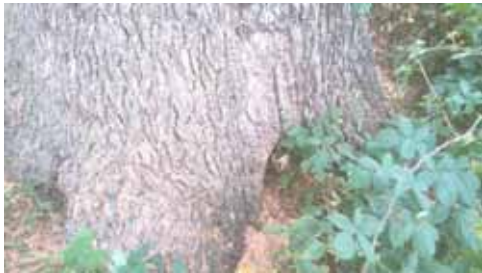
Open cavity on the northern side of the stem

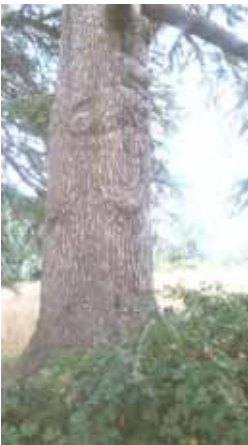
Stem with numerous well occluded wounds

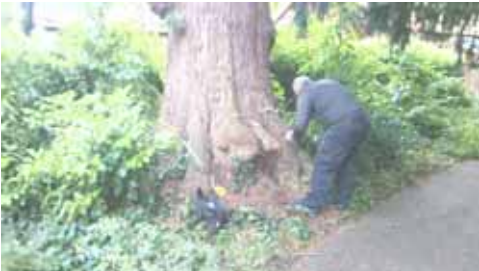
Well buttressed with decay between buttress roots. Picus results indicate extensive decay with sound buttress roots.

Photograph of the buttress roots with decay between buttress roots

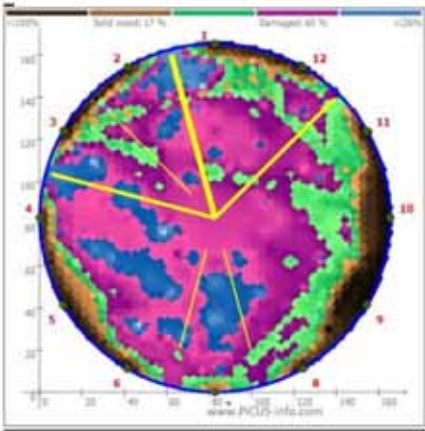
Picus results indicate extensive decay with sound buttress roots

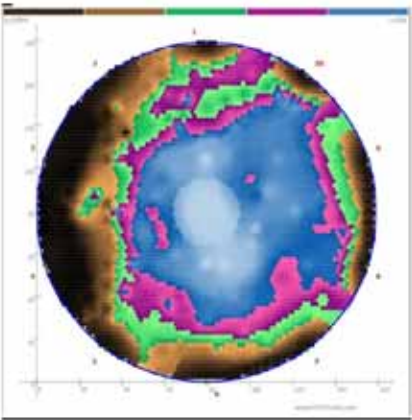
Picus results indicate extensive decay with sound buttress roots.

Picus results indicate extensive decay with sound buttress roots

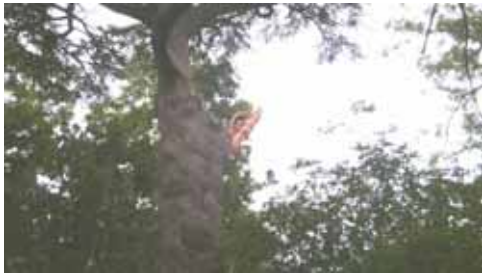
Significant deadwood located throughout crown.  
 Heavy over-extended limbs liable to failure.

Large failure of decayed limb

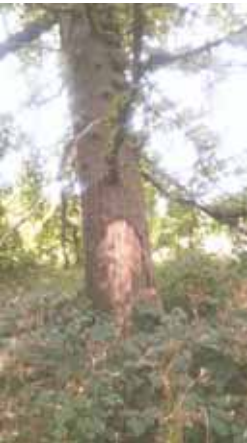
Bark necrosis on the northern side

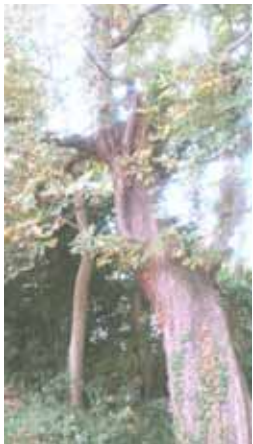
Large area of decay at 8m from old wound likely to extend 3m below. Twin stemmed at 10m with weak union and signs of limb separation.

Large area of decay from old wound

Remove and replace due to location adjacent to road and poor response of this species to heavy pruning.

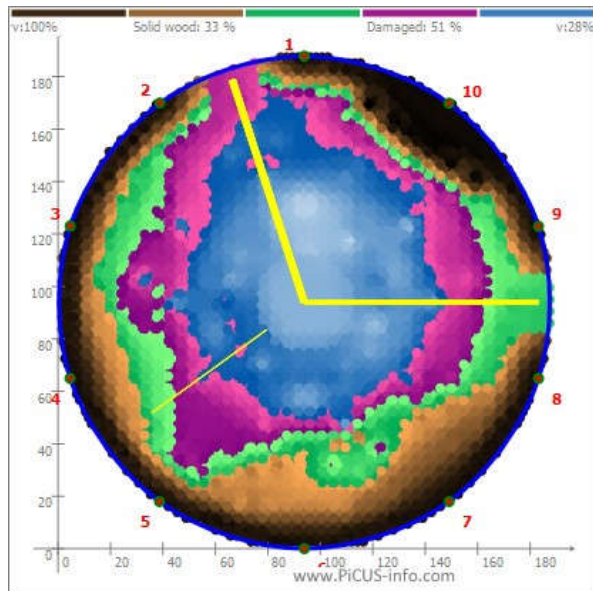
Test 1 @ level: 30cms approximately from ground level.

The measuring point readings give evidence of low velocities overall in the area of test representation showing as decayed timber. The tomographic images shown above has a percentage amount of altered timber. With reference to the 'colour chart see figure 2', the slower sonic speed of sound is represented by three bands of data representation blue/violet/white being the slowest altered/decayed timber, green being faster altered timber, brown being fast sonic-speeds solid timber.

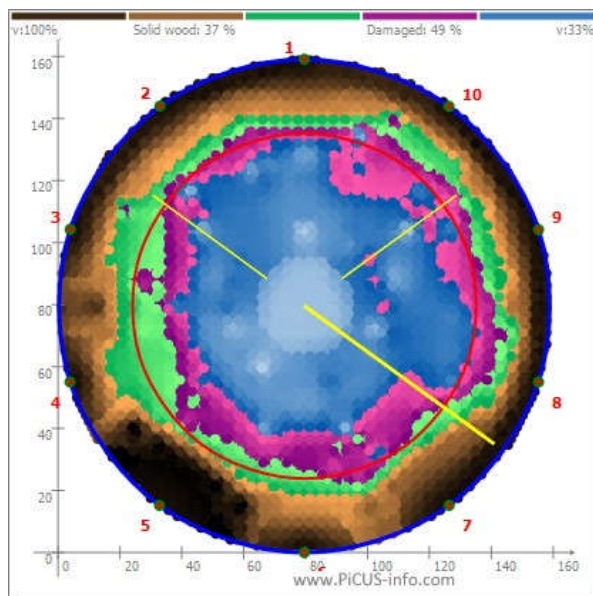
**Test 1 @ level: 30cms**

The measuring point readings give evidence of low velocities overall in the area of test representation showing as decayed timber. The tomographic images shown above has a percentage amount of altered timber. With reference to the 'colour chart see figure 2', the slower sonic speed of sound is represented by three bands of data representation blue/violet/white being the slowest altered/decayed timber, green being faster altered timber, brown being fast sonic-speeds solid timber.

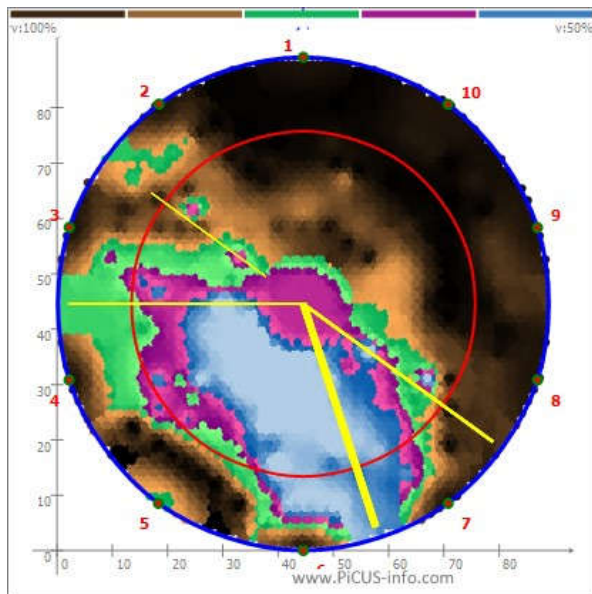
Test 1 @ level: 20cms approximately from ground level.

The measuring point readings give evidence of low velocities overall in the area of test representation showing as decayed timber. The tomographic images shown above has a percentage amount of altered timber. With reference to the 'colour chart see figure 2', the slower sonic speed of sound is represented by three bands of data representation blue/violet/white being the slowest altered/decayed timber, green being faster altered timber, brown being fast sonic-speeds solid timber.

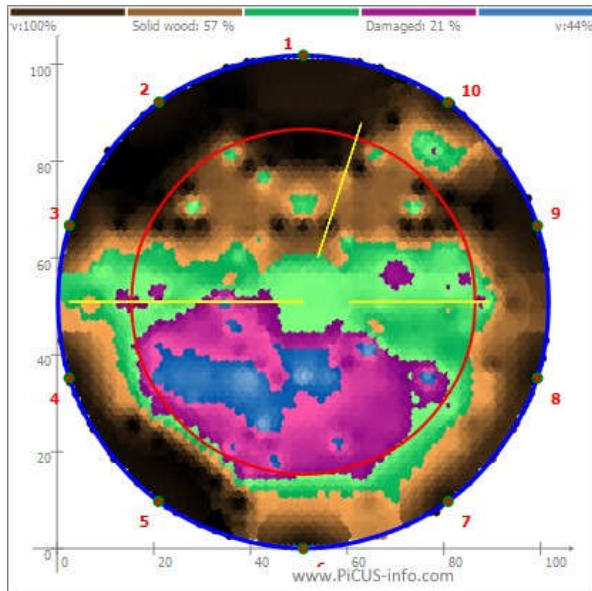
Test 1 @ level: 30cms

The measuring point readings give evidence of medium velocities overall in the area of test representation showing as altered timber. The tomographic images shown above has a percentage amount of altered timber. With reference to the 'colour chart see figure 2', the slower sonic speed of sound is represented by three bands of data representation blue/violet/white being the slowest altered/decayed timber, green being faster altered timber, brown being fast sonic-speeds solid timber.

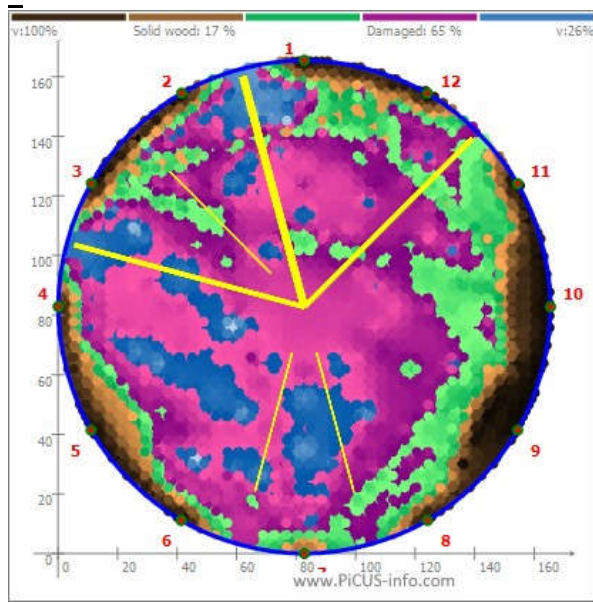
Test 1 @ level: 30 cms

The measuring point readings give evidence of low velocities overall in the area of test representation showing as decayed timber. The tomographic images shown above has a percentage amount of altered timber. With reference to the 'colour chart see figure 2', the slower sonic speed of sound is represented by three bands of data representation blue/violet/white being the slowest altered/decayed timber, green being faster altered timber, brown being fast sonic-speeds solid timber.

Consider major crown reduction to reduce stress from the decayed areas.

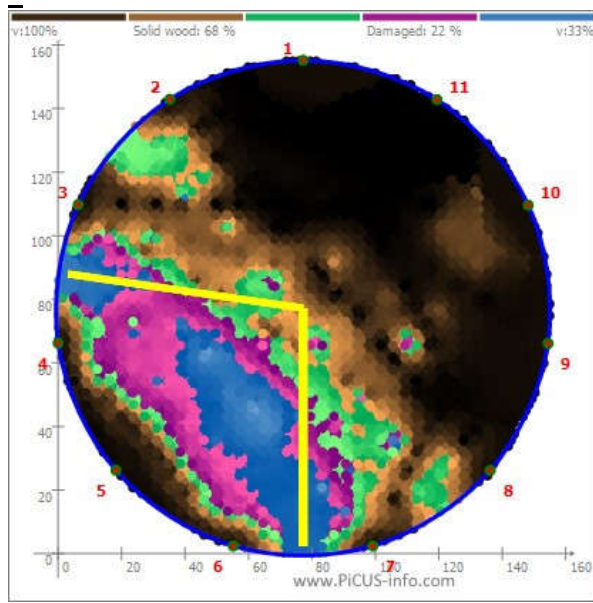
Test 1 @ level: 30 cms

The measuring point readings give evidence of medium velocities overall in the area of test representation showing as decayed timber. The tomographic images shown above has a percentage amount of altered timber. With reference to the 'colour chart see figure 2', the slower sonic speed of sound is represented by three bands of data representation blue/violet/white being the slowest altered/decayed timber, green being faster altered timber, brown being fast sonic-speeds solid timber.

Consider major crown reduction to reduce stress from the decayed areas.

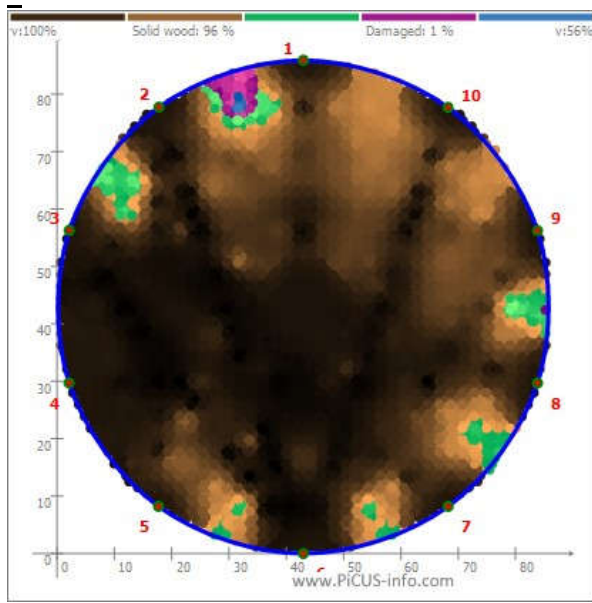
Test 1 @ level: 30 cms

The measuring point readings give evidence of high velocities overall in the area of test representation showing as sound timber. The tomographic images shown above has a percentage amount of altered timber. With reference to the 'colour chart see figure 2', the slower sonic speed of sound is represented by three bands of data representation blue/violet/white being the slowest altered/decayed timber, green being faster altered timber, brown being fast sonic-speeds solid timber.

Consider major crown reduction/ monolith to reduce stress from the decayed areas.

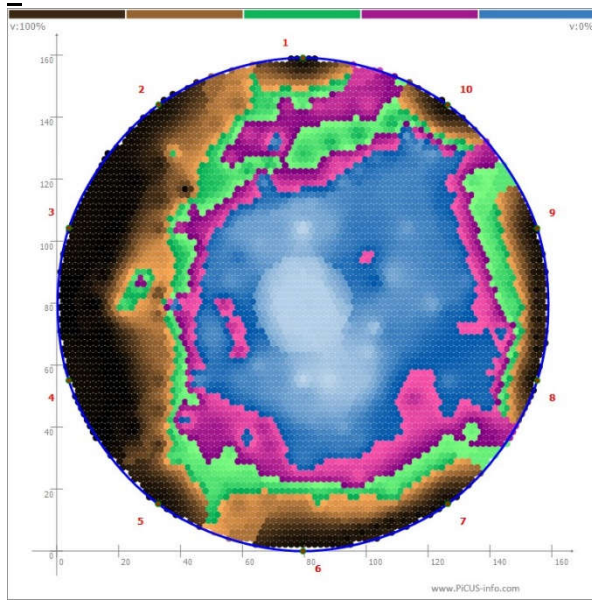
**Test 1 @ level: 30 cms**

The measuring point readings give evidence of low velocities overall in the area of test representation showing as decayed timber. The tomographic images shown above has a percentage amount of altered timber. With reference to the 'colour chart see figure 2', the slower sonic speed of sound is represented by three bands of data representation blue/violet/white being the slowest altered/decayed timber, green being faster altered timber, brown being fast sonic-speeds solid timber.

Consider major crown reduction/monolith to reduce stress from the decayed areas.
