**87 Balmore Drive  
Caversham  
Berkshire  
RG4 8NN**

# **Preliminary Bat Roost Assessment**

**Ref: R2757a**

**April 2021**

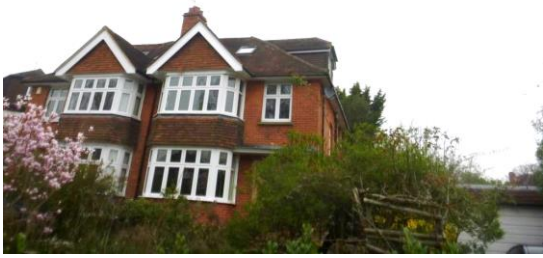
1. Front of the house viewed from the south.

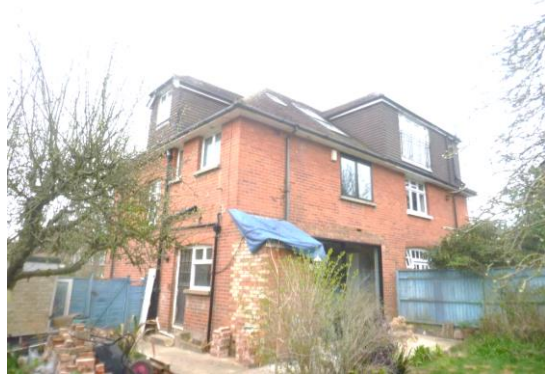
2. Rear and side of the house viewed from the northeast.

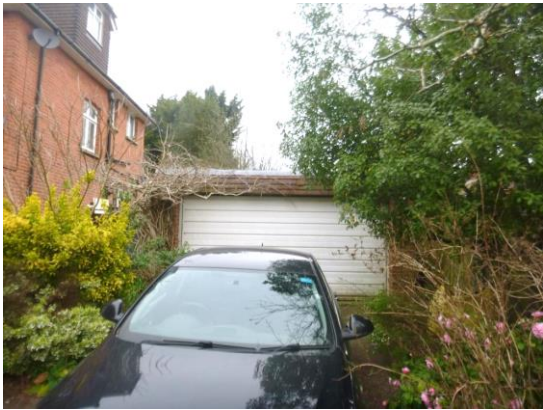
3. Detached garage to the east of the house.

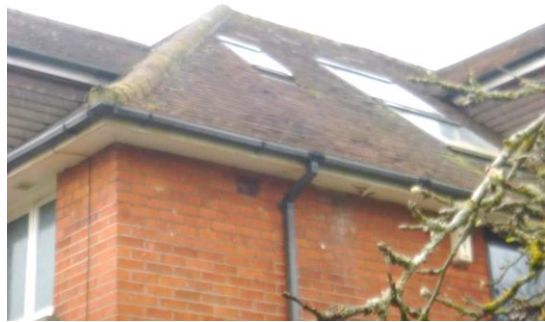
4. Roof tiles mostly fitted tightly.

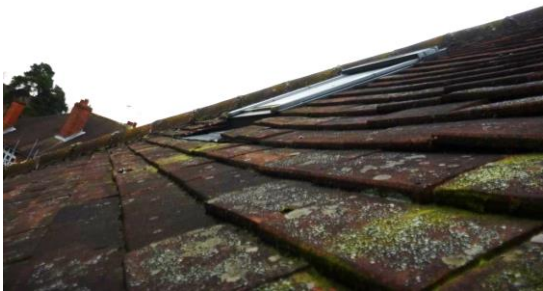
**3.2.2** The house's roof was covered with flat roof tiles that were mostly in place and fitted tightly, apart from some occasional gaps under the tiles around two skylights situated to the rear of the house (**Photographs 4 & 5; Target notes 1 & 2**). The ridge and hip tiles were all in place and fitted tightly on the main roof and dormer window (**Photograph 6; Target note 3**). The timber soffit boxes were tight to the eaves around the house (**Photograph 7; Target note 4**). The pitched roof and bay window to the front of the house was clad with hanging tiles, which were mostly tight apart from where one tile was slipped towards the apex and around the corners of the bay window (**Photograph 8; Target notes 5 & 6**). The half-hipped dormer window to the eastern side of the house was also clad with hanging tiles, which were lifted around the corners (**Photograph 9; Target note 7**). The gaps under the hanging tiles offered features suitable for roosting bats.

5. Gaps under the roof tiles around the skylight to the side of the house.

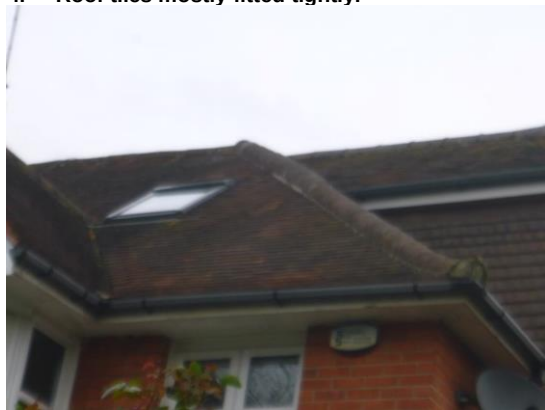
6. Ridge and hip tiles in place and mortared.

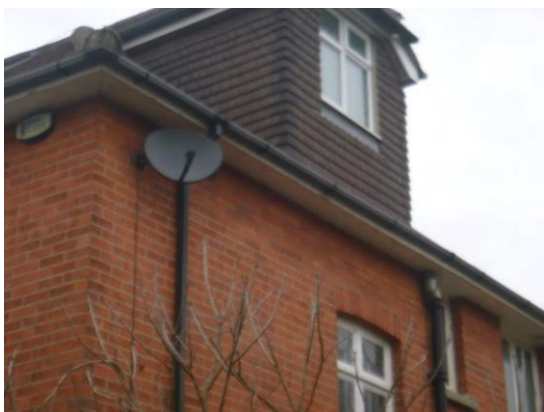
7. Timber soffits tight to the eaves.

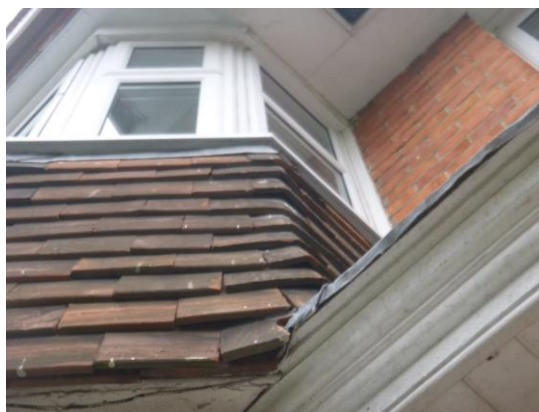
- 4.1.2** Externally, the house had features suitable for use by crevice-dwelling species such as the pipistrelles (*Pipistrellus* spp.) and/or small *Myotis* species. These features included the gaps under and behind the hanging tiles, in particular to the eastern side and front of the house. No evidence of roosting bats (i.e. staining or droppings) was visible on the exterior of the house during the inspection.

8. Corner hanging tiles lifted on the bay window to the front of the house.

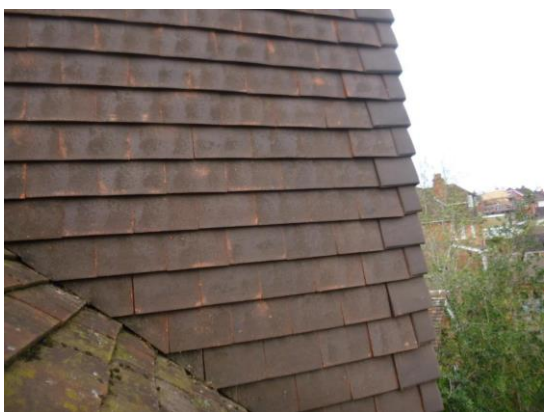
9. Hanging tiles lifted on the dormer window at the eastern side of the house.

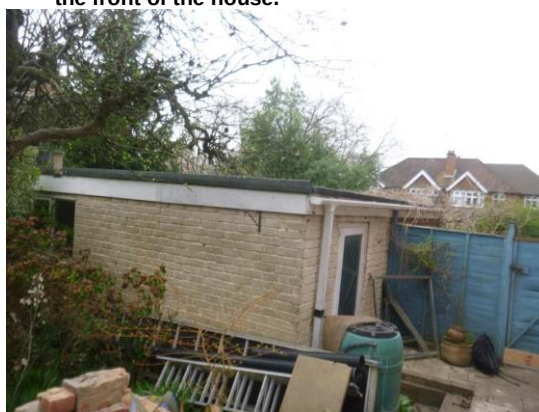
**3.2.3** The flat roof on the garage was tightly lined with bitumen felt (**Photograph 10; Target note 8**). The timber fascias were tight to the wall on the western side of the garage (**Photograph 11; Target note 9**). A gap was present behind the timber fascia on the eastern side of the garage, which was cobwebbed (**Photograph 12; Target note 10**). A small, cobwebbed gap was present behind the fascias to the rear of the garage, which were of limited extent (**Photograph 13; Target note 11**). A narrow strip of hanging tiles on the front southern side of the garage had some gaps behind them,

10. Flat roof garage tightly fitted with bitumen roofing felt.

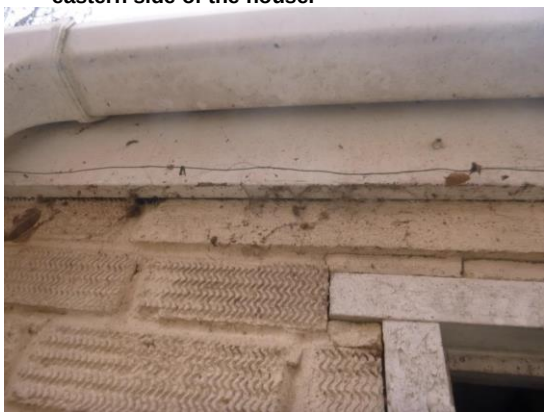
11. Timber fascias tight on the western side of the garage.

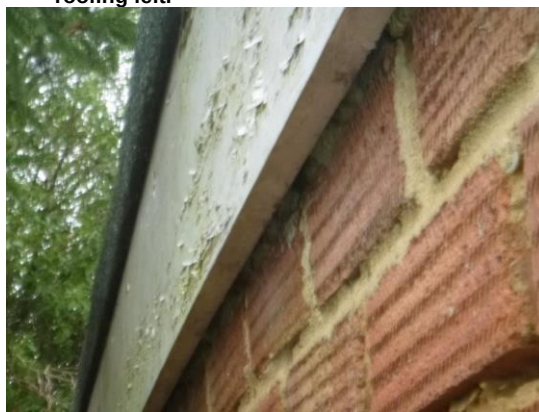
12. Gaps behind timber fascias on the eastern side of the garage.

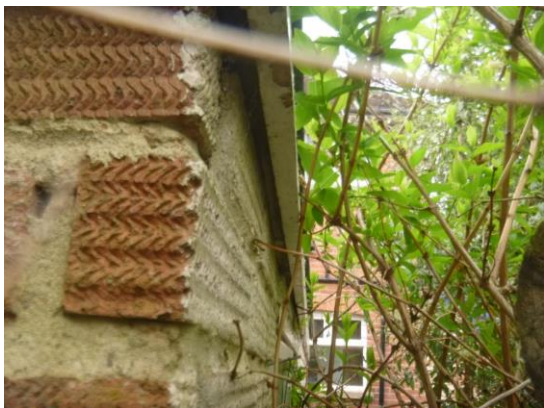
13. Small cobwebbed gap behind fascias to the rear of the garage.

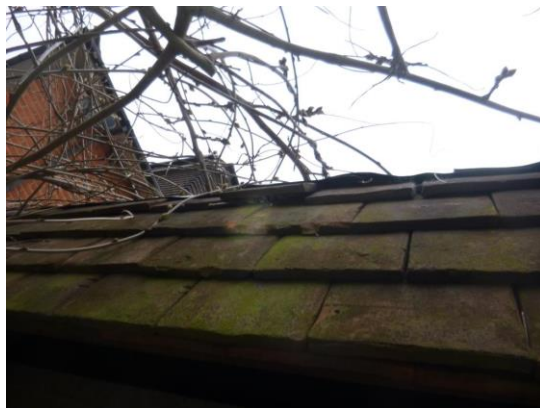
but they showed no evidence of use by bats during a close inspection (**Photograph 14; Target note 12**).

14. Strip of hanging tiles on the front of the garage lifted in places.

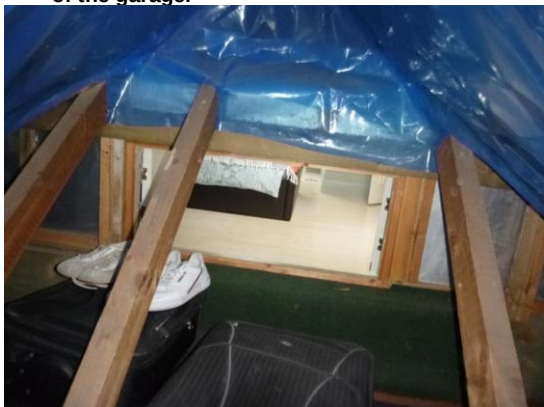
15. Internal view of eaves space 1 with a south facing gable end.

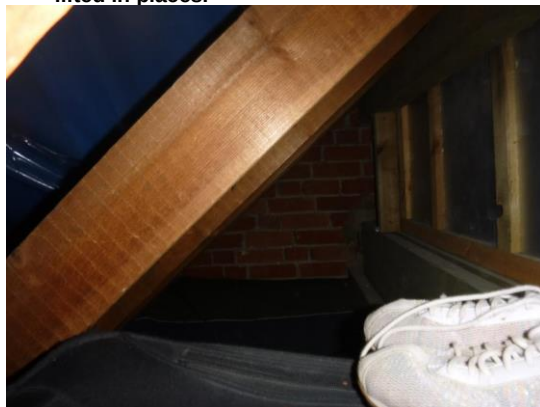
16. Brick wall at the western end of the eaves space 1.

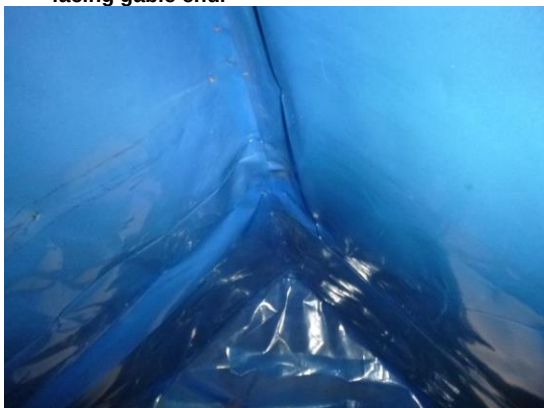
17. The unlined roof covered in plastic in eaves space 1.

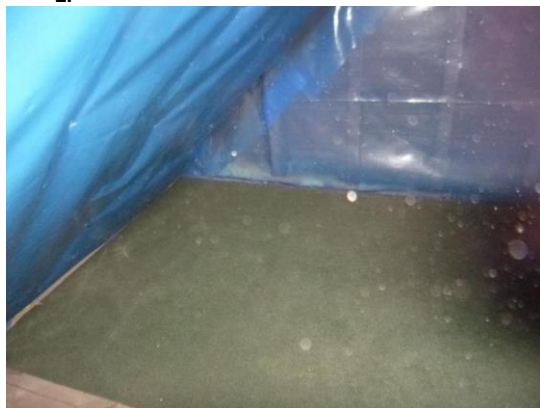
18. Floor boarded in eaves space 1.

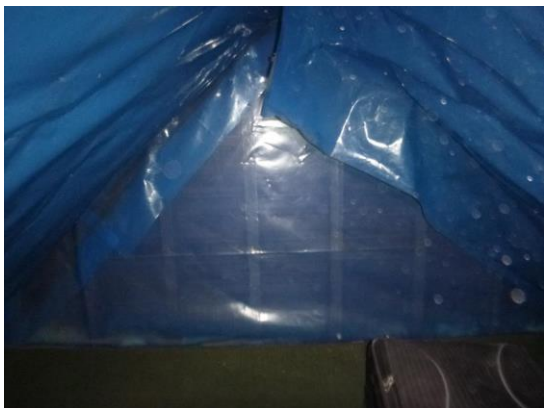
- 3.3.1** Within the house there were two eaves spaces. Eaves space 1 was situated along the front (southern) side of the house and was accessed through a central doorway. The roof within the space was of 'cut and pitch' construction. The space had an approximate floor-to-ridge height of one metre and had a front facing gable end (**Photograph 15**). A brick wall was present towards the western end of the eaves, but the eastern end was not visible (**Photograph 16; Target note 13**). The roof was unlined but was covered with plastic sheeting under the rafters (**Photograph 17; Target note 14**). The floor was boarded centrally and around the doorway with carpet in places and was insulated with fibreglass (**Photograph 18; Target note 15**). The eaves were open (**Target note 16**). The southern gable end was covered with plastic sheeting with the hanging tiles visible behind (**Photograph 19; Target note 17**).

19. Hanging tiles covered with plastic at the southern gable end in eaves space 1.

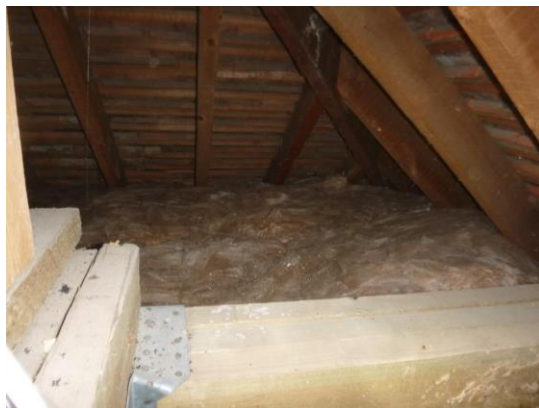
- 3.3.2** Eaves space 2 was situated along the rear (northern) side of the house and was accessed through a couple of doorways and had an approximate floor-to-ridge height of one metre (**Photograph 20**). A plasterboard wall and pipework were present towards the south eastern end of the eaves space (**Photograph 21; Target note 18**). The roof was unlined with the undersides of the roof tiles visible (**Photograph 22; Target note 19**). The floor was boarded in places and was insulated with fibreglass (**Photograph 23; Target note 20**). The eaves were open (**Photograph 24; Target note 21**).

20. Internal view of eaves space 2.

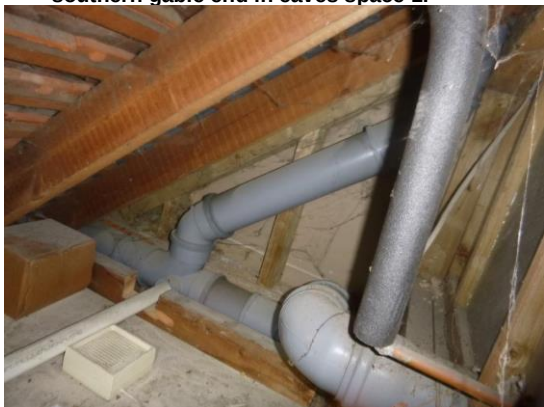
21. Plasterboard wall at the south eastern end of eaves space 2.

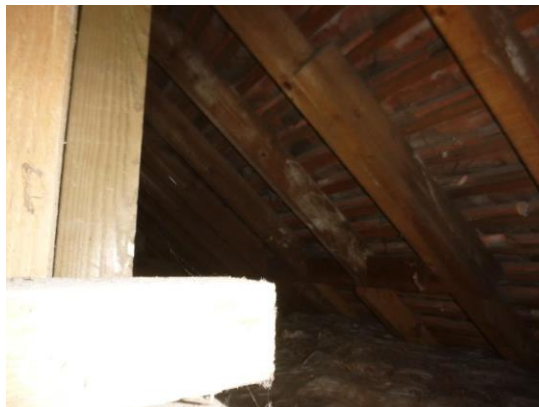
22. The unlined roof of eaves space 2.

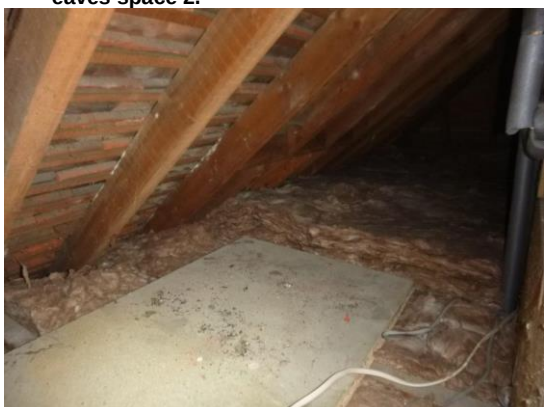
23. The boarded floor and insulation in eaves space 2.

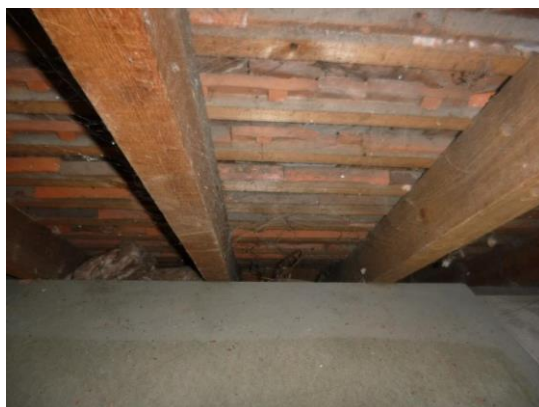
24. The open eaves in eaves space 2.

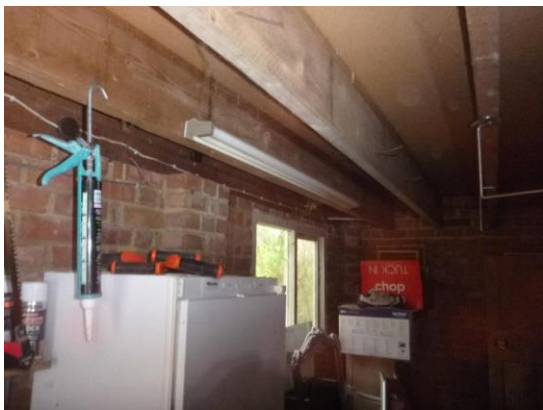
- 3.3.3** The garage had a concrete floor and was lined with hardboard, which was tight to the walls (**Photograph 25; Target note 22**). A gap was present around the top of the metal doorways (**Photograph 26; Target note 23**).

25. The internal view of the garage with hardboard tightly fitted on the roof.

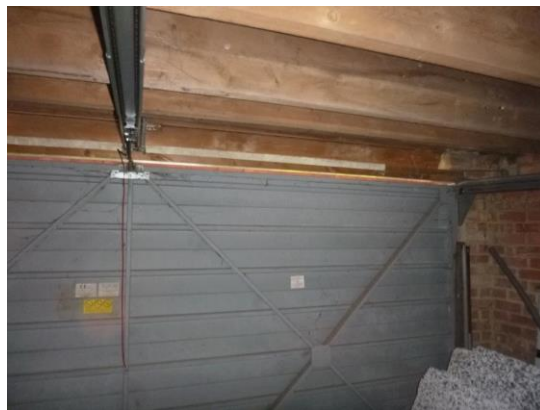
26. Gap present at the top of the garage door.
