**36 Chazey Road  
Reading  
Berkshire  
RG4 7DS**

# **Preliminary Bat Roost Assessment**

**Ref: R2838a**

**July 2021**

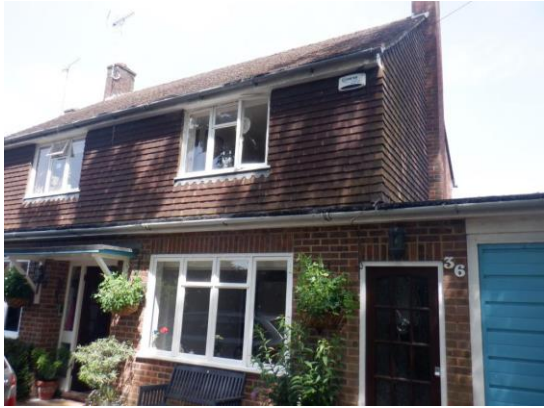
1. Front of the house viewed from the south.

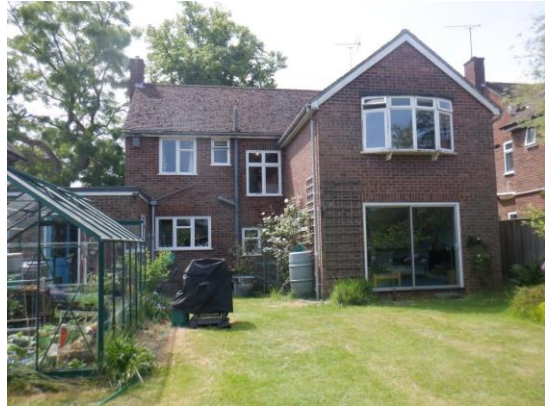
2. Rear of the house viewed from the north.

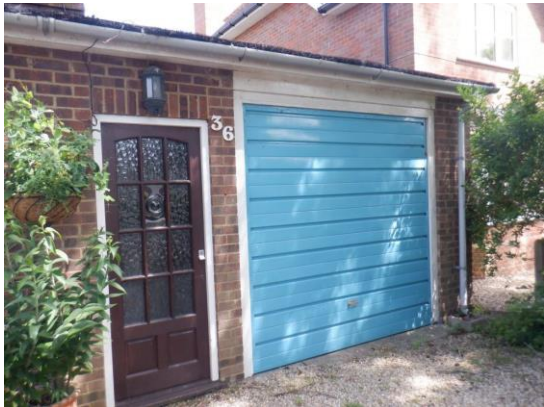
3. Flat roof garage attached to the eastern side of the house.

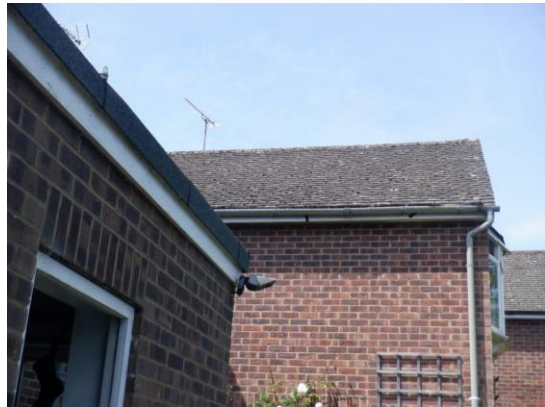
**4.2.2** The roof was covered with flat roof tiles that were mostly in place and fitted tightly, apart from some occasional gaps including by the chimney on the front elevation and under a few lifted tiles along the verge to the rear of the house where a tile had slipped (**Photographs 4 & 5; Target notes 1 & 2**). The gaps offered potential roosting opportunities for crevice dwelling bats. The ridge tiles were all in place and fitted tightly (**Photograph 6; Target note 3**). The timber soffit boxes were mostly tight to the eaves around the house, apart from a few gaps on the rear gable end where there was some missing mortar (**Photograph 7; Target note 4**). The front and half of the sides of the house was clad with hanging tiles, which had the occasional gaps, including around the corners, the edges of the window and where they were lifted on the front elevation, and at the eastern end of the house where there was a broken tile and at the join with the timber soffits (**Photographs 8, 9, 10 & 11; Target notes 5, 6, 7, 8 & 9**). The verges were mostly all mortared, apart from a small section at the eastern side on the rear elevation where it had cracked and the roof tiles were lifted (**Photograph 12; Target note 10**). A slight gap was present between the timber fascias and under cloaking on the rear gable end, offering potential access opportunities for bats (**Photograph 13; Target note 11**).

4. Roof tiles mostly tight to the rear of the house.

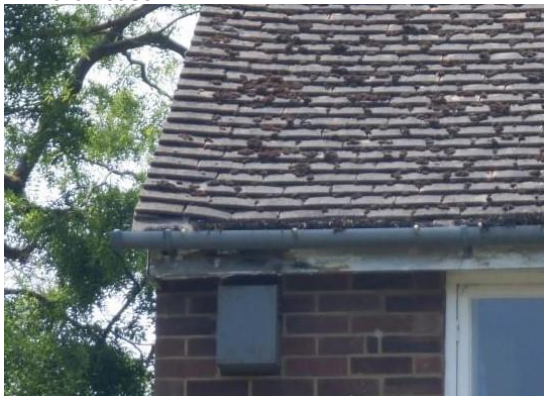
5. Roof tiles slightly lifted on the rear eastern verge.

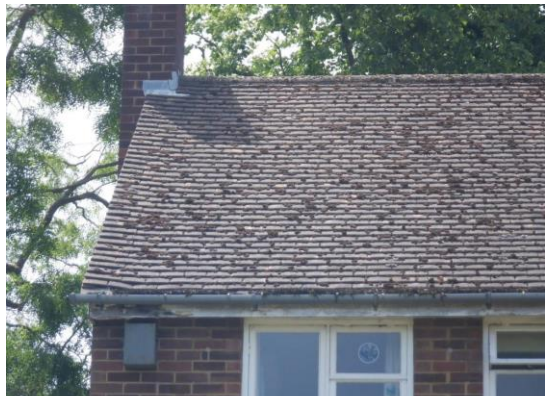
6. Ridge tiles all in place and mortared.

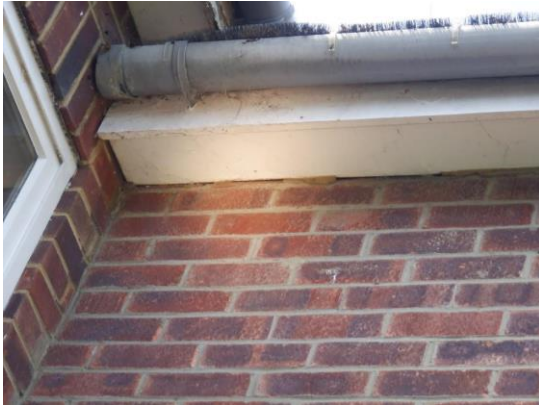
**7. Missing mortar along edge of the soffit box on the rear gable end.**

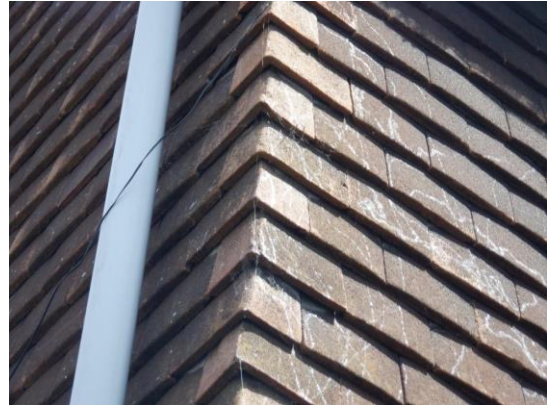
- 5.1.2** Externally, the house had features suitable for use by crevice-dwelling species such as pipistrelle (*Pipistrellus* spp.) and/or small *Myotis* species. These features included the gaps under and behind the hanging tiles, which were all limited to the front and front half of the eastern and western side walls, and some gaps behind the soffits, under a roof tile by the chimney and at the verge of the two-storey rear gable end. No evidence of roosting bats (i.e., staining or droppings) was visible on the exterior of the house during the inspection.

**8. Gaps under the corner hanging tiles at the front of the house.**

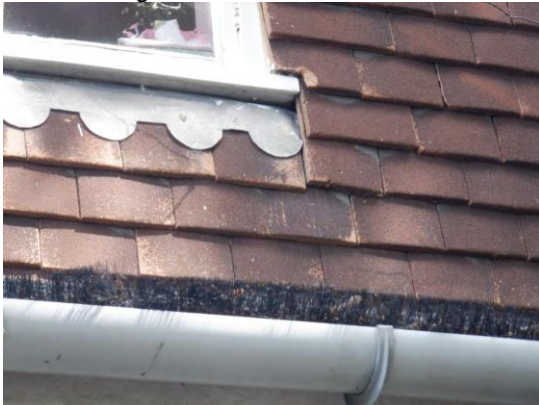
**9. Gaps behind hanging tiles at the edge of the windows to the front of the house.**

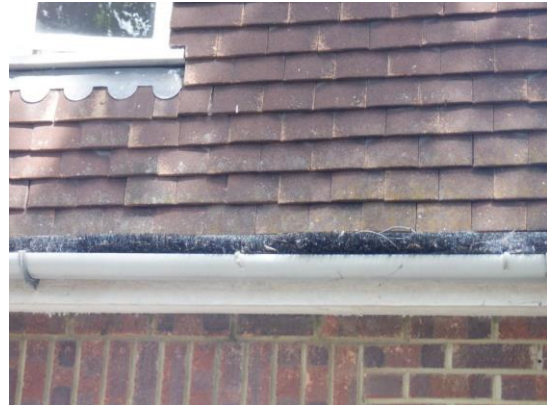
**10. Lifted hanging tiles at the front of the house.**

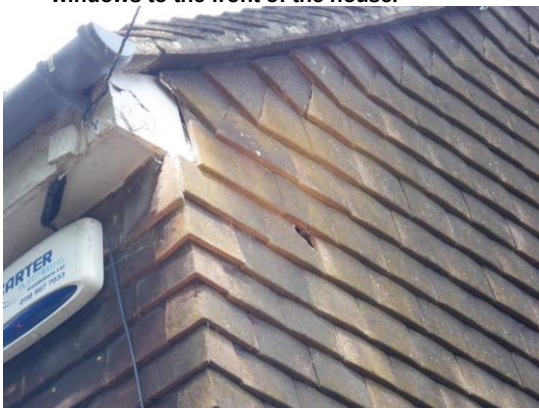
**11. Broken hanging tile and gap at the edge of the soffit box at the eastern side of the house.**

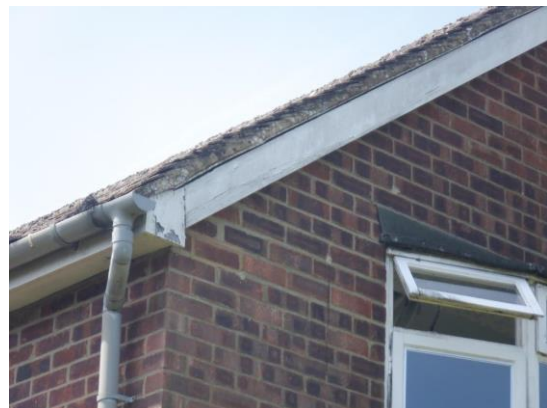
**12. Verges mortared to the rear of the house.**

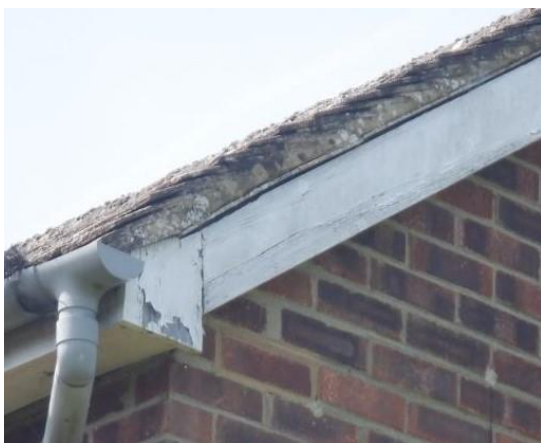
**13. Gap between the timber fascia and under cloak at the rear gable end.**

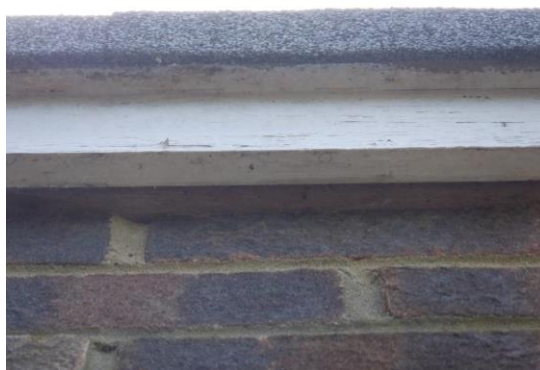
**4.2.3** The flat roof on the garage and single storey extension was tightly lined with bitumen felt and timber barge boards (**Photograph 14; Target note 12**).

**14. Bitumen felt and timber barge boards tight on the garage.**

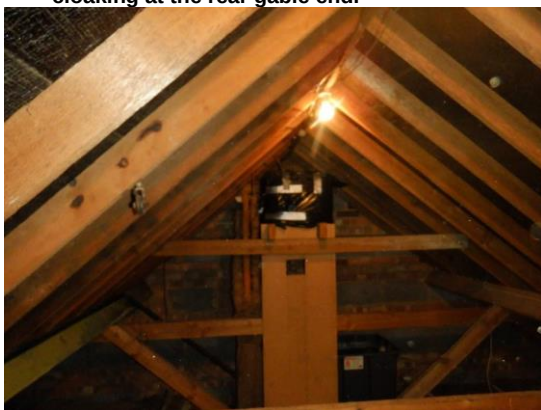
**15. Internal view of the main loft space.**

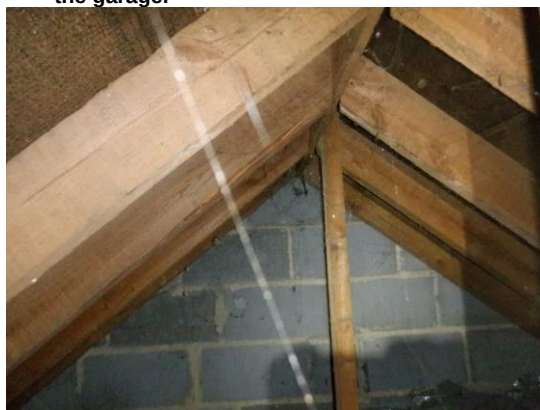
**16. Internal view of the rear gable end.**

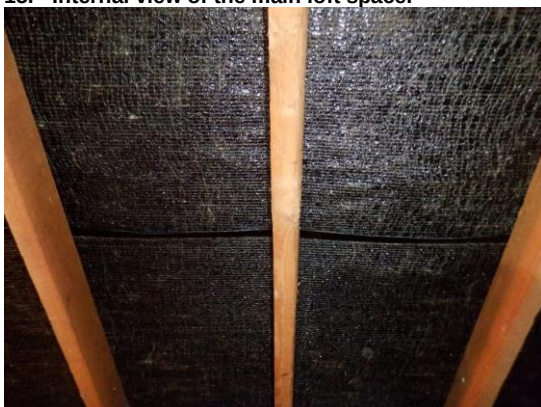
**17. Roof tightly lined with bitumen felt.**

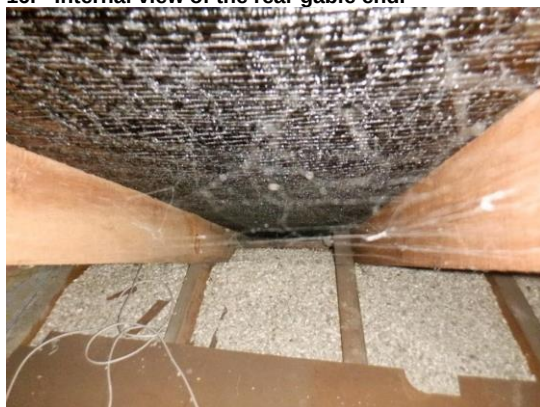
**18. The floor insulated with vermiculite.**

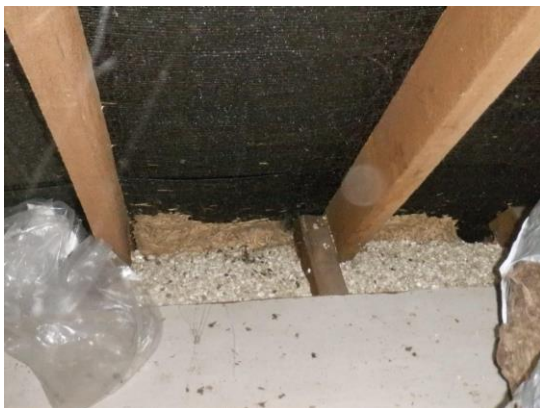
**19. The eaves open in the main section of roof but old wasps' nest present.**

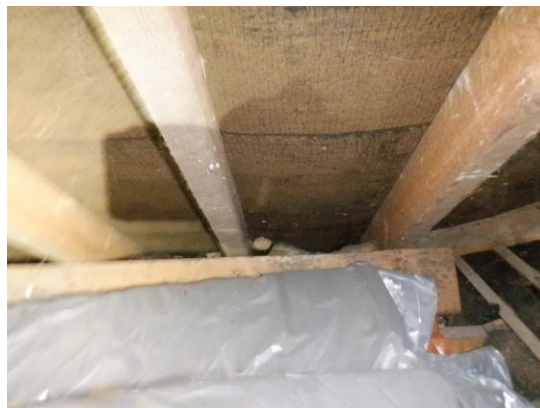
**20. The eaves filled with fibreglass in the rear section of roof.**

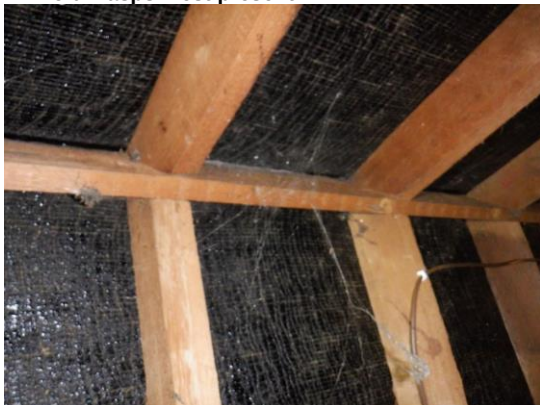
**21. The ridge heavily cobwebbed.**

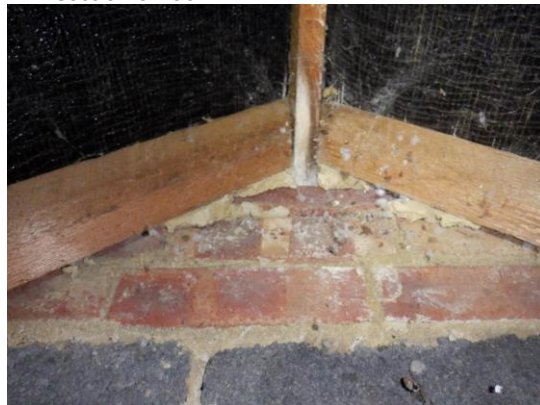
**22. The side gable ends of block work and brick work construction, with cement filling the gaps around the edges.**

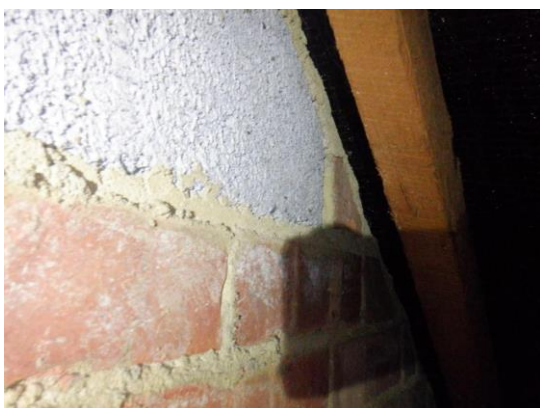
**23. The side gable ends of block work and brick work construction, with cement filling the gaps around the edges.**

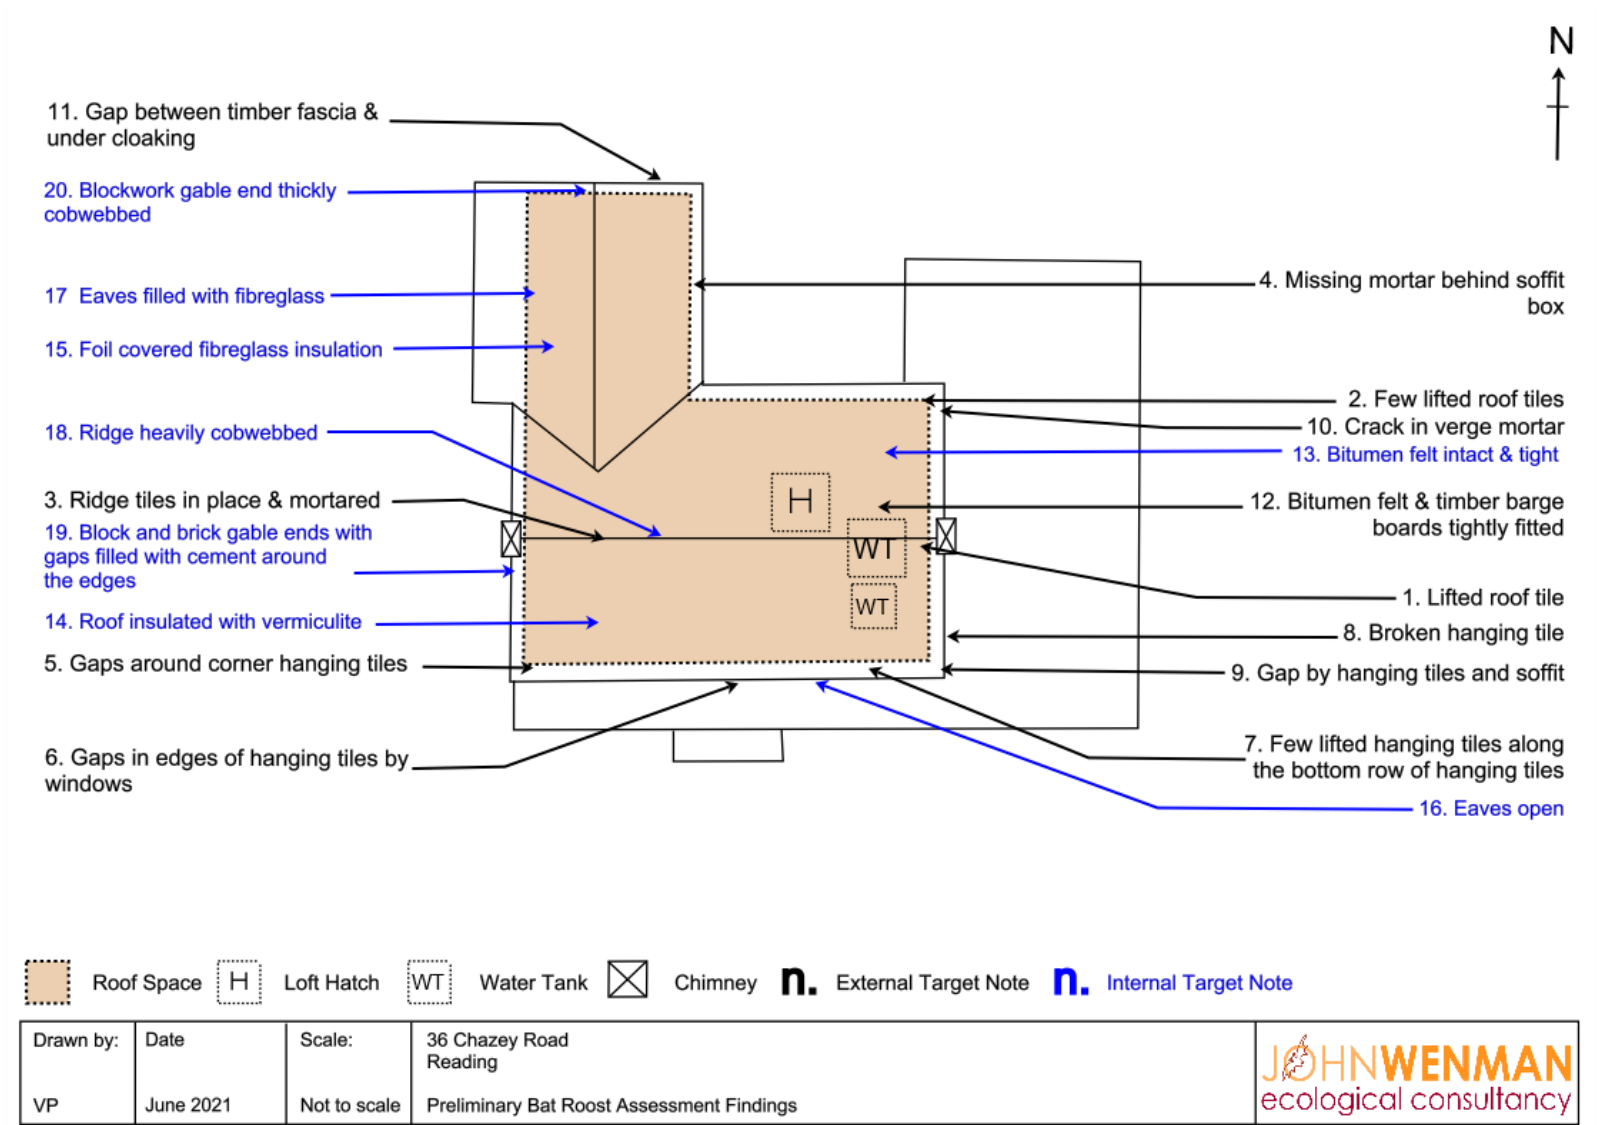
APPENDIX 2 – PRELIMINARY BAT ROOST ASSESSMENT FINDINGS

**4.1.1** Photographs of the property are presented in **Appendix 1** and a plan of the external and internal survey findings with associated target notes is shown in **Appendix 2**. The survey findings from the exterior and interior of the house are described as follows:
