# Existing Culvert Condition Survey

Green Park Village, Reading

**St. Edwards**  
**Ref:** 11056  
**Date:** Jan 2021

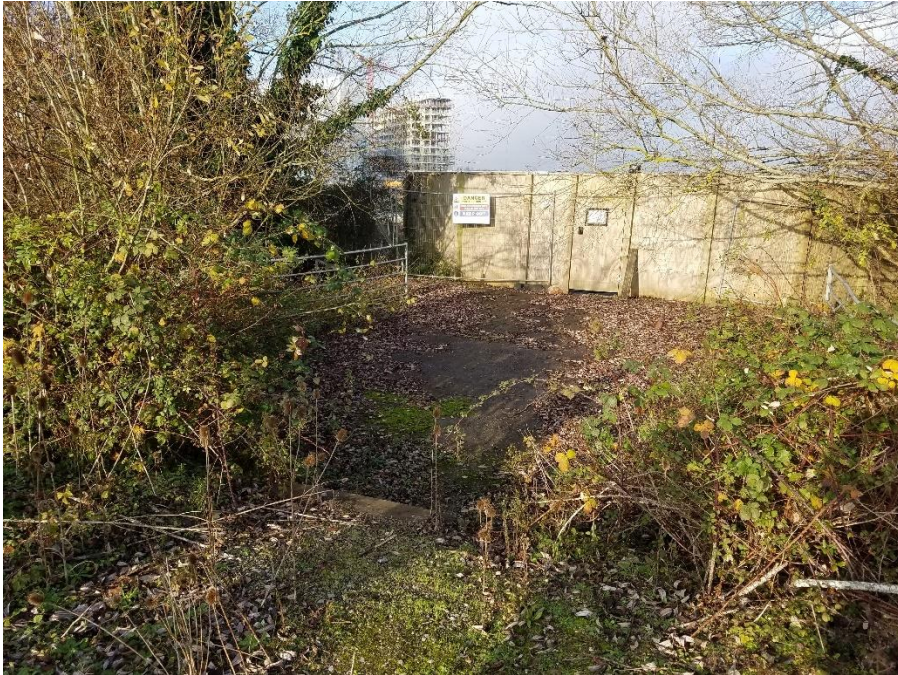
View across existing crossing, towards north-west

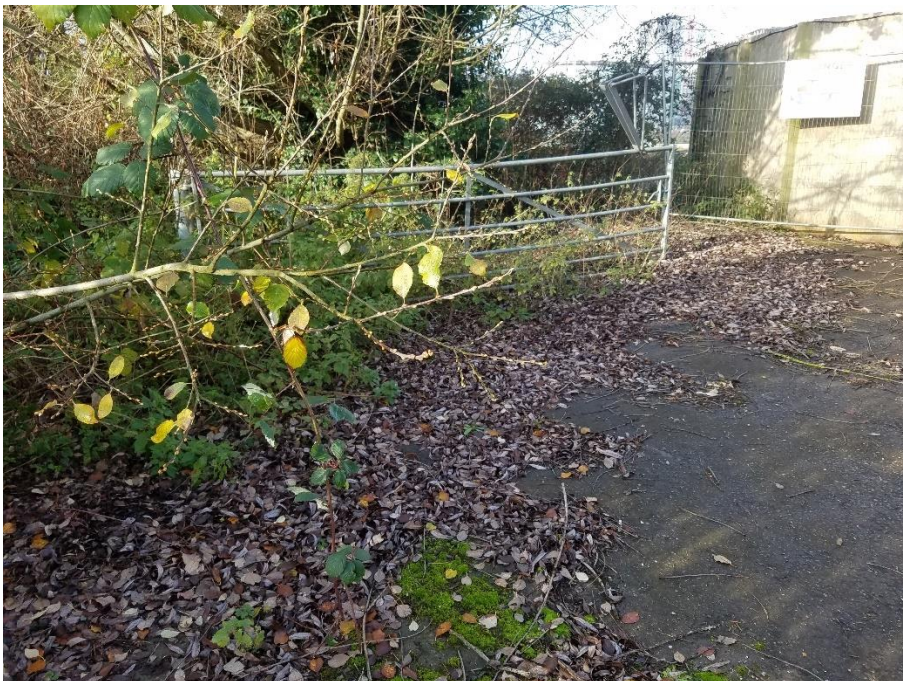
View across existing crossing, towards north-west

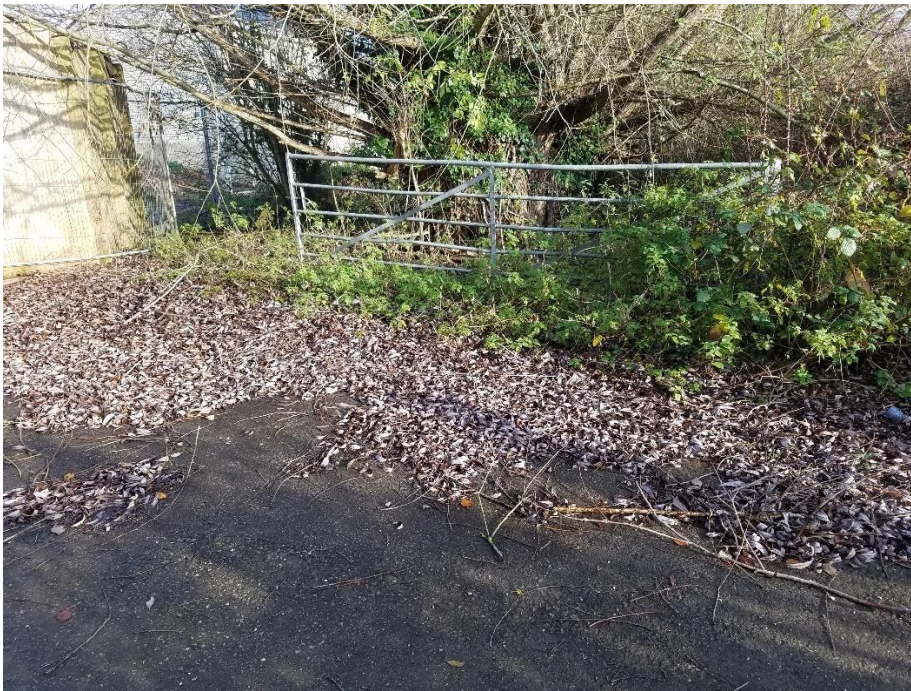
View across existing crossing, towards north-east

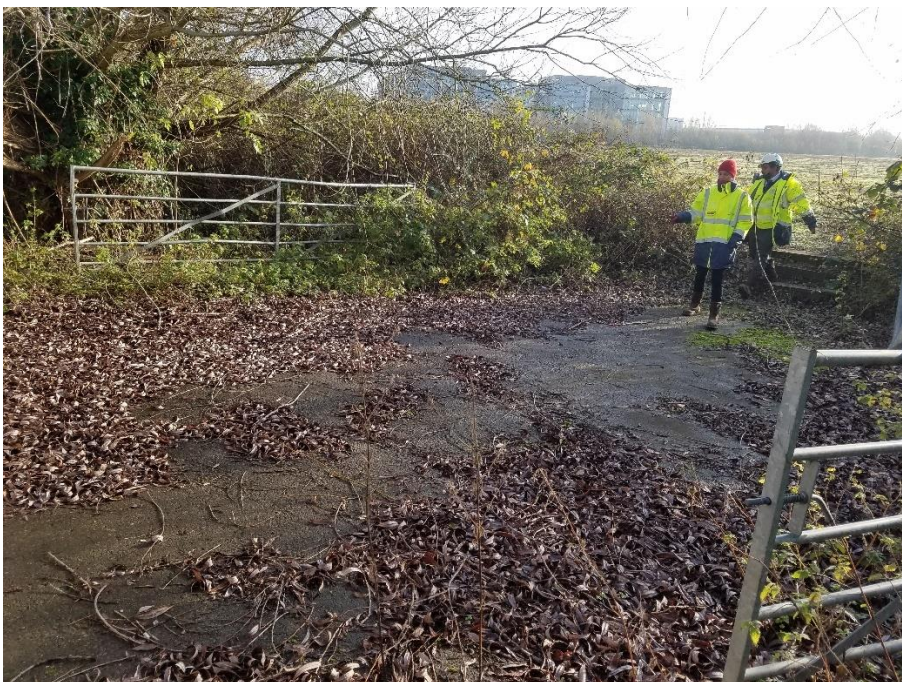
View along culvert route, looking east.

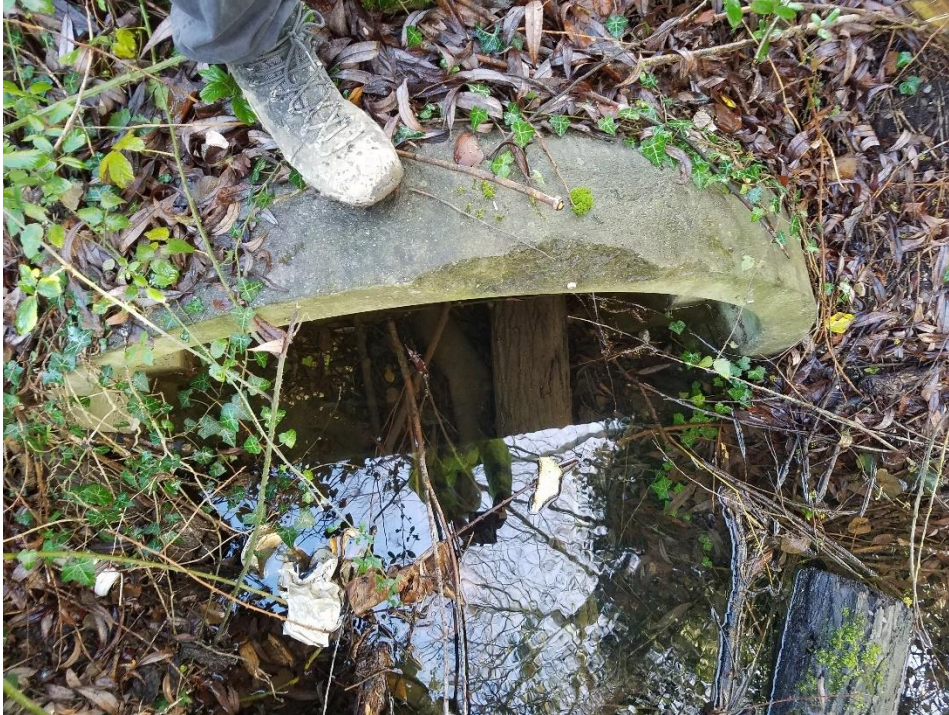
Western end of culvert

- 2.4 The walls of the culvert pipe were 100mm thick.
- 2.5 Both ends of the culvert were inspected and found to have no visible signs of significant structural defects. Some minor damage to the exposed concrete was visible.

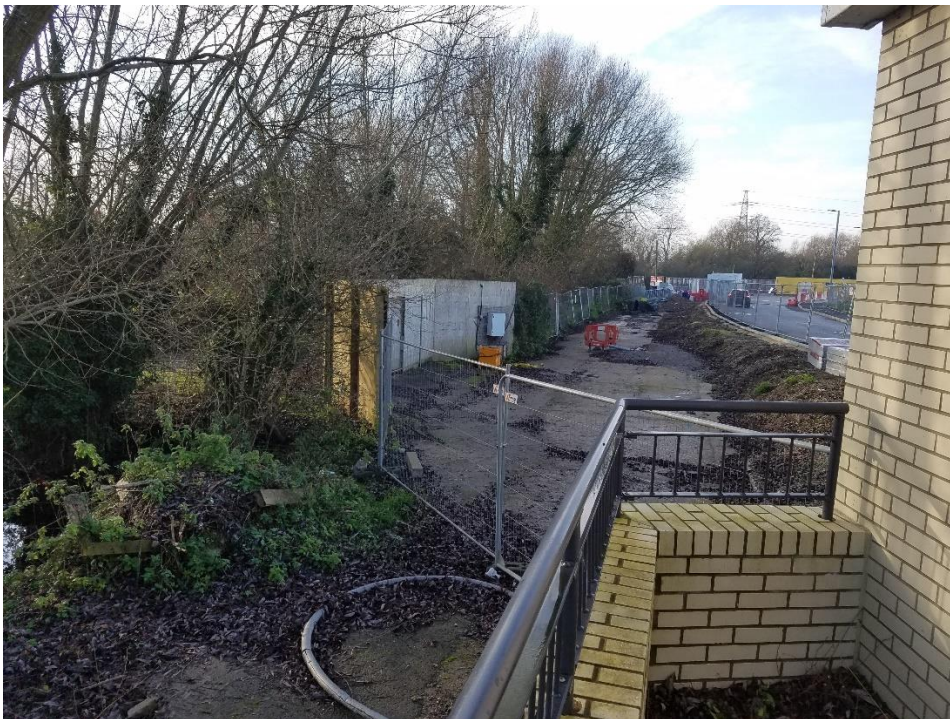
- 4.4 The existing ditch crossing is approximately 1 metre lower than both the adjacent field and the road from which the new car park will be accessed, so the addition of 1000mm of road construction across the culvert is likely to be required in order to stop vehicles grounding as they pass.

View across culvert, looking west, showing difference in level to the newly built road

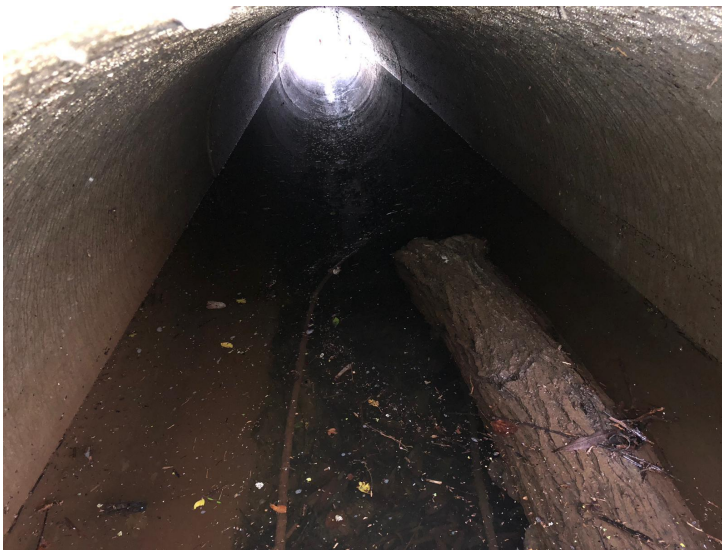
*Figure 1: Culvert view Eastern Boundary*

The existing condition of the culvert looks good, there are no signs of any cracks or weakening of the inner lining of the pipe. There are signs of silt buildup at the bottom of the pipe which is natural and expected. Upstream of the pipe (Western Boundary) there is an existing tree branch which is growing inside the pipe and is restricting the natural flow of water through the pipe causing the water levels to rise slightly.
