## CCTV Inspection Report

| Job Number<br><b>32865</b> | Surveyed by (Operator)<br><b>ASHLEY WATERS</b> | Base Unit<br><b>3MMI3T6O6S</b> | Date<br><b>09/10/2020</b> |

| Page 5 | Survey Run Sheet(Survey 1 - S5 TANK JETTING ACCESS POINT to CAPPED OFF END) |

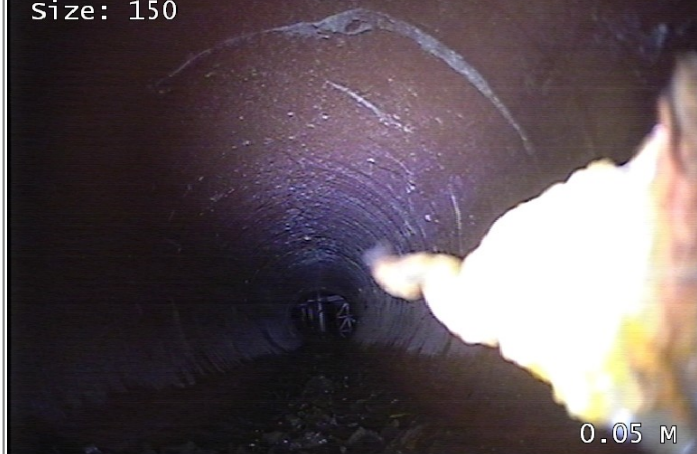
From: S5 TANK JETTING ACCESS POINT / To:  
TANK 2  
Size: 150

| Position | Code | Description | Photo | Type/Grade |
|---|---|---|---|---|
| 0.05 | CL | Crack longitudinal at 10 o'clock | 4461404 | Structural / 2 |

Crack longitudinal at 10 o'clock

Manholes: **S5 TANK JETTING  
ACCESS POINT to TANK 2**  
Pipe Length: **1.27 metres**  
Structural Grade: **2**  
Service Grade: **0**  
Material: **CLAY**  
Pipe Size: **150mm**  
Use: **STORM**

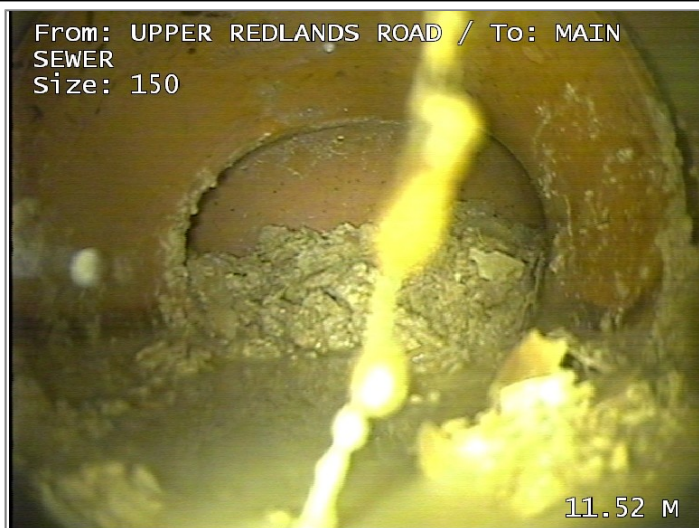
| Position | Code | Description | Photo | Type/Grade |
|---|---|---|---|---|
| 11.52 | REM | PUSHED OF PROPERTY LINE THAMES WATER TO CLEAN | 4462487 | Comment / 0 |

PUSHED OF PROPERTY LINE THAMES WATER TO CLEAN
