## **Arboricultural monitoring report**

**5-9 BERKELEY AVENUE, READING, RG1 6EL**

**Site visits undertaken on the 02/05/2019 and the 08/05/19**

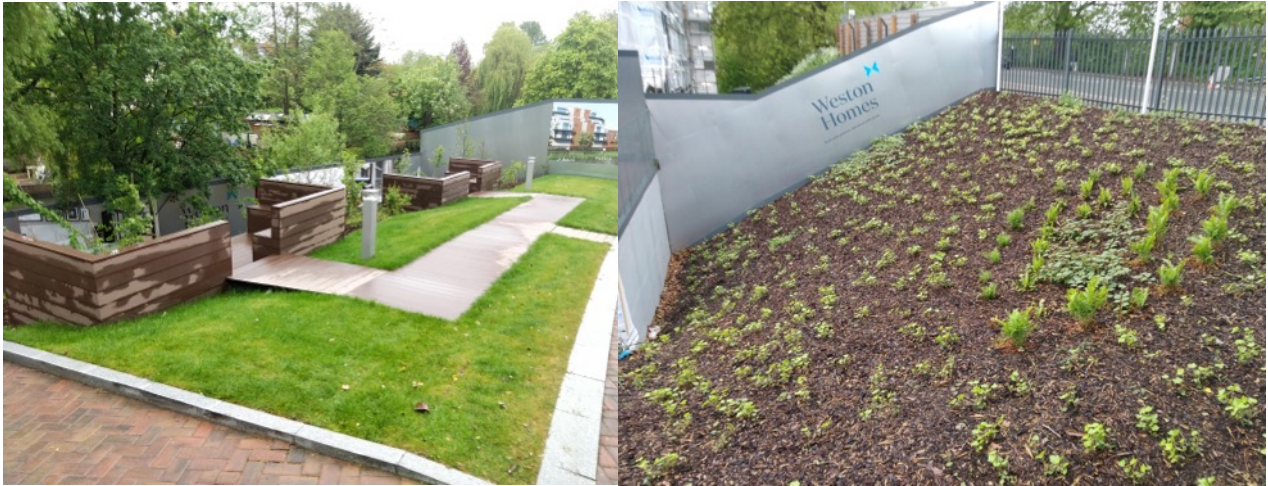
The soft landscaping works in the north east corner of the site has been completed and is establishing well.

*Photo 1 and 2: The image on the left shows the area south of the northern access to Berkeley Avenue. The image on the right shows the condition of landscape area beneath London Plane T7 - NB this is the same as proposed beneath T1.*

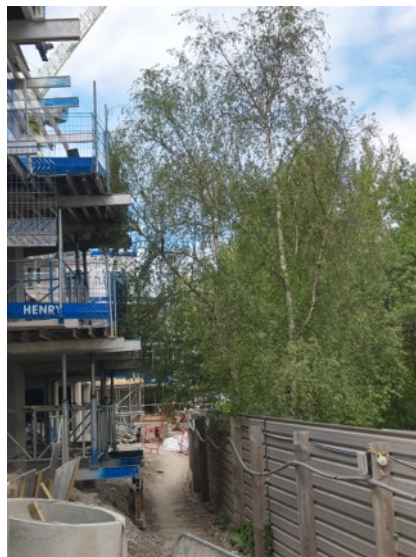
The exterior scaffold has been installed on the southern part of the site. It was noted in discussion with the site manager that the crowns of the offsite silver birch trees (not identified on the original SJ Stephens tree survey) are in contact with scaffold (see photo 3 below). The branches are small and flexible and have been moved to one side during the scaffold installation. It is not proposed to prune these branches as the conflict with the scaffold is only temporary and the final build line is some 2-3m back from the crown edge.

*Photo 3: showing the minor contact between scaffolding and offsite silver birch trees.*

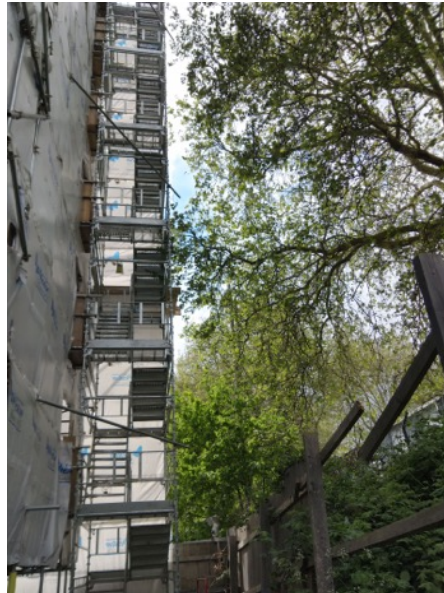
The same issue was noted with regards to the crown of T1 (See photo 4 below). This is in part due to the growth of T1 since the temporary scaffold access stairs were installed. Again, no pruning is required as the final offset between the crown and the building elevation is circa 3m.

*Photo 4: showing the minor contact between temporary access stairs and the crown of T1.*

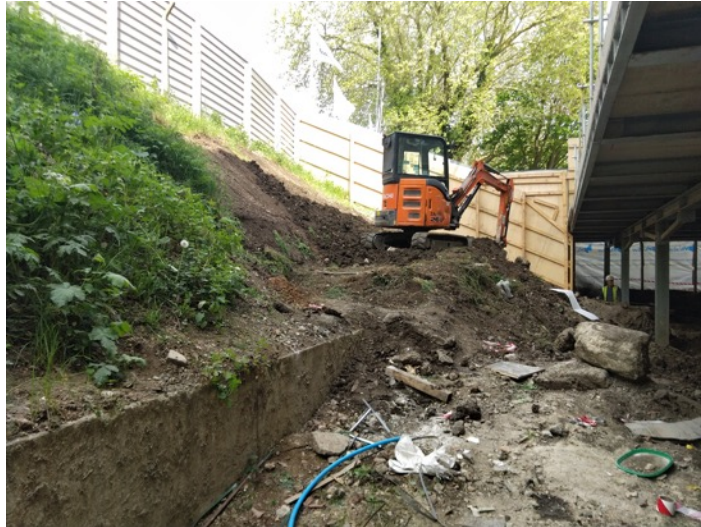
However, in order to carry out this work it is necessary for a small excavator to create a working platform at the base of the slope. Site access restrictions prevent a large excavator being used and the platform is required for the safe operation of the machine. The approach can be seen in photo 5, overleaf. The embankment works extend in to the CEZ beneath T1.

*Photo 5: showing the regrading work required to the embankment down to the edge of the parking bays and over the existing retaining wall. Note, this is not within the CEZ of T1.*

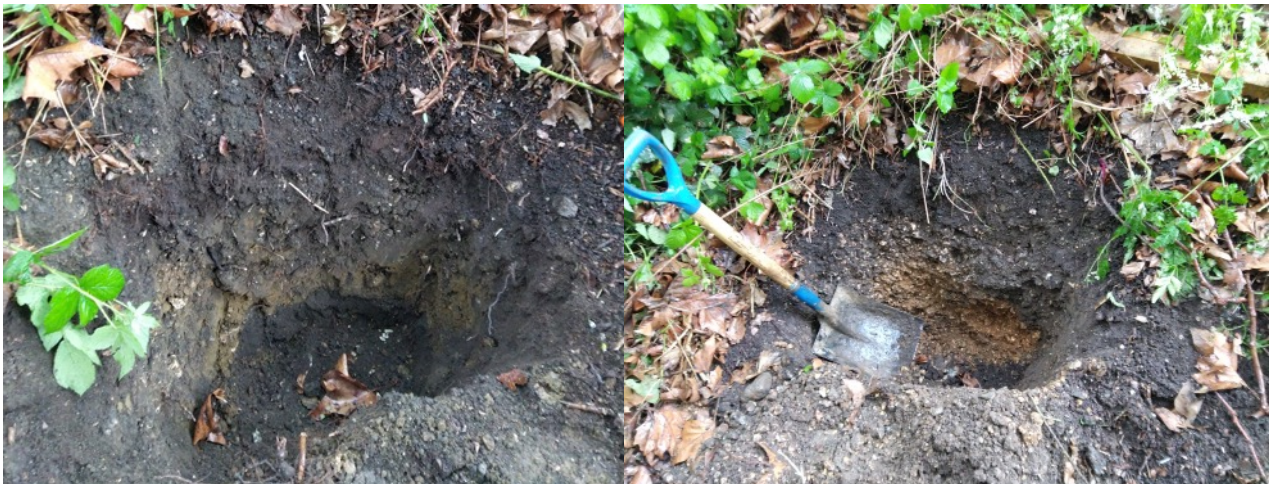
*Photo 6 and 7: showing the trial pits excavated in the CEZ of T1. Photo 6 was excavated approximately 3m south of the stem of T1 and to a depth of circa 400mm. Photo 7 was excavated approximately 1m north of the existing retaining wall to a depth of circa 600mm on the alignment of the platform required for machine access (similar location to that shown in photo 5).*

The trial hole on the alignment of the work platform was excavated to 100mm below the required depth of the platform. Approximately 300mm of topsoil/humus was discovered and this did not contain any roots emanating from T1. Beneath this was approximately 300mm of made ground comprised of a gravel type material which contained no roots at all.

The trial hole excavated 3m south of T1 revealed 300mm of topsoil/humus and a dark coloured sub soil below; possibly made ground. A small number (3 in total) of fine roots up to 2mm diameter were observed at a minimum depth of 200mm. These are believed (although not confirmed with laboratory identification) to emanate from T1. The maximum required depth of regarding at this location on the slope is 100mm. Based on the trial holes the fine root layer is beneath the depth of regrading.

On the basis of the trial hole excavations the Project Manager was advised that works could continue using the same methodology to regrade the bank within the CEZ of T1. A buffer of 3m from the stem where no regrading work should be carried out was also recommended. Once the regrading work is completed the remaining vegetation will be sprayed off using a systemic contact herbicide and the area soft landscaped in line with the approved landscape drawings (as per photo 2 - including mulching).

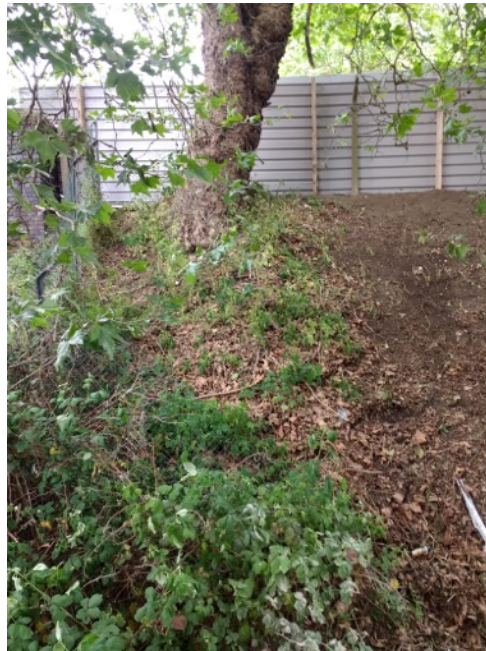
*Photo 8: showing the base of T1 with the area recommended for retention left in situ and the bank regraded. Note, the soil disturbance close to the stem was only for vegetation clearance and the upper slope was not regraded.*

- The installation of the soft landscape beneath T1 is undertaken by the landscape contractor in discussion with the project arboriculturist.
- At an appropriate time the external scaffold and access stairs are removed with care to avoid damage to the crowns of the offsite birch and T1.
- That a further site monitoring inspection is undertaken in July 2019 with an interim call to the site manager to discuss any issues or queries that may have arisen.
