Katesgrove School, Reading

The Simmonds Building (Formerly known as The Henry Building)

Proposed Timber Window and External Fabric Repairs

Heritage Statement

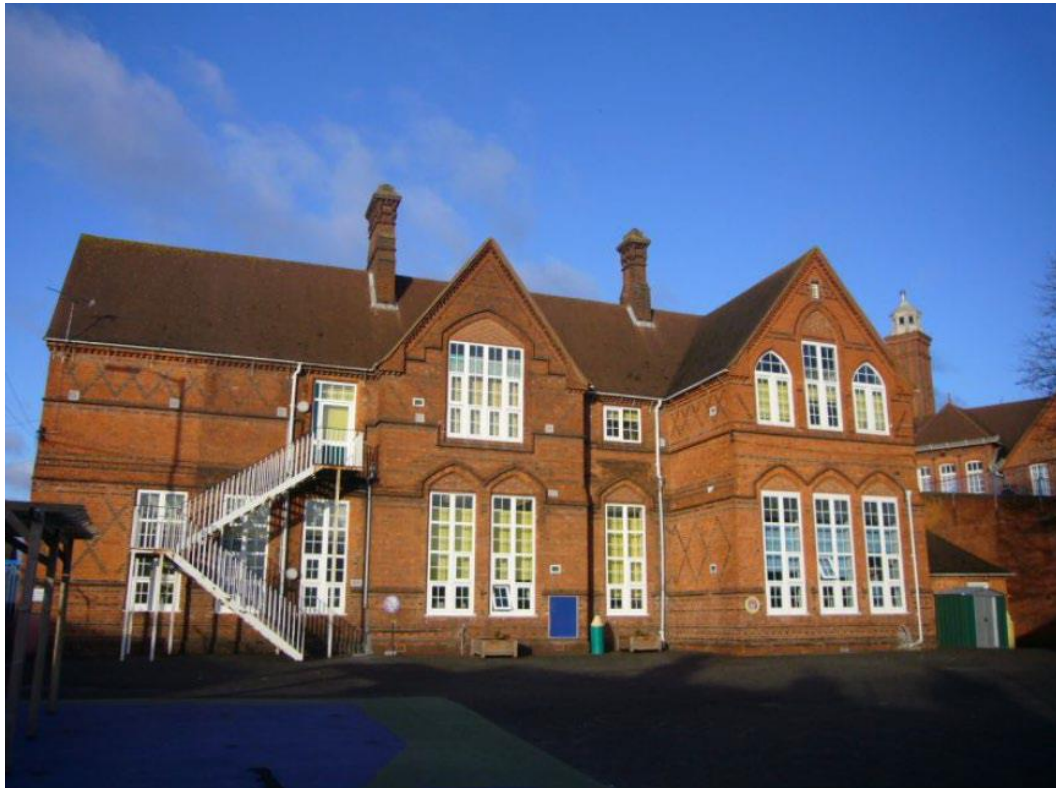
Fig 3: South elevation

All the windows on this elevation are modern aluminium framed double glazed

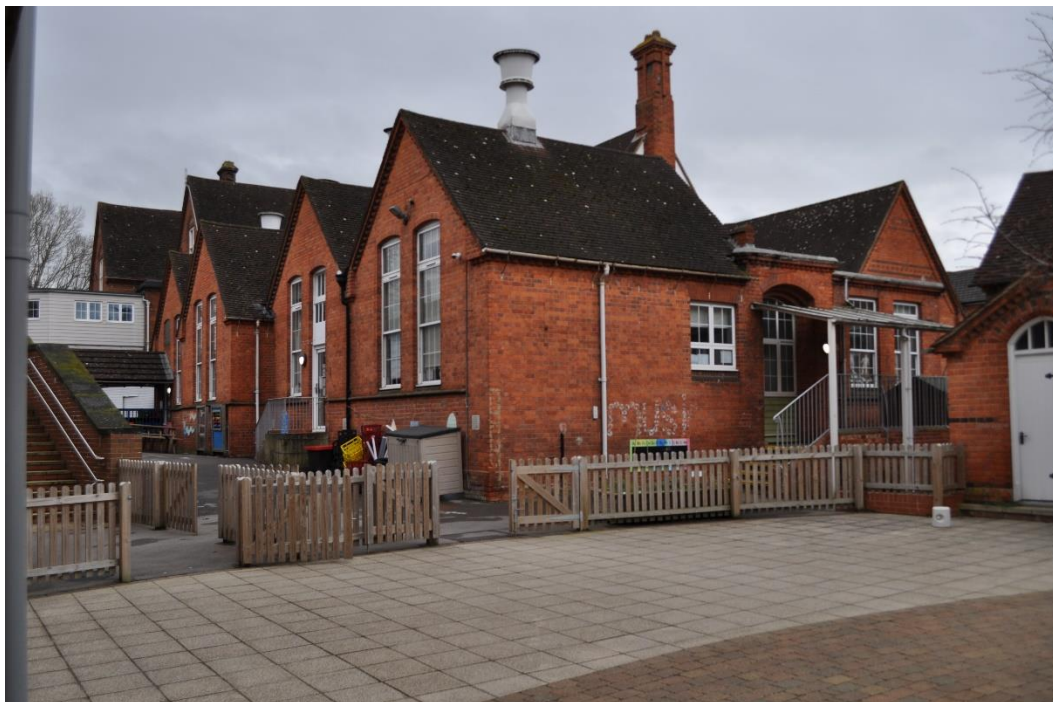
Fig 4 North wing classrooms surrounding the original hall.

All the timber windows have been replaced with modern aluminium framed double glazed.

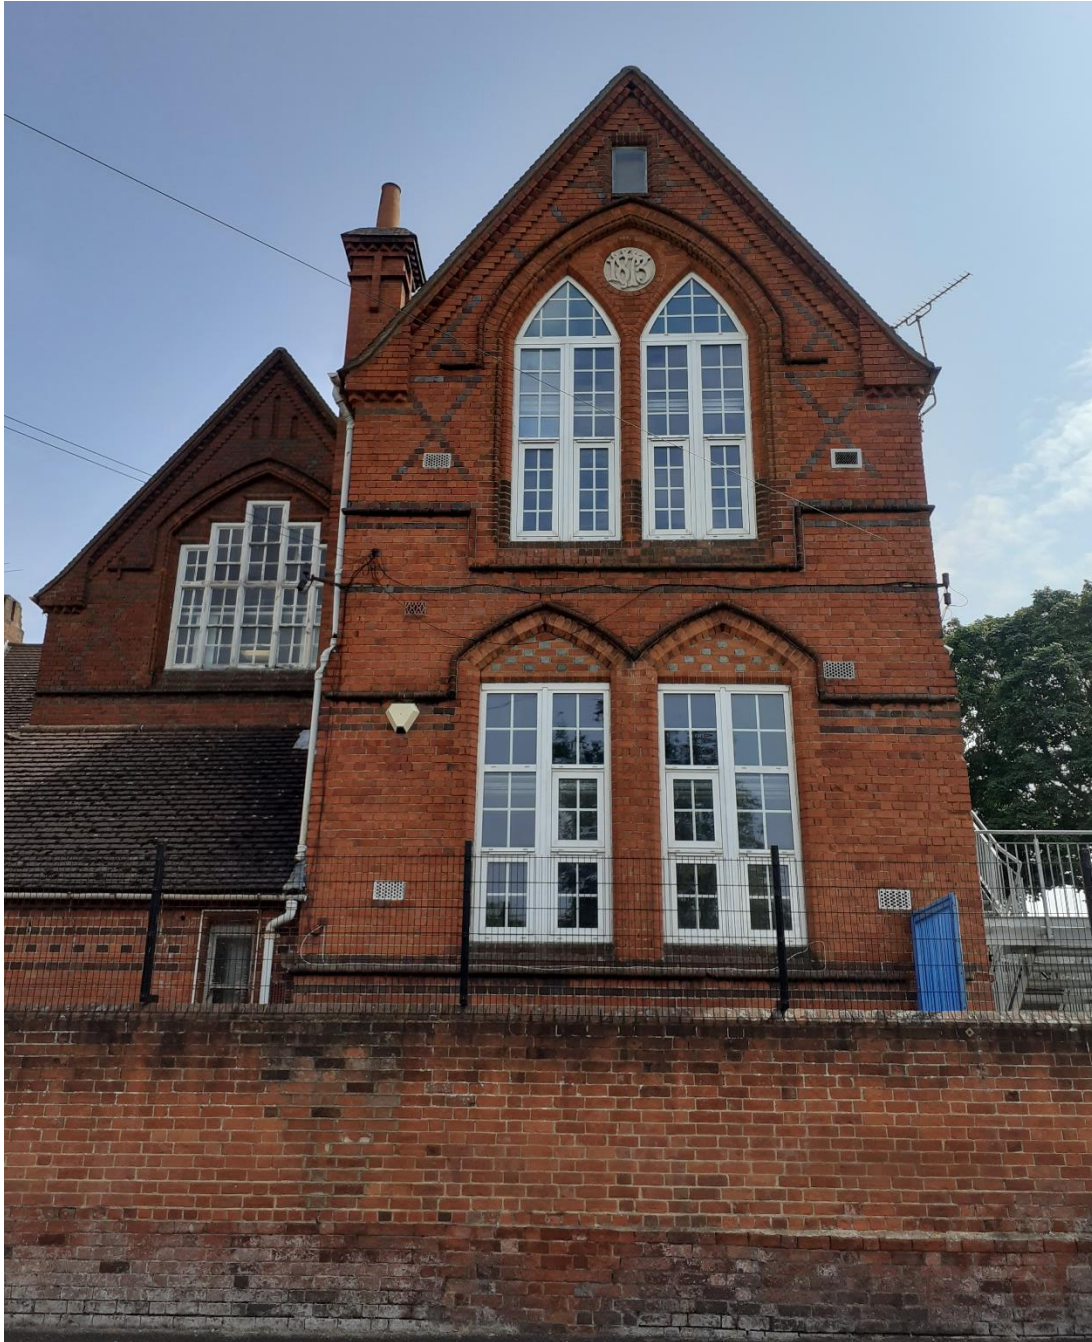
Fig 5 West side of south wing  
Modern replacement aluminium windows, original timber windows in gable on the left.

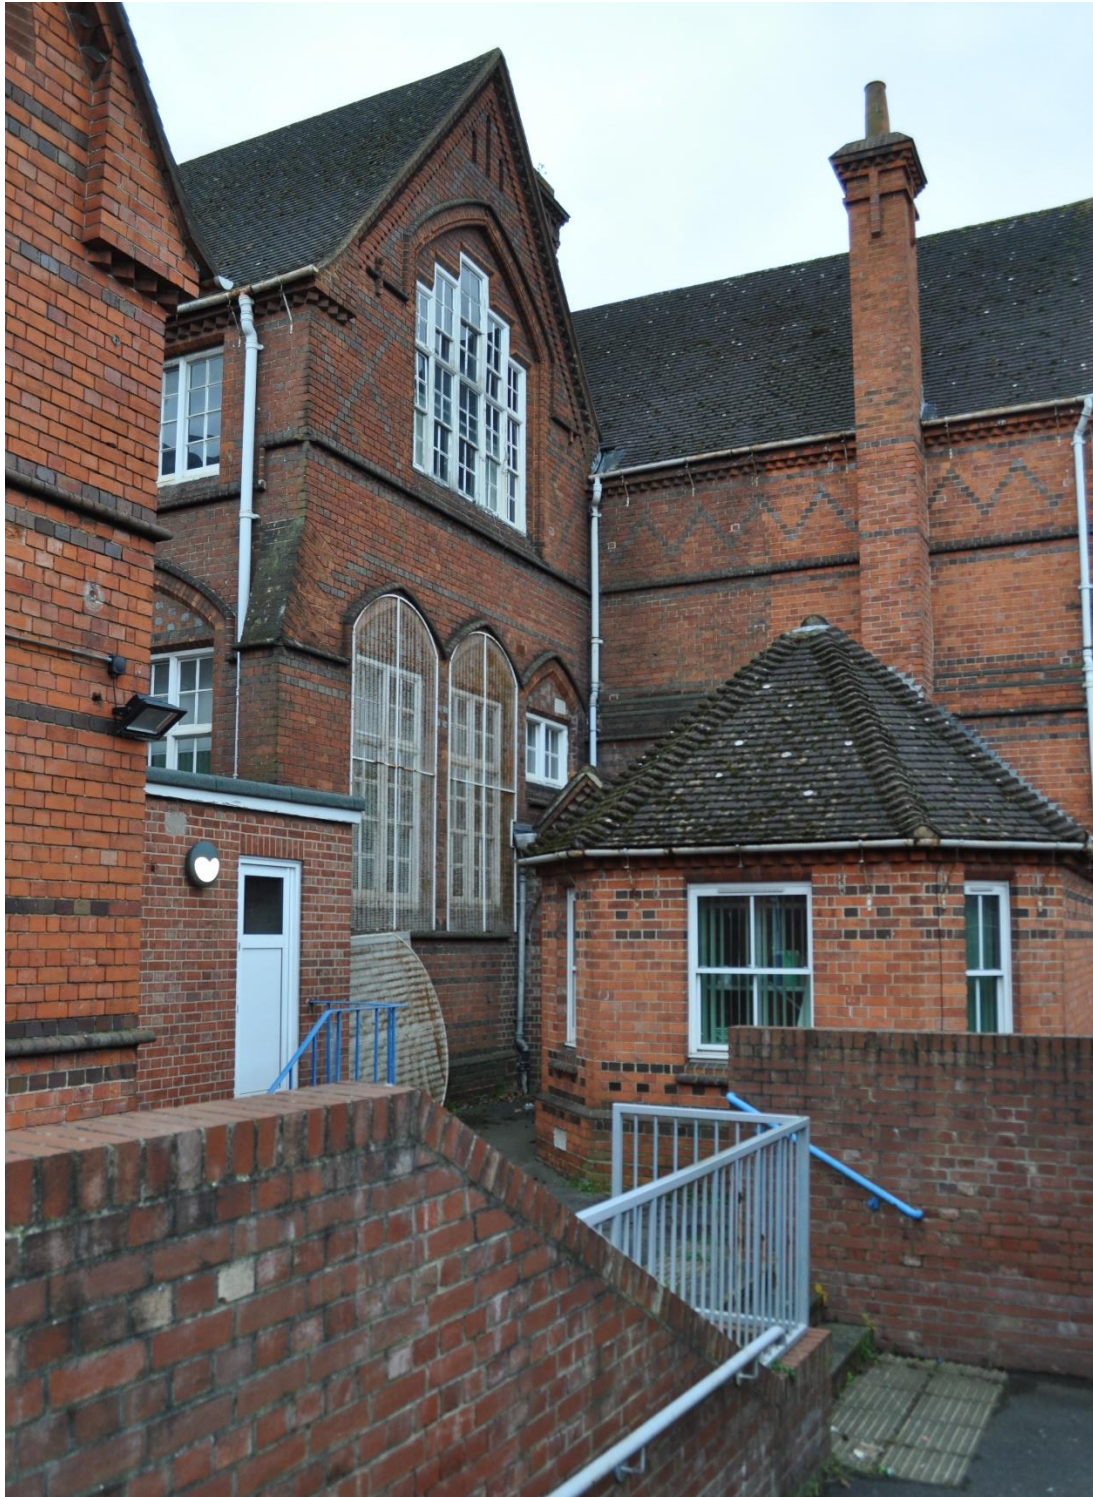
Fig 6 West elevation behind south wing  
Original timber windows in gable on the left.

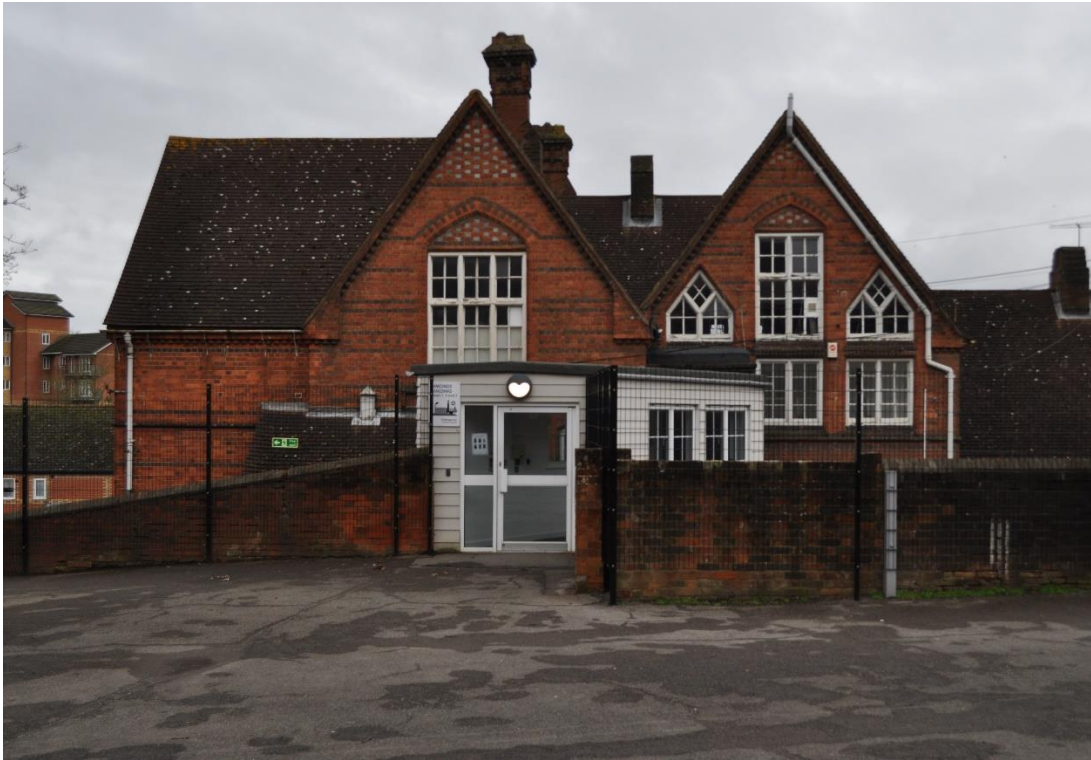
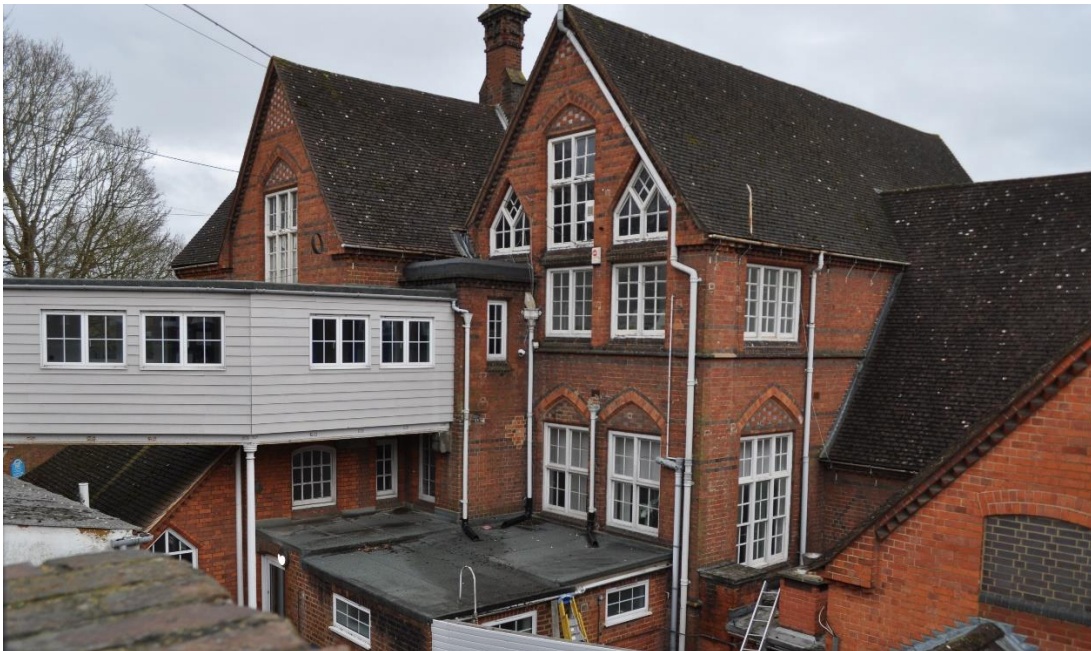
Fig 7 Two views of east elevation south and central wings with original timber windows

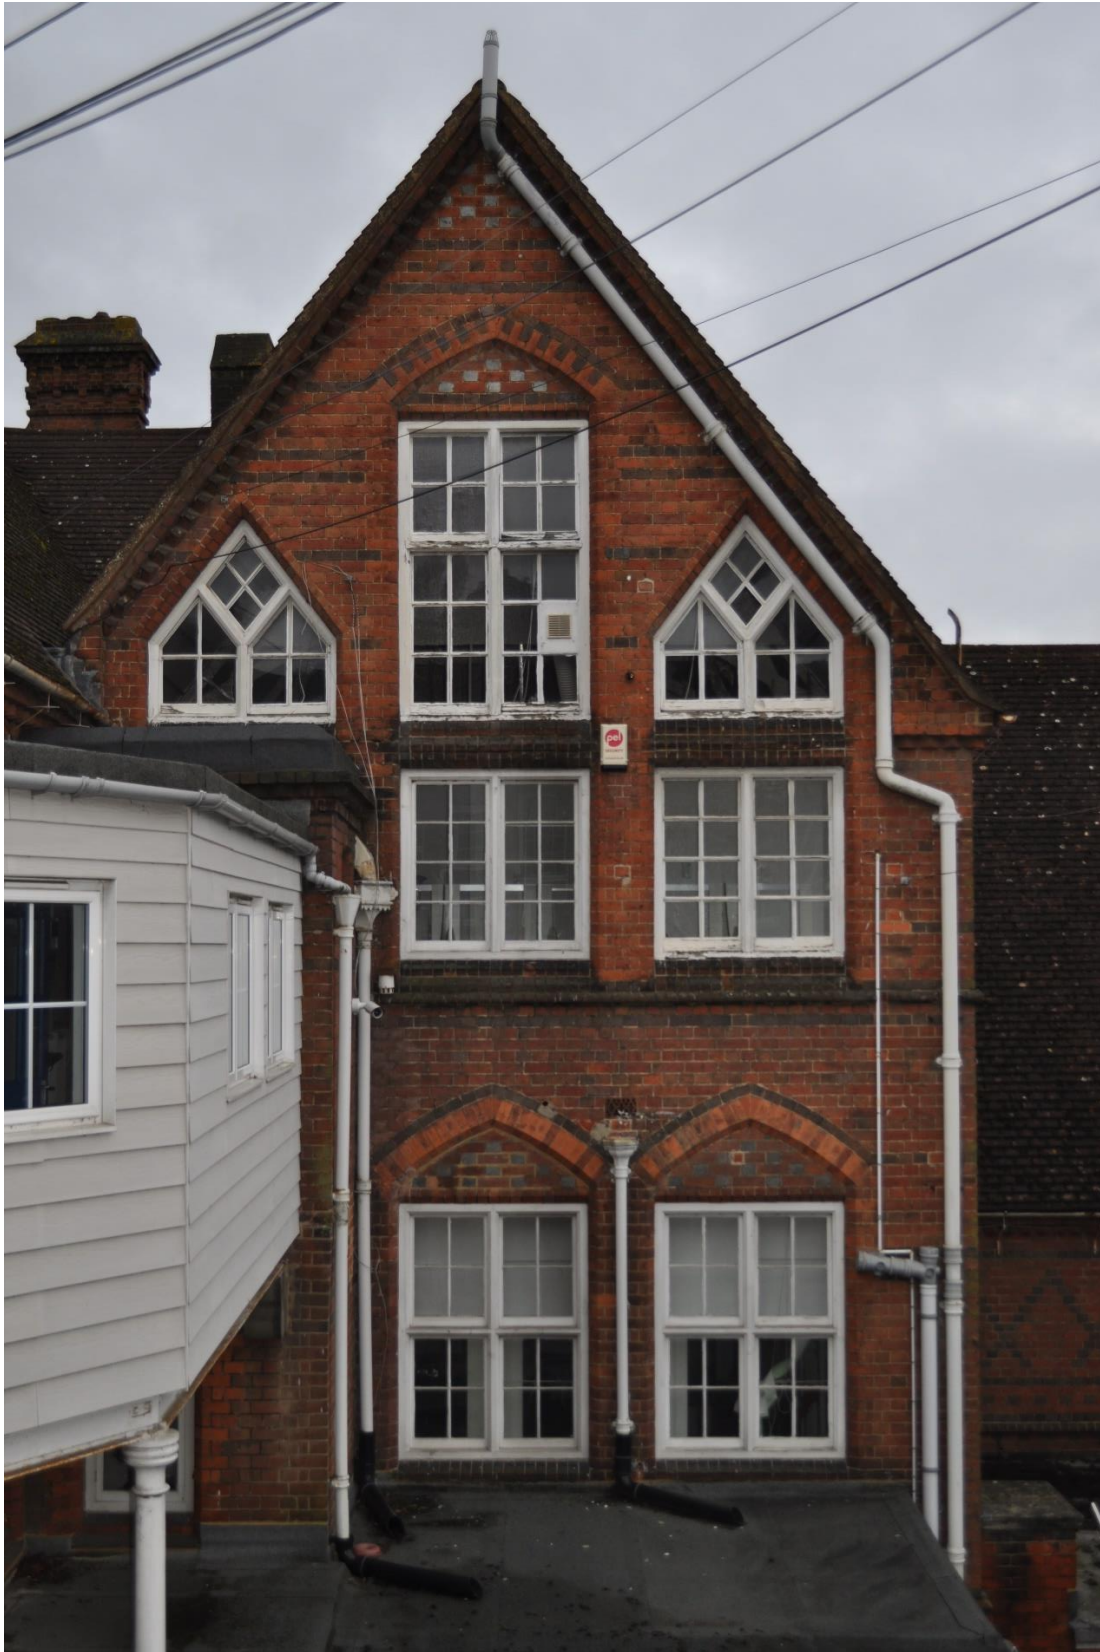
Fig 8 East elevation central wings with original timber windows, the upper parts are blocked by suspended ceilings

1. Where appropriate, permanently stop the suspended ceilings further back from the window to create light and ventilation shafts to their full height. This will not apply to the first floor toilet room where the suspended ceiling will be reinstated to its existing line on completion of the window refurbishment above.
2. Make minor modification to opening casement sashes in order to fit draft seals so that a greater degree of air-tightness is achieved when the window is shut.
3. Replace cord operated window opening with a more robust and reliable Teleflex system operated by a winding handle. Where there are stacks of opening vents these will be grouped together to a single opener. Where the installation of this new operating system allows, the existing sash hoops, quadrant arm stays and pulley wheels will be retained as evidence of how these windows were originally operated.

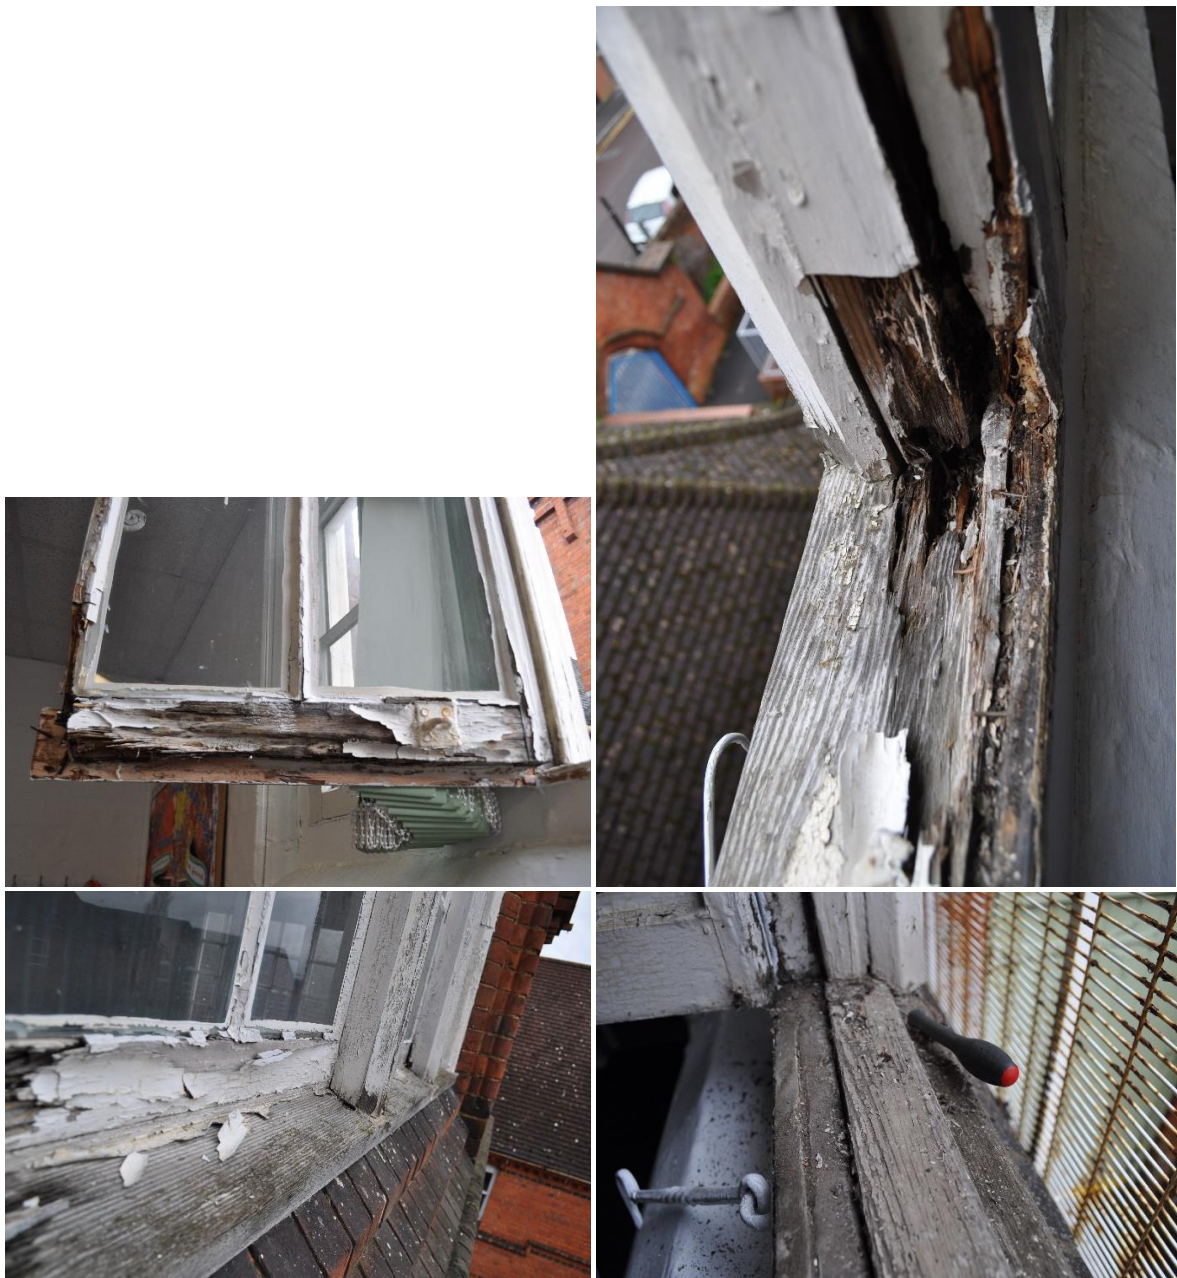
Generally, apart from being overdue re-decoration, the windows are in good condition except for some of the more exposed higher level ones, particularly those facing the sun and the prevailing south west wind where there is decay to sills and the bottom of mullions. There is also an issue with opening casements where the build-up of paint thickness over successive re-decorations is frustrating free movement and the original system of cords and pulleys have not been maintained. Suspended ceilings have been installed in the centre wing on ground and first floors. These cross the windows effectively blocking the upper parts. Internal bulkheads are too close to the windows to allow the upper opening casements to open or to let the room benefit from natural light and ventilation from the upper parts.

Fig 9 Examples of localized decay caused by concentration of rain water saturation in cills and at the bottom of mullions .

The proposal is to carry out like-for-like repairs, replacing decayed sills and casements and scarfing in the bottom section of frame jambs and mullions where they are compromised by wet rot. This is only required on a limited number of windows. Generally the intention is to improve the function of the windows in three ways:

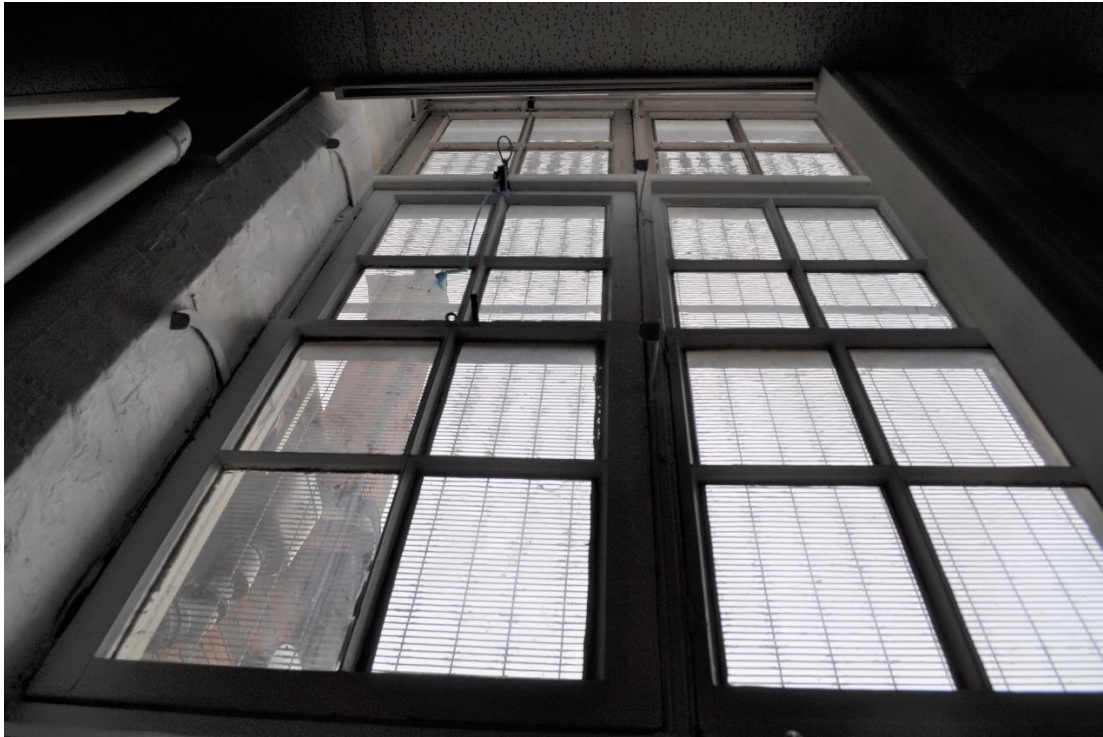
Fig 10 Stacked bottom hung opening casements with aligned heads and sills

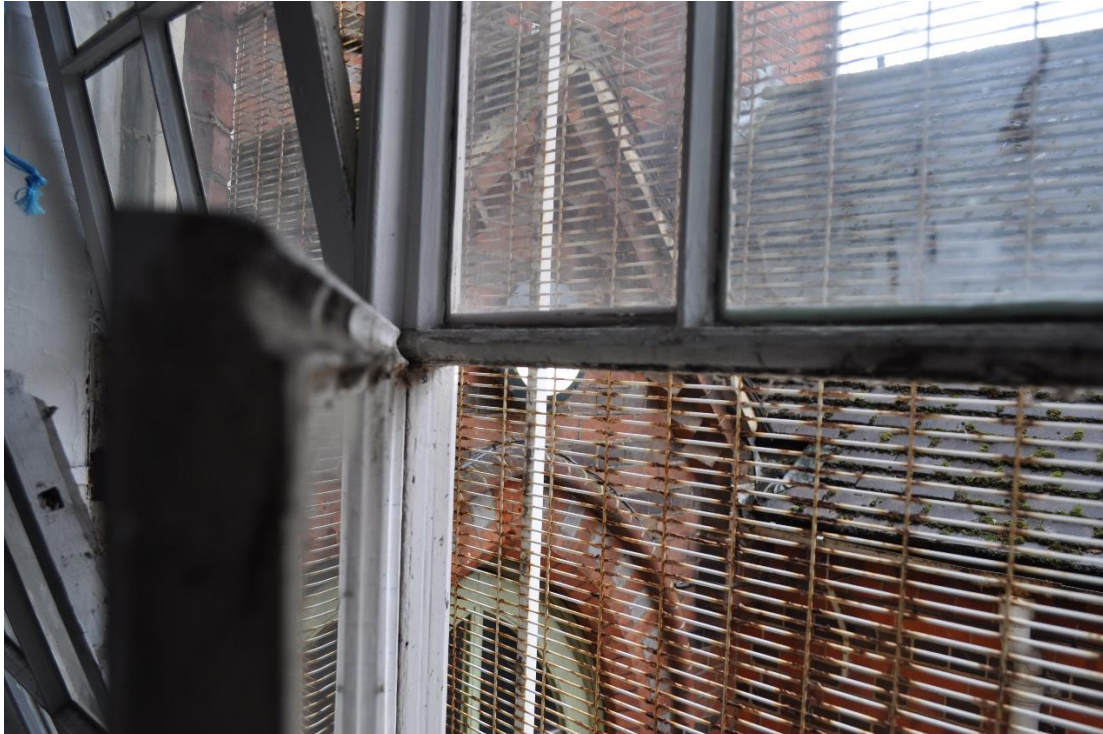
Fig 11 profiled meeting of head and cill normally where both bottom hung, here used in a side-hung format.

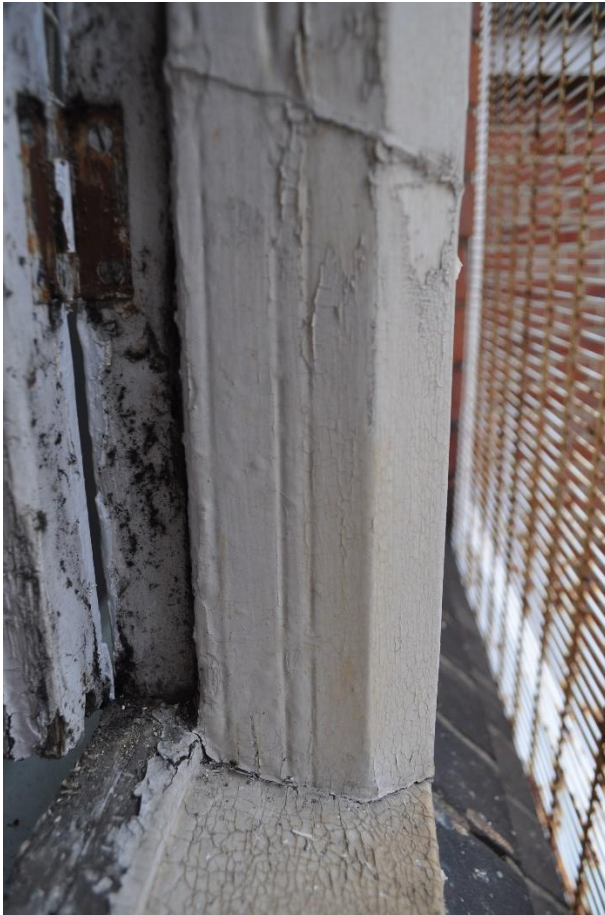
Fig 12 Example of previous scarfed in bottom of mullion

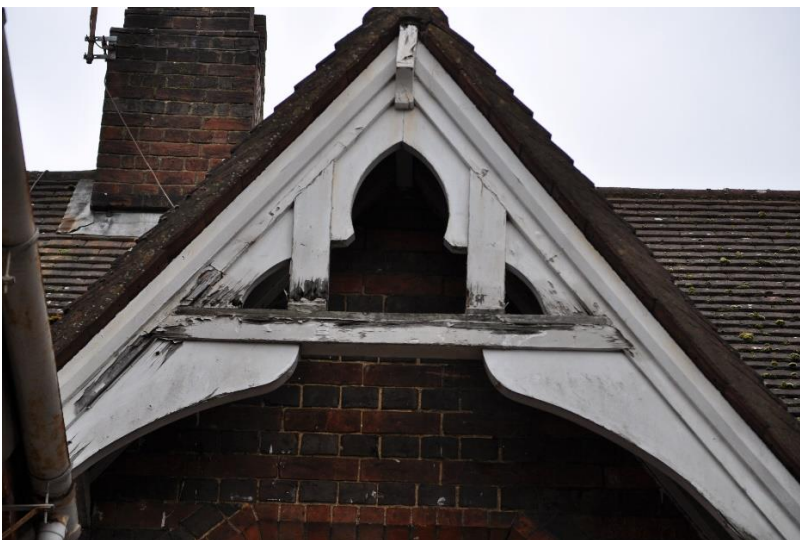
There is very little external woodwork on the building since the verges are generally detailed in brickwork. There is a bracketed and tied gable truss which is in poor condition and will be repaired with the replacement of decayed members with matching timber.

Fig 13 West facing gable woodwork suffering from decay.

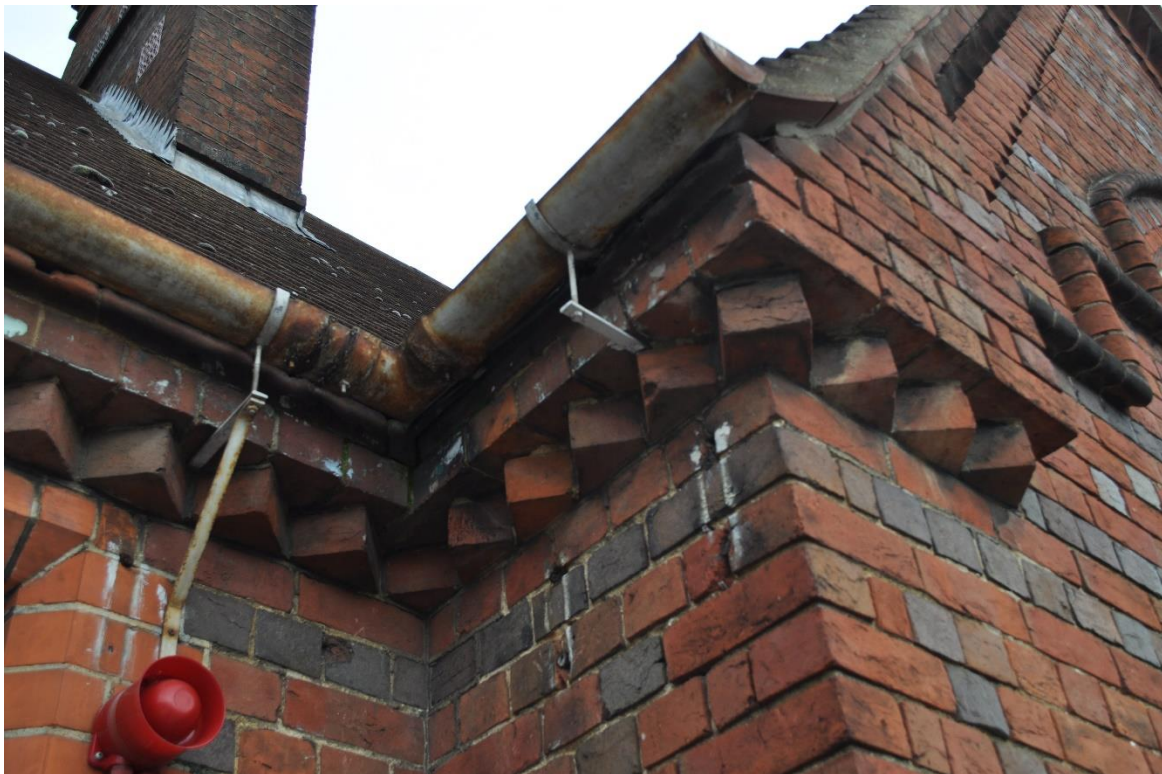
The brick used for this building is large format compared to the modern standard brick. 73 x 230 mm face dimensions giving a course module of 83 mm or 830mm over 10 courses. The condition is generally good but with loss of mortar from exposed faces, ie south and west facing elevations at the higher more exposed levels. There is also the typical loss of mortar at ground level from splash up from impervious ground, tarmac playground etc. These areas have been mapped onto the elevations. It is interesting to note that generally north and east facing elevations have not suffered from mortar erosion anything like as much as south and west facing ones.

Fig 14 Open joints in high level brickwork exposed to south westerly prevailing weather

The proposal is to re-point sympathetically with a soft ie permeable hot mixed lime mortar naturally coloured with selected aggregates to match the original lime mortar as far as is possible.

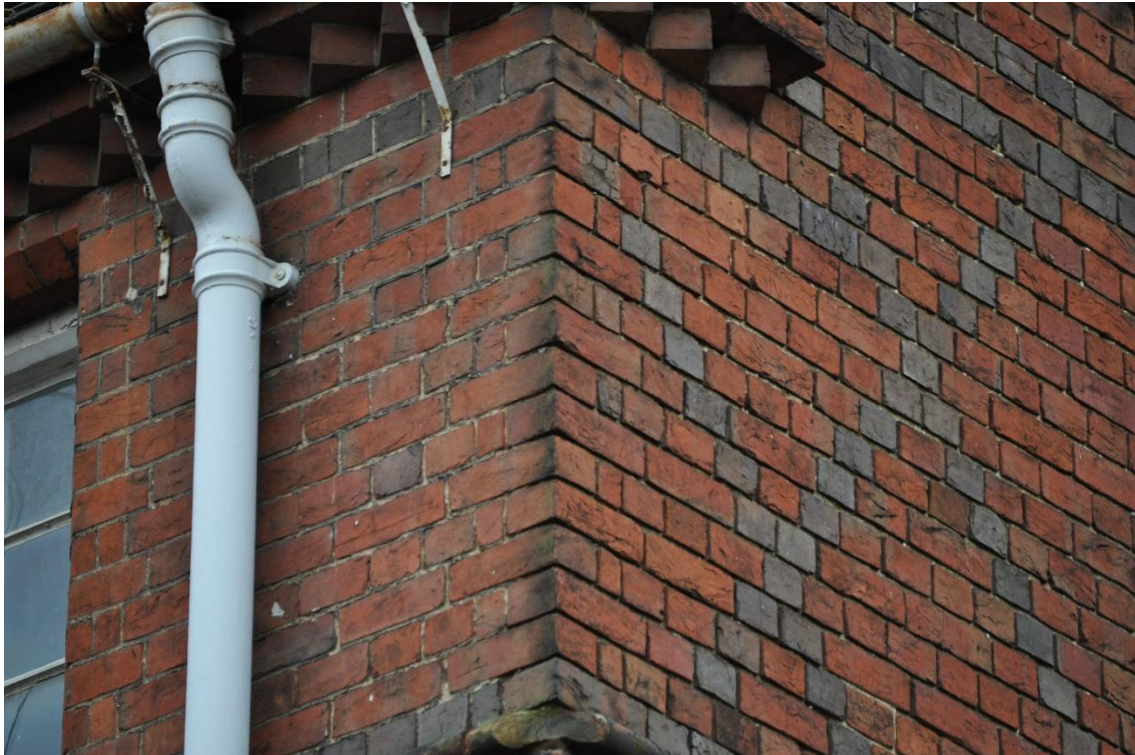
Fig 15 Showing the change from eroded west facing brickwork joints (right) to pointing surviving virtually as built on north facing brickwork (left)

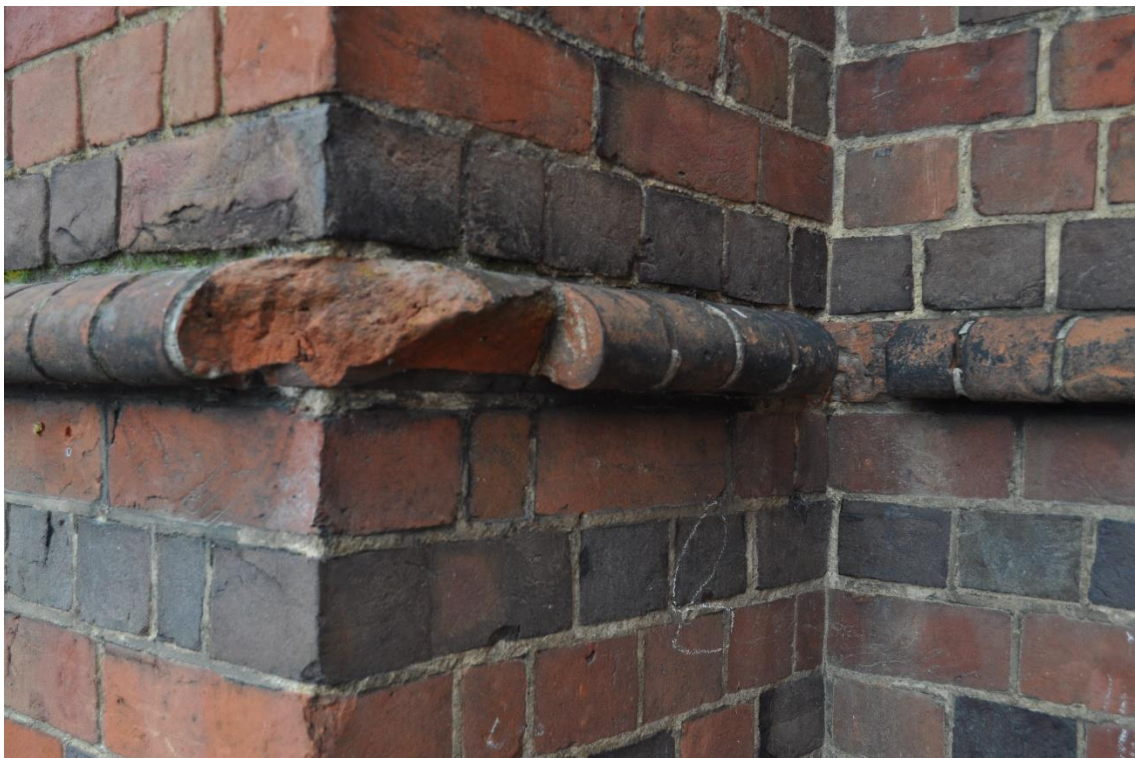
Fig 16 Example of a broken external corner string course brick.

There are a very few places where facing bricks have lost their face and need replacing. There are also a number of special string course bricks which are broken. These will be replaced with specials made to match the colour / make up, size, and profiles of the existing.

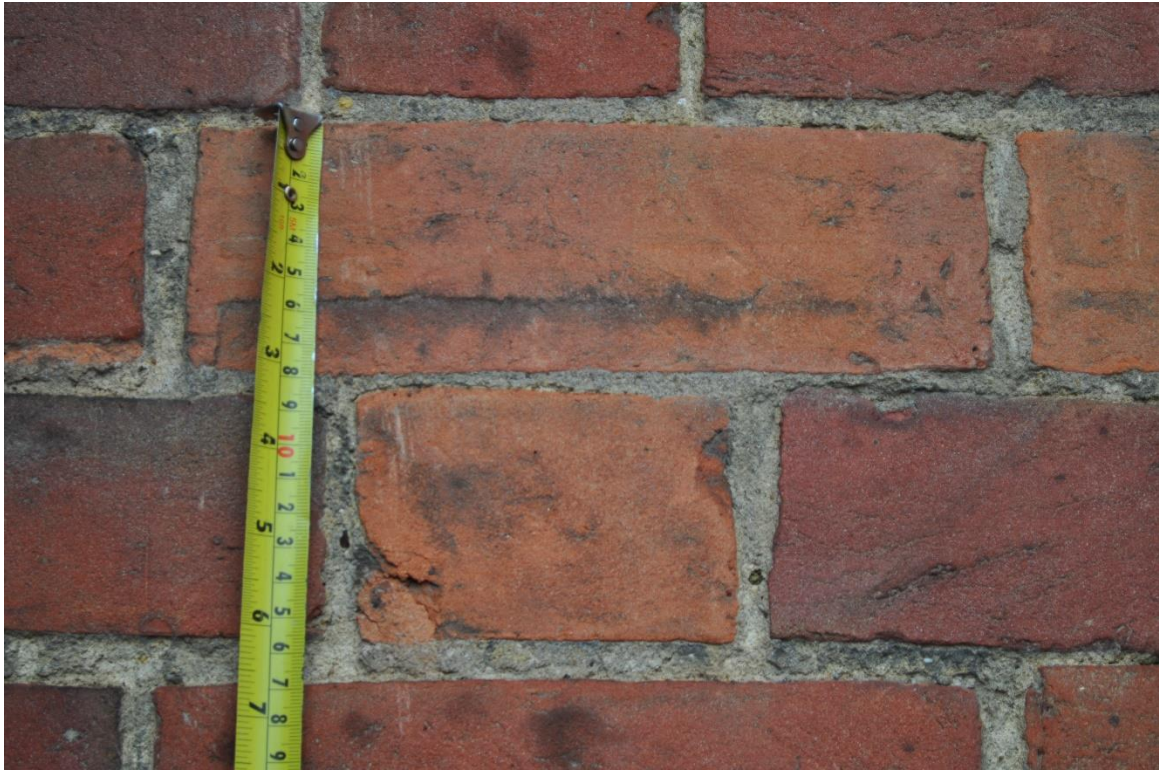
Fig 17 brick size and original lime mortar including visible grit.

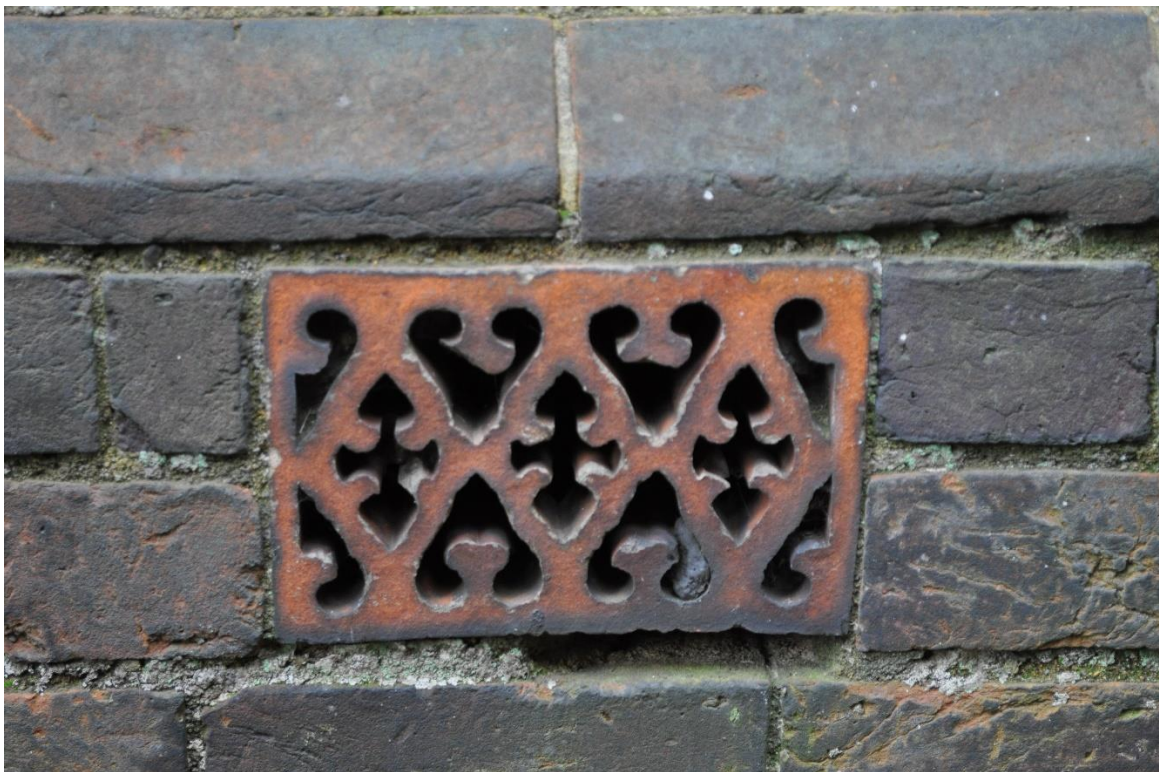
Fig 18 Standard ornamental air brick in plinth showing typical mortar loss at ground level.

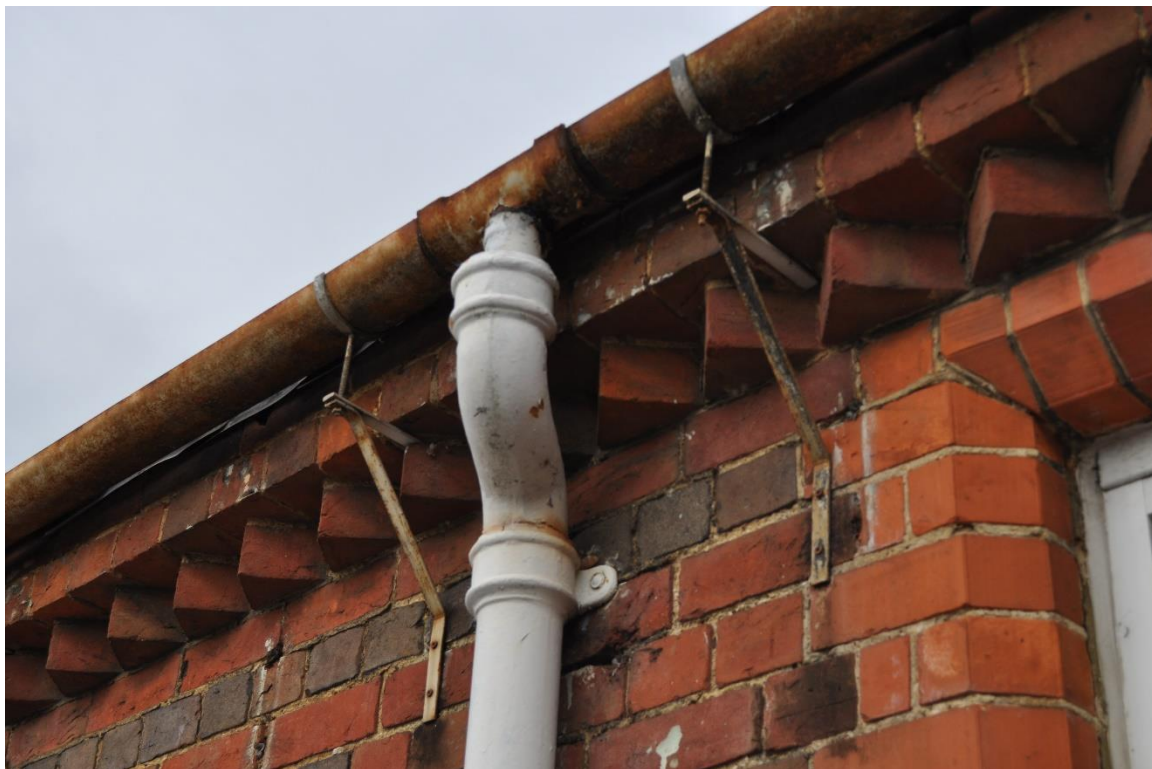
It looks like the gutters were replaced, possibly when the building was last re-roofed. They are either cast iron or steel but the fabricated gallows brackets are definitely steel and are showing rust. There is one area of cast iron guttering to the flat roofed infill at the north end of the building and this is in poor condition. Over the years the cast iron rain-water pipes have been altered or partly replaced in plastic, some completely. There are a number of obvious breaks and holes in the remaining cast iron rain water goods. There are many cast iron and some framed mesh face grilles on the building which may be part of an original natural ventilation system.

Fig 19 Corrosion of modern steel or cast gutter and steel brackets, poor connection detail at outlet

The proposal is to clean and decorate gutters and support brackets, making repairs as necessary. The down pipes will be methodically dismantled for identification of which sections can be refurbished and reused, not necessarily in the same location. It is likely that much of the older apparently healthy pipes will be near to corroding through on their difficult to access for decoration wall facing side and will have to be discarded. Pipe drops will either be reassembled using all refurbished components or will be completely replaced with new cast iron work, avoiding mixing old and new in one drop.

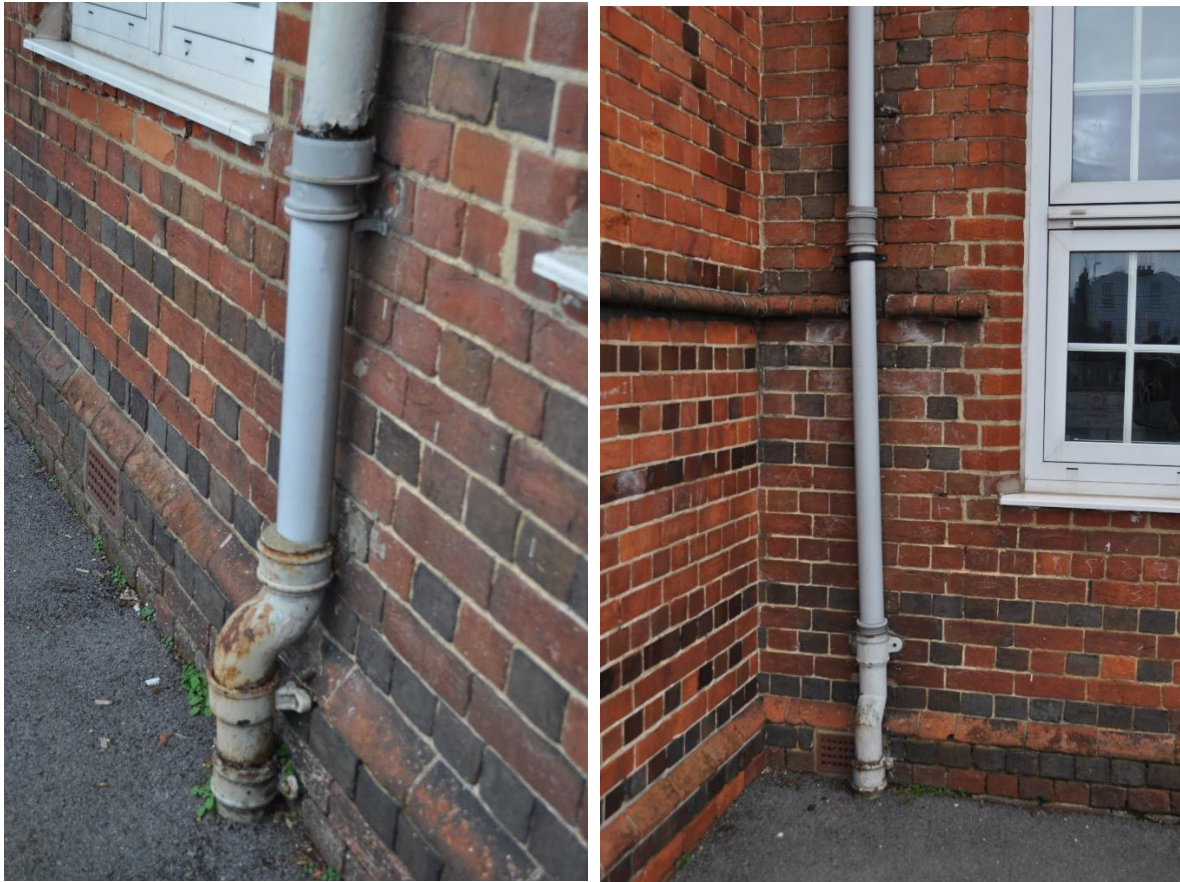
Fig 20 Examples of ad hoc repairs to cast iron using plastic, evidence of corrosion.

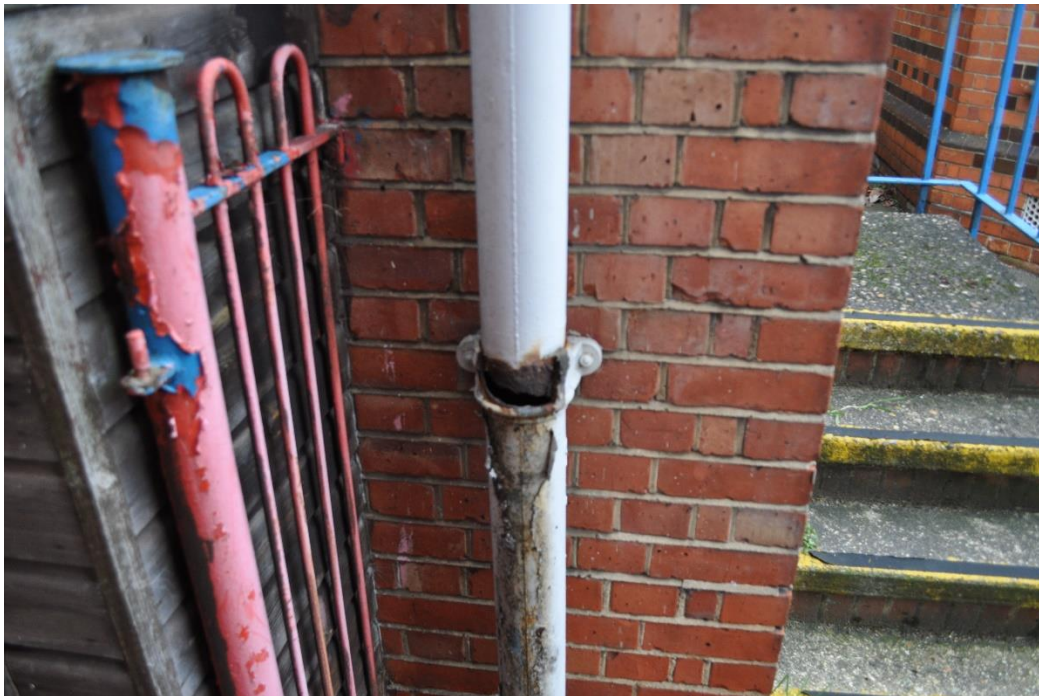
Fig 21 Broken pipe collar causing leak

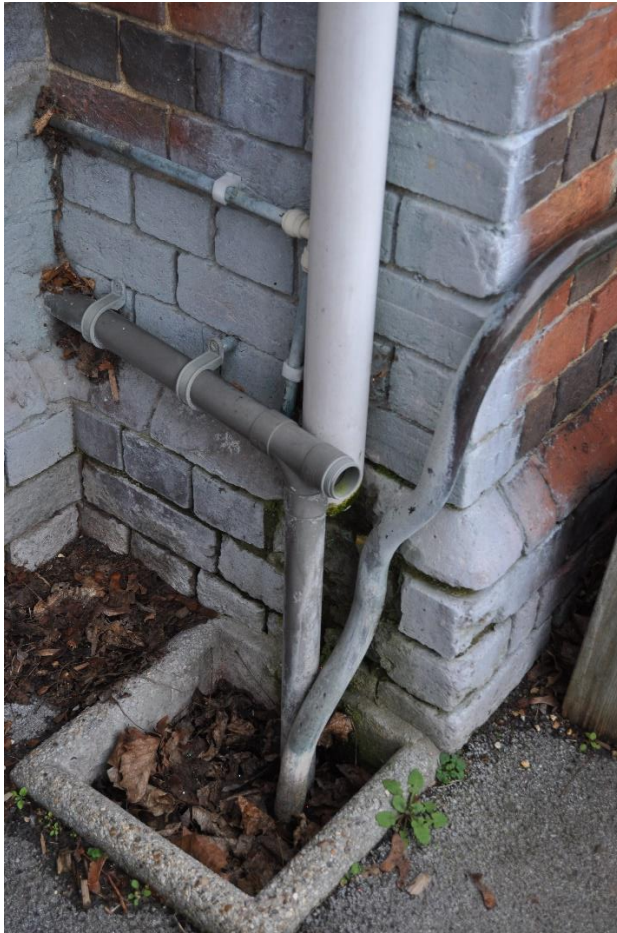
Fig 22 short down pipe and leaking services discharges causing brick damage

It is proposed to rationalize the area over the flat roofed ground floor toilet extension on the east side of the building, removing redundant pipework and adding connecting pipework to remove concentrated discharge onto this flat roof.

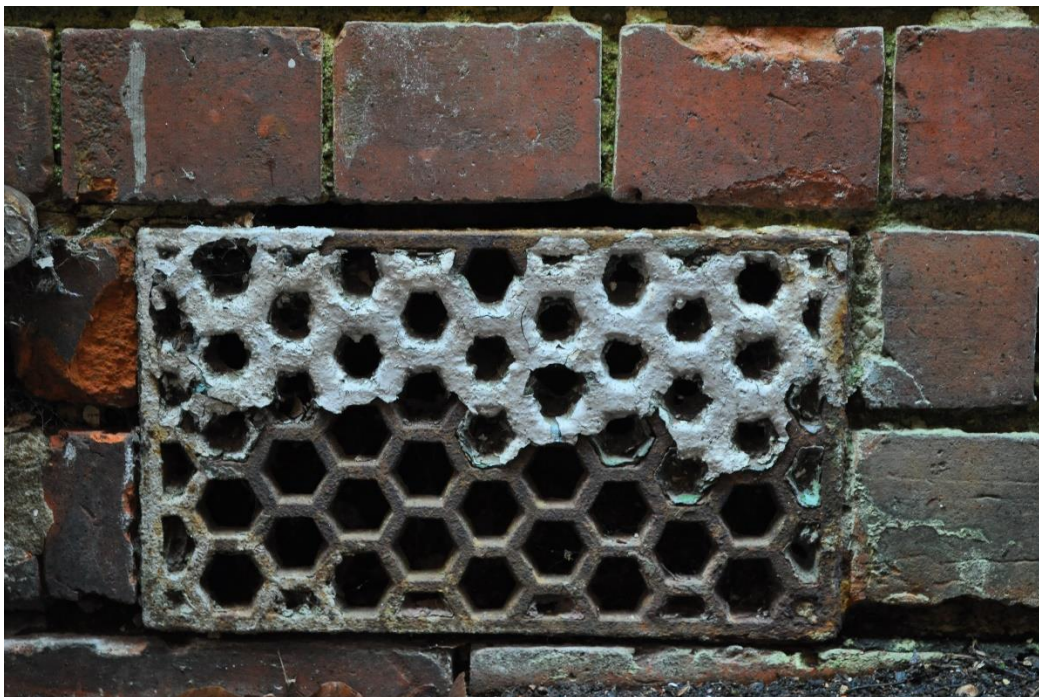
Fig 23 Cast iron air brick / ventilation grille at low level, high level ones similar design.
