**14 The Rise  
Caversham  
Reading  
Berkshire  
RG4 8NZ**

# **Preliminary Bat Roost Assessment**

**Ref: R2944/a**

**November 2021**

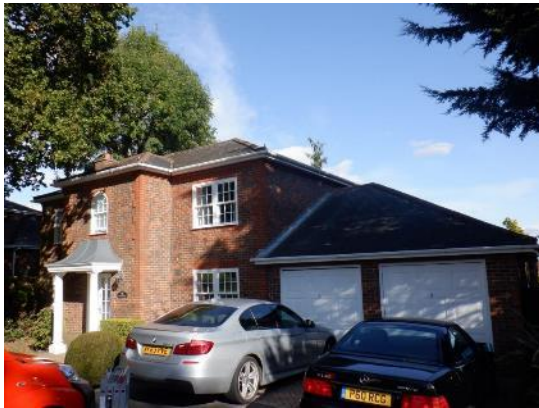
1. Front of house viewed from the west.

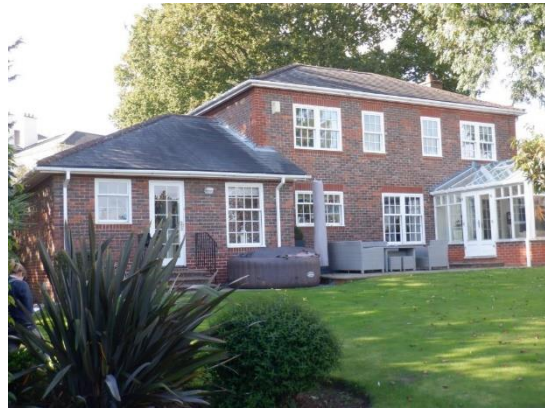
2. Rear of house viewed from the east.

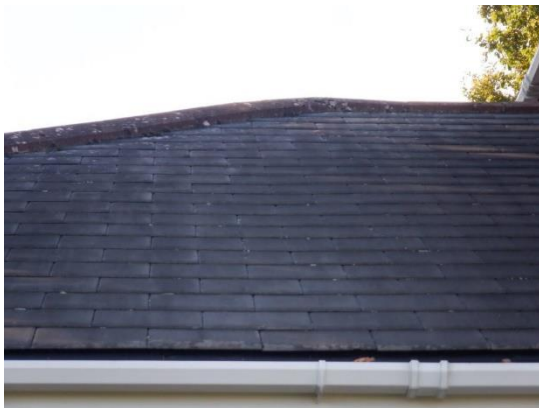
3. Flat slate roof tiles (rear elevation).

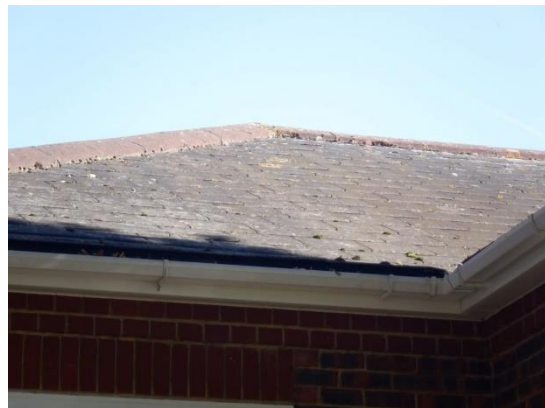
**5.1.2** The building on the whole lacked external features suitable for use by crevice-dwelling bats, such as pipistrelle (*Pipistrellus* spp.) and/or small *Myotis* species. The uPVC soffits were sealed to the brickwork and the roof, ridge and hip tiles were intact across the roof of the house and garage. Overall, the property is considered to be of negligible bat roost potential.

4. Tight ridge and hip tiles with intact mortar.

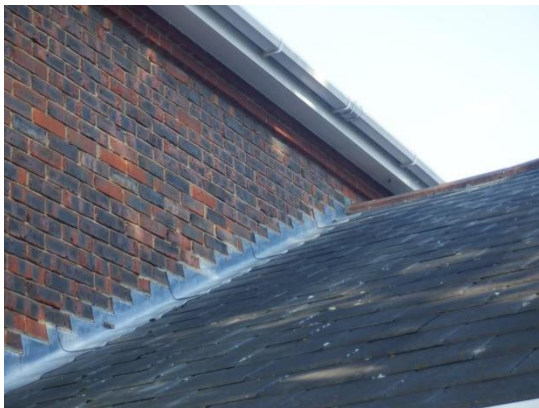
5. Tight lead flashing where the garage roof joins the house (front elevation).

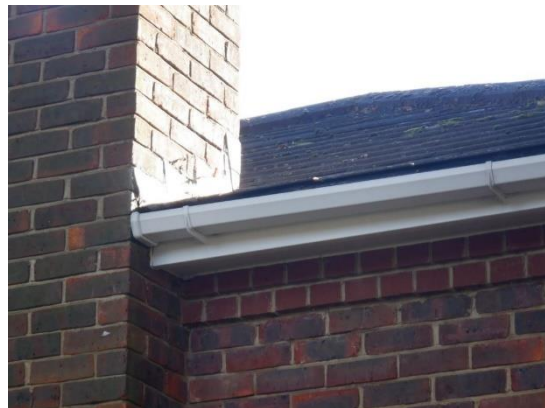
6. Tight lead flashing and sealed soffit to chimney stack (north elevation).

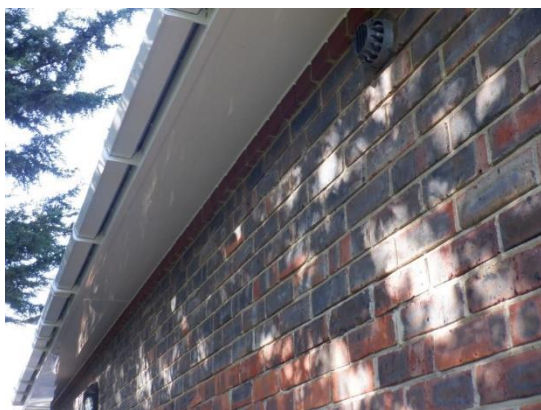
**7. Soffit sealed to brickwork along garage.**

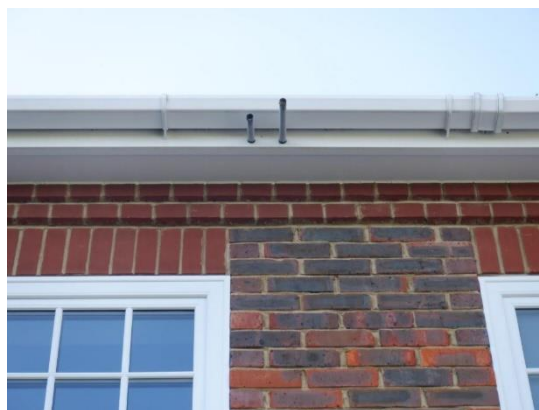
**8. Overflow pipes out of uPVC soffit (rear elevation).**

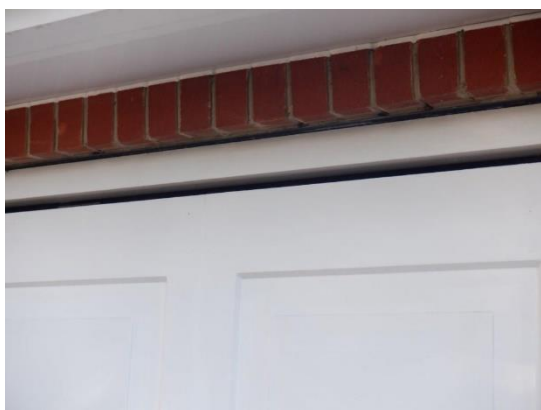
- 4.2.1** The house featured an attached garage on the southern elevation and a glass-roofed conservatory on the rear extension (**Photographs 1 & 2; Target note 1**). The building was of modern brick cavity construction, with a hipped roof on the house and garage which featured flat slate roof tiles (**Photograph 3; Target note 2**). The ridge and hip tiles were tightly fitted, and the mortar was also intact offering no roosting opportunities for bats (**Photograph 4; Target notes 3 & 4**). The lead flashing was tight at the junction between where the garage and conservatory joined the brickwork of the house (**Photograph 5; Target note 5**). A brick chimney was present on the northern elevation of the house, with tight lead flashing around the base and sealed soffit to the chimney stack (**Photograph 6; Target note 6**). The uPVC soffit was sealed to the brickwork along all sides of the house and garage, with two overflow pipes visible coming out of the soffit on the rear elevation (**Photographs 7 & 8; Target notes 7 & 8**). There were gaps above the garage doors on the front elevation which could offer access for bats into the interior of the garage (**Photograph 9; Target note 9**).

**9. Gap above garage doors (front elevation).**

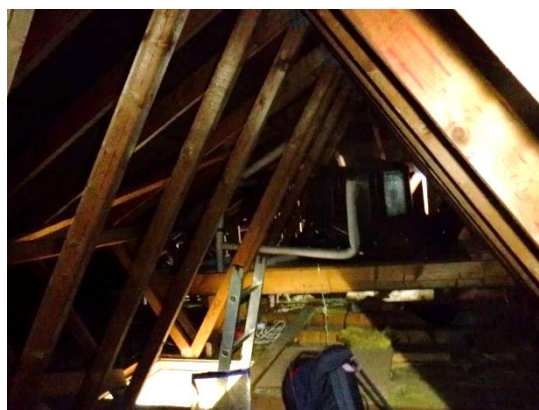
**10. First roof void above the house.**

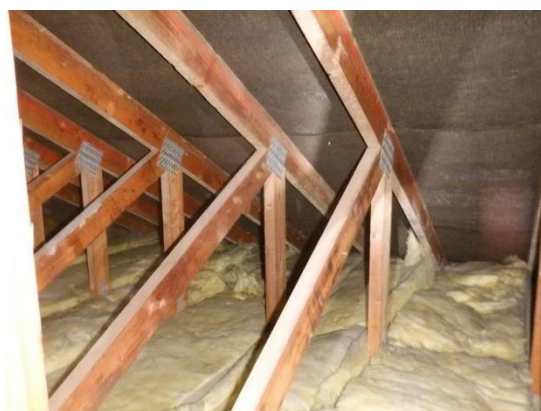
**11. Hipped roof at southern end with trussed rafters.**

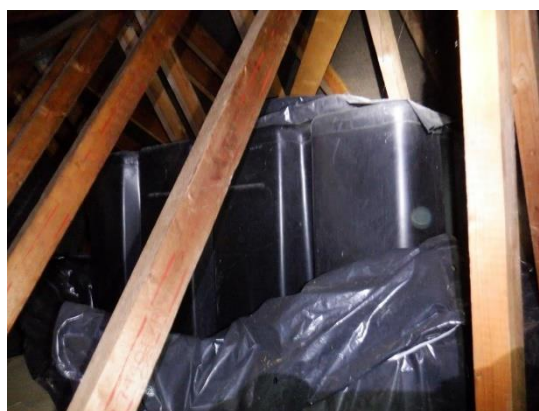
**12. Covered water tanks adjacent to loft hatch.**

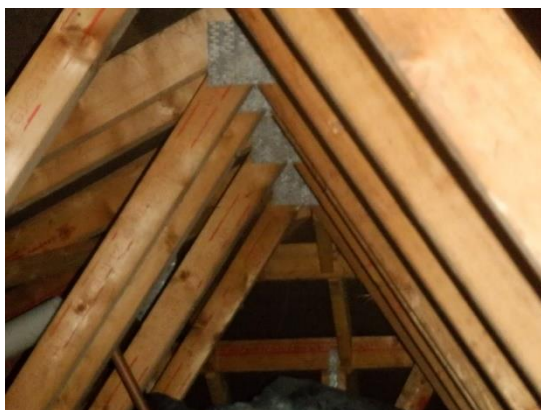
**5.1.1** The house and garage showed no evidence of the presence of roosting bats. The cobwebs along the ridge and absence of bat droppings inside both roof voids indicates that primarily void-dwelling species, such as the long-eared bats (*Plecotus* spp.), are highly unlikely to be present.

**13. Lightly cobwebbed ridge.**

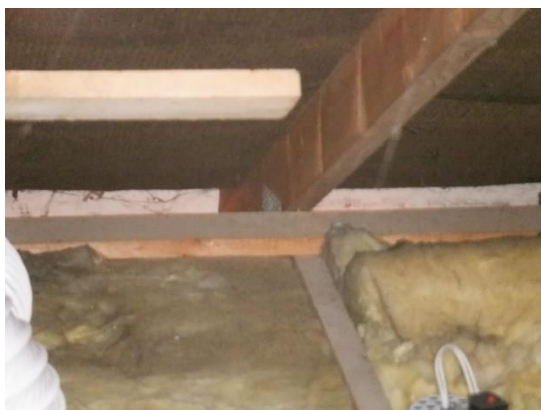
**15. Eaves open into the soffits.**

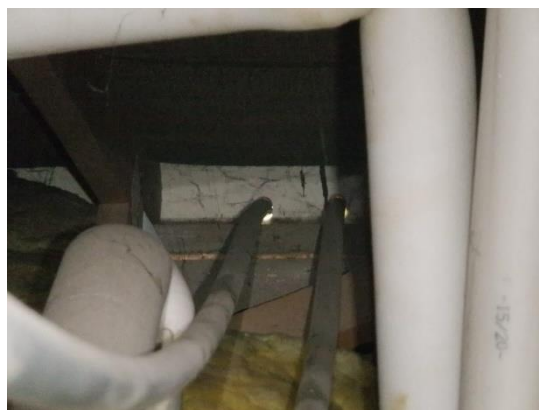
**16. Daylight visible around overflow pipes in soffit on rear elevation.**

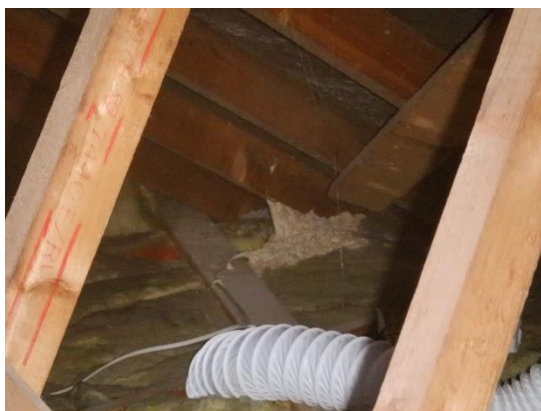
**17. Medium sized wasps' nest at eaves.**

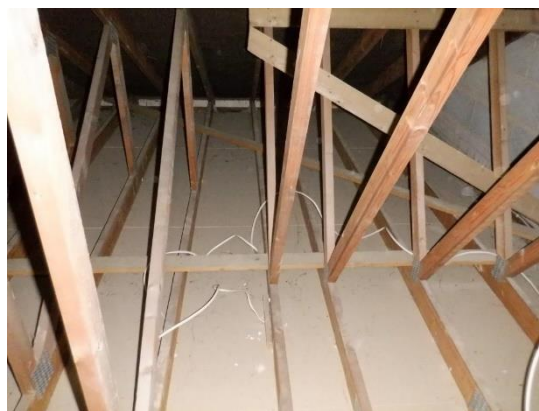
**18. Second roof void above the garage.**

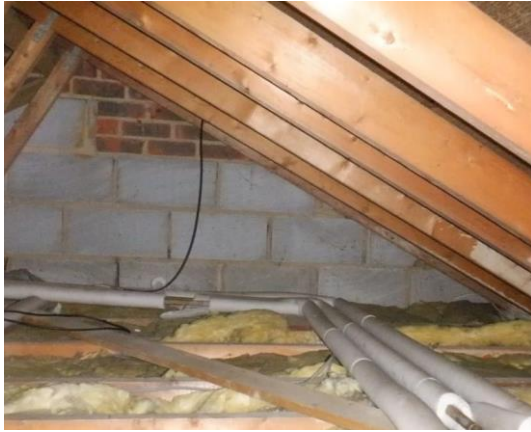
**19. Part block and part brickwork wall of the house.**

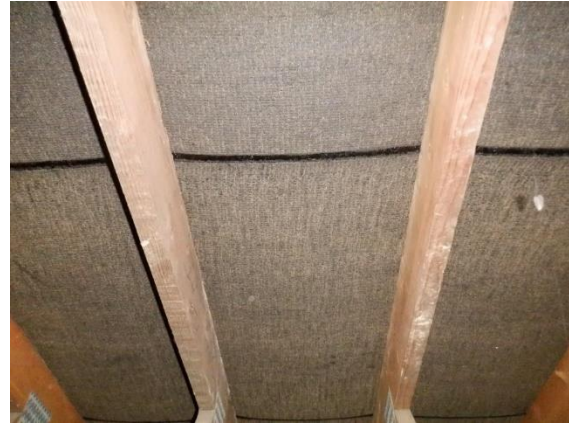
**20. Roof lined with hessian and bitumen roofing felt.**

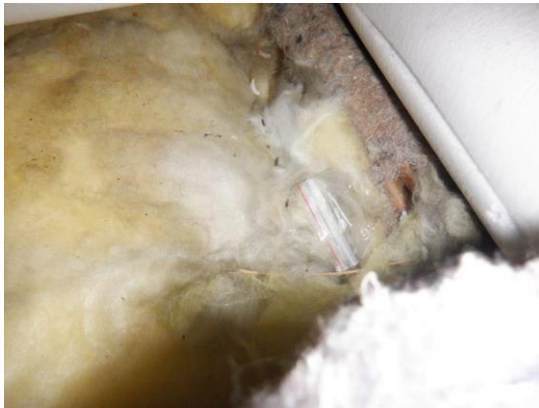
**21. Occasional mouse droppings on fibreglass insulation.**

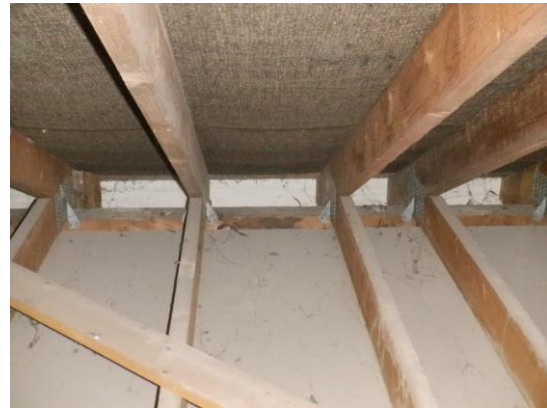
**22. Open eaves into soffit.**

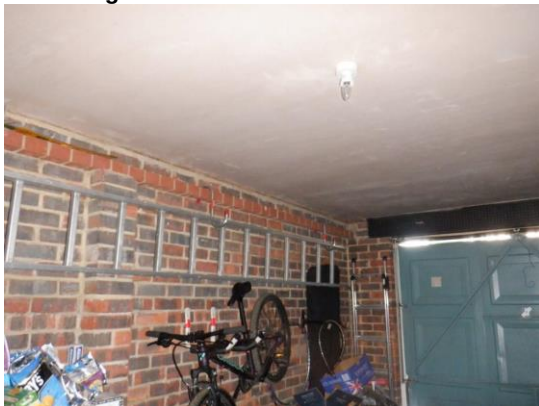
**23. Plastered ceiling of garage tight to brickwork.**

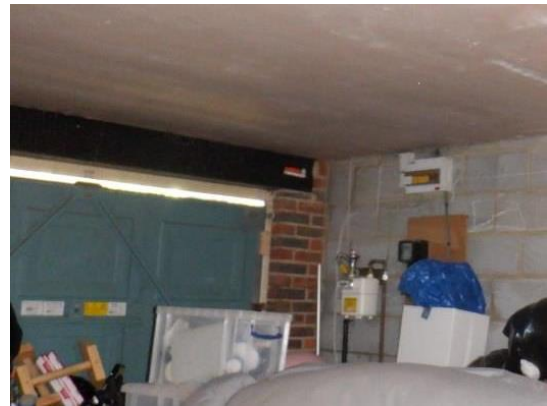
**24. Daylight visible above garage doors, which were cobwebbed.**
