## Phase 1 Geo-Environmental Investigation (Desk Study)

105, Addington Road,  
Reading,  
Berkshire,  
RG1 5PZ

Project Reference J117

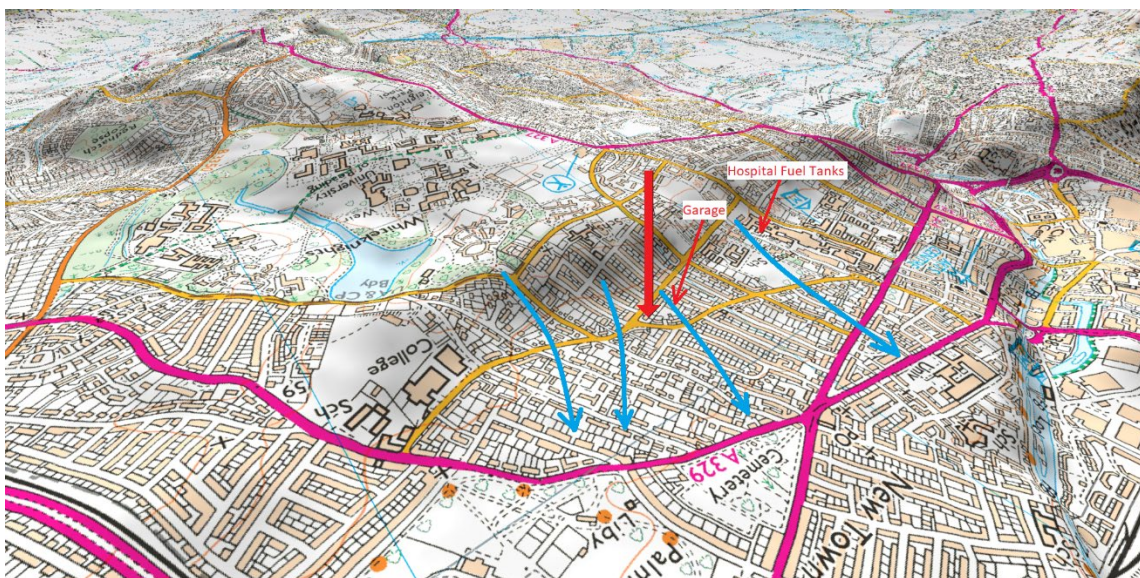
*Above, expected direction of surface and shallow groundwater flow*

Any mobile contamination in the site area, either floating (fuel or lubricants) or dissolved would be expected to move with surface waters in 1) the streams, drains and culverts and 2) within the flow of shallow groundwater, in any made ground or the terrace gravels downhill to the north. Contamination in areas to the north, east or the west of the site is unlikely to have historically migrated toward or onto the proposed development site.

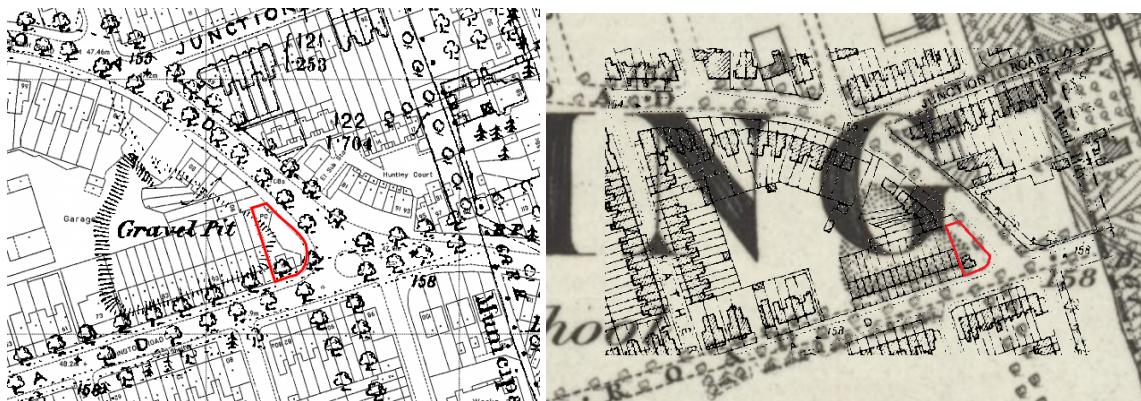
*Above, an overlay of the 1877 & 1993 maps(left) and 1877 & 1899 maps (right)*

The historical maps have shown that this site lies at the very edge of a gravel pit. The overlaid maps presented above show that the edge of the gravel pit occupies most of the garden to No.105. During site visits it was possible to see that the topography of the site matched what can be seen on the map overlay above with a steep slope beyond the advertising hoardings. This suggests that the gravel pit void is still in place and has not been infilled.

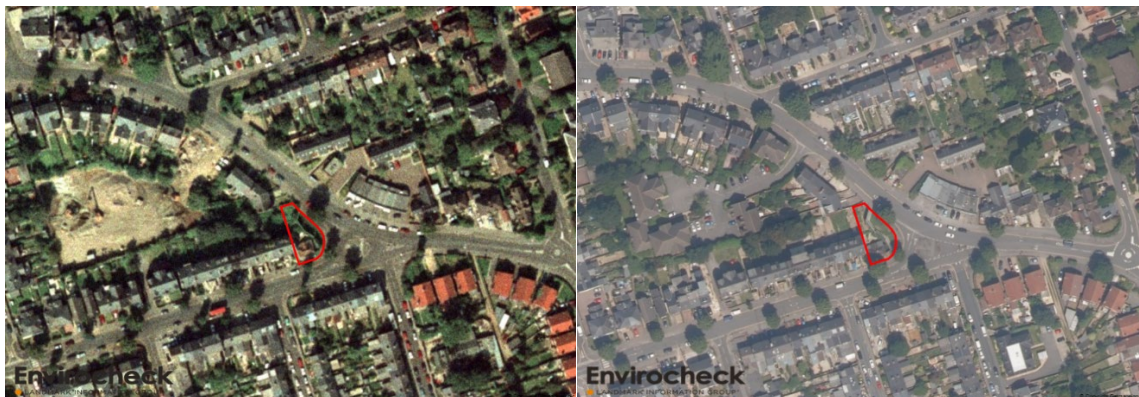
*Above, aerial pictures dated 1999 (left) and 2020 (right)*

Sixteen pictures are shown on Google Earth dated between 2003 and 2018. All for these pictures show the site with bungalow in place and the four advertising hoardings in place. All of the pictures show the garden to be an overgrown slope and not in use as a garden.

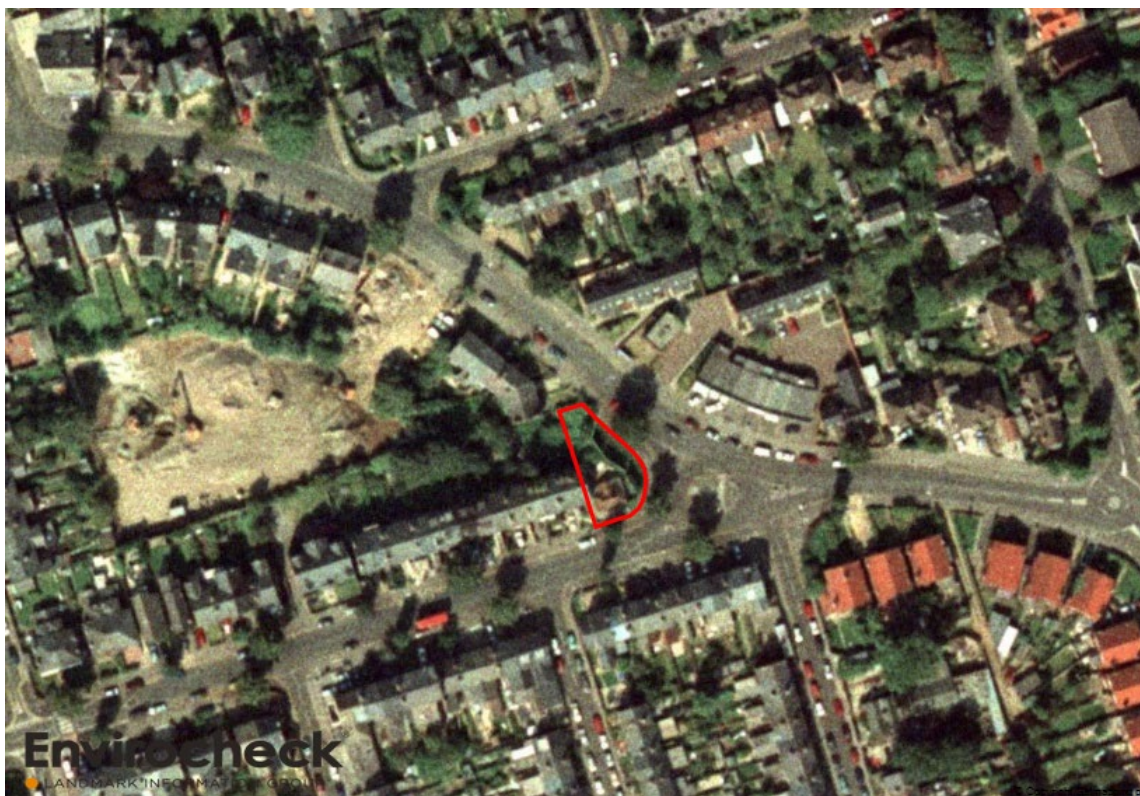
The works / garage building 100m to the north west of the site is the closest plausible source of contamination to the site. The garage building appears to have been removed and re-developed with flats on a new cul-de-sac road.

Aerial pictures dated 1999 show the area to have been cleared with bare earth visible over the whole garage site. The garage workshops can be contaminated by the decay of old vehicles on the site. Outside and unprotected cars can degrade into piles of brown rust leaving just an engine, wheels and axels behind. When corroding, any alloy components of the steel such as Boron, Chrome, Nickel can be released. Old batteries can add Lead in an acidic mobile state and of course hydrocarbons associated with fuel, lubrication oil and hydraulic oil can cause contamination.

The workshop itself may have generated waste such as old engine oil and old hydraulic oil from brake and steering systems. This oil waste is often stored in old barrels and similar containers. Inevitable spillage and leakage can leave the ground blackened with these old oils.

I assume that some forms of investigation would have been carried out before the flats were constructed. Hydrocarbons, particularly fuel, can cause nuisance odours if any have been left behind so I would expect any obvious contamination to have been removed. However, I have not made any formal enquiries about the re-development of that area with the Local Authority at this stage and I cannot rule out the potential for that area to have been contaminated.
