# Initial Bat Assessment

**20 Shinfield Road**

Reading  
Berkshire  
RG2 7BW

Dr Stacey Dawn Waring  
21-006-IBA  
March 2021

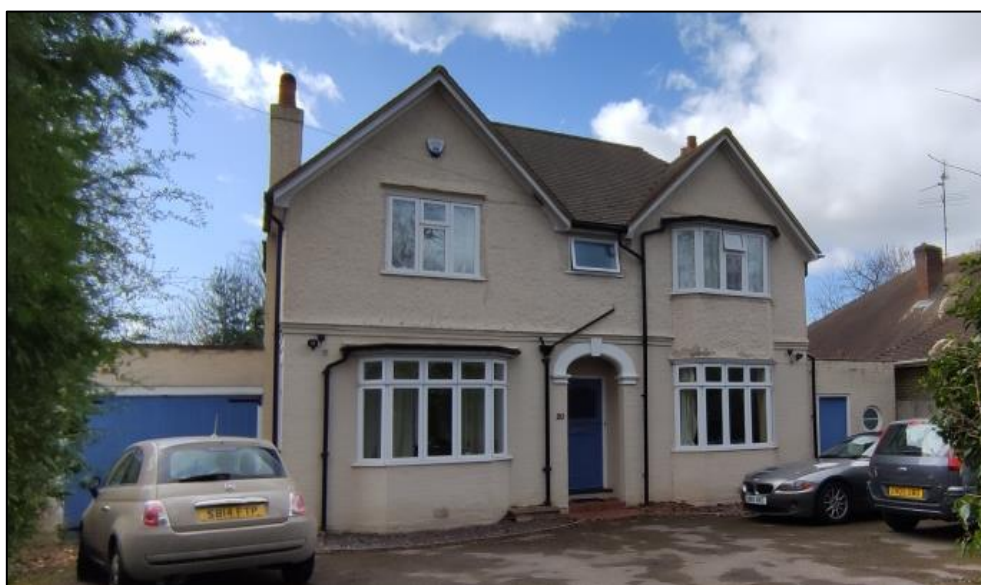
The site consists of an early 20<sup>th</sup> century (1920s), detached, two storey building of cavity wall, brick construction (Figure 2 and 3) with a pitched (hipped and gabled) roof, consisting of timber rafters resting on the walls and a machine-made, clay tile covering. There is a single storey, brick walled, flat-roofed garage/workshop to either side of the building and two single storey extensions to the rear of the same construction (Figures 2 and 3). The property is in good condition and is currently occupied.

**Figure 2** - Front (eastern) elevation of 20 Shinfield Road

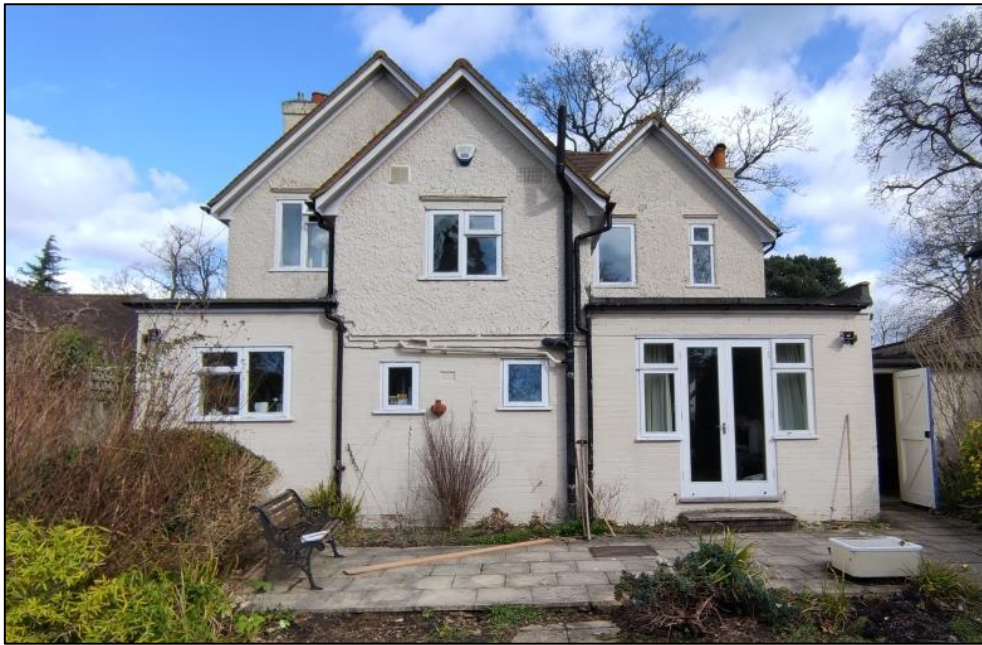
**Figure 3** – Rear (western) elevation of 20 Shinfield Road

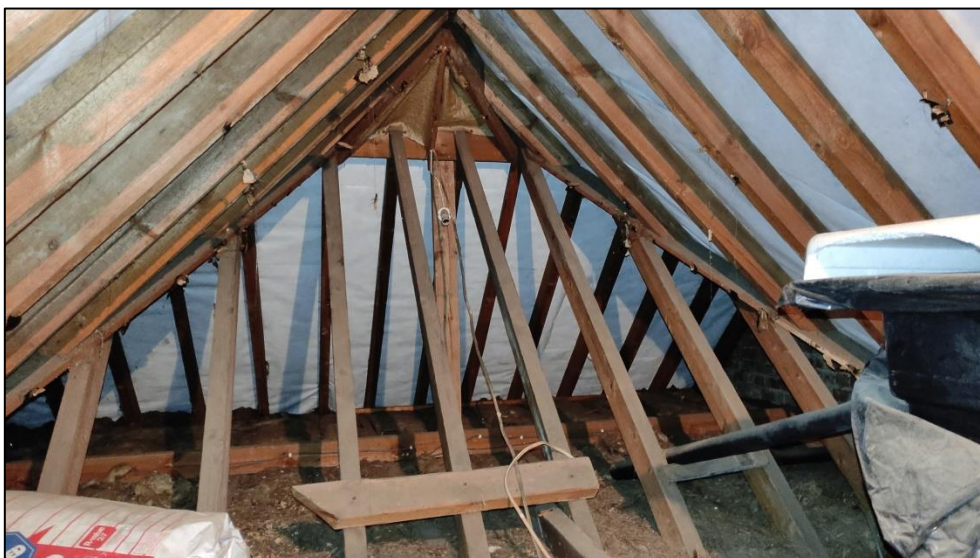
The property had a single roof void accessible through a loft hatch in the ceiling. The roof void was of moderate size, H-shaped in design and approx. 1.75m high at the ridge in the central section (Figure 4) and along the northern elevation. The section that ran along the southern elevation was smaller and approximately 1.2m high at the ridge. The underlay beneath the primary roof covering (Figures 4, 5 & 6), consisted of a non-woven breathable roofing membrane; which was in good condition throughout, with no tears or sagging. There was no evidence of 'fluffing' on the breathable roofing membrane, which can occur if bats roost against the product. The presence of the breathable roofing membrane, lines up with information suggesting the property has been re-roofed within the last 10 years.

**Figure 4** – showing central section of the roof void with access to other areas

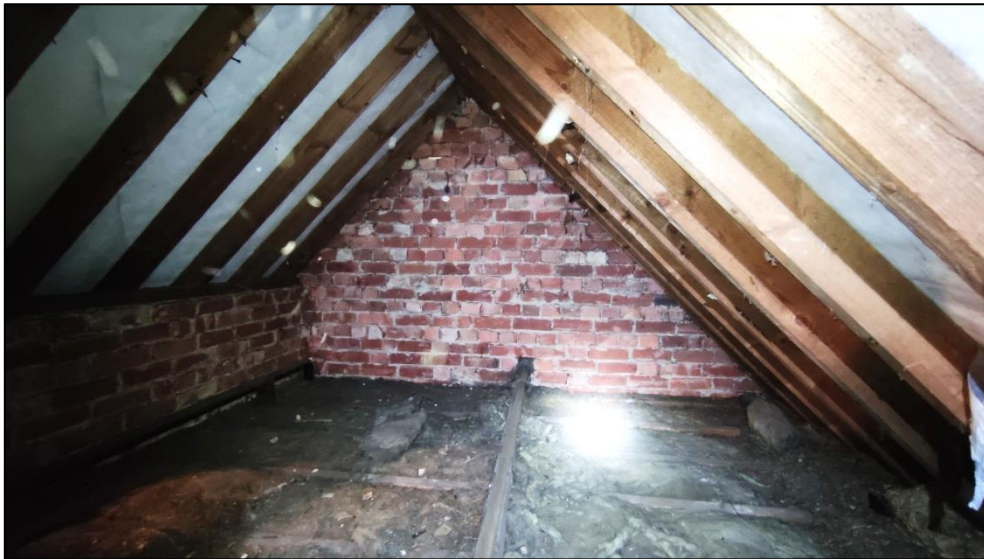
On each of the gable ends the walls were in good condition (Figure 5) with no gaps in the mortar, brickwork or visible access points from outside. Timber battens had been fitted where the roof meets the wall plate, further reducing the chance of gaps.

**Figure 5** – showing excellent condition of breathable membrane and gable end brickwork

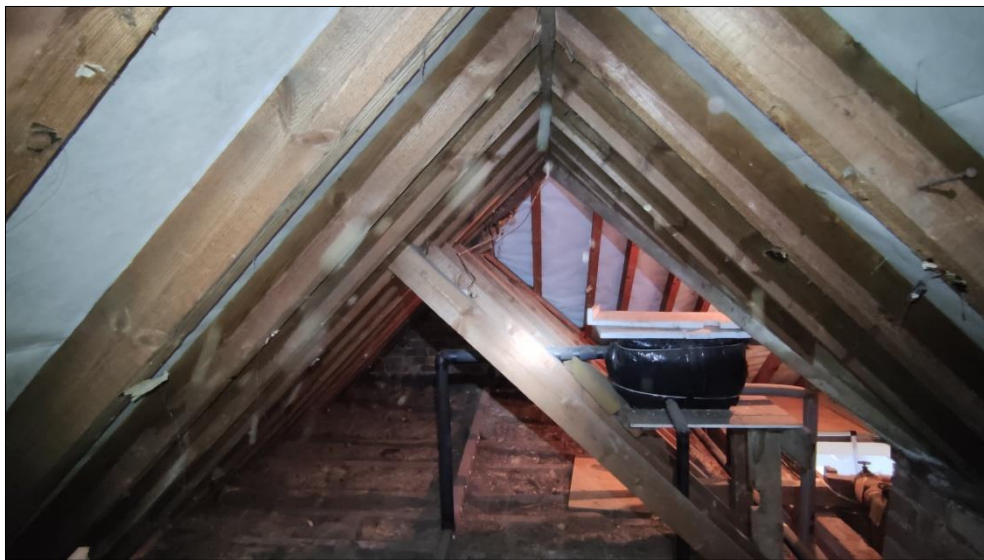
**Figure 6** – showing the section of roof running along the northern elevation

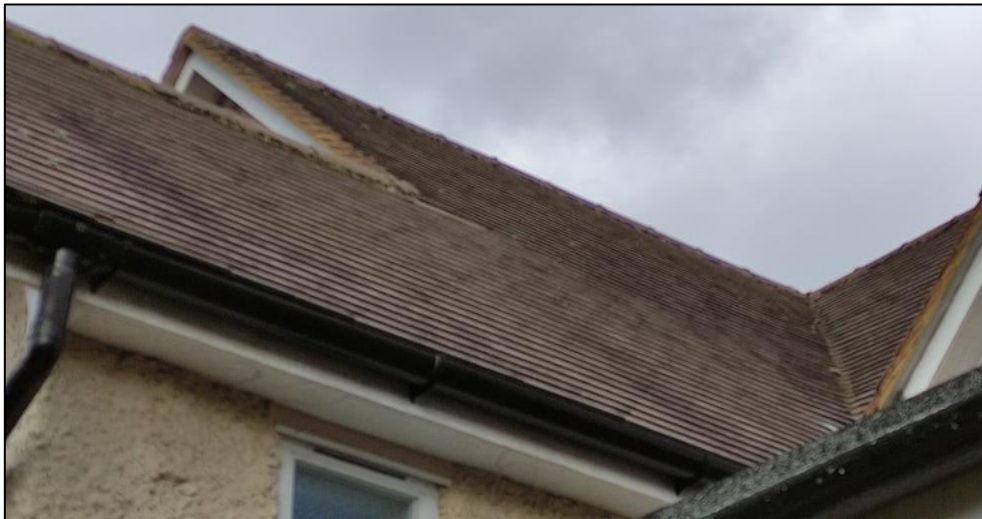
The primary roof covering consisted of machine-made, clay tiles over the entirety of the house (Figures 2, 3 and 7). The primary roof covering was in good condition and had been maintained over the years. The tiles were tightly fitting (Figure 7) and there were no missing or broken tiles, which could provide access to roosting bats. The ridge consisted of universal half round tiles (Figures 2, 3 and 8) which were all present and the mortar along the ridge and verges (Figure 8) was in good condition with no missing sections that could be utilised by bats. The eaves were sealed with boxed soffits (Figure 7), these were in good condition with no areas open to the interior (Figure 9). The lead flashing on the chimneys and in the valleys was in good condition and tightly fitting.

**Figure 7** – roof showing tightly fitting machine-made clay tiles and sealed soffits

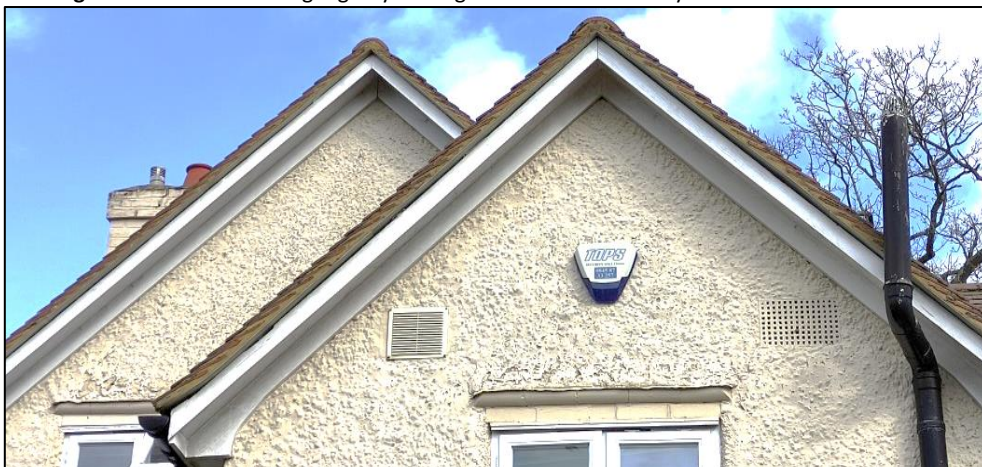
**Figure 8** – image showing mortar on verges in good condition

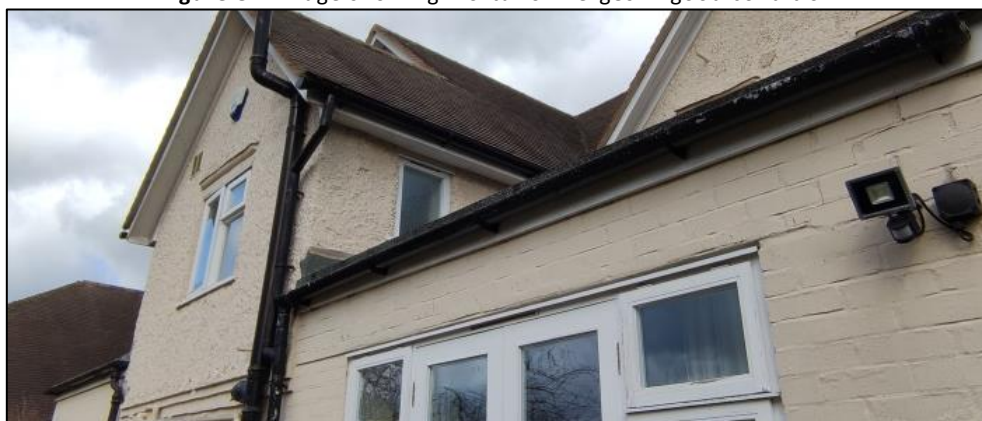
The flat-roofed garage/extensions to the sides and rear of the property all had bitumen felt roofs (Figure 9), which were in good condition. There were no areas of lifted felt, that could be used by roosting bats and the weatherboarding was tightly fitted against the wall (Figure 9) with no gaps or potential roosting areas.

**Figure 9**– showing flat roofs on extensions in good condition, with tightly fitting weatherboarding
