## Ground Conditions Statement

**Conversion of Office Building to  
Residential Use Under Part 3 Class  
O of the GPDO 2015 (as amended)-  
34 units**

**In respect of:**  
Rose Kiln Court  
Rose Kiln Lane  
Reading

**Reference:**  
MA/STEN/002-2/R002

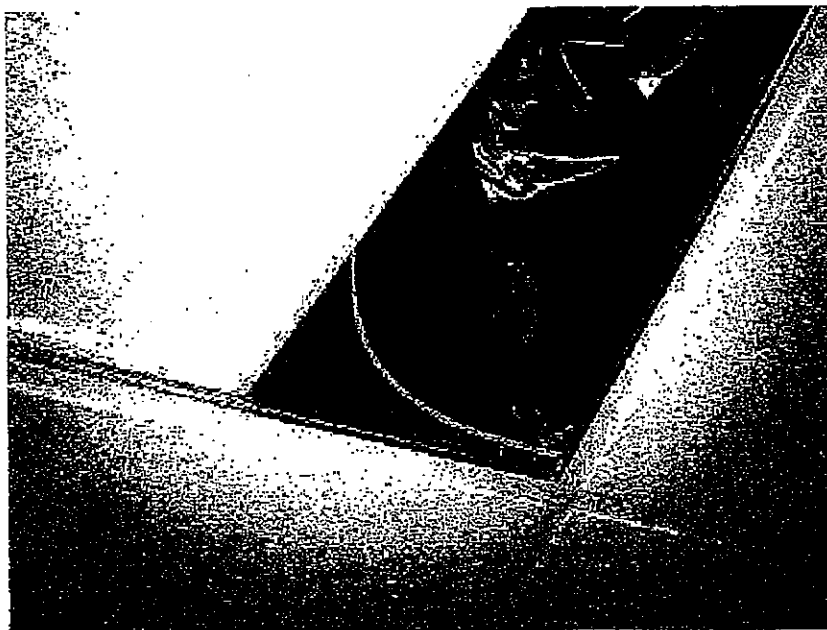
**NO ASBESTOS DETECTED IN SAMPLE - Insulation (within ceiling void).**  
**Sample No. ECS 94361**

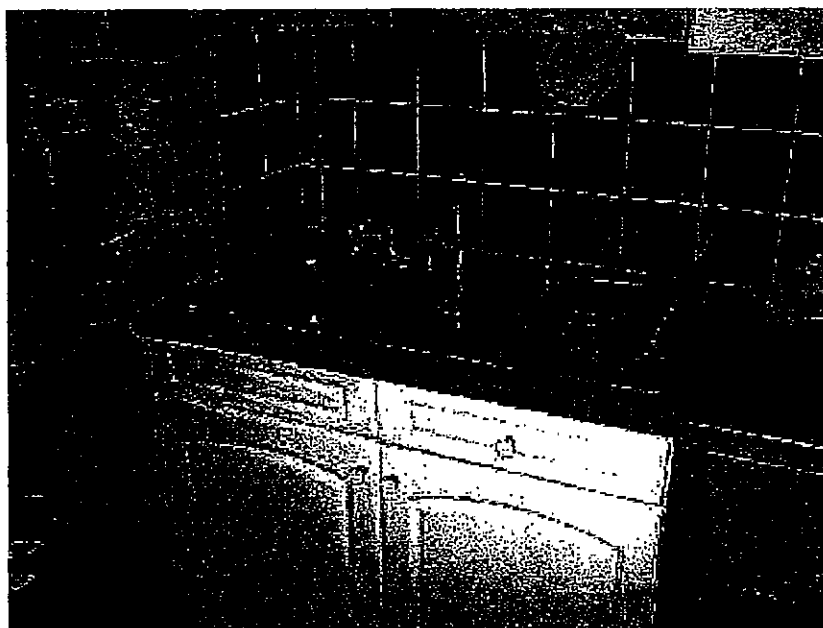
**NO ASBESTOS DETECTED IN SAMPLE - Bitumen Pad (beneath sink). Sample No. ECS 94363**

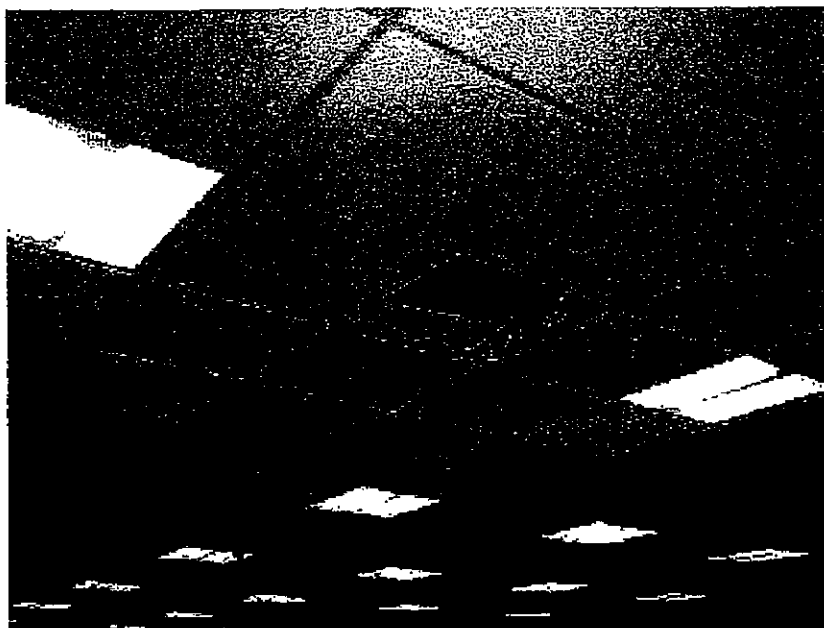
**NO ASBESTOS DETECTED IN SAMPLE - Ceiling Tiles. Sample No. ECS 94340**

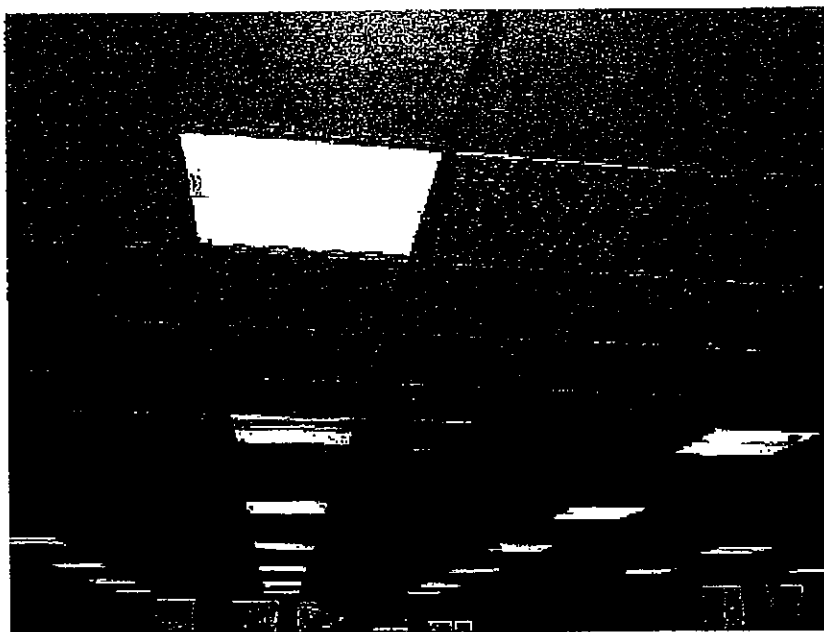
**NO ASBESTOS DETECTED IN SAMPLE - Ceiling Tiles. Sample No. ECS 94341**

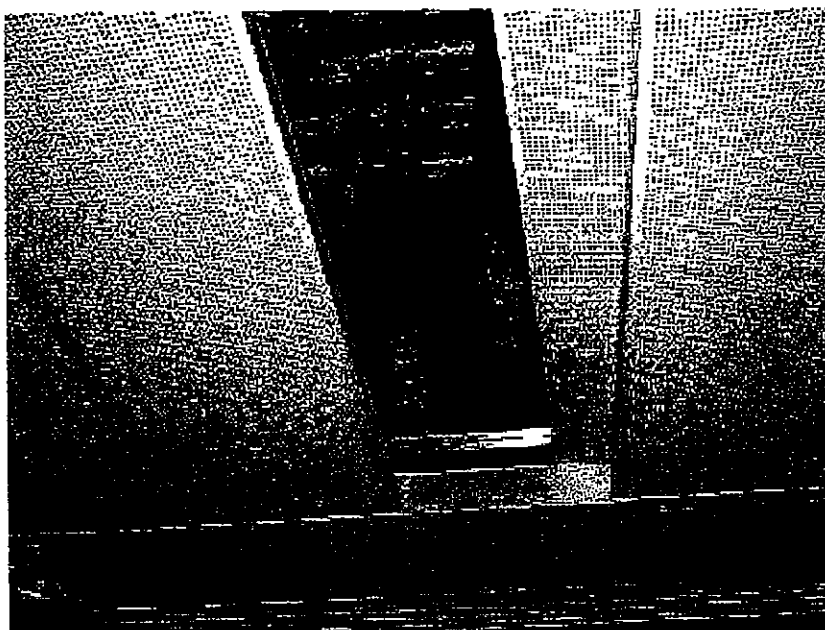
**NO ASBESTOS DETECTED IN SAMPLE - Pipework Insulation (within ceiling void). Sample No. ECS 94343**

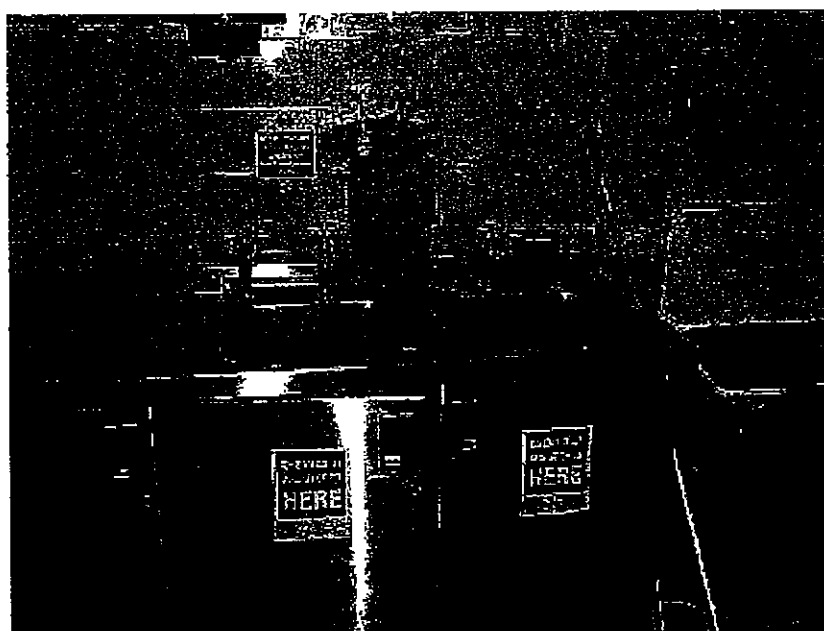
**NO ASBESTOS DETECTED IN SAMPLE - Bitumen Pad (beneath sink). Sample No. ECS 94344**

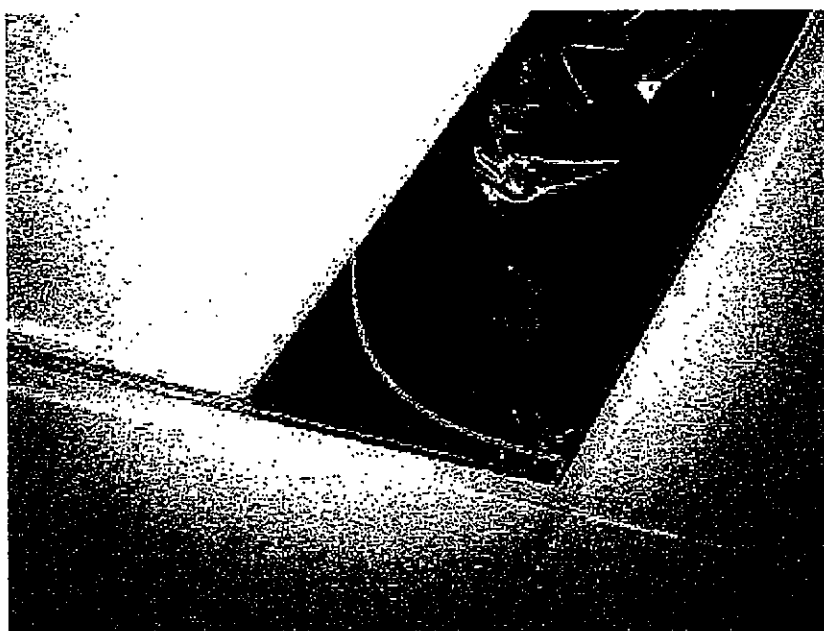
**NO ASBESTOS DETECTED IN SAMPLE - Insulation (within ceiling void).  
Sample No. ECS 94361**

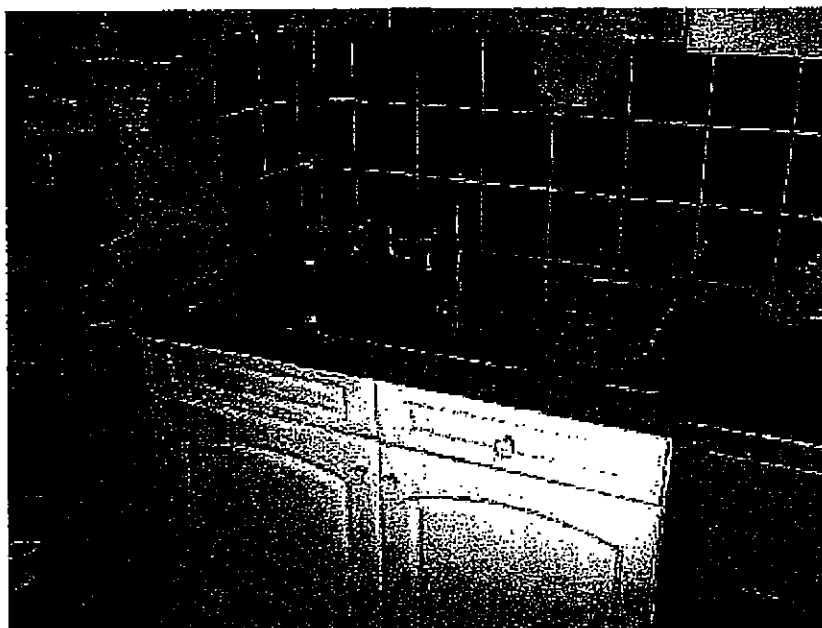
**NO ASBESTOS DETECTED IN SAMPLE - Bitumen Pad (beneath sink). Sample No. ECS 94363**
