**129 WHITEKNIGHTS ROAD, READING,  
BERKSHIRE**

**PRELIMINARY BAT ROOST  
ASSESSMENT**

Report No: RT-MME-156393

Date: December 2021

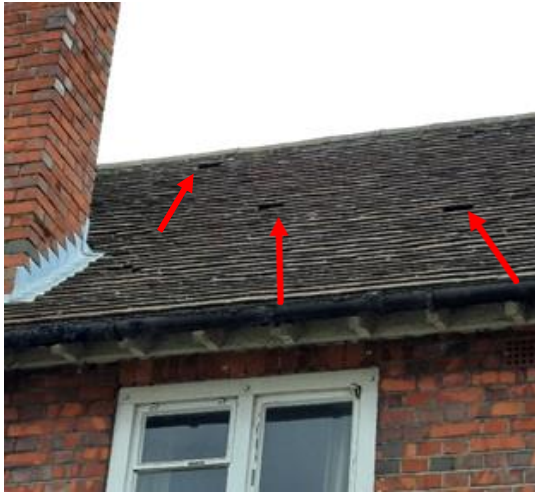
A survey of the roof of the building was conducted from ground level. Numerous features were recorded within the roof in form of missing, broken, or lifted clay roof and ridge tiles (Plates 4.3, 4.4, 4.5, 4.6 and 4.7) on all elevations which could be utilised by bats to enter the building and potential roosting locations. Lifted lead flashing was recorded where the kitchen extension roof and main building meet (Plate 4.8). It was not possible to inspect any of these ingress holes due to the height at which they were located and as such it was not possible to establish if bats had used these features to enter a roost location at the time of surveying.

Plate 4.3: Numerous missing and lifted roof tiles (north-west elevation)

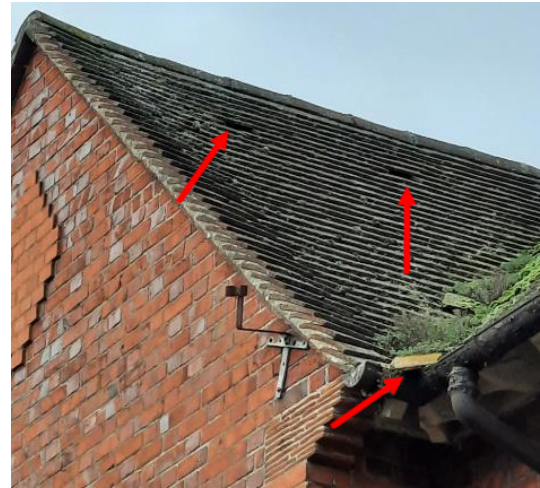
Plate 4.4: Missing and lifted roof tiles (south-east elevation)

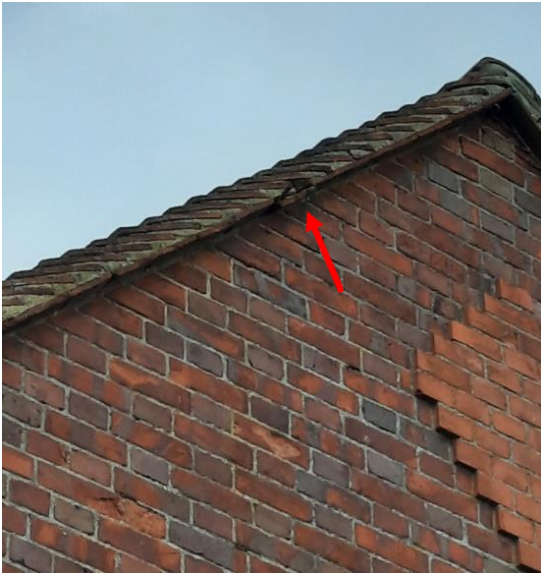
Plate 4.5: Broken tiles on gable end (north-east elevations)

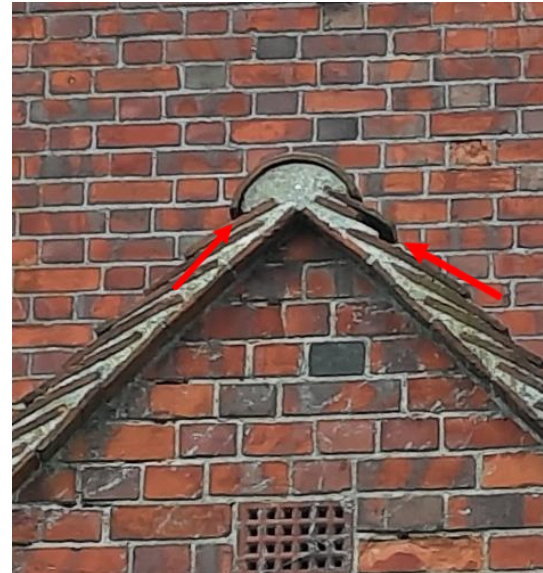
Plate 4.6: Lifted roof and ridge tiles on kitchen extension gable end

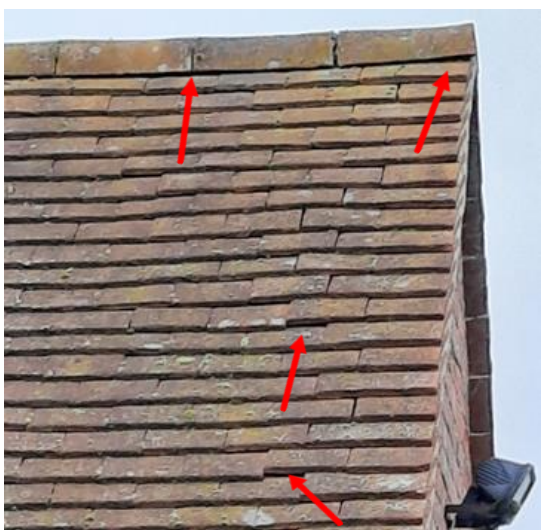
Plate 4.7: Lifted roof and ridge tiles on kitchen extension roof

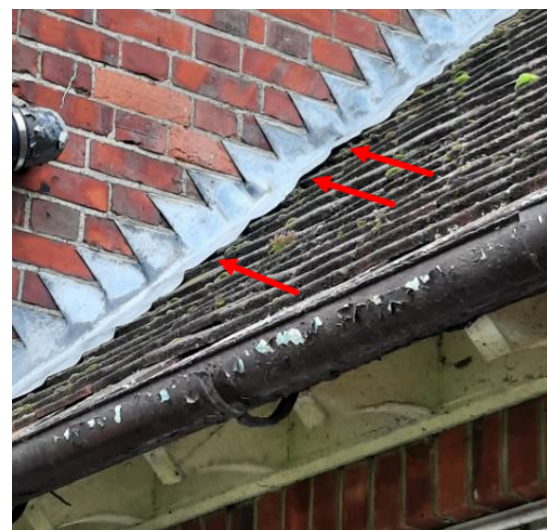
Plate 4.8: Lifted lead flashing between kitchen extension roof and main building

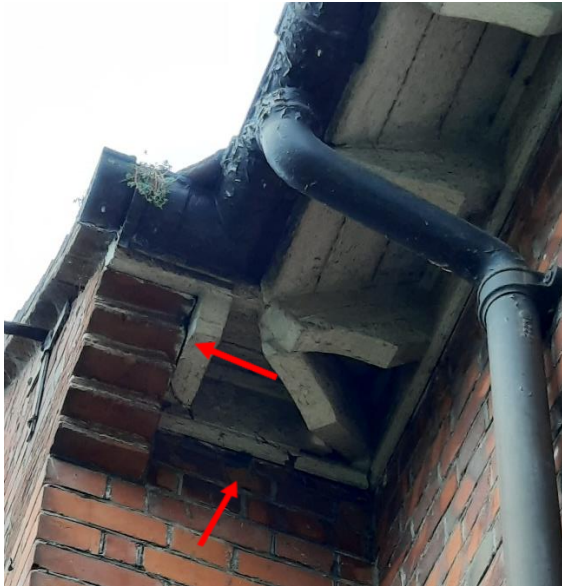
**Plate 4.9: Gaps between wooden board and brickwork**

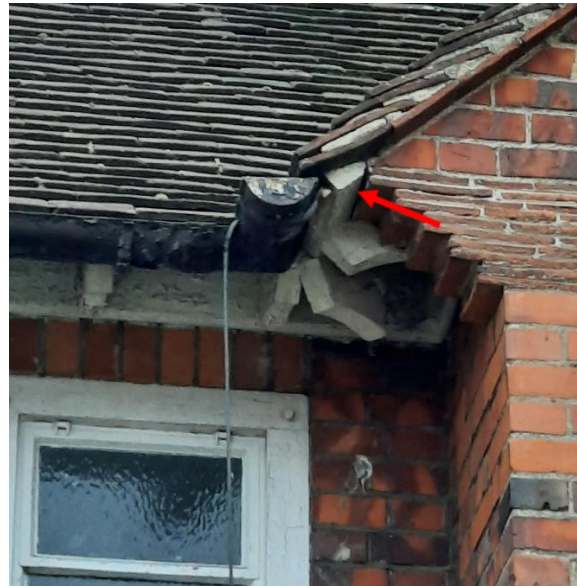
**4.10: Gaps between wooden board and brickwork**

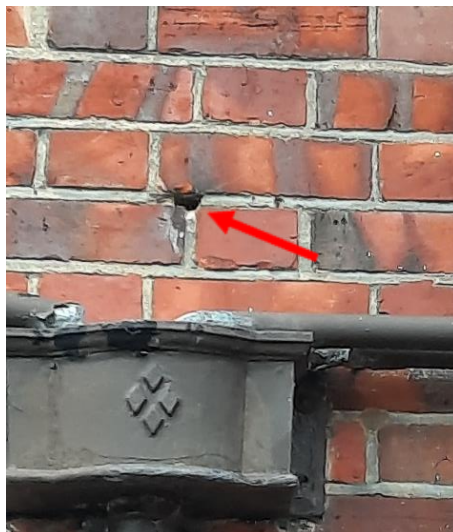
**4.11: Missing mortar in brickwork (north-west elevation)**

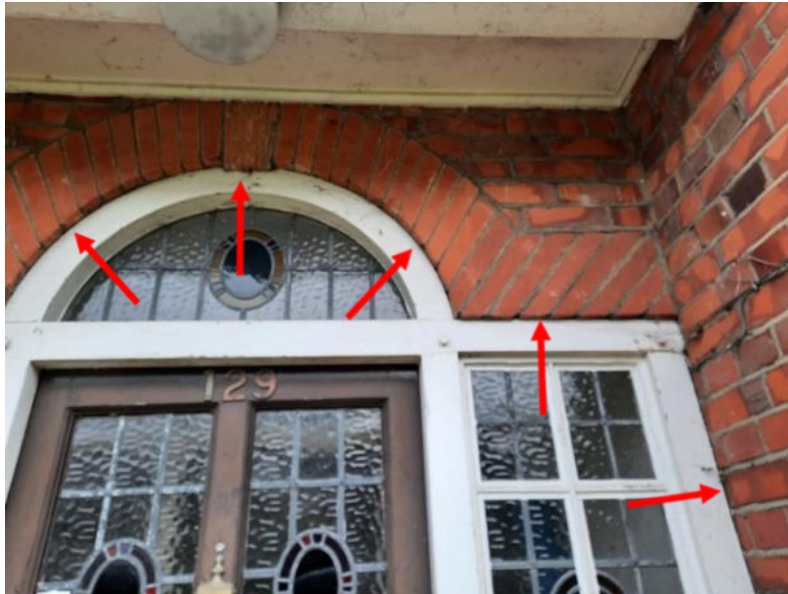
The previous assessment report found the wooden window frames, door frames and brickwork, had no gaps that could be utilised by bats and the single glazed windows were all in good condition. However, in the updated assessment, gaps were noted around wooden ornamental door and window frame on the front of the building (Plates 4.12 and 4.13). In addition, it was noted that the ornamental wooden lintel above the front door had degraded, and the associated lead flashing was lifted, creating gaps between the lintel and the wall (Plate 4.14). These features could be utilised by bats to enter the building and potential roosting locations. At the time of the survey no evidence of use by bats e.g. droppings, urine staining, feeding remains or scratch marks, was recorded within the features.

**Plate 4.12: Gaps between wooden door/window frames and brickwork**

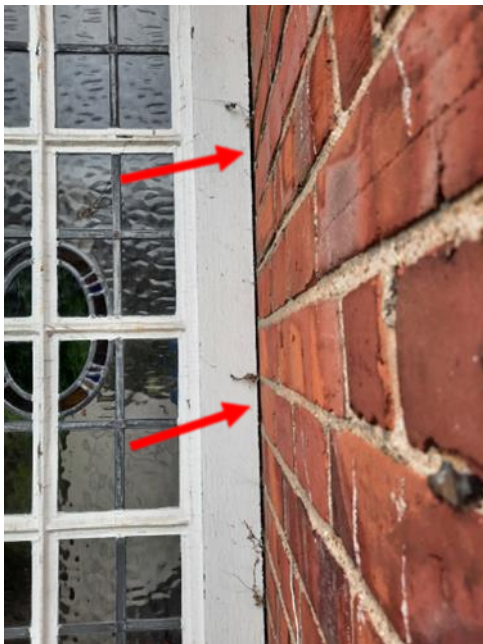
**Plate 4.13: Gap between window frame and brickwork**

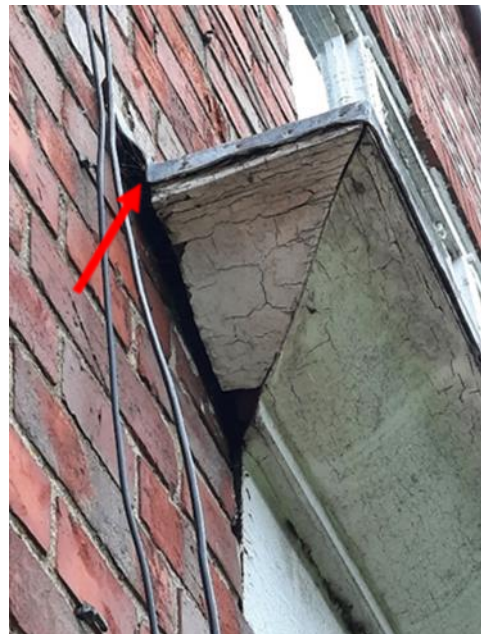
**Plate 4.14: Gap behind wooden lintel and lifted lead flashing**

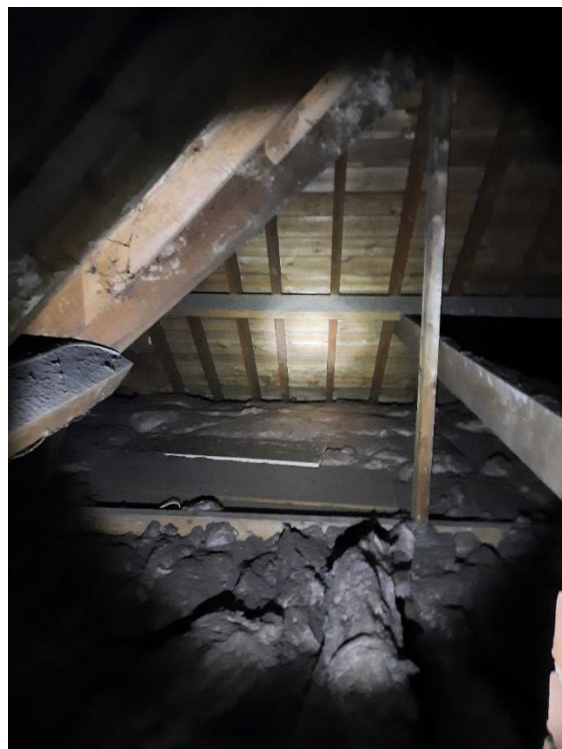
Wooden ridge beams and rafters were heavily cobwebbed indicating the space had not recently been used by fauna. The brick gable ends (Plate 4.18) had gaps around the edges which could be utilised as potential roosting feature by bats. The most northerly rear gable end was noted to be in a poor state with degraded mortar (Plate 4.18). The loft void had a slight draft at the time of the survey indicating that the loft space may not provide consistent temperature or a stable environmental conditions to support void dwelling bats; however, this was not significant enough to rule out the probability of roosting bats. Additionally, there was external damage to the roof tiles that has created large ingress point for bats to utilise (Plate 4.19). The remains of a wasp's nest was noted indicating there are access points into the loft void for fauna. Evidence of faunal feeding remains in the form of wing cases were noted on the floor.

**Plate 4.16: Main loft void – heavy cobwebbing**

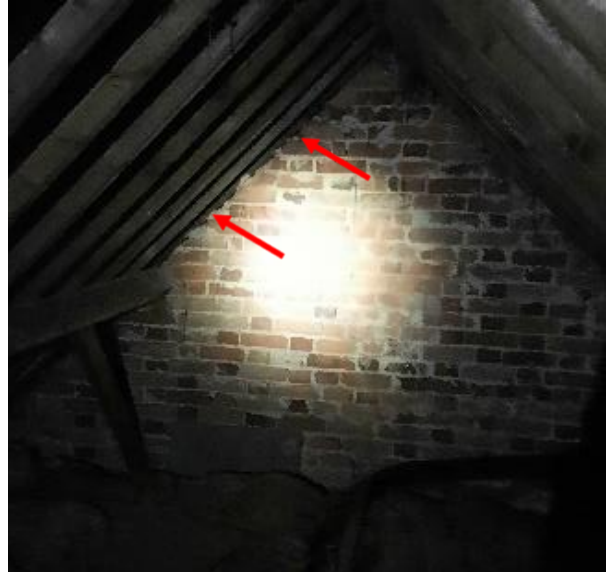
**Plate 4.18: Gaps around most northerly rear gable end**

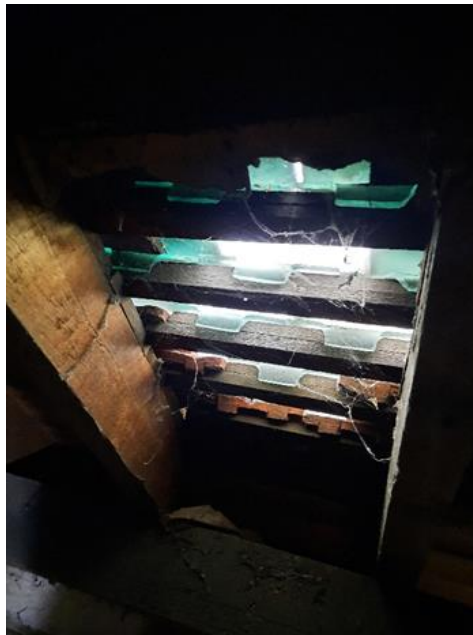
**4.19: Broken roof tiles and missing sarking**
