**8 Copperfields  
Caversham  
Reading  
Berkshire  
RG4 7PQ**

# **Preliminary Bat Roost Assessment**

**Ref: R2742/a**

**April 2021**

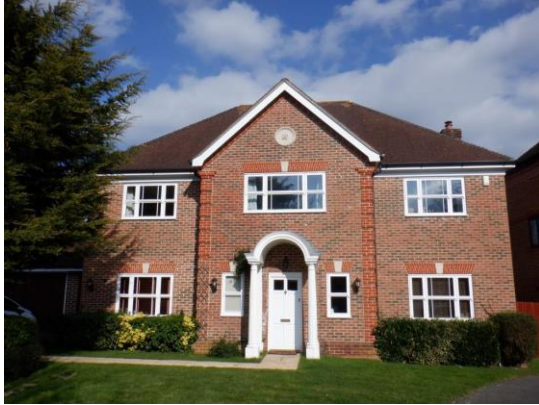
- 3.2.1** The detached house was of modern, brick cavity wall construction and had a hipped roof with a rear hipped end and a front gable; the shared detached garage stood to the north of the house (**Photographs 1, 2 & 3**).

1. Front of property viewed from west.

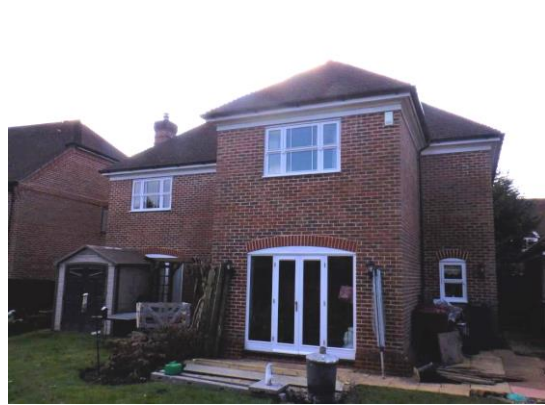
2. Rear of property viewed from east.

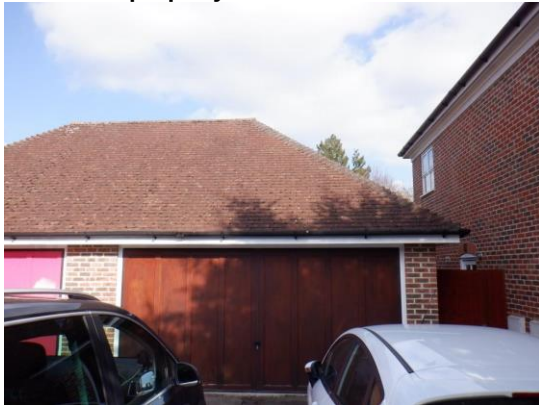
3. Front of shared detached garage viewed from west.

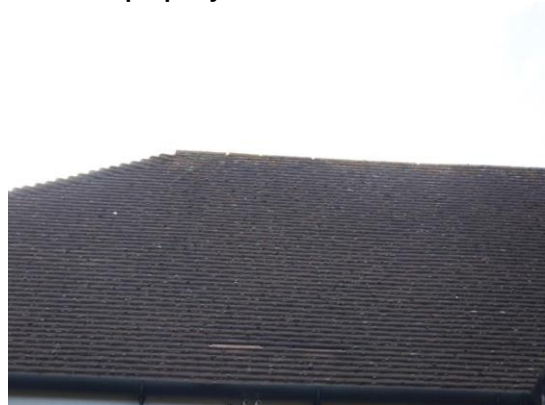
- 3.2.2** The house was covered in tightly overlapping roof tiles, with securely mortared ridge and hip tiles, presenting roosting bats with no discernible potential points of ingress (**Photographs 4, 5 & 6; Target notes 1, 2 & 3**). The front gable had intact verge mortar and soffits that were flush against the brickwork (**Photograph 7; Target note 4**). The lead flashing lining the chimney was fitted closely to the surrounding roof tiles and the soffits were also flush against the stack (**Photograph 8; Target notes 5 & 6**). All the soffits on the house were tightly fixed against the brickwork except for one slight gap, which was cobwebbed and of limited extent (**Photographs 9 & 10; Target notes 7 & 8**). There was a small, curved metal porch roof at the front of the house (**Photograph 11; Target note 9**). The garage had a hipped roof covered in tight overlapping tiles with intact ridge and hip mortar (**Photograph 12; Target notes 10 & 11**).

4. Flat overlapping roof tiles (rear elevation).

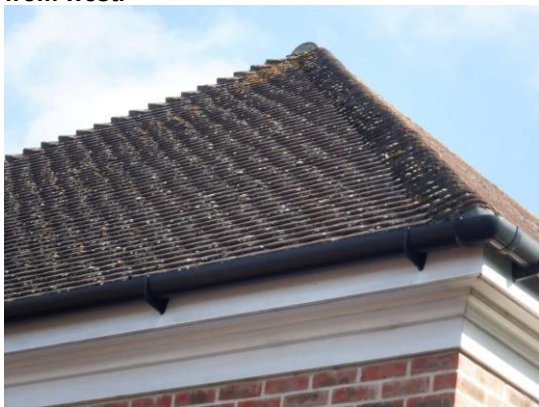
5. Mortared ridge and hip tiles (northern elevation).

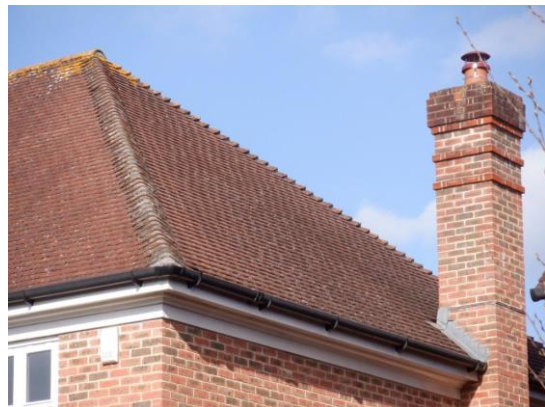
6. Mortared ridge and hip tiles (southern elevation).

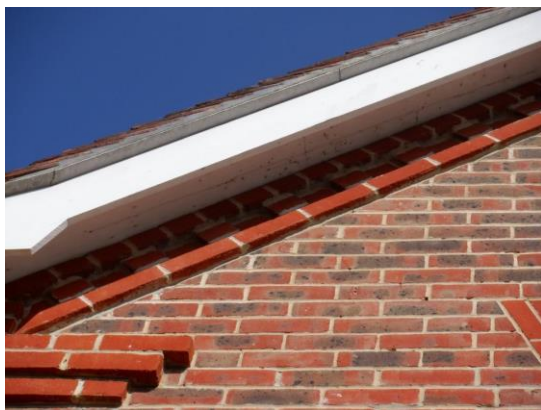
**7. Intact verge mortar on front gable (front elevation).**

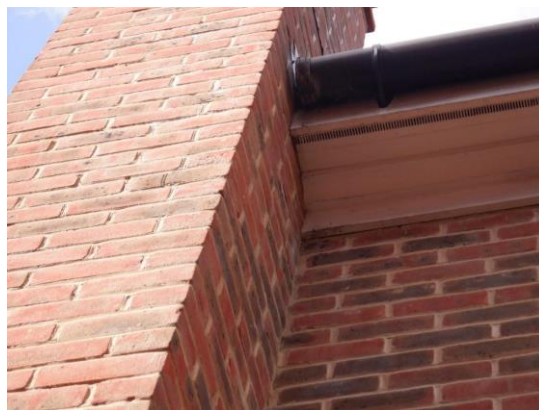
**8. Soffit flush to chimney stack (southern elevation).**

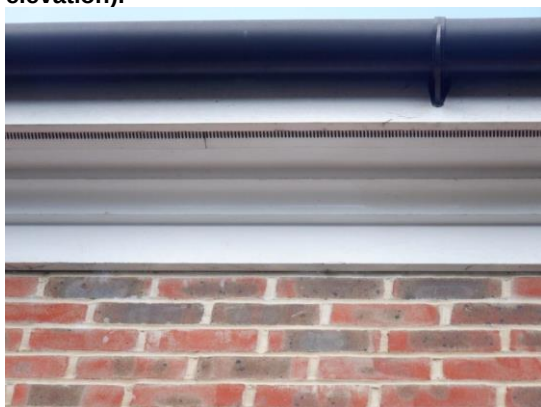
**9. Soffit box tight against brickwork (rear elevation).**

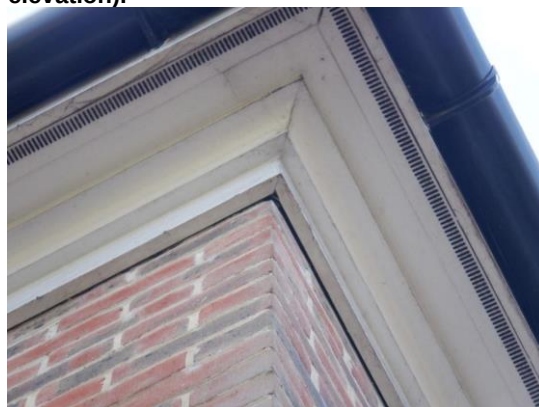
**10. Slight gap of limited extent behind soffit (rear/northern elevations).**

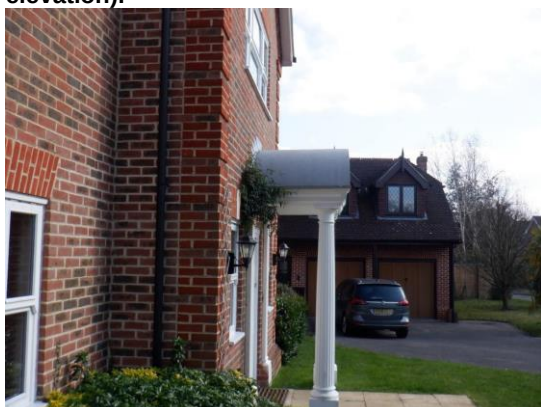
**11. Curved metal porch roof (northern elevation).**

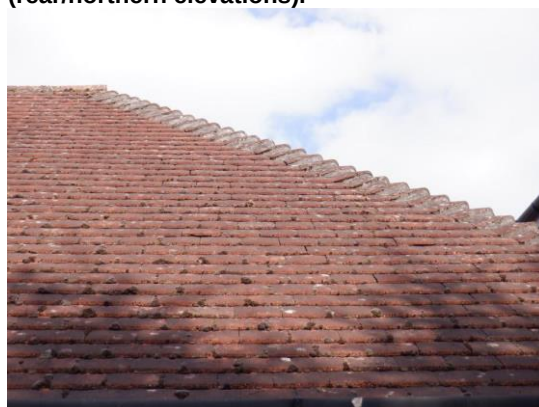
**12. Tight overlapping tiles and mortared hip tiles on garage (front elevation).**

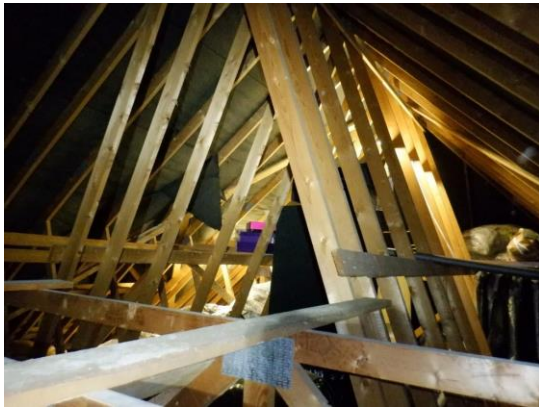
- 3.3.1** The house's roof void spanned the two-storey footprint and was accessible via a loft hatch on the first floor. The void had an approximate floor-to-ridge height of 3.5 metres and was of pre-formed trussed rafter construction (**Photograph 13**). The roof was lined with intact bitumen-and-hessian felt and there were cobwebs along the ridge, which indicates a lack of void-dwelling bat activity (**Photograph 14; Target notes 12 & 13**). The floor had some central boarding and was insulated with fibreglass; the eaves were open, and the soffit boxes were visible (**Photographs 15 & 16; Target notes 14 & 15**). There were two covered water tanks in the centre of the void (**Photograph 17**). The front gable end was of breezeblock construction and had gaps over the top of the blockwork (**Photograph 18; Target note 16**).

**13. Roof void.**

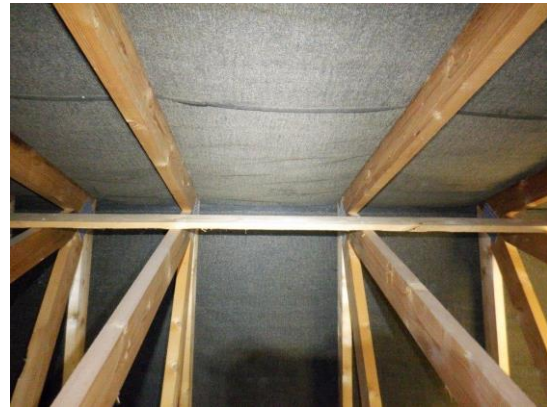
**14. Intact bitumen roofing felt.**

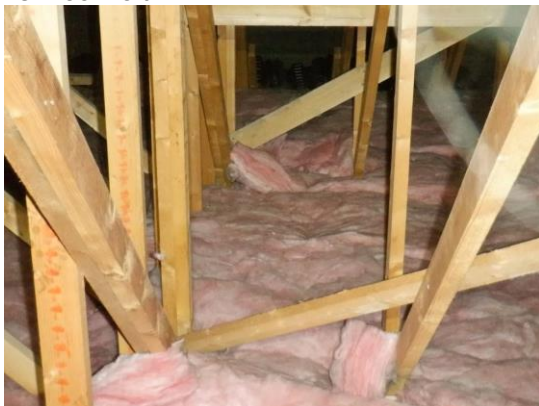
**15. Fibreglass floor insulation.**

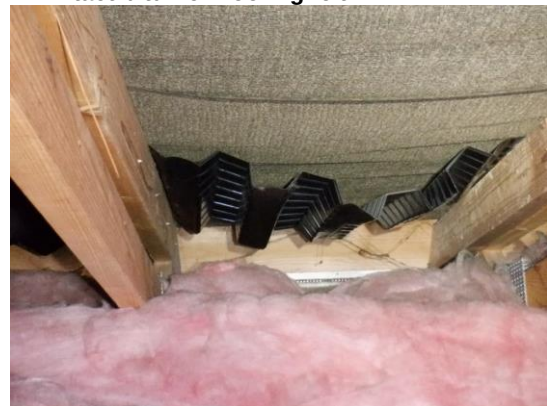
**16. Open eave with visible soffit box.**

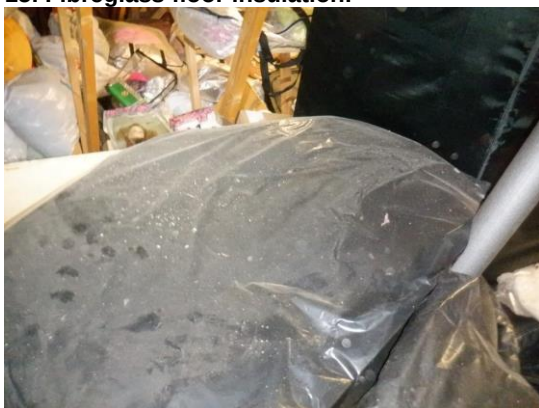
**17. Covered water tank.**

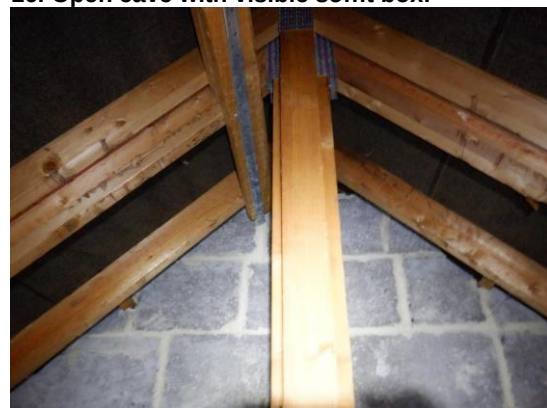
**18. Front gable end.**

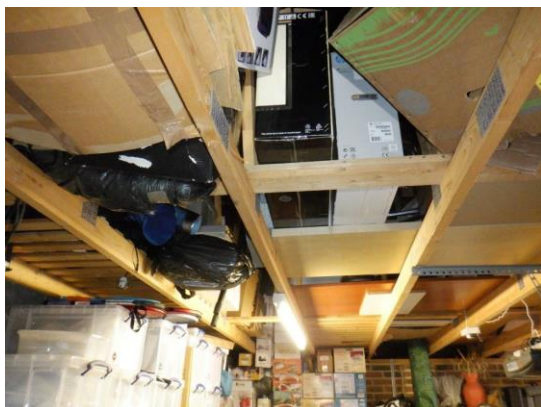
- 3.3.2** In the garage, the preformed trussed rafters were exposed and there was miscellaneous storage on the joists (**Photograph 19; Target note 17**). The roof was lined with bitumen-and-hessian felt and the concrete floor was covered in mats (**Photograph 20; Target note 18**). Timber wall plates were sealed to the brick walls (**Photograph 21; Target note 19**). There was a gap into the garage along the top of the garage door (**Photograph 22; Target note 20**).

**19. Stored items on joists in garage.**

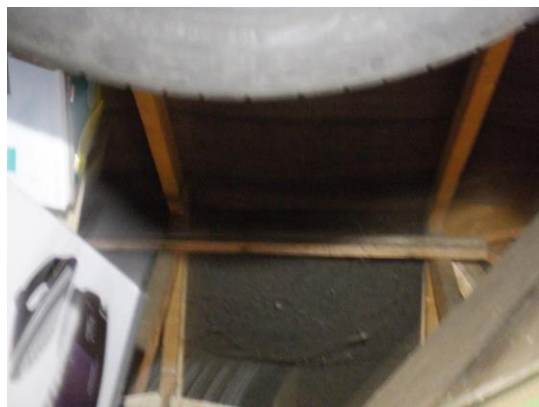
**20. Bitumen roof lining in garage.**

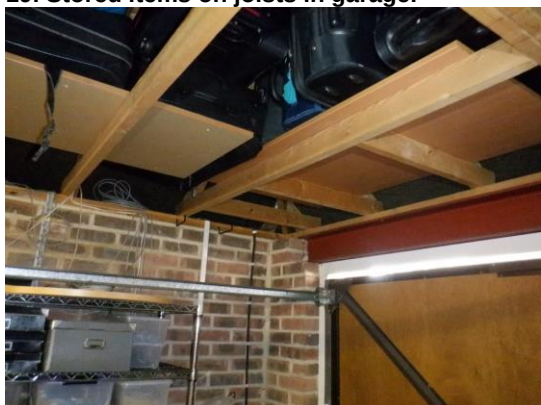
**21. Tight timber wall plate on garage walls.**

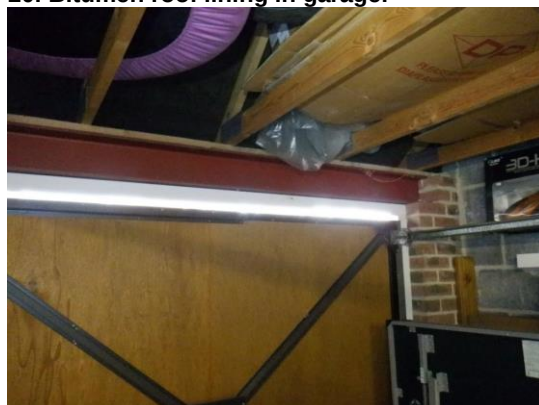
**22. Gap along top of garage door.**
