# PRELIMINARY ROOST ASSESSMENT REPORT

**SITE:** 75 BIRDHILL AVENUE, READING, RG2 7JU

**DATE:** 22nd April 2021

**REF:** 1266

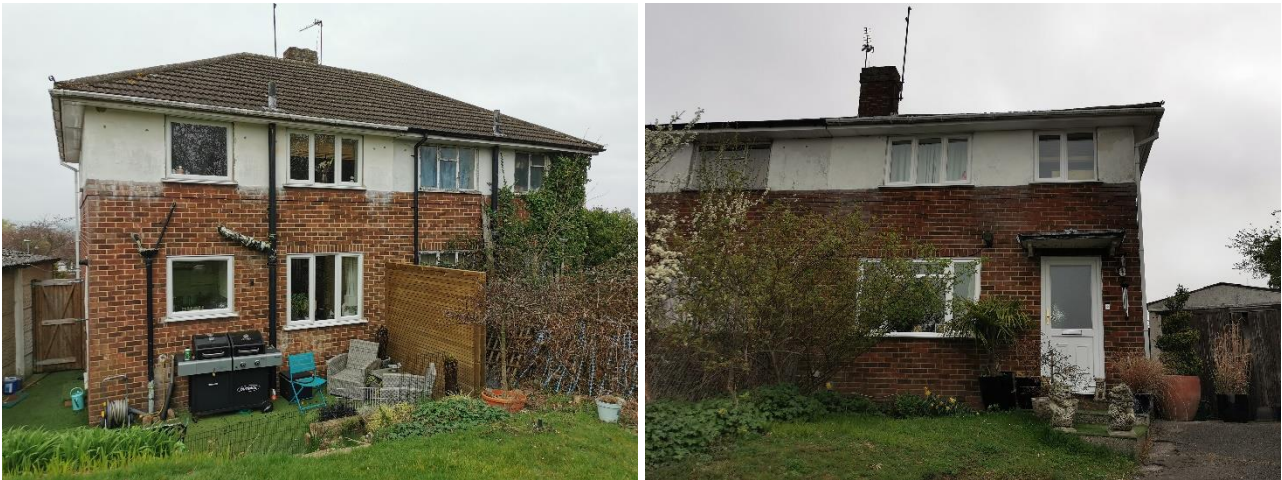
The dwelling on site is an occupied, semi-detached, two-storey building of brick construction, with a rendered upper level. The building supports a hipped roof, covered by interlocking concrete tiles.

Figure 3. View of the rear/eastern (left) and front/western (right) elevations of the dwelling

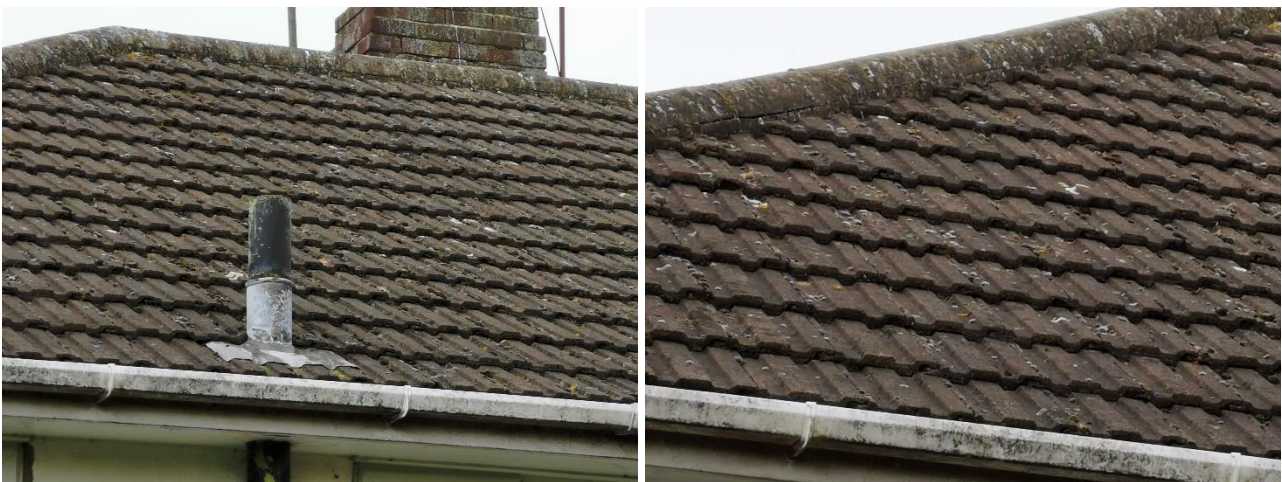
The brickwork is in a good state of repair, with no cracks, holes or areas of missing mortar present. The roof tiles are also in a good condition and tightly fitted, with no missing, misaligned, broken or lifted tiles recorded (Figures 4 & 5). Similarly, the ridge tiles are also in a good state of repair with no areas of missing mortar recorded. The uPVC soffit is tightly fitted along the eaves, with no gaps present (Figure 6). A single flue is present in the rear elevation, along with a brick chimney in the front elevation of the building. The lead flashing around the base of both of these features is tightly fitted (Figure 7).

Figure 4. Example of roof tiles in a good condition

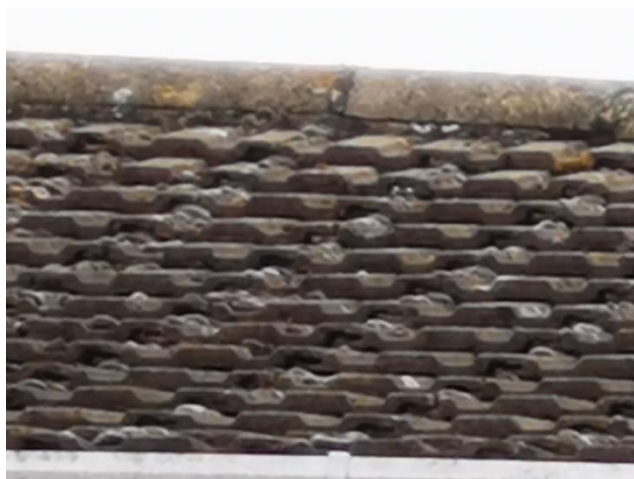
Figure 5. Example of roof tiles in a good condition

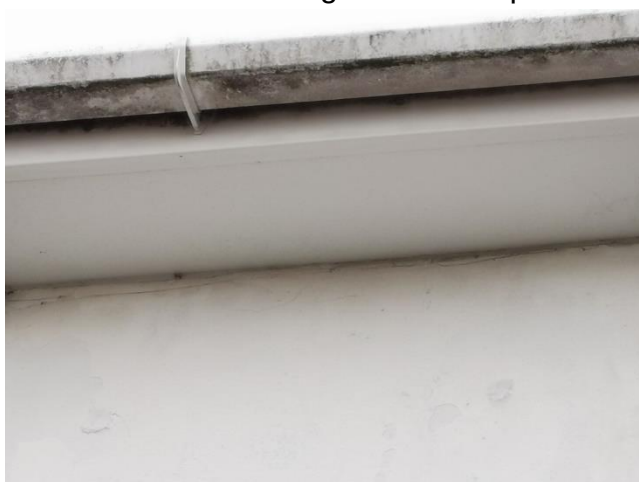
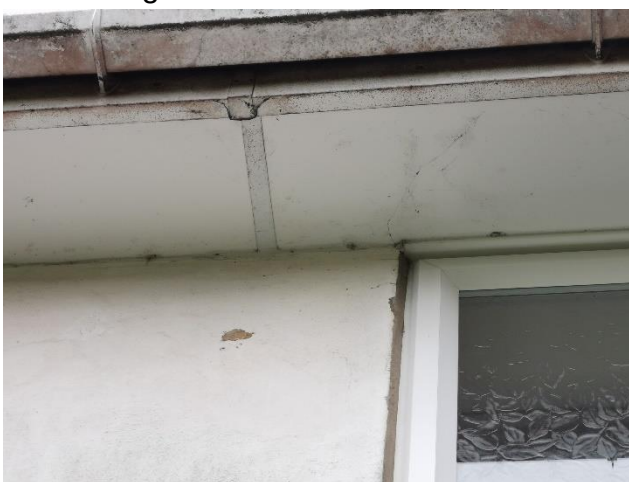
Figure 6. Example of tightly fitted soffit

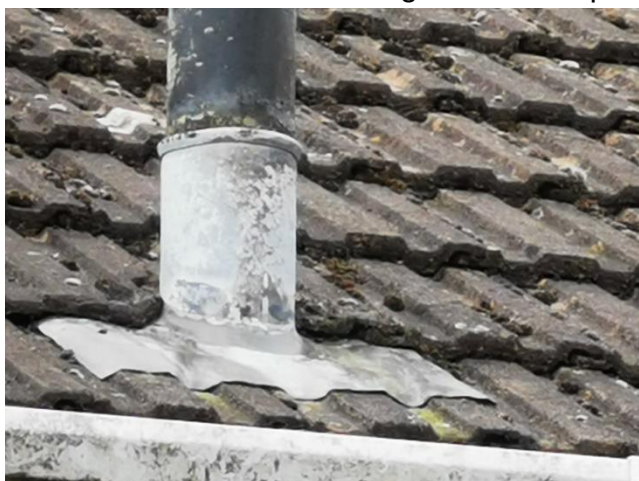
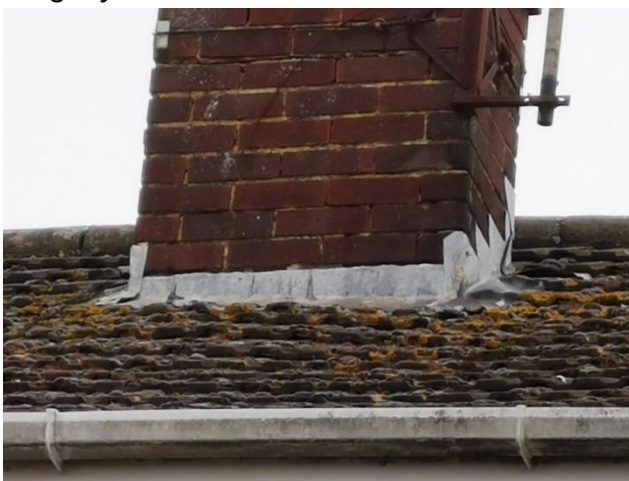
Figure 7. View of the lead flashing around the base of the flue and chimney

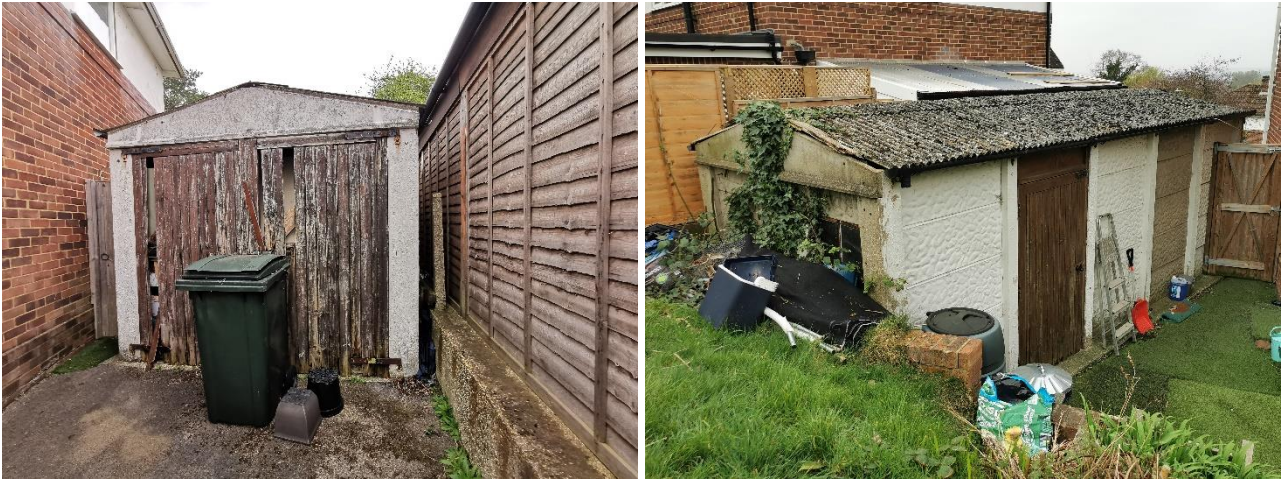
To the south of the main dwelling on site is a detached garage with concrete walls and a pitched roof covered by corrugated (potentially asbestos) sheets (Figure 8). The eastern elevation of the garage supports single-glazed windows, with the western elevation supporting a wooden door. A single potential entry point into the garage was recorded where the corrugated roof sheet joins the concrete gable-end (Figure 9).

Figure 8. View of the detached garage on site

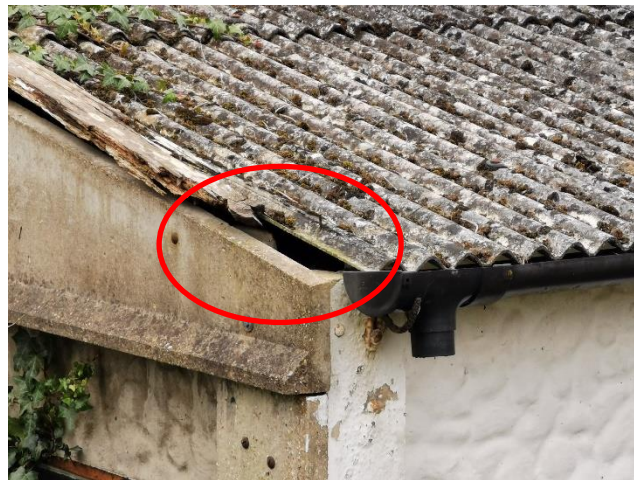
Figure 9. View of the potential access point into the garage

Whilst a potential access point into the garage was recorded at the time of survey, internally there are no suitable roosting features present for bats and therefore the detached garage in the south is considered to be of negligible potential for roosting bats.

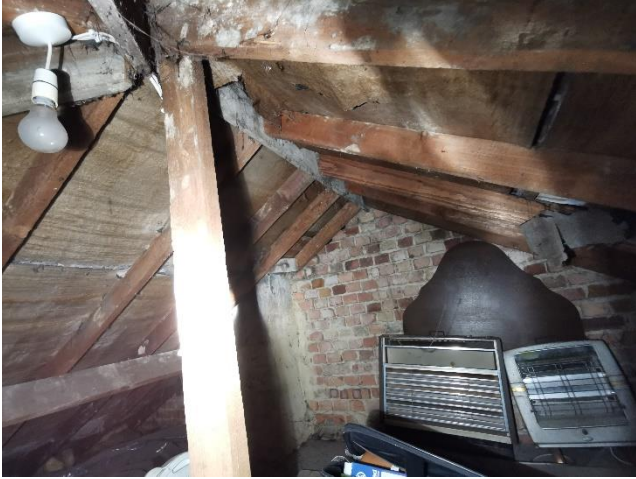
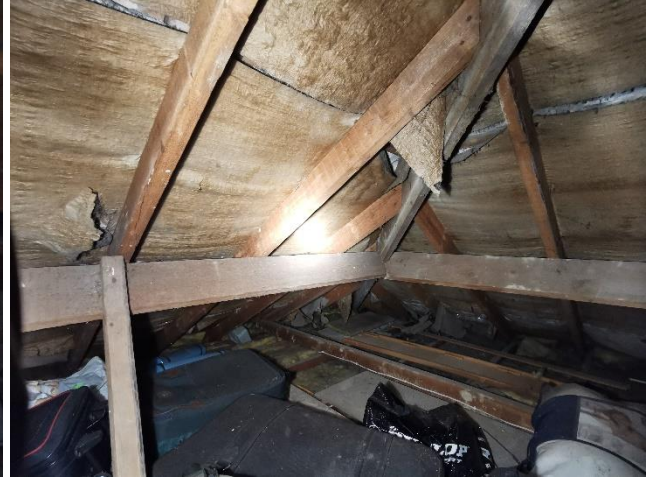
Internally, a small loft is present (Figures 10 & 11). The floor to apex height is approximately 1m and the loft floor is insulated. Roofing felt is present between the roof tiles and the timber rafters. The roofing felt is in a poor state of repair with some areas of sagging and cuts/tears present (Figures 12 & 13). A ridge beam is also present. A brick gable separates the loft void from the neighbouring loft. No light entered the loft void, indicating that it is well-sealed.

Figure 10. Internal view of the loft void

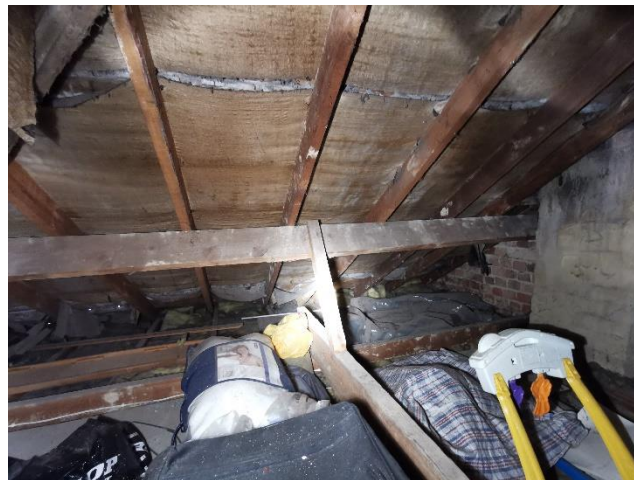
Figure 11. Internal view of the loft void

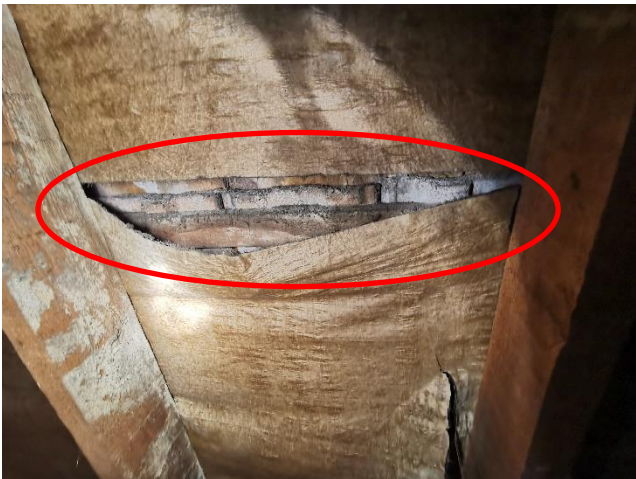
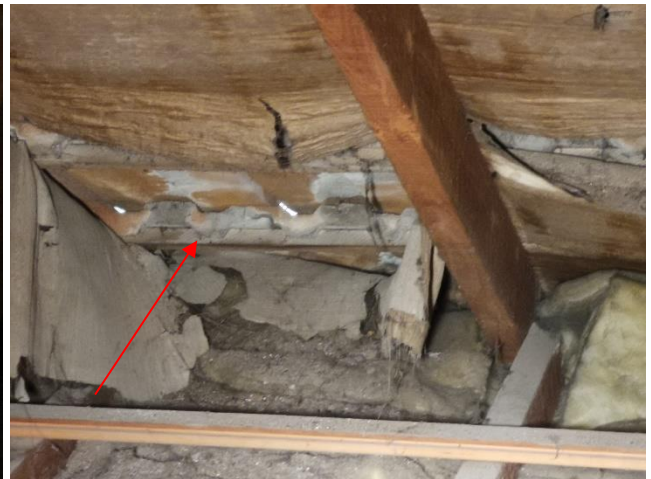
Figure 12. Example of tears/cuts in the roofing felt

No evidence of roosting bats in the form of droppings, urine staining, scratch marks or feeding remains was present within the loft. Whilst the roof underlay is in a poor condition, the interlocking concrete roof tiles are tightly fitted onto the battens and did not provide any potential access into the loft space and PRFs. Therefore, due to the lack of evidence and well-sealed nature of the dwelling on site, it is appointed a negligible value for roosting bats.

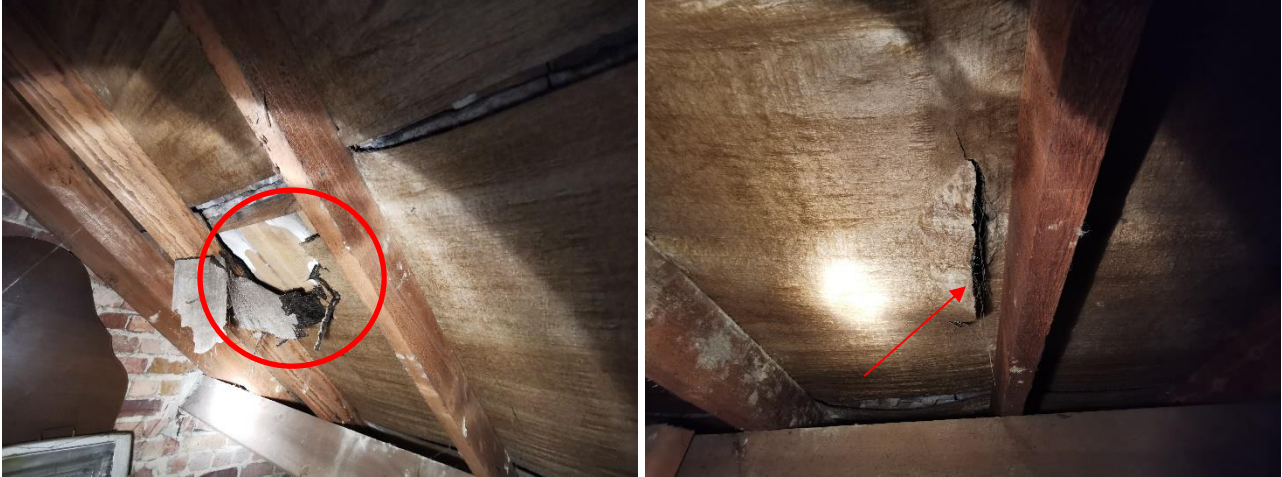
Figure 13. Example of tears/cuts in the roofing felt
